Cultural Heritage Impact Statement—12862 Dixie Road, Town of Caledon

FINAL

Decemebr 15, 2023

File: 160940773

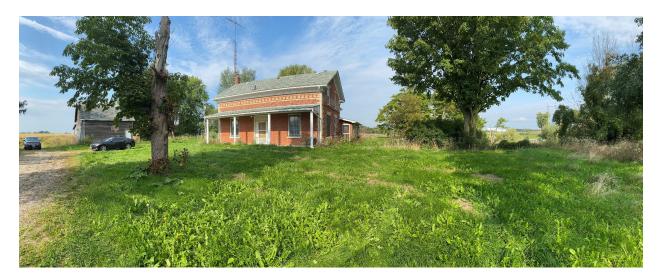
Photo 7: Residence, adjacent trees and outbuilding looking northwest

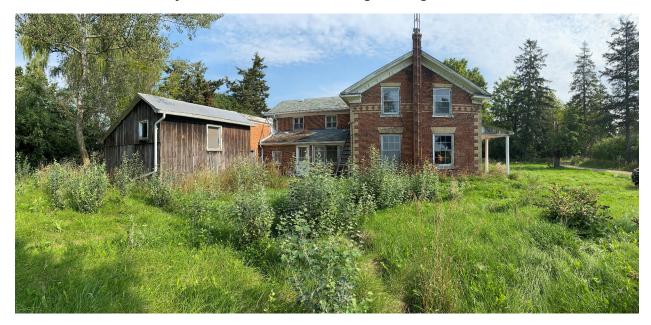
Photo 8: Residence and adjacent trees looking east

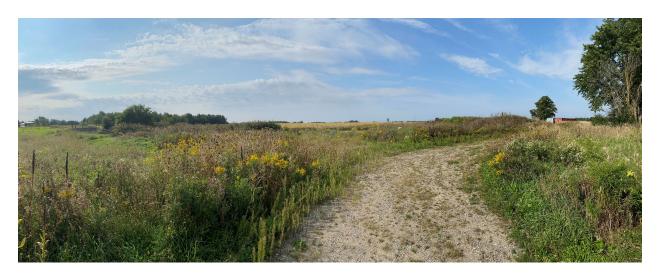
Photo 9: Adjacent fields to residence looking west

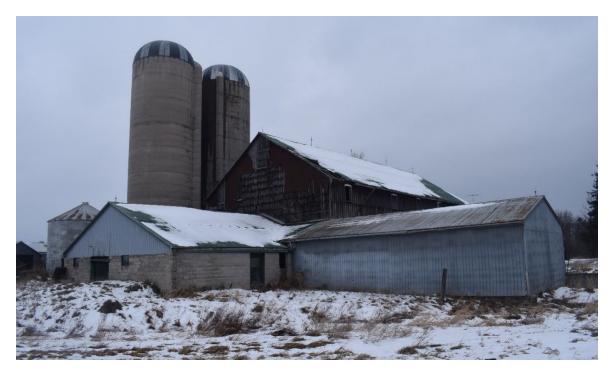
Photo 66: Looking northeast at the barn, showing gable roof, lighting rods, and gable roof additions

A structural assessment of the barn was completed by Stephenson Engineering on February 4, 2021 (Appendix A). The report concluded that several areas of the barn were unsafe to access due to rotting wood and deck beams. A portion of the exterior perimeter wall of rubblestone had collapsed at the north side, and vertical cracks were identified on the wall, both resulting from settling and freeze/thaw conditions and shear load resulting in differential settlement of the wall footings. Several original timber

beams had decayed at their bearing connection to the masonry walls. The report concluded the barn to be structurally inadequate and in poor condition, requiring extensive remediation or demolition to make it safe for use (Stephenson Engineering 2021). As such, the barn was removed in 2021.
