ARBORIST REPORT

Hunsden Sideroad Residential

10249 Hunsden Sideroad
Caledon, Ontario

Revised: April 3, 2024

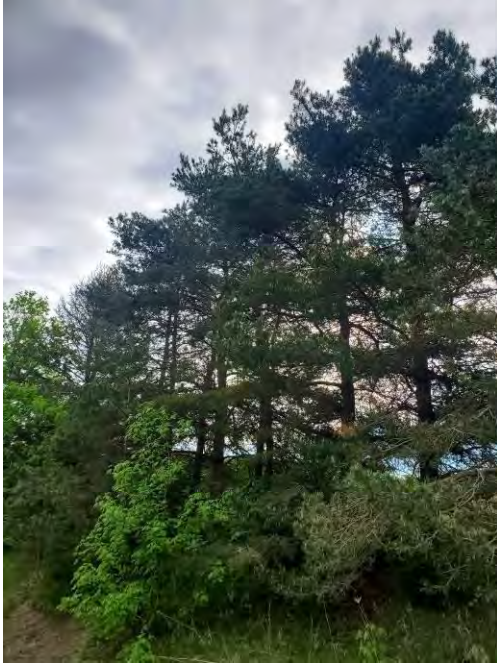
Figure 3: Trees of group 1.

Tree Number	Species	DBH (cm)	Canopy diameter (m)	Biological Health	Structural Condition	Recommended Action	Comments	Location
1a	Pinus sylvestris (Scots Pine)	33	7	H	MH	P	Multibranch node and backfilled.	M
1b	Pinus sylvestris (Scots Pine)	21	7	H	H	P	Backfilled.	M
1c	Pinus sylvestris (Scots Pine)	24	7	H	H	P	Backfilled.	M
1d	Pinus sylvestris (Scots Pine)	15, 14	5	H	M	P	Multi-leader with included bark from 0.15m-0.3m ht. and backfilled.	M
1e	Pinus sylvestris (Scots Pine)	26	7	H	H	P	Backfilled.	M
1f	Pinus sylvestris (Scots Pine)	22	6	H	H	P	Backfilled.	M
1g	Pinus sylvestris (Scots Pine)	20	6	H	H	P	Backfilled.	M
1h	Pinus sylvestris (Scots Pine)	22.5	6	H	H	P	Backfilled.	M
2	Picea glauca (White Spruce)	44	8	M	H	P	Branch tips with dieback of 30% of canopy.	M
3	Acer negundo (Manitoba Maple)	41, 33, 31	12	M	M	P	Three leaders, approx. 20 medium-sized dead branches, emerging included bark at the main union.	M
4	Pinus sylvestris (Scots Pine)	~15	n/a	D	D	P	Dead.	M

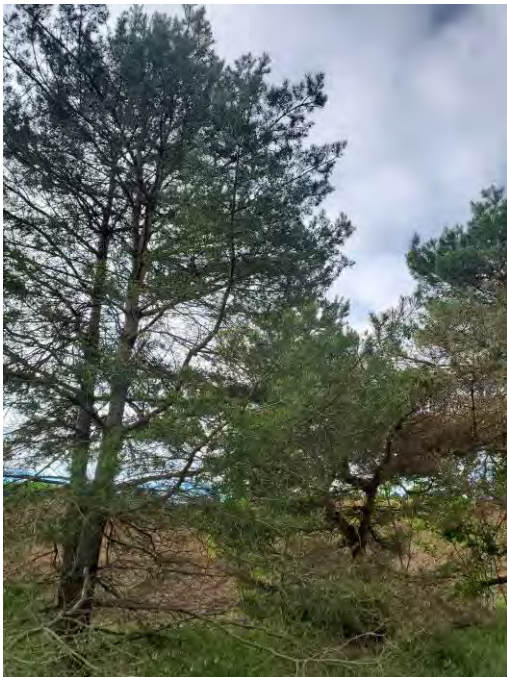
Figure 5: Tree 8.

6	Pinus sylvestris (Scots Pine)	39	7	H	M	P	Large limb of 15cm dia. Torn off with ripping wound, co-dominant leaders, and backfilled.	M
7	Pinus sylvestris (Scots Pine)	21	4	ML	M	P	Backfilled, canopy 60% dead.	M
8	Pinus sylvestris (Scots Pine)	21.5, 25	6	H	M	RC	Co-dominant leaders with included bark (10cm length), backfilled, medium branch fused with 2 leaders.	M
9	Pinus sylvestris (Scots Pine)	32	6	H	MH	RC	Large broken limb, branch stubs with ripping wound.	M
10	Acer negundo (Manitoba Maple)	25.5	7	H	M	P	Multiple limbs cut at base.	M
11	Pinus sylvestris (Scots Pine)	31.5	6	MH	H	P	Some defoliation on twigs, 1 limb broken at branch collar.	M
12	Pinus sylvestris (Scots Pine)	21	4	ML	ML	P	Unbalanced canopy to west, zig zag branch from on leader. Wound on leader with 30% trunk circumference.	M
13	Pinus sylvestris (Scots Pine)	29.5	6	H	MH	P	Co-dominant leaders.	M
14	Pinus sylvestris (Scots Pine)	46	9	H	M	P	Co-dominant leaders with included bark from 4m to 5.5m ht.	M

In addition trees 8 and 9 are municipal trees that would require removal in order to install the road into the subdivision.

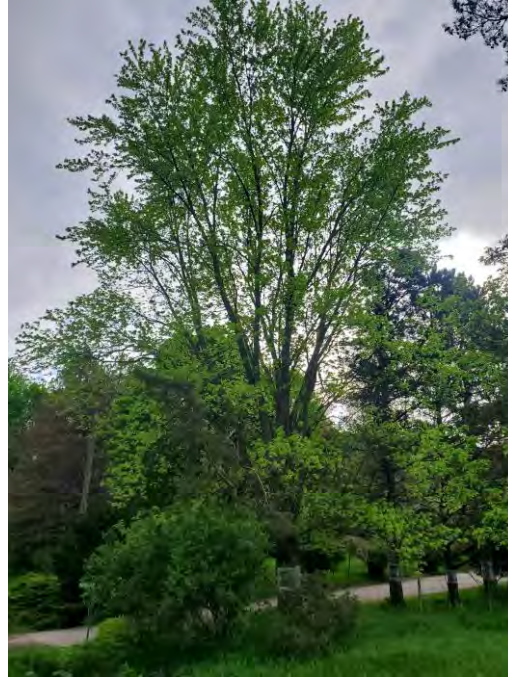
Figure 8: Trees 16 in foreground

15	Pinus sylvestris (Scots Pine)	17	5	M	M	P		M
16	Acer saccharinum (Silver Maple)	~70	14	MH	M	P	Multiple leaders from 2m ht., included bark at 6m ht. Has wrap on trunk for pest.	N
17	Pinus nigra (Austrian Pine)	~45	7	M	M	P	Co-dominant leaders from 6m ht. with medium sized branch fused between them and browning foliage. Has wrap on trunk for pest.	N
18	Pinus nigra (Austrian Pine)	~30	5	M	M	P	Unbalanced canopy to west and browning foliage. Has wrap on trunk for pest.	N
19	Pinus nigra (Austrian Pine)	~50	7	MH	H	P	Browning foliage and has wrap on trunk for pest.	N
20	Picea glauca (White Spruce)	~25	5	H	H	P	Has wrap on trunk for pest.	N
21	Picea glauca (White Spruce)	~25	5	MH	H	P	Suppressed branches at 10 - 15m from #22 but top is in leaf. Has wrap on trunk for pest.	N

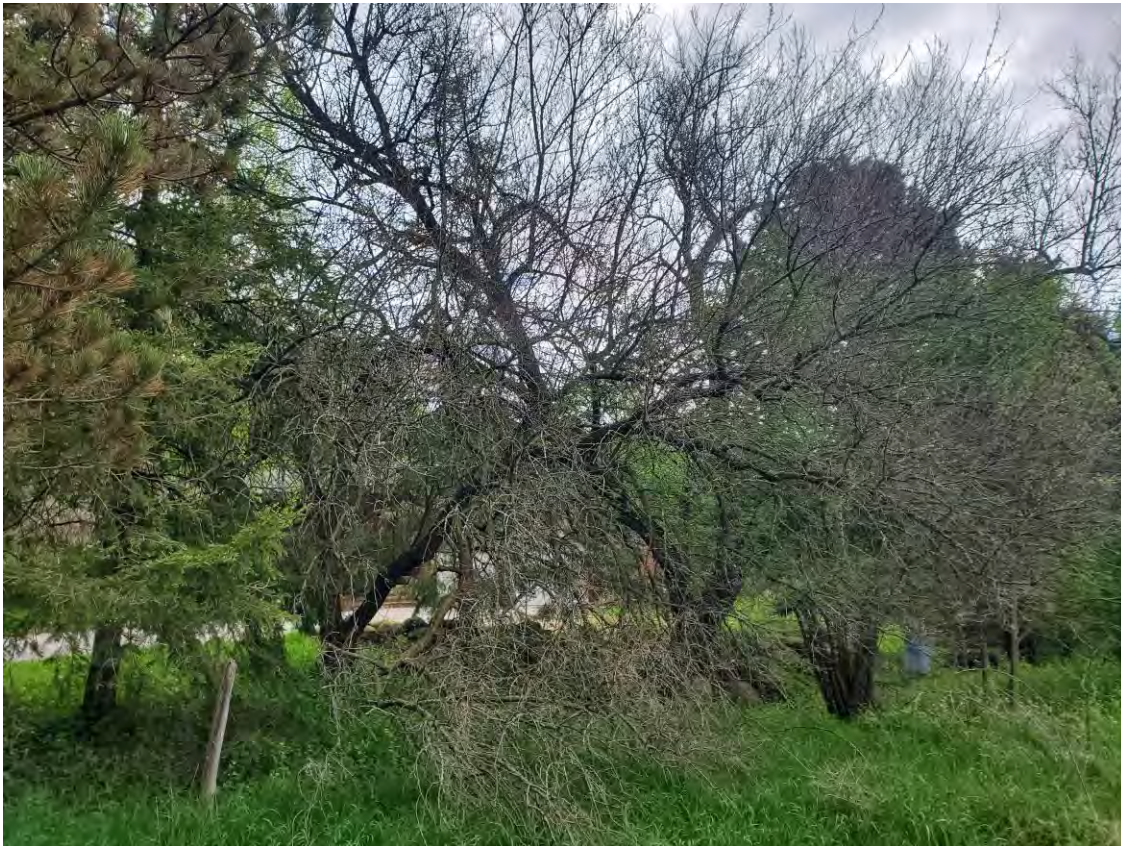
Figure 9: Trees 21-24

22	Eleagnus angustifolius (Russian Olive)	~25, ~20	10	ML	M	P	Co-dominant, limb/trunk leans 45° to east and to west, slower canopy has a lot of dieback (50%).	N
23	Eleagnus angustifolius (Russian Olive)	~45, ~25	11	M	M	P	Fusing branch on trunk, 3 leaders, leans 45° to north and west, and grown on stone slope.	N
24	Pinus nigra (Austrian Pine)	~60	8	MH	MH	P	Co-dominant leaders, and wrap on trunk for pest.	N
25	Picea glauca (White Spruce)	~40	6	H	H	P		N
26	Picea glauca (White Spruce)	~35	6	H	H	P		N
27	Picea glauca (White Spruce)	~35	6	H	H	P		N
28	Picea glauca (White Spruce)	~20	4	H	H	P		N
29	Picea glauca (White Spruce)	~35	5	H	H	P		N
30	Picea glauca (White Spruce)	~30	5	H	H	P		N
31	Picea glauca (White Spruce)	~20	4	M	H	P	Suppressed at top 4m.	N
32	Acer negundo (Manitoba Maple)	40.5	10	H	M	P	Unbalanced canopy to west, leans 10° to west, and included bark at main union.	N
33	Picea glauca (White Spruce)	~35	5	H	H	P	Unbalanced canopy to east.	N

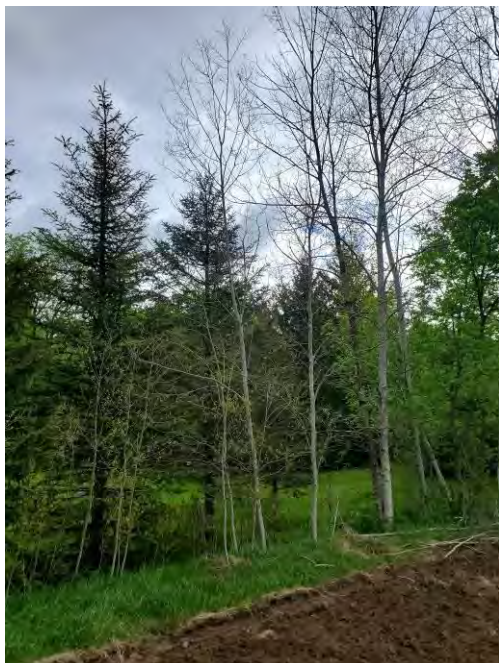
Figure 11: Trees around tree 37

34	Picea glauca (White Spruce)	~30	5	H	H	P	Unbalanced canopy to southwest.	N
35	Picea glauca (White Spruce)	~20	4	H	H	P		N
36	Picea glauca (White Spruce)	~18	4	H	H	P	Has wrap on trunk for pest.	N
37	Populus tremuloides (Trembling Aspen)	20	5	ML	ML	P	Co-dominant leaders with one leader dead, remaining leader has 25% dead branches in lower canopy.	S
38	Populus tremuloides (Trembling Aspen)	18	4	MH	MH	P	Wound with rot at 0.3m ht.	S
39	Populus tremuloides (Trembling Aspen)	20	5	MH	MH	P	One leader cut at the base with fungus fruiting bodies and 20% of canopy dead particularly in lower canopy.	S

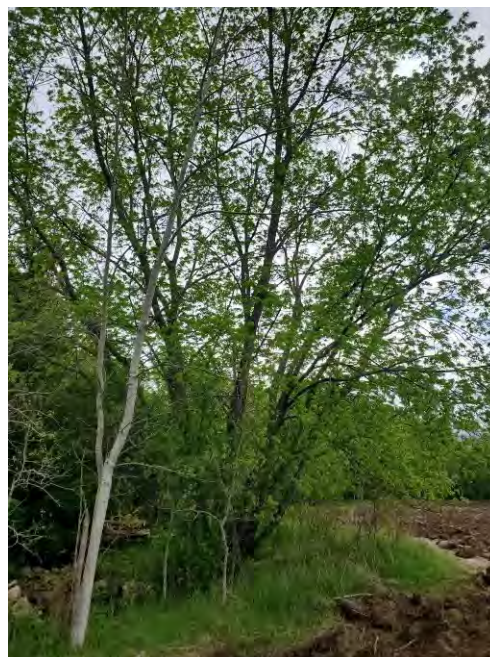
Figure 12: Trees 42 - 49.

40	Populus tremuloides (Trembling Aspen)	20	7	M	ML	P	Multiple leaders with included bark at base to 0.3m ht. One leader has 75% of canopy dead 2 leaders are in satisfactory health.	N
41	Acer saccharinum (Silver Maple)	~35 x1, ~30 x1, ~25 x2, ~20 x3, ~15 x3, ~10 x6	14	H	M	P	Multiple leaders with numerous points of fusing.	N
42	Picea glauca (White Spruce)	~20	4	M	M	P	Leader with dieback and new leader emerging.	N
43	Picea glauca (White Spruce)	~15	5	H	H	P		N
44	Acer platanoides (Norway Maple)	~45	9	H	H	P		N
45	Acer platanoides (Norway Maple)	~25, ~25	9	H	M	P	Co-dominant leader and included bark.	N
46	Acer platanoides (Norway Maple)	~50	9	H	H	P		N
47	Tilia americana (Basswood)	52, 28, 58	10	H	M	P	Three leaders with included bark.	S
48	Acer saccharum (Sugar Maple)	48	8	H	MH	P	Unbalanced canopy to northwest.	S
49	Acer saccharum (Sugar Maple)	25, 67	12	MH	M	RC	Co-dominant leaders with included bark. The smaller leader is hollow with wound of 25% trunk circumference and main leader leans 10° to south.	S

Of those trees that are over 15cm DBH on the subject site, remove trees #49, 50, 51, 52, 53 and 54 for construction as identified on the Tree Inventory & Preservation Plan. This is a total of 6 trees.

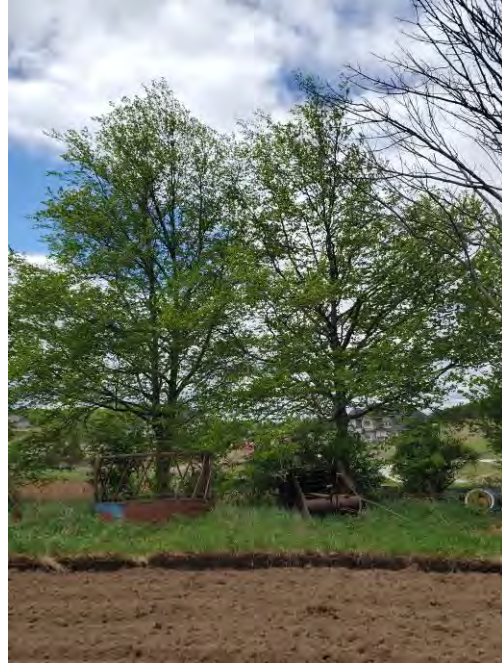
Figure 14: Trees 55 to 56

54	<i>Ostrya virginiana</i> (Ironwood)	28, 27	8	H	H	RC		S
55	<i>Ostrya virginiana</i> (Ironwood)	31, 30	8	H	M	P	Co-dominant leaders with included bark.	S
56	<i>Ostrya virginiana</i> (Ironwood)	35	10	H	H	P		S
57	<i>Fraxinus</i> sp. (Ash)	~30 x4	6	D	D	R	Dead	S
58	<i>Tilia americana</i> (Basswood)	24	6	H	H	P		S
59	<i>Fraxinus</i> sp. (Ash)	65	10	L	L	R	Dying, 50% canopy is dead.	S
60	<i>Crataegus monogyna</i> (European Hawthorn)	25, 25, 30	7	M	M	P	Canopy is 50% dead, multiple leaders, and a large wound on trunk of 50% circumference.	S
61	<i>Acer saccharum</i> (Sugar Maple)	30	4	M	M	P	Leader topped and resprouted.	N
62	<i>Acer saccharum</i> (Sugar Maple)	15	5	H	H	P		S
B1	<i>Juglans cinerea</i> (Butternut)	13	5	MH	M	P	Has a wound of 30% of trunk circumference from a fallen tree, rot is apparent, but growth is showing at all branch tips.	S
B2	<i>Juglans cinerea</i> (Butternut)	18	5	H	MH	P	Fusing branch with trunk leaving wound and growth showing at all branch tips.	S
