ARBORIST REPORT

Hunsden Sideroad Residential

10249 Hunsden Sideroad
Caledon, Ontario

Revised: April 3, 2024

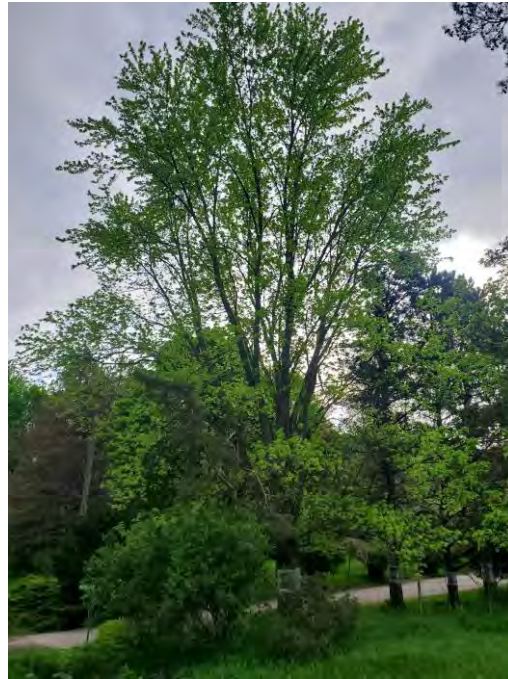
Figure 8: Trees 16 in foreground

15	Pinus sylvestris (Scots Pine)	17	5	M	M	P		M
16	Acer saccharinum (Silver Maple)	~70	14	MH	M	P	Multiple leaders from 2m ht., included bark at 6m ht. Has wrap on trunk for pest.	N
17	Pinus nigra (Austrian Pine)	~45	7	M	M	P	Co-dominant leaders from 6m ht. with medium sized branch fused between them and browning foliage. Has wrap on trunk for pest.	N
18	Pinus nigra (Austrian Pine)	~30	5	M	M	P	Unbalanced canopy to west and browning foliage. Has wrap on trunk for pest.	N
19	Pinus nigra (Austrian Pine)	~50	7	MH	H	P	Browning foliage and has wrap on trunk for pest.	N
20	Picea glauca (White Spruce)	~25	5	H	H	P	Has wrap on trunk for pest.	N
21	Picea glauca (White Spruce)	~25	5	MH	H	P	Suppressed branches at 10 - 15m from #22 but top is in leaf. Has wrap on trunk for pest.	N

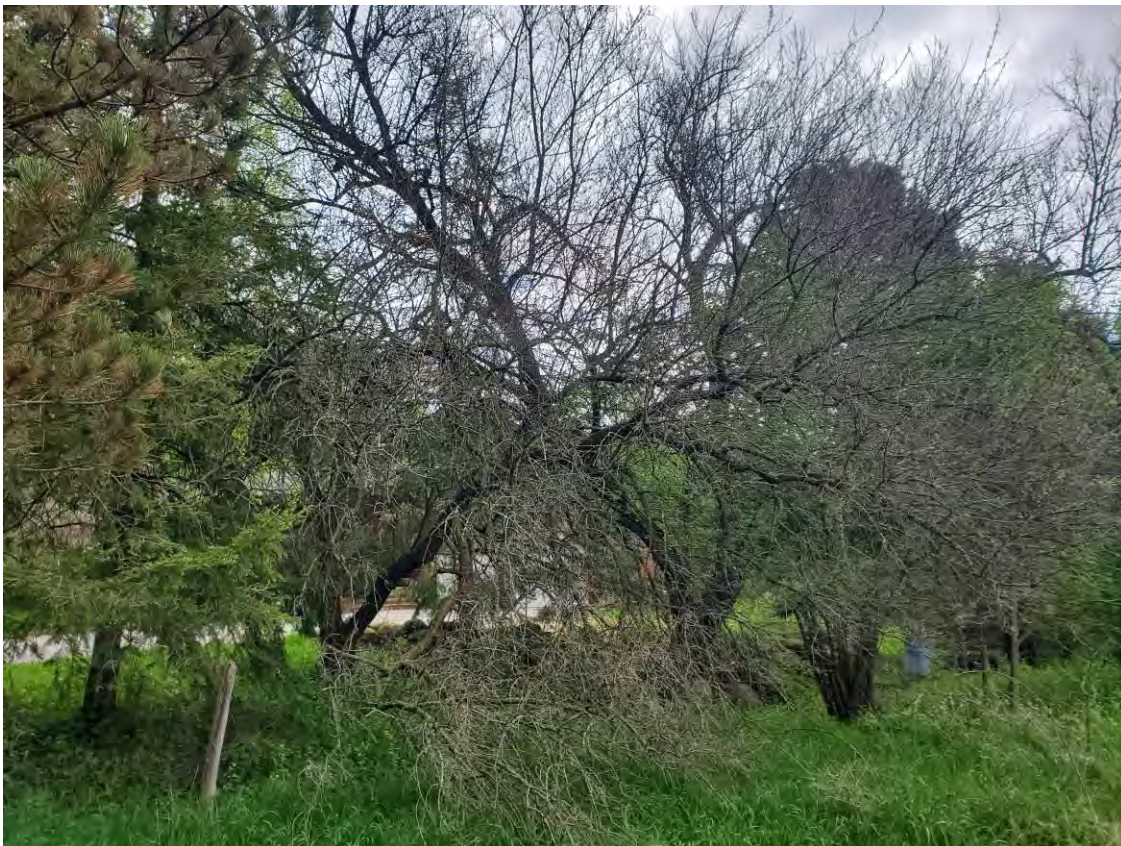
Figure 9: Trees 21-24

22	Eleagnus angustifolius (Russian Olive)	~25, ~20	10	ML	M	P	Co-dominant, limb/trunk leans 45° to east and to west, slower canopy has a lot of dieback (50%).	N
23	Eleagnus angustifolius (Russian Olive)	~45, ~25	11	M	M	P	Fusing branch on trunk, 3 leaders, leans 45° to north and west, and grown on stone slope.	N
24	Pinus nigra (Austrian Pine)	~60	8	MH	MH	P	Co-dominant leaders, and wrap on trunk for pest.	N
25	Picea glauca (White Spruce)	~40	6	H	H	P		N
26	Picea glauca (White Spruce)	~35	6	H	H	P		N
27	Picea glauca (White Spruce)	~35	6	H	H	P		N
28	Picea glauca (White Spruce)	~20	4	H	H	P		N
29	Picea glauca (White Spruce)	~35	5	H	H	P		N
30	Picea glauca (White Spruce)	~30	5	H	H	P		N
31	Picea glauca (White Spruce)	~20	4	M	H	P	Suppressed at top 4m.	N
32	Acer negundo (Manitoba Maple)	40.5	10	H	M	P	Unbalanced canopy to west, leans 10° to west, and included bark at main union.	N
33	Picea glauca (White Spruce)	~35	5	H	H	P	Unbalanced canopy to east.	N

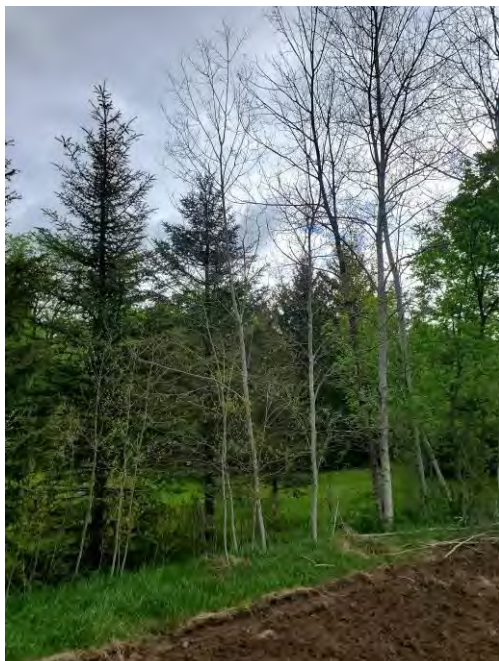
Figure 11: Trees around tree 37

34	Picea glauca (White Spruce)	~30	5	H	H	P	Unbalanced canopy to southwest.	N
35	Picea glauca (White Spruce)	~20	4	H	H	P		N
36	Picea glauca (White Spruce)	~18	4	H	H	P	Has wrap on trunk for pest.	N
37	Populus tremuloides (Trembling Aspen)	20	5	ML	ML	P	Co-dominant leaders with one leader dead, remaining leader has 25% dead branches in lower canopy.	S
38	Populus tremuloides (Trembling Aspen)	18	4	MH	MH	P	Wound with rot at 0.3m ht.	S
39	Populus tremuloides (Trembling Aspen)	20	5	MH	MH	P	One leader cut at the base with fungus fruiting bodies and 20% of canopy dead particularly in lower canopy.	S

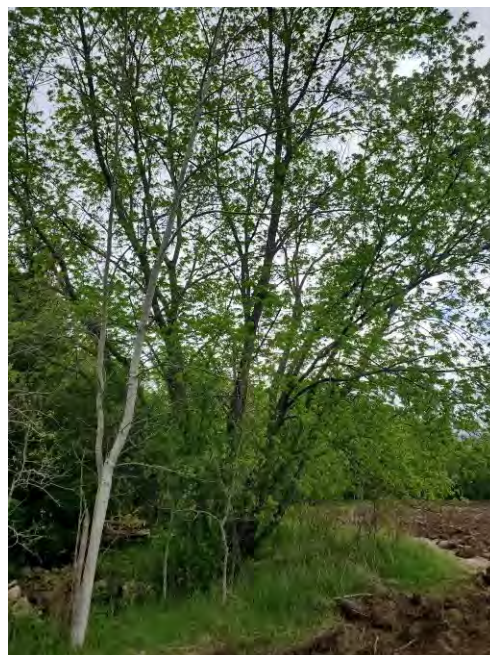
Figure 12: Trees 42 - 49.

40	Populus tremuloides (Trembling Aspen)	20	7	M	ML	P	Multiple leaders with included bark at base to 0.3m ht. One leader has 75% of canopy dead 2 leaders are in satisfactory health.	N
41	Acer saccharinum (Silver Maple)	~35 x1, ~30 x1, ~25 x2, ~20 x3, ~15 x3, ~10 x6	14	H	M	P	Multiple leaders with numerous points of fusing.	N
42	Picea glauca (White Spruce)	~20	4	M	M	P	Leader with dieback and new leader emerging.	N
43	Picea glauca (White Spruce)	~15	5	H	H	P		N
44	Acer platanoides (Norway Maple)	~45	9	H	H	P		N
45	Acer platanoides (Norway Maple)	~25, ~25	9	H	M	P	Co-dominant leader and included bark.	N
46	Acer platanoides (Norway Maple)	~50	9	H	H	P		N
47	Tilia americana (Basswood)	52, 28, 58	10	H	M	P	Three leaders with included bark.	S
48	Acer saccharum (Sugar Maple)	48	8	H	MH	P	Unbalanced canopy to northwest.	S
49	Acer saccharum (Sugar Maple)	25, 67	12	MH	M	RC	Co-dominant leaders with included bark. The smaller leader is hollow with wound of 25% trunk circumference and main leader leans 10° to south.	S

Of those trees that are over 15cm DBH on the subject site, remove trees #49, 50, 51, 52, 53 and 54 for construction as identified on the Tree Inventory & Preservation Plan. This is a total of 6 trees.
