Project Title
Carringwood Homes
Hunsden Residential
10249 Hunsden Sideroad
Town of Caledon, ON
TREE INVENTORY & PROTECTION PLAN

Date Issued
April 2022

Sheet Number File Number
TS.1

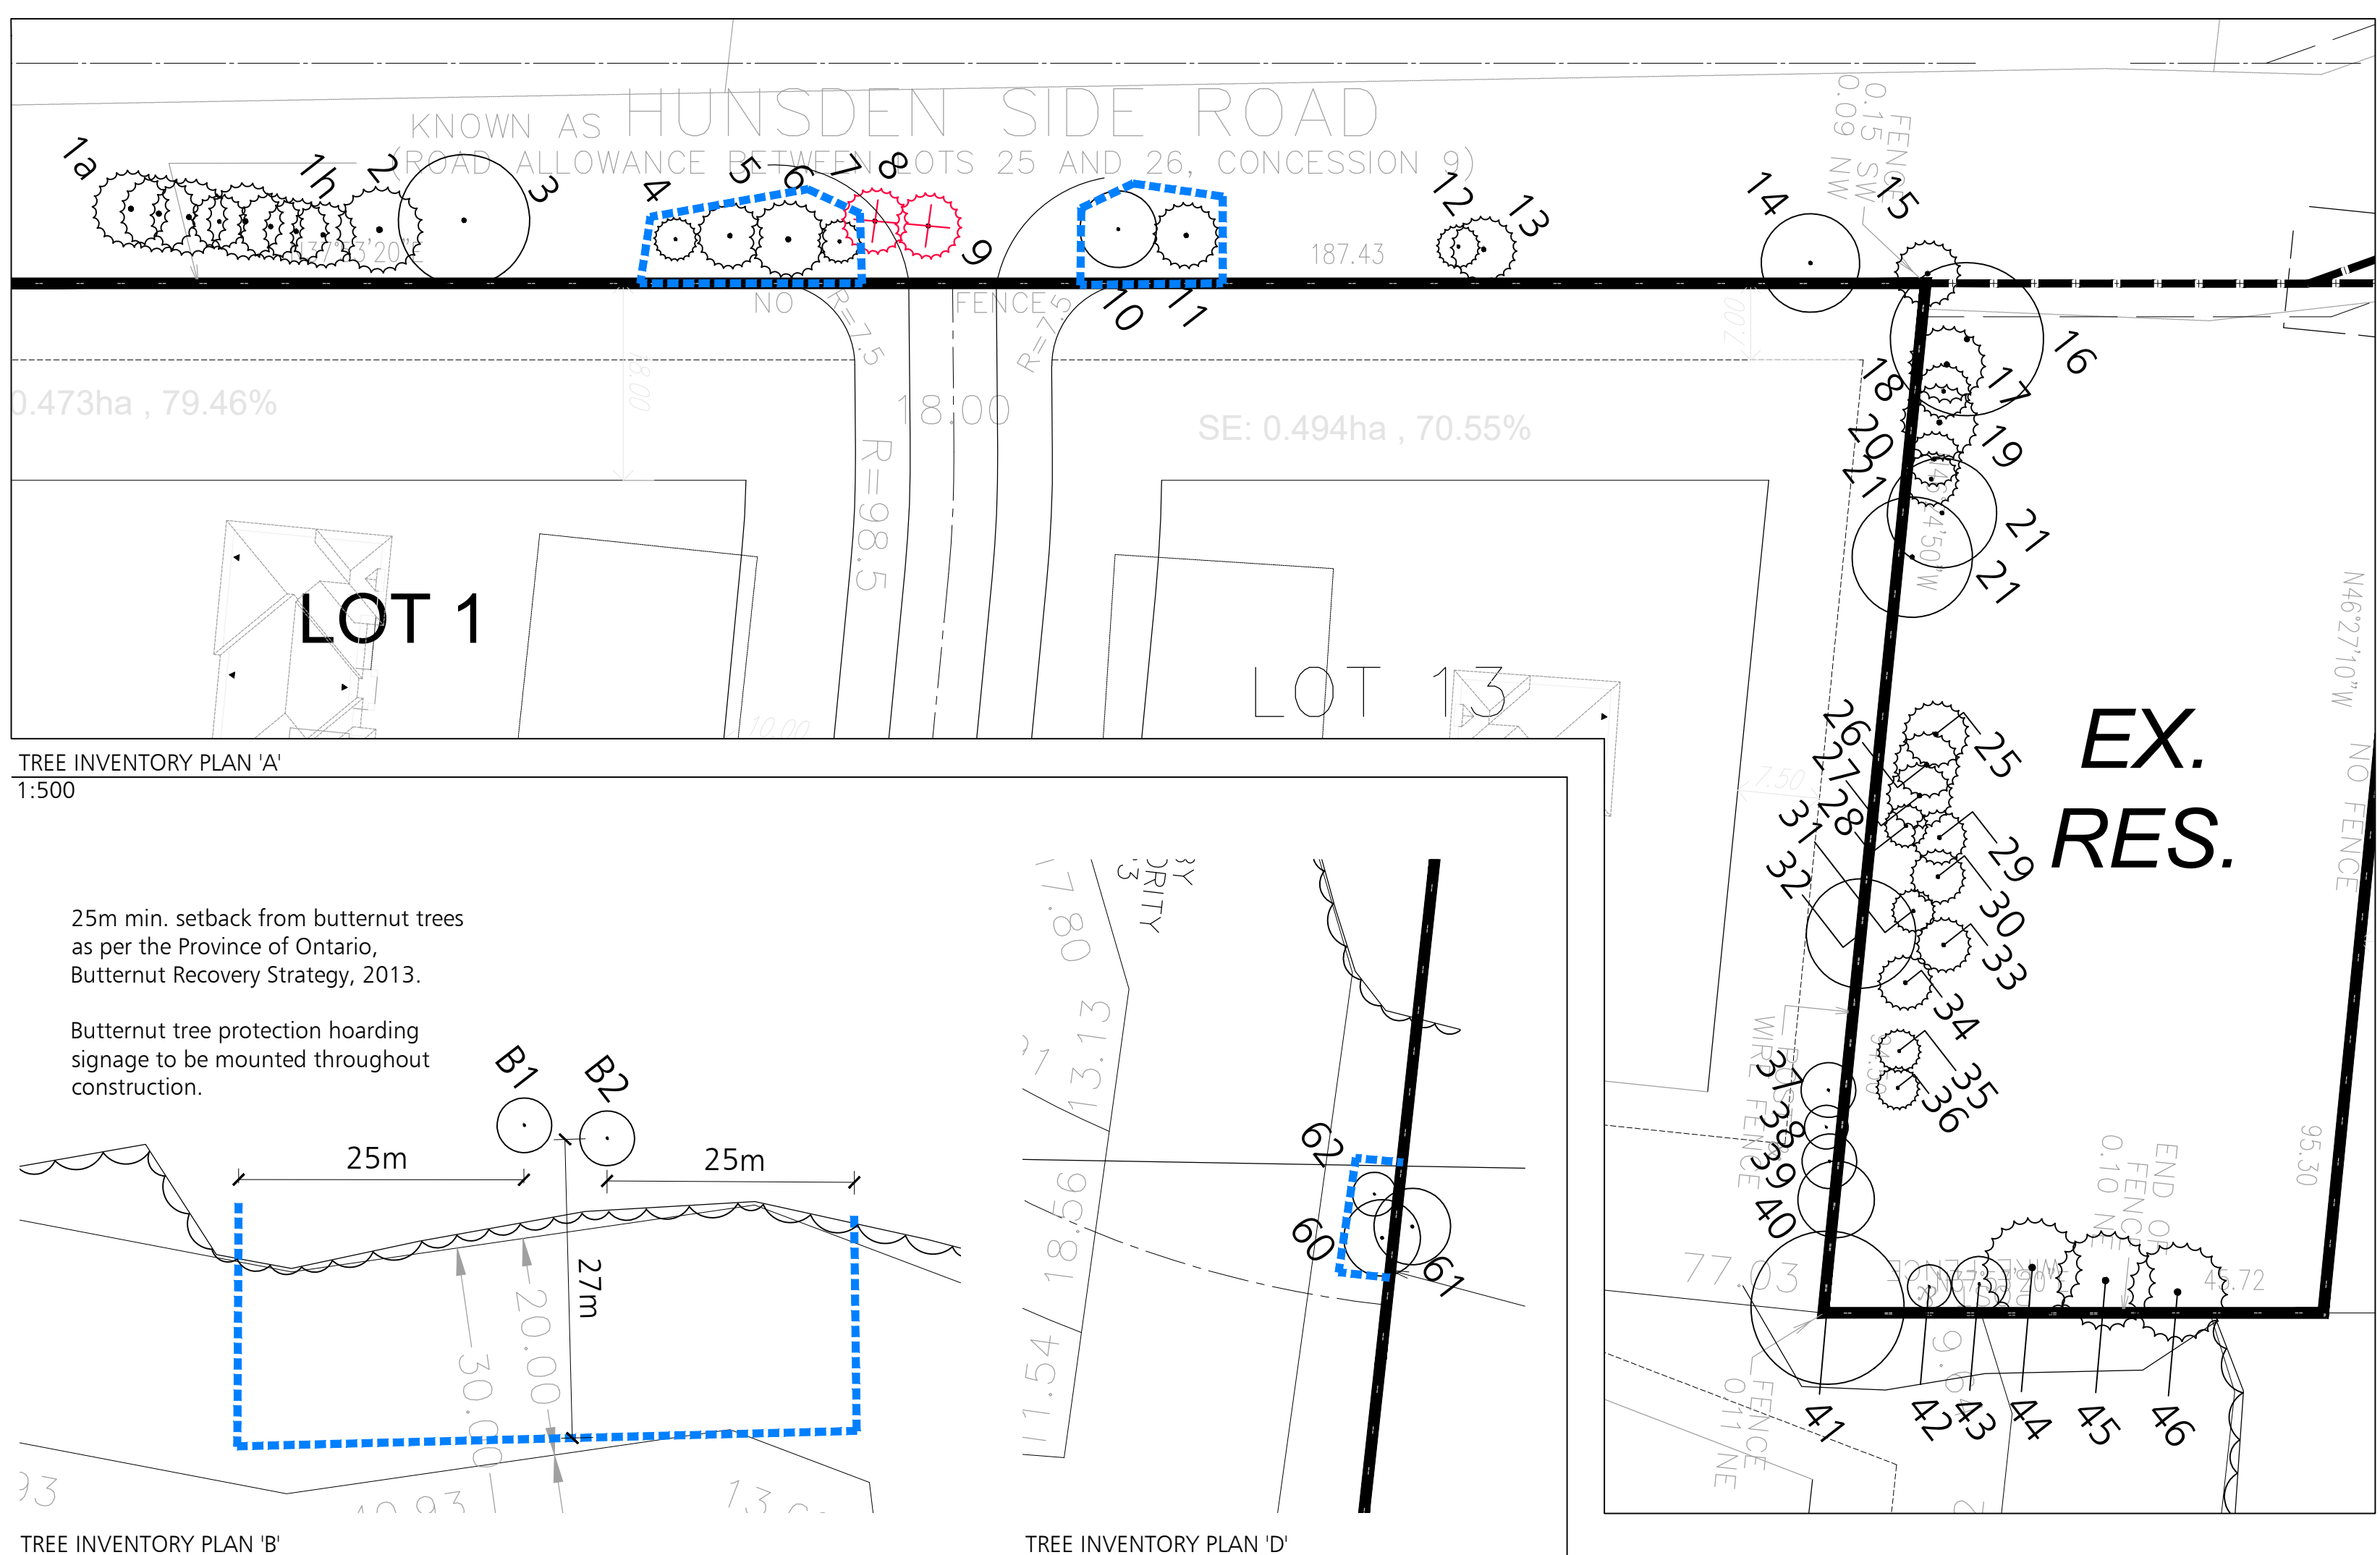
TREE INVENTORY PLAN 'A'
1:500

ID	Species	DBH (cm)	Canopy diameter (m)	Biological Health	Structural Condition	Recommended Action	Comments	Location
1a	Pinus sylvestris (Scots Pine)	33	7	H	MH	P	Multibranch node and backfilled.	M
1b	Pinus sylvestris (Scots Pine)	21	7	H	H	P	Backfilled.	M
1c	Pinus sylvestris (Scots Pine)	24	7	H	H	P	Backfilled.	M
1d	Pinus sylvestris (Scots Pine)	15, 14	5	H	M	P	Multi-leader with included bark from 0.15m-0.3m ht. and backfilled.	M
1e	Pinus sylvestris (Scots Pine)	26	7	H	H	P	Backfilled.	M
1f	Pinus sylvestris (Scots Pine)	22	6	H	H	P	Backfilled.	M
1g	Pinus sylvestris (Scots Pine)	20	6	H	H	P	Backfilled.	M
1h	Pinus sylvestris (Scots Pine)	22.5	6	H	H	P	Backfilled.	M
2	Picea glauca (White Spruce)	44	8	M	H	P	Branch tips with dieback of 30% of canopy.	M
3	Acer negundo (Manitoba Maple)	41, 33, 31	12	M	M	P	Three leaders, approx. 20 medium-sized dead branches, emerging included bark at the main union.	M
4	Pinus sylvestris (Scots Pine)	-15	6	D	D	P	Dead.	M

5	Pinus sylvestris (Scots Pine)	29	6	H	H	P	Backfilled.	M
6	Pinus sylvestris (Scots Pine)	39	7	H	M	P	Large limb of 15cm dia. Torn off with ripping wound, co-dominant leaders, and backfilled.	M
7	Pinus sylvestris (Scots Pine)	21	4	ML	M	P	Backfilled, canopy 60% dead.	M
8	Pinus sylvestris (Scots Pine)	21.5, 25	6	H	M	RC	Co-dominant leaders with included bark (10cm length), backfilled, medium branch fused with 2 leaders.	M
9	Pinus sylvestris (Scots Pine)	32	6	H	MH	RC	Large broken limb, branch stubs with ripping wound.	M
10	Acer negundo (Manitoba Maple)	25.5	7	H	M	P	Multiple limbs cut at base.	M
11	Pinus sylvestris (Scots Pine)	31.5	6	MH	H	P	Some defoliation on twigs, 1 limb broken at branch collar.	M
12	Pinus sylvestris (Scots Pine)	21	4	ML	ML	P	Unbalanced canopy to west, zig zag branch from on leader. Wound on leader with 30% trunk circumference.	M
13	Pinus sylvestris (Scots Pine)	29.5	6	H	MH	P	Co-dominant leaders.	M

14	Pinus sylvestris (Scots Pine)	46	9	H	M	P	Co-dominant leaders with included bark from 4m to 5.5m ht.	M
15	Pinus sylvestris (Scots Pine)	17	5	M	M	P	Multiple leaders from 2m ht., included bark at 6m ht. Has wrap on trunk for pest.	M
16	Acer saccharinum (Silver Maple)	-70	14	MH	M	P		N

ID	Species	DBH (cm)	Canopy diameter (m)	Biological Health	Structural Condition	Recommended Action	Comments	Location
17	Pinus nigra (Austrian Pine)	-45	7	M	M	P	Co-dominant leaders from 6m ht. with medium sized branch fused between them and browning foliage. Has wrap on trunk for pest.	N
18	Pinus nigra (Austrian Pine)	-30	5	M	M	P	Unbalanced canopy to west and browning foliage. Has wrap on trunk for pest.	N
19	Pinus nigra (Austrian Pine)	-50	7	MH	H	P	Browning foliage and has wrap on trunk for pest.	N
20	Picea glauca (White Spruce)	-25	5	H	H	P	Has wrap on trunk for pest.	N
21	Picea glauca (White Spruce)	-25	5	MH	H	P	Suppressed branches at 10-15m from #22 but top is in leaf. Has wrap on trunk for pest.	N
22	Elaeagnus angustifolius (Russian Olive)	-25, -20	10	ML	M	P	Co-dominant, limb/trunk leans 45o to east and to west, slower canopy has a lot of dieback (50%).	N
23	Elaeagnus angustifolius (Russian Olive)	-45, -25	11	M	M	P	Fusing branch on trunk, 3 leaders, leans 45° to north and west, and grown on stone slope.	N

24	Pinus nigra (Austrian Pine)	-60	8	MH	MH	P	Co-dominant leaders, and wrap on trunk for pest.	N
25	Picea glauca (White Spruce)	-40	6	H	H	P		N
26	Picea glauca (White Spruce)	-35	6	H	H	P		N
27	Picea glauca (White Spruce)	-35	6	H	H	P		N
28	Picea glauca (White Spruce)	-20	4	H	H	P		N
29	Picea glauca (White Spruce)	-35	5	H	H	P		N
30	Picea glauca (White Spruce)	-30	5	H	H	P		N
31	Picea glauca (White Spruce)	-20	4	M	H	P	Suppressed at top 4m.	N
32	Acer negundo (Manitoba Maple)	40.5	10	H	M	P	Unbalanced canopy to west, leans 10° to west, and included bark at main union.	N
33	Picea glauca (White Spruce)	-35	5	H	H	P	Unbalanced canopy to east.	N
34	Picea glauca (White Spruce)	-30	5	H	H	P	Unbalanced canopy to southwest.	N
35	Picea glauca (White Spruce)	-20	4	H	H	P		N
36	Picea glauca (White Spruce)	-18	4	H	H	P	Has wrap on trunk for pest.	N
37	Populus tremuloides (Trembling Aspen)	20	5	ML	ML	P	Co-dominant leaders with one leader dead, remaining leader has 25% dead branches in lower canopy.	S

38	Populus tremuloides (Trembling Aspen)	18	4	MH	MH	P	Wound with rot at 0.3m ht.	S

ID	Species	DBH (cm)	Canopy diameter (m)	Biological Health	Structural Condition	Recommended Action	Comments	Location
39	Populus tremuloides (Trembling Aspen)	20	5	MH	MH	P	One leader cut at the base with fungus fruiting bodies and 20% of canopy dead particularly in lower canopy.	S
40	Populus tremuloides (Trembling Aspen)	20	7	M	ML	P	Multiple leaders with included bark at base to 0.3m ht. One leader has 75% of canopy dead 2 leaders are in satisfactory health.	N
41	Acer saccharinum (Silver Maple)	-35, x1, -30, x1, -25, x2, -20, x3, -15, x3, -10, x6	14	H	M	P	Multiple leaders with numerous points of fusing.	N
42	Picea glauca (White Spruce)	-20	4	M	M	P	Leader with dieback and new leader emerging.	N
43	Picea glauca (White Spruce)	-15	5	H	H	P		N
44	Acer platanoides (Norway Maple)	-45	9	H	H	P		N
45	Acer platanoides (Norway Maple)	-25	9	H	M	P	Co-dominant leader and included bark.	N
46	Acer platanoides (Norway Maple)	-50	9	H	H	P		N

47	Tilia americana (Basswood)	52, 28	10	H	M	P	Three leaders with included bark.	S
48	Acer saccharum (Sugar Maple)	48	8	H	MH	P	Unbalanced canopy to northwest.	S
49	Acer saccharum (Sugar Maple)	25, 67	12	MH	M	RC	Co-dominant leaders with included bark. The smaller leader is hollow with wound of 25% trunk circumference and main leader leans 10° to south.	S
50	Acer saccharum (Sugar Maple)	65	9	MH	M	RC	Co-dominant leaders, with included bark at base to 4m ht and larger trunk has fallen.	S
51	Acer saccharum (Sugar Maple)	60, 51	12	M	ML	RC	One (1) leader is dead and 2 leaders remain with included bark between, a wound of 50% trunk circumference and a few large dead branches.	S
52	Prunus serotina (Black Cherry)	52	11	MH	MH	RC	Approximately 5 large dead branches.	S

ID	Species	DBH (cm)	Canopy diameter (m)	Biological Health	Structural Condition	Recommended Action	Comments	Location
53	Tilia americana (Basswood)	54, 57	10	ML	ML	RC	One (1) leader remains with five (5) large broken or fallen trunk and four (4) large dead branches.	S
54	Ostrya virginiana (Ironwood)	28, 27	8	H	H	RC	Co-dominant leaders with included bark.	S
55	Ostrya virginiana (Ironwood)	31, 30	8	H	M	P		S
56	Ostrya virginiana (Ironwood)	35	10	H	H	P		S
57	Fraxinus sp. (Ash)	-30, x4	6	D	D	R	Dead	S
58	Tilia americana (Basswood)	24	6	H	H	P		S
59	Fraxinus sp. (Ash)	65	10	L	L	R	Dying, 50% canopy is dead. Canopy is 50% dead, multiple leaders, and a large wound on trunk of 50% circumference.	S
60	Crataegus monogyna (European Hawthorn)	25, 25, 30	7	M	M	P	Leader topped and resprouted.	N
61	Acer saccharum (Sugar Maple)	30	7	M	M	P	Leader topped and resprouted.	N
62	Acer saccharum (Sugar Maple)	15	4	H	H	P		S
B1	Juglans cinerea (Butternut)	13	5	MH	M	P	Has a wound of 30% of trunk circumference from a fallen tree, rot is apparent, but growth is showing at all branch tips.	S

B2	Juglans cinerea (Butternut)	18	5	H	MH	P	Fusing branch with trunk leaving wound and growth showing at all branch tips.	S

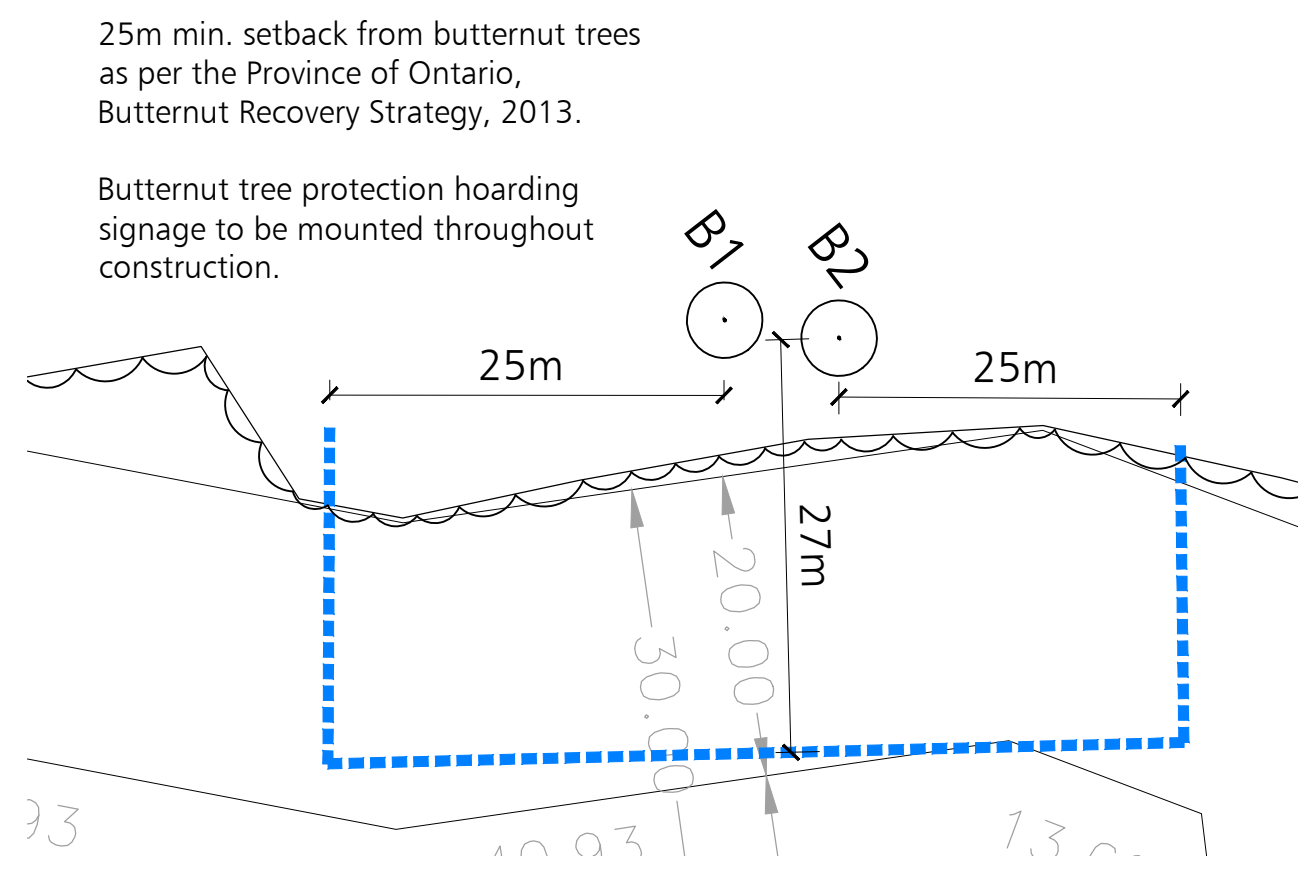
25m min. setback from butternut trees as per the Province of Ontario, Butternut Recovery Strategy, 2013.

Butternut tree protection signage to be mounted throughout construction.
