**Summary Action Report**  
**Structure B20092243 (MTO Site No. )**  
**Old School Road, 0.45 km West of Torbram Road**

Inspection Date 06/10/2021 mm/dd/yyyy

# Municipal Structure Inspection Form

**B20092243**

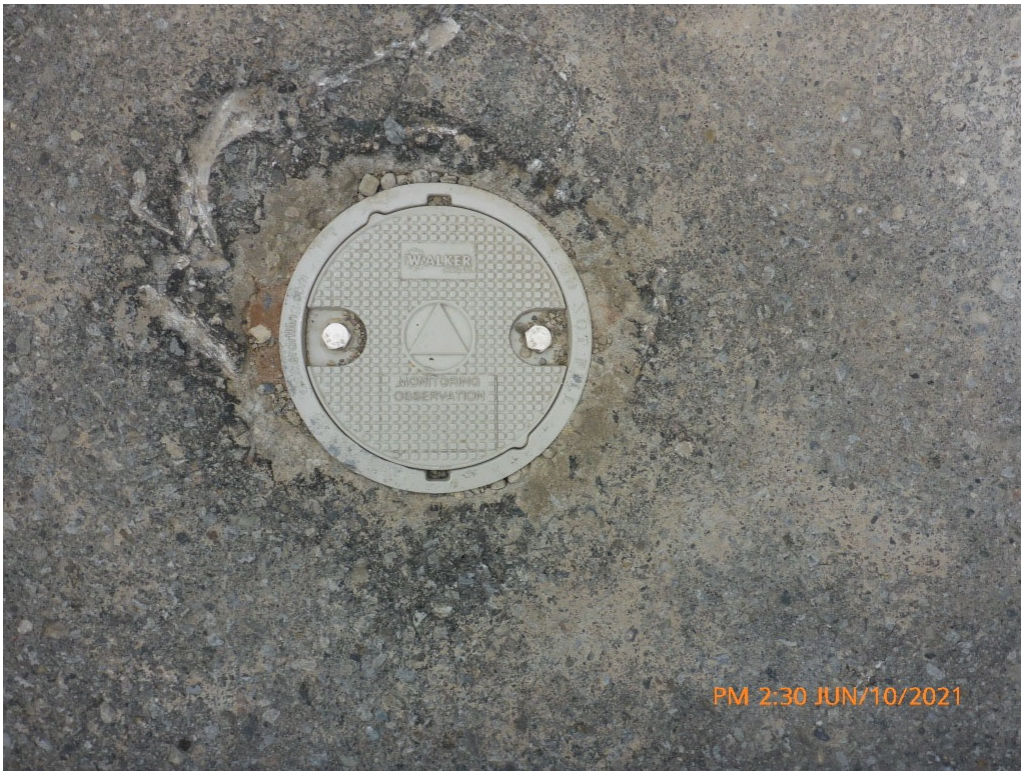
**Comments**  
 Light cracks, asphalt patches, monitoring wells at West and East approaches, East approach resurfaced in 2018.

**Approaches - Wearing Surface - Monitoring Well - East Approach - Photo 5**

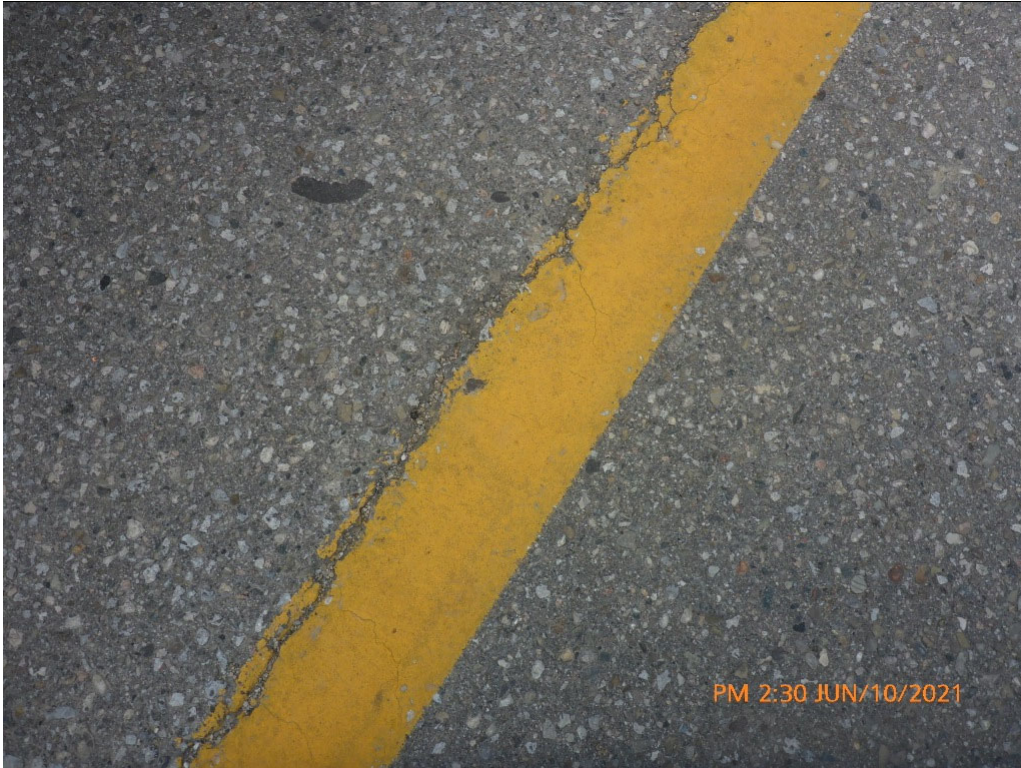
**Approaches - Wearing Surface - Monitoring Well - West Approach - Photo 6**

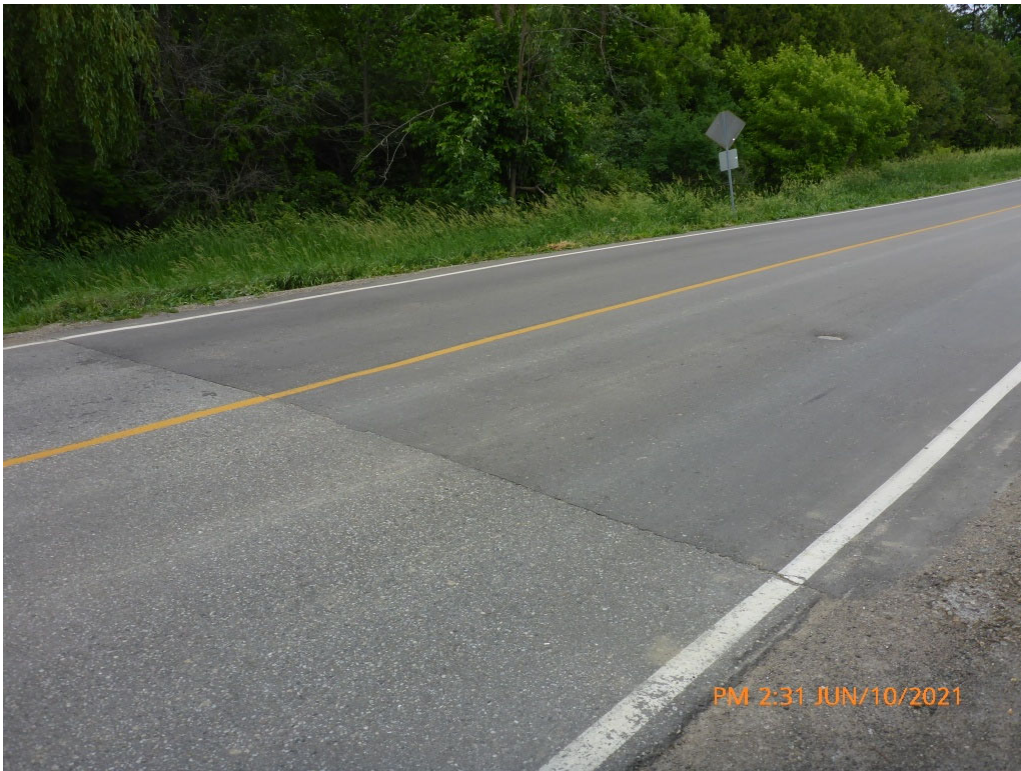
**Approaches - Wearing Surface - Light Crack - West Approach - Photo 7**

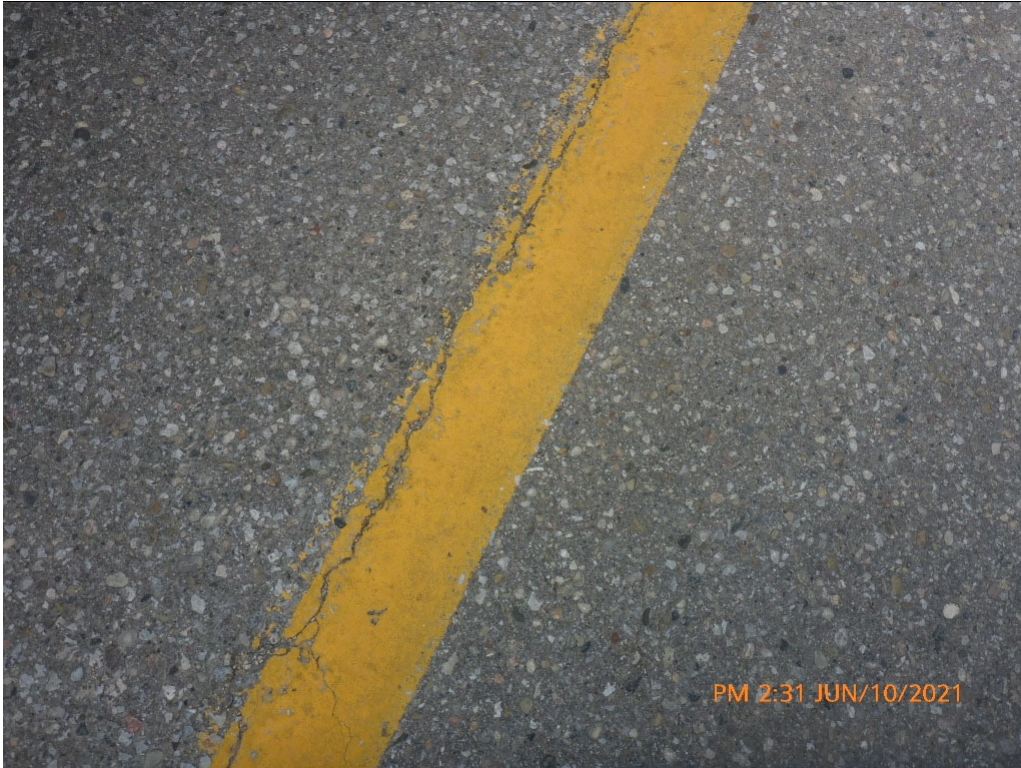
**Approaches - Wearing Surface - East Approach Recently Resurfaced - Photo 8**

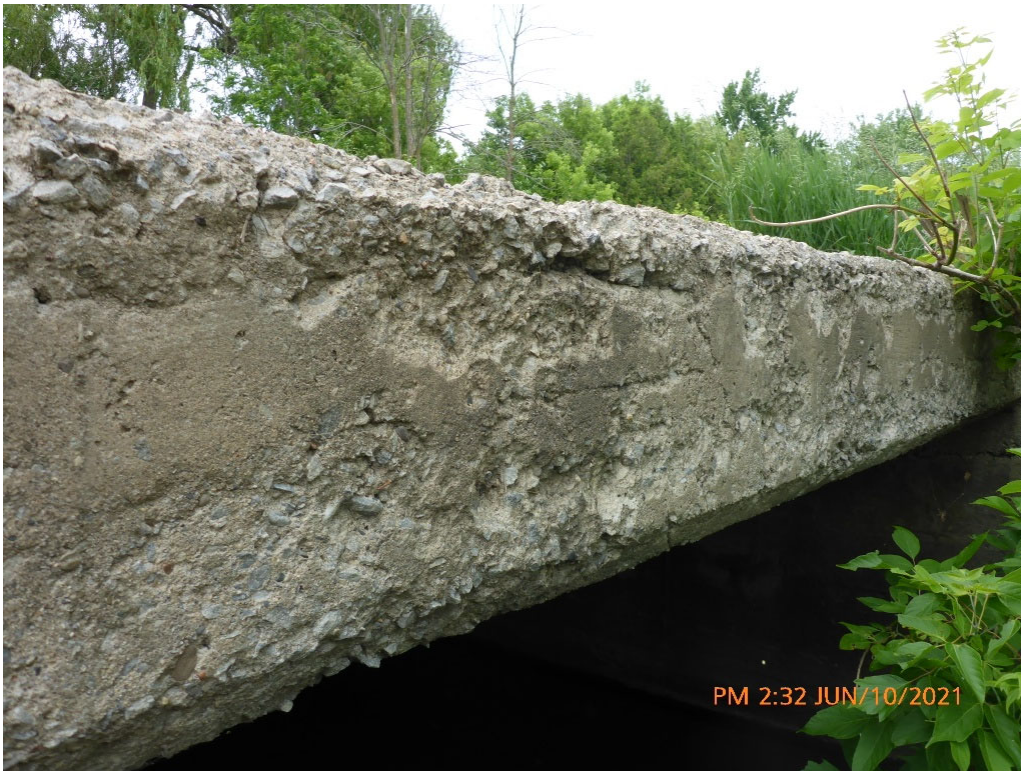
**Comments**  
 Light cracks.

**Decks - Wearing Surface - Light Crack - Photo 9**

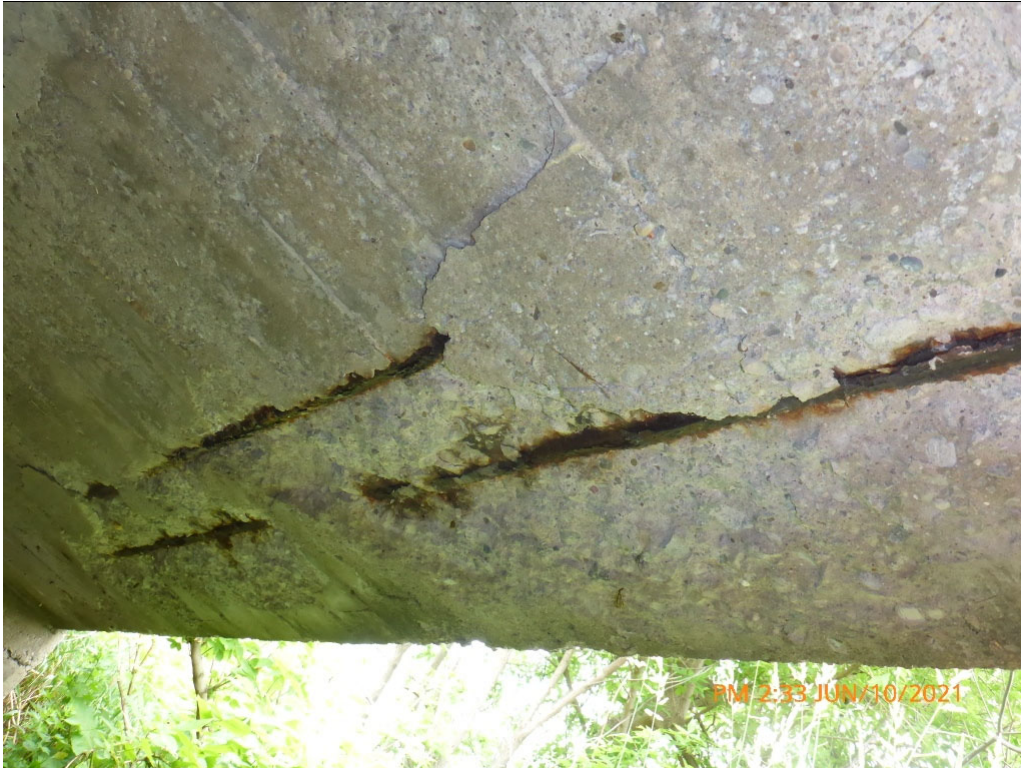
**Comments**  
 Light to severe scaling, extensive severe spalling and delaminations at both ends, wet areas.

**Decks - Soffit - Thick Slab - Exterior - Severe Scaling - South - Photo 10**

Rehab/Repair Recommendations	Priority	Cost	Comments
Rehab	1-5 yrs	\$15,000	Patch repair soffit

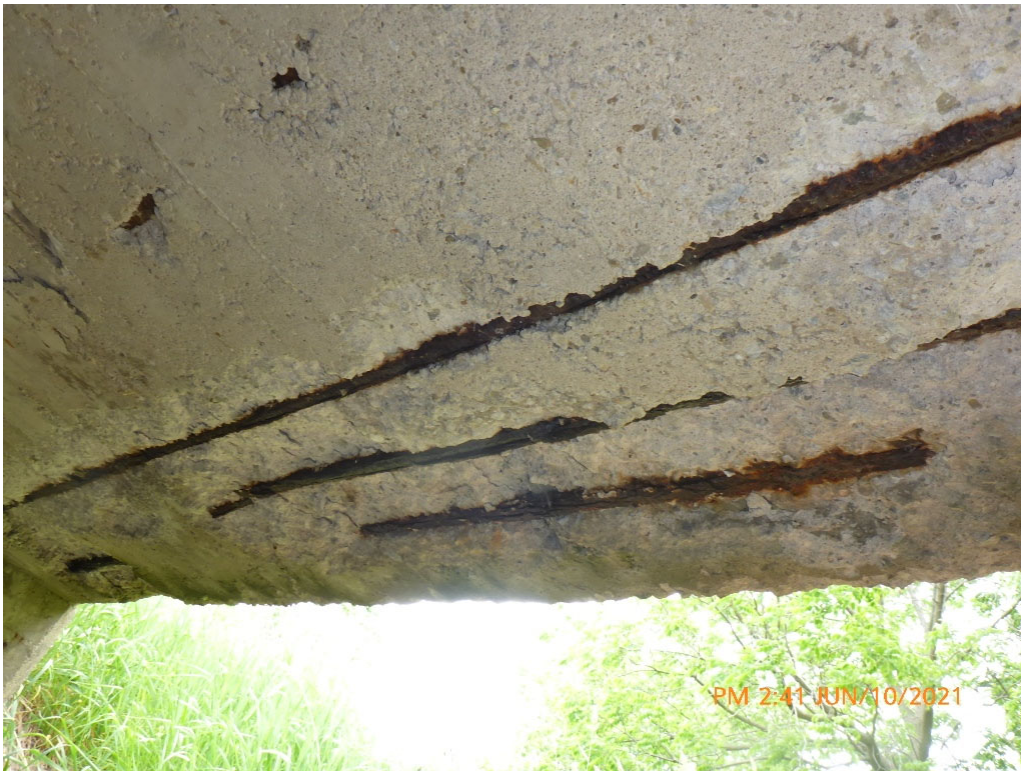
**Decks - Soffit - Thick Slab - Exterior - Severe Spalls \_ Delaminations - South - Photo 11**

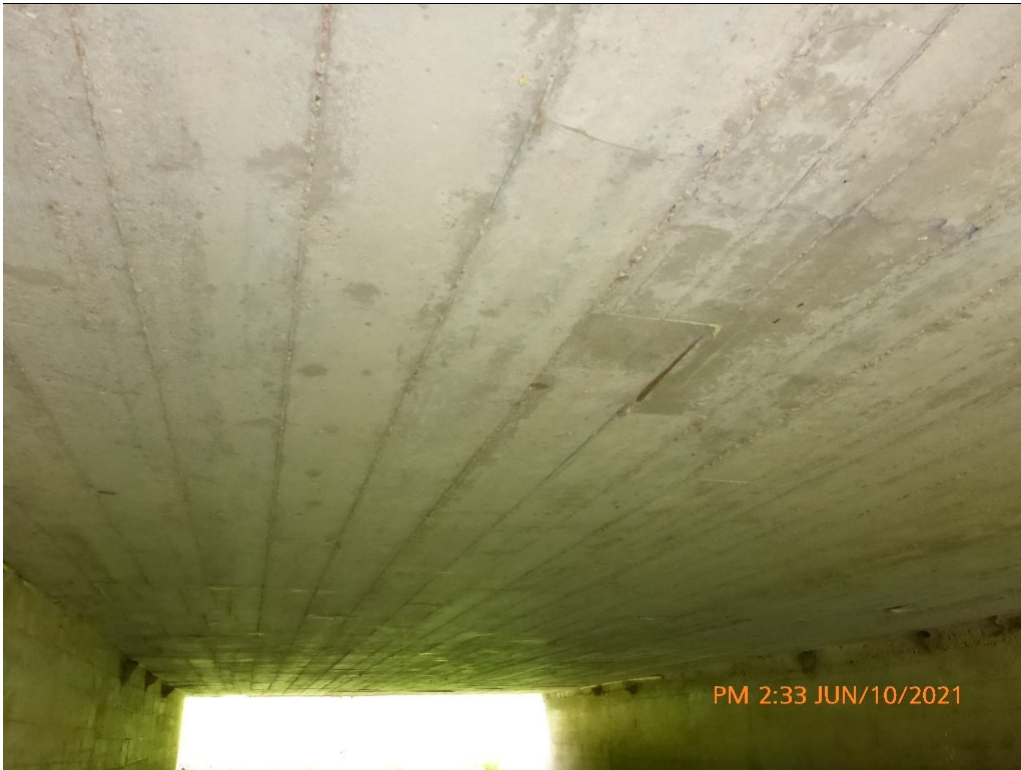
**Decks - Soffit - Thick Slab - Exterior - Severe Spalls - North - Photo 12**

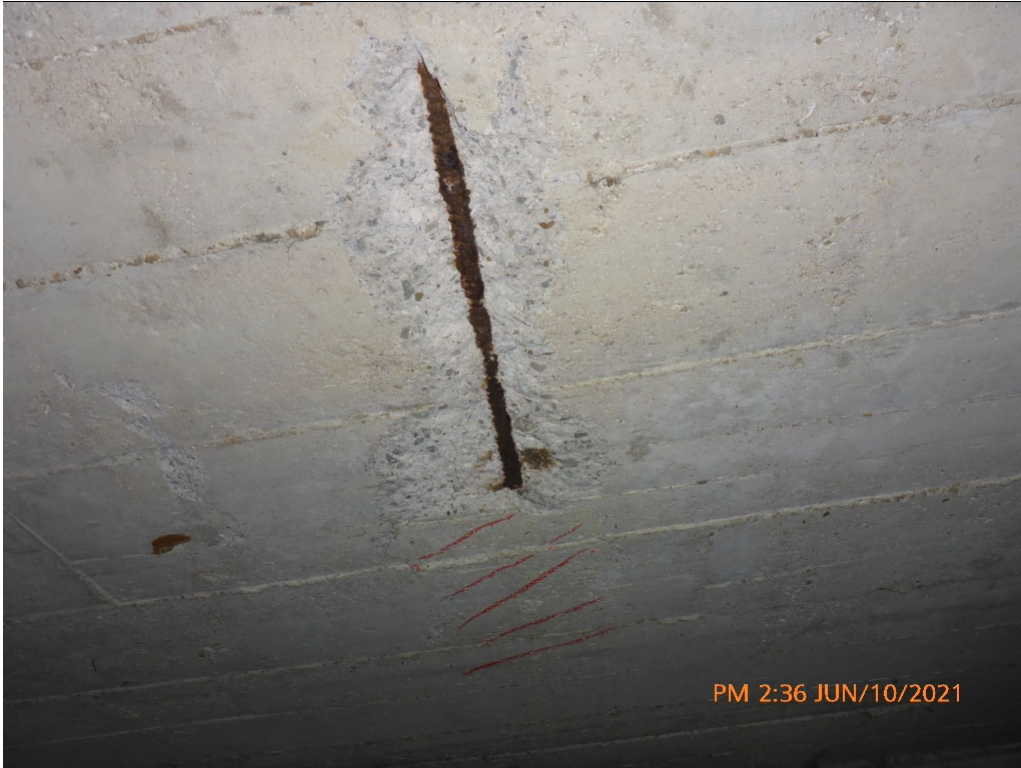
**Comments**  
Light to severe spalls and delaminations, light to severe honeycombing, wet areas.

**Decks - Soffit - Thick Slab - Interior - Medium Delamination - Photo 14**

Rehab/Repair Recommendations	Priority	Cost	Comments
Rehab	1-5 yrs	\$20,000	Patch soffit

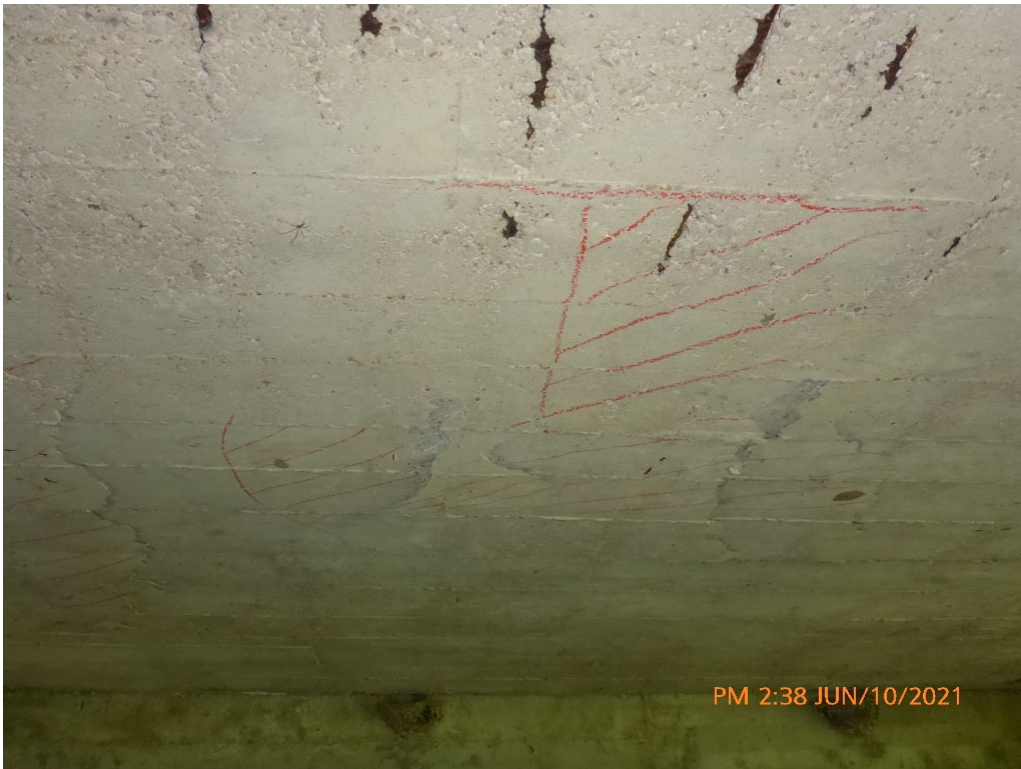
**Decks - Soffit - Thick Slab - Interior - Severe Spall - Photo 15**

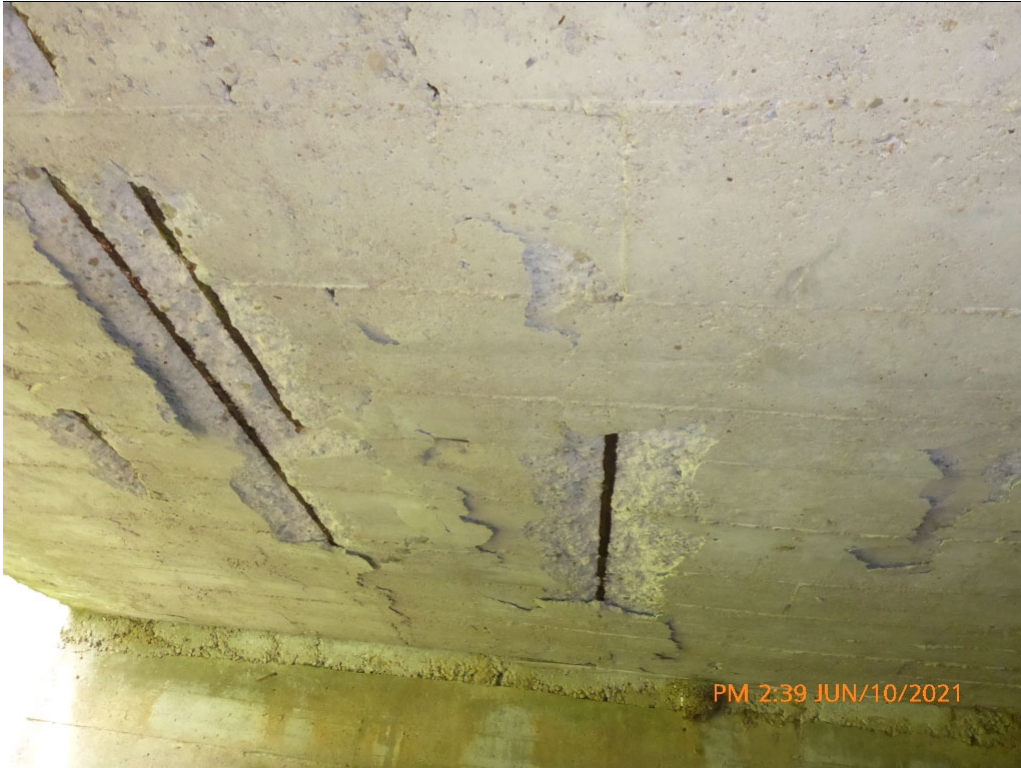
**Decks - Soffit - Thick Slab - Interior - Severe Delaminations - Photo 16**

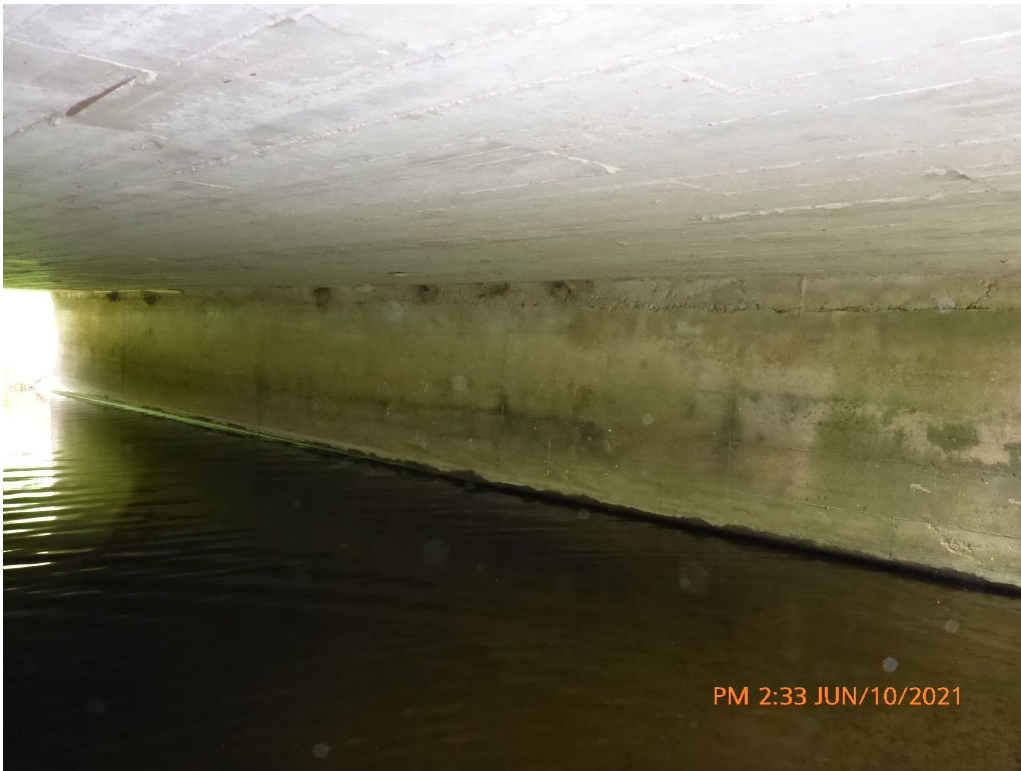
**Decks - Soffit - Thick Slab - Interior - Severe Spalls - Photo 17**

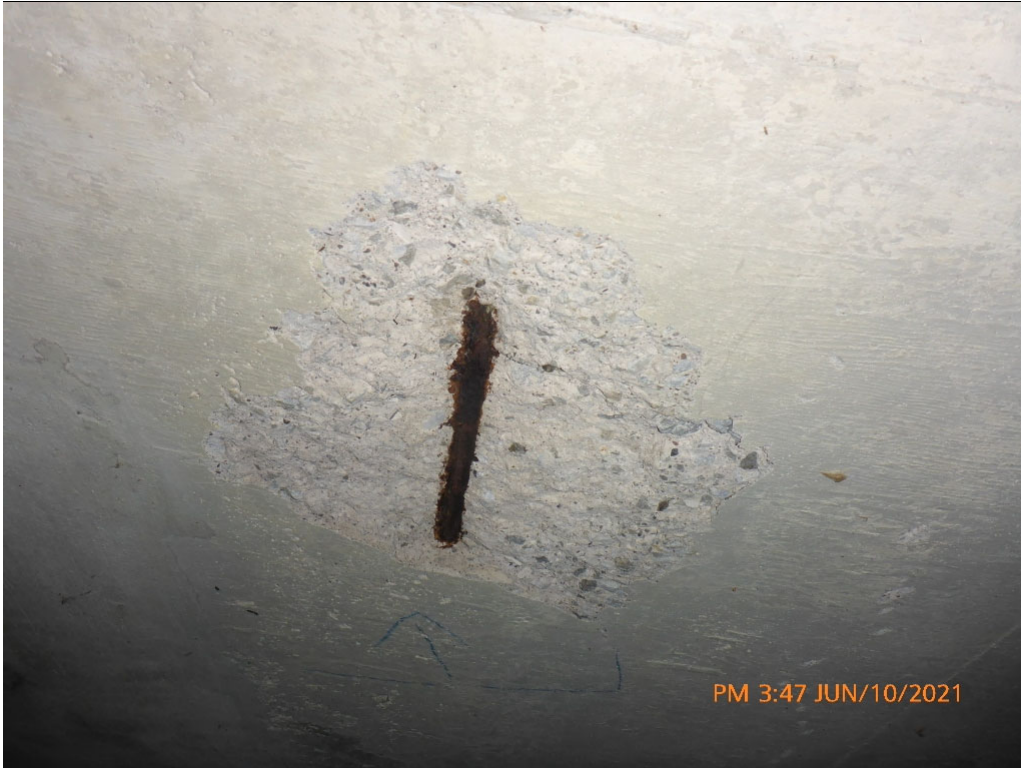
**Culverts - Barrels - Severe Delaminations on Soffit - Photo 14**

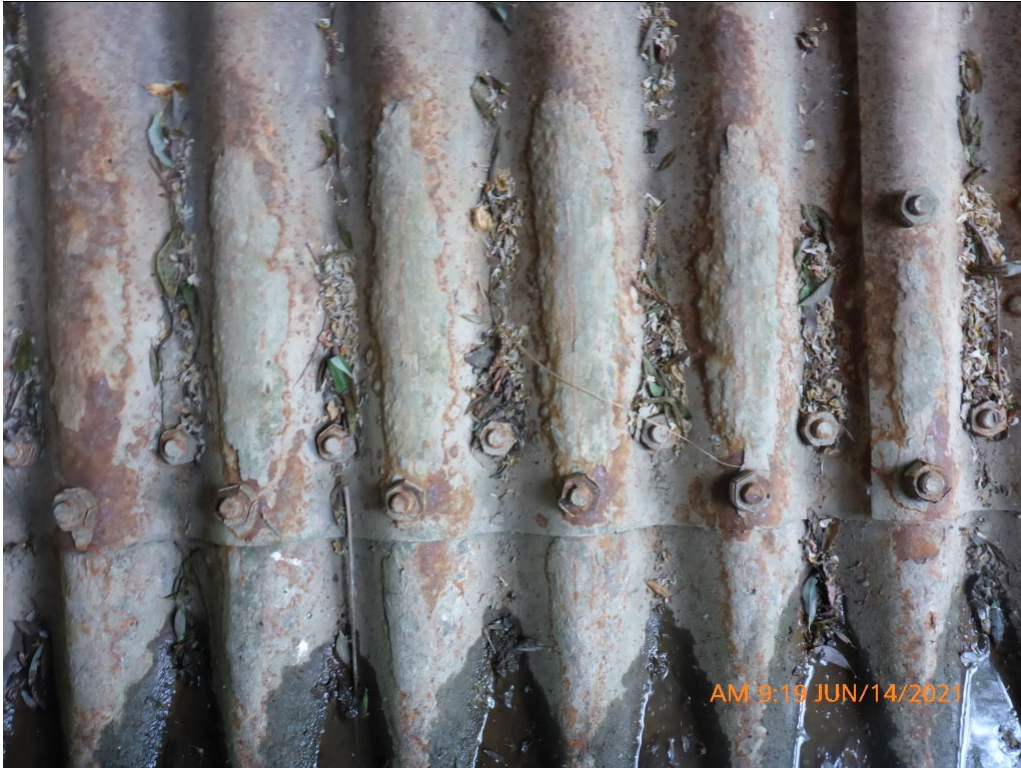
**Culverts - Barrels - Efflorescence on Wall - Photo 12**

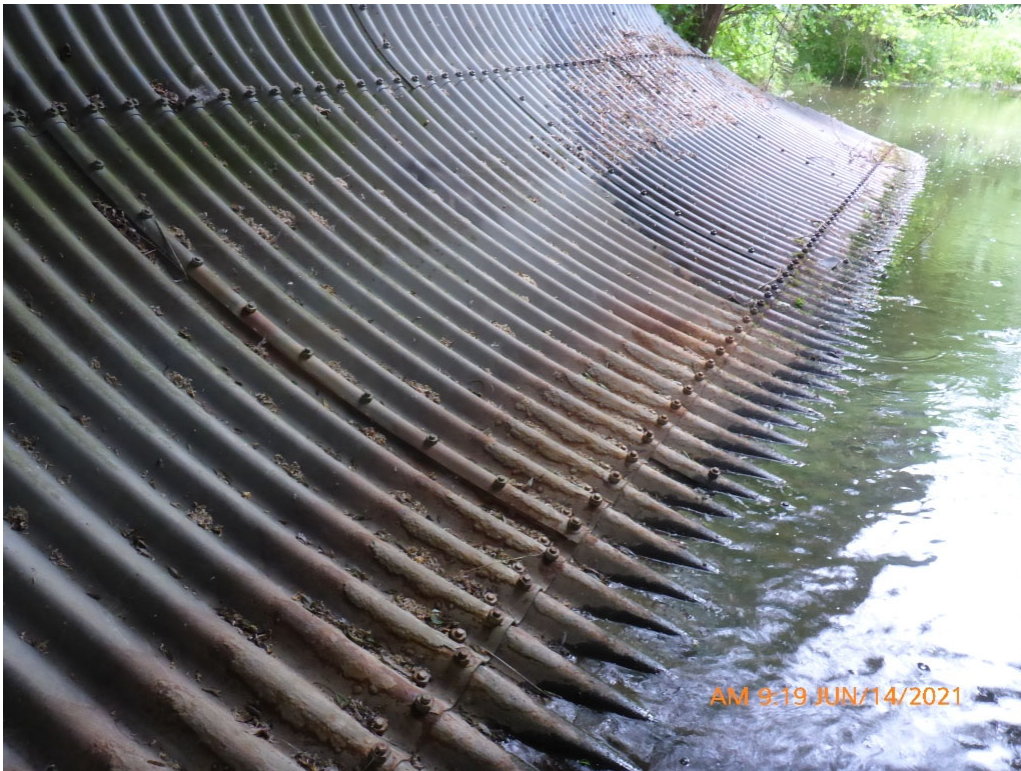
**Culverts - Barrels - Medium Corrosion on Invert - Photo 13**

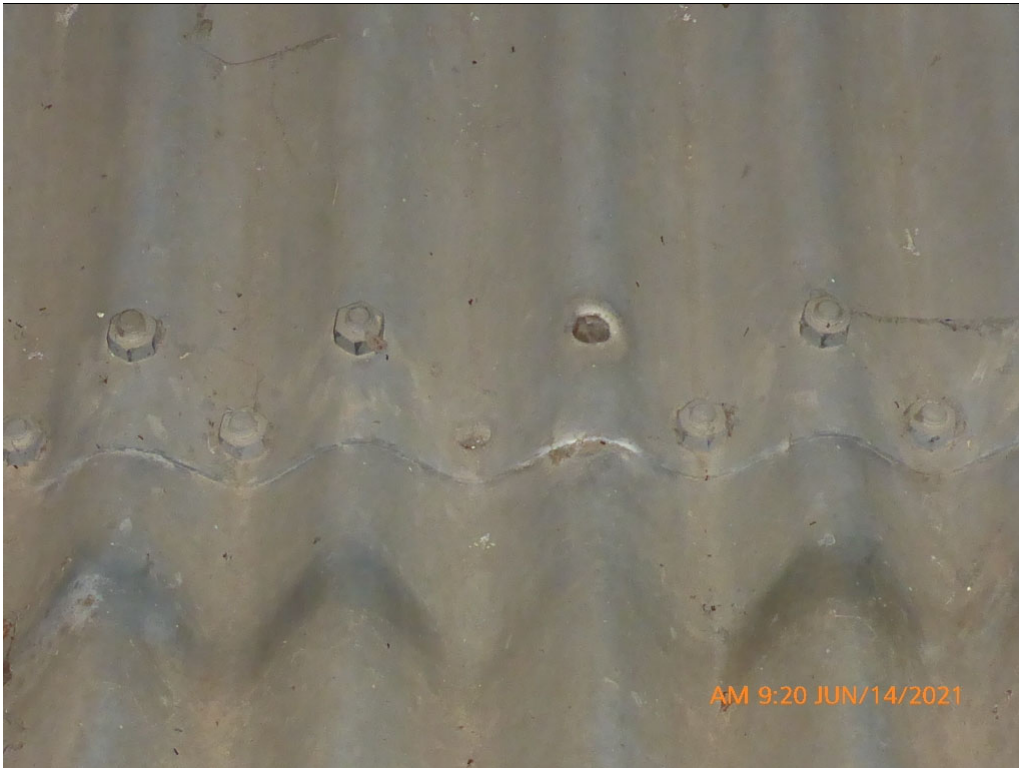
**Culverts - Barrels - Overall Light Corrosion - Photo 14**

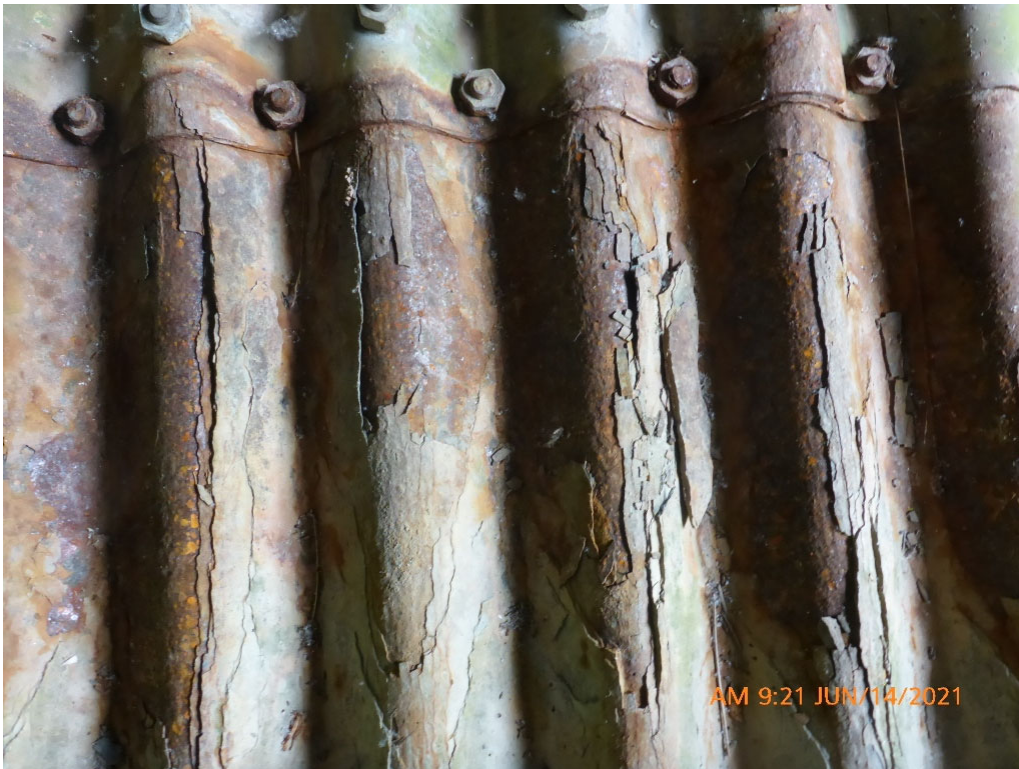
**Culverts - Barrels - Missing Bolts - South Wall - Midspan - Photo 15**

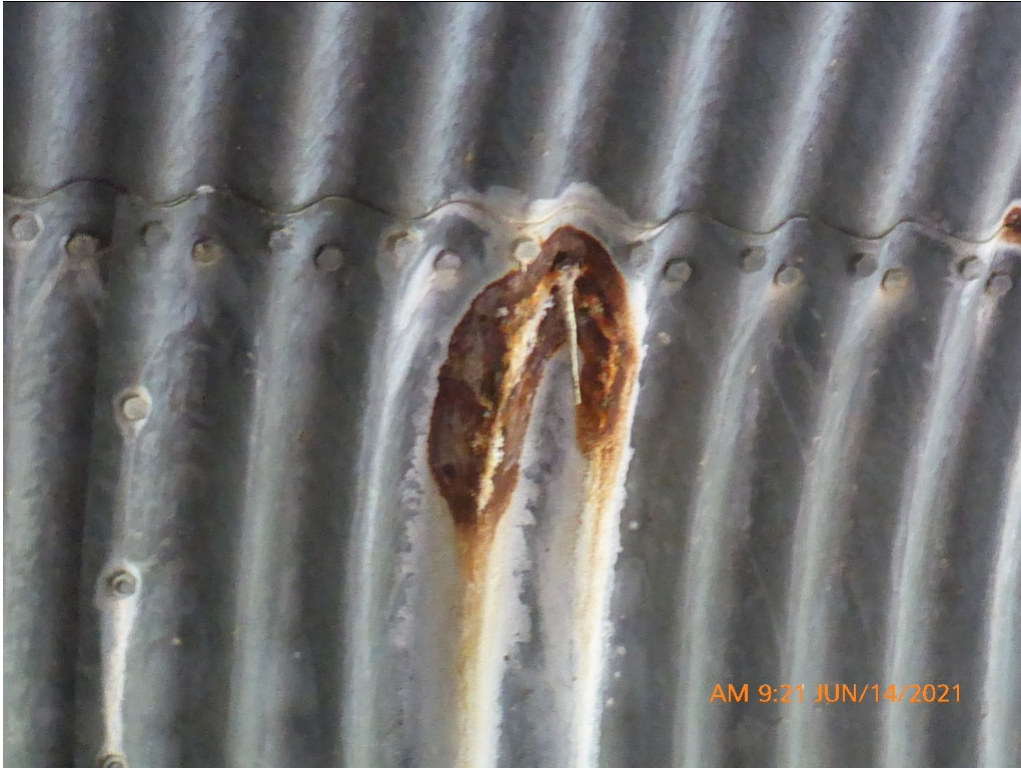
**Culverts - Barrels - Medium Corrosion on Invert - Photo 16**

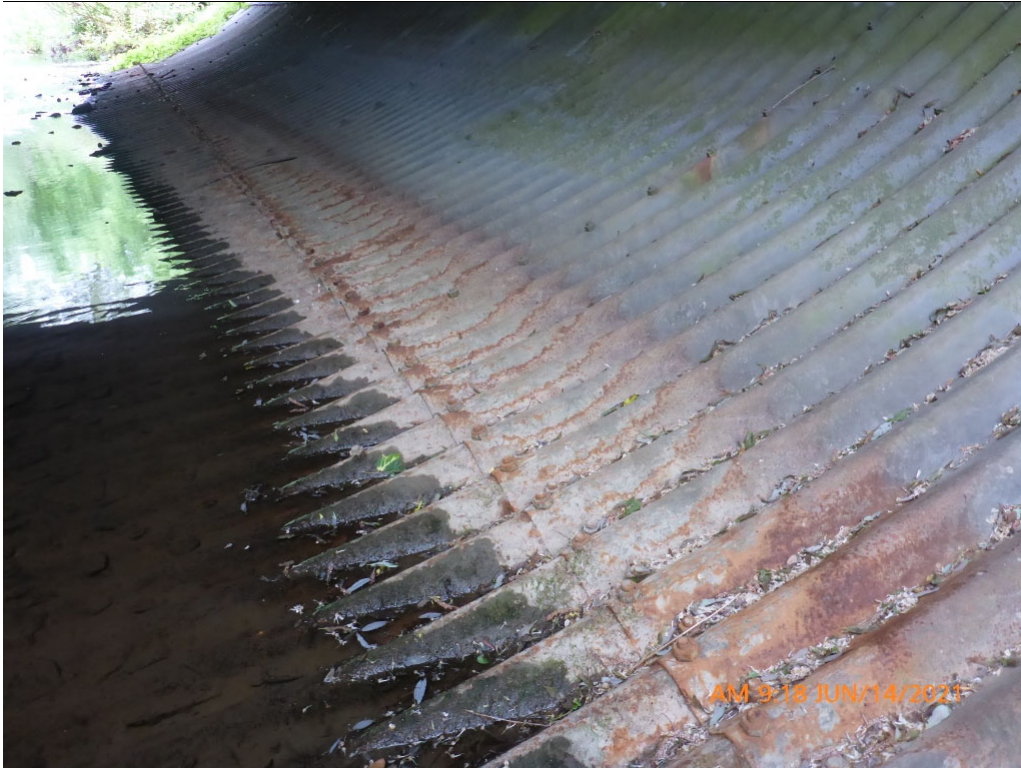
**Culverts - Barrels - Improper Bolt Layout - Photo 20**

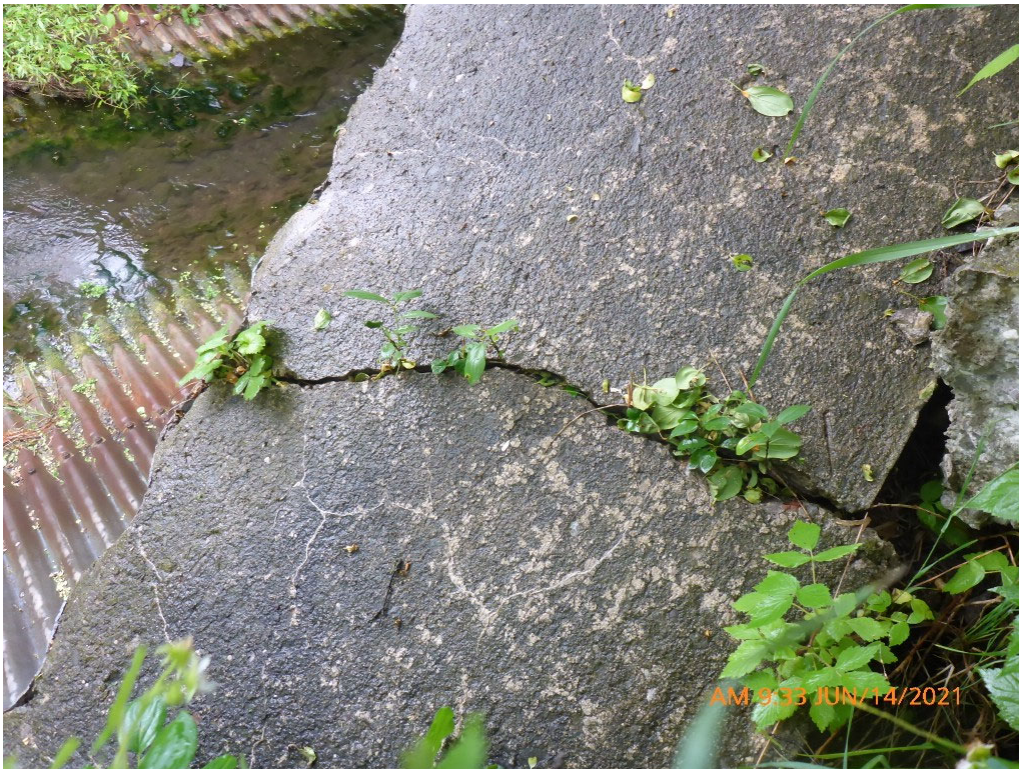
**Culverts - Inlet Components - Light Spall on Stiffener - West - Photo 25**

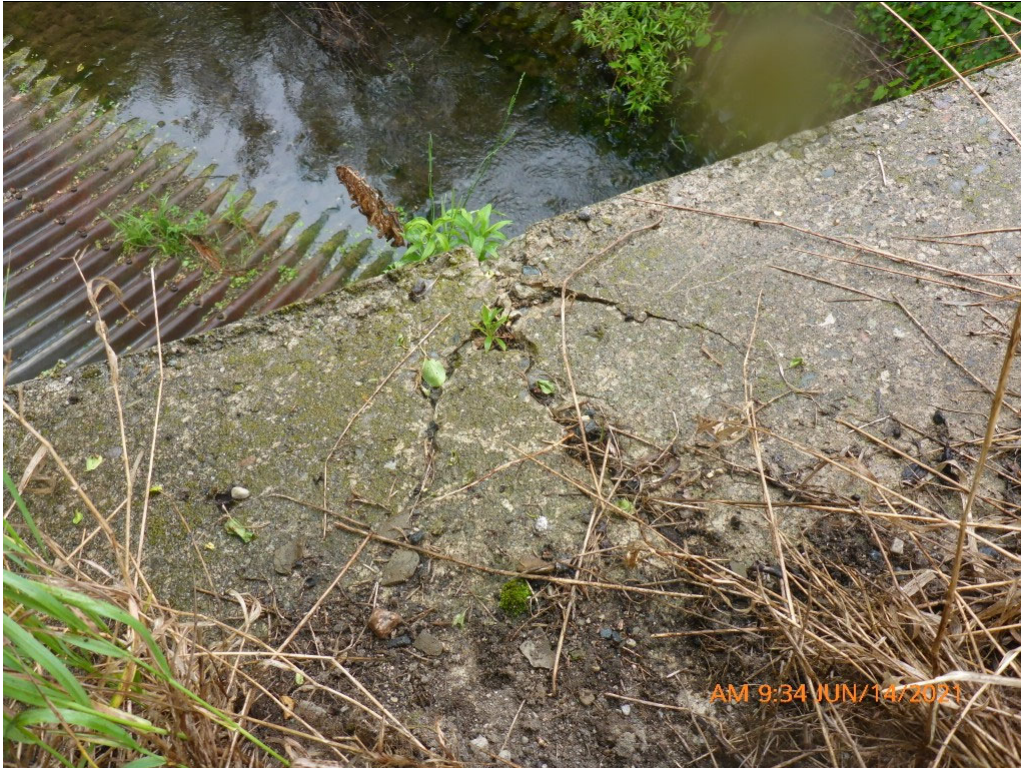
**Culverts - Inlet Components - Wide Crack on Stiffener - SW - Photo 26**

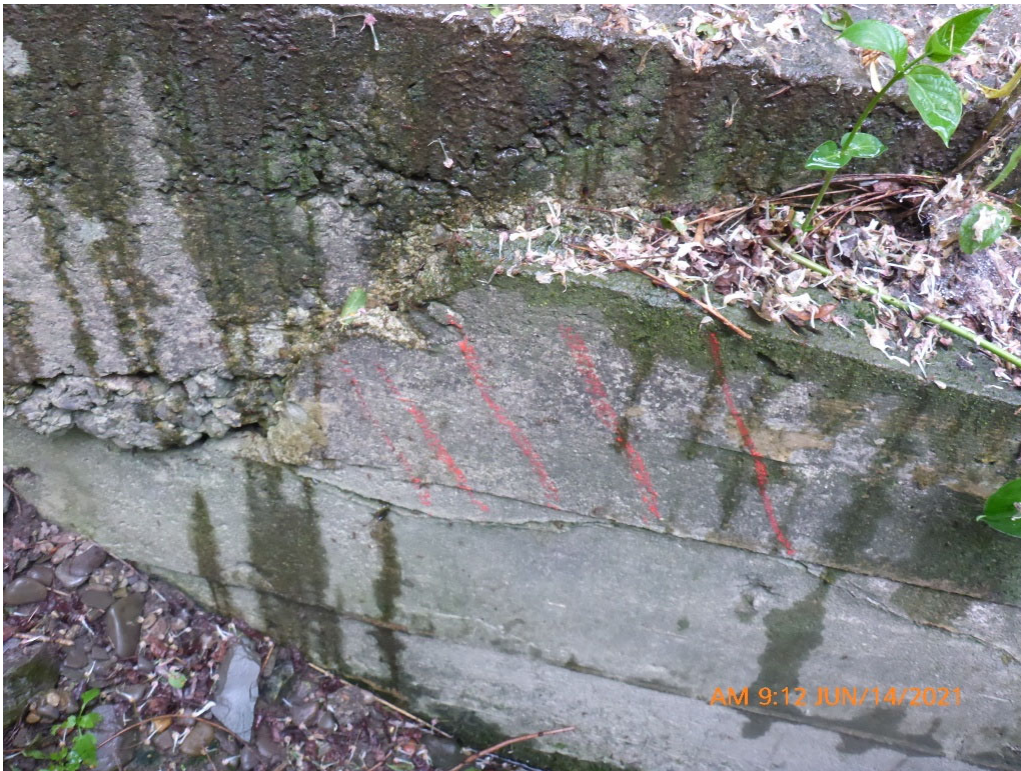
**Culverts - Inlet Components - Wide Cracks on Stiffener - SW - Photo 27**

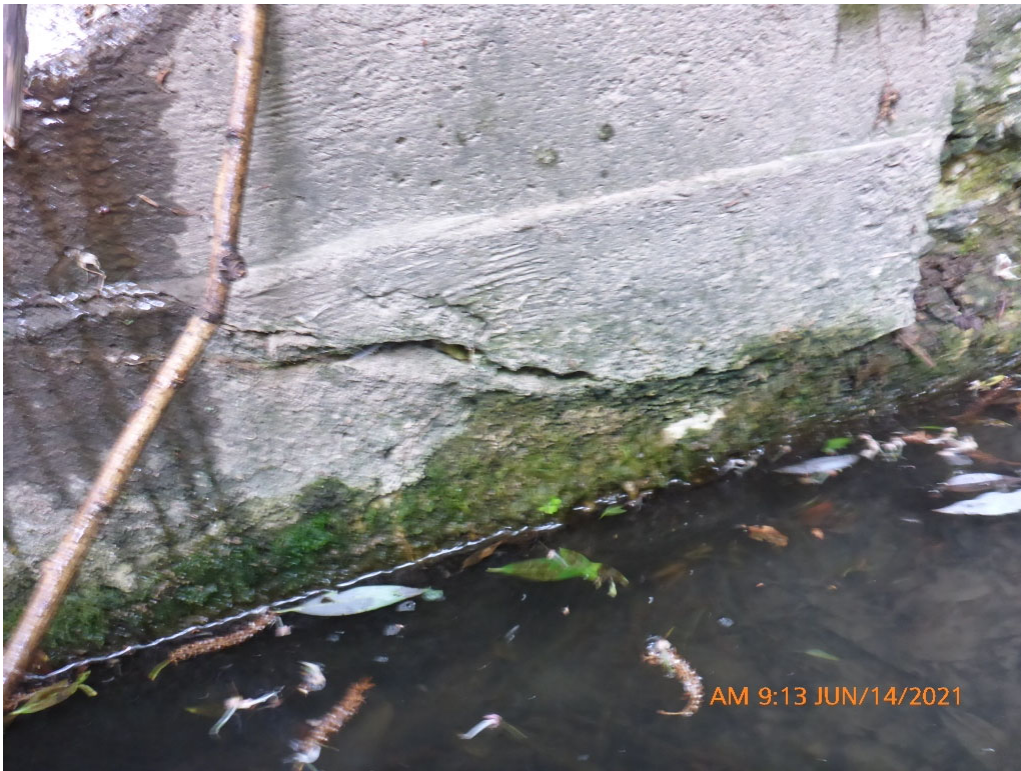
**Culverts - Outlet Components - Severe Honeycombing - SE Cut-off Wall - Photo 29**

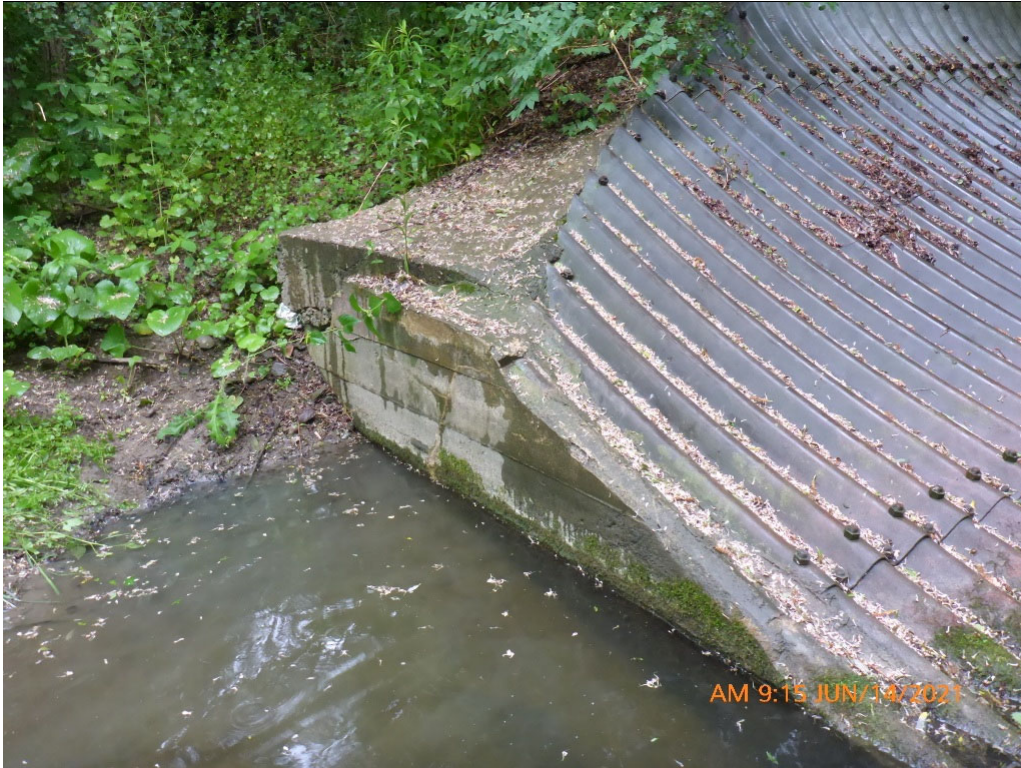
**Culverts - Outlet Components - Wide Crack - NE Cut-off Wall - Photo 30**

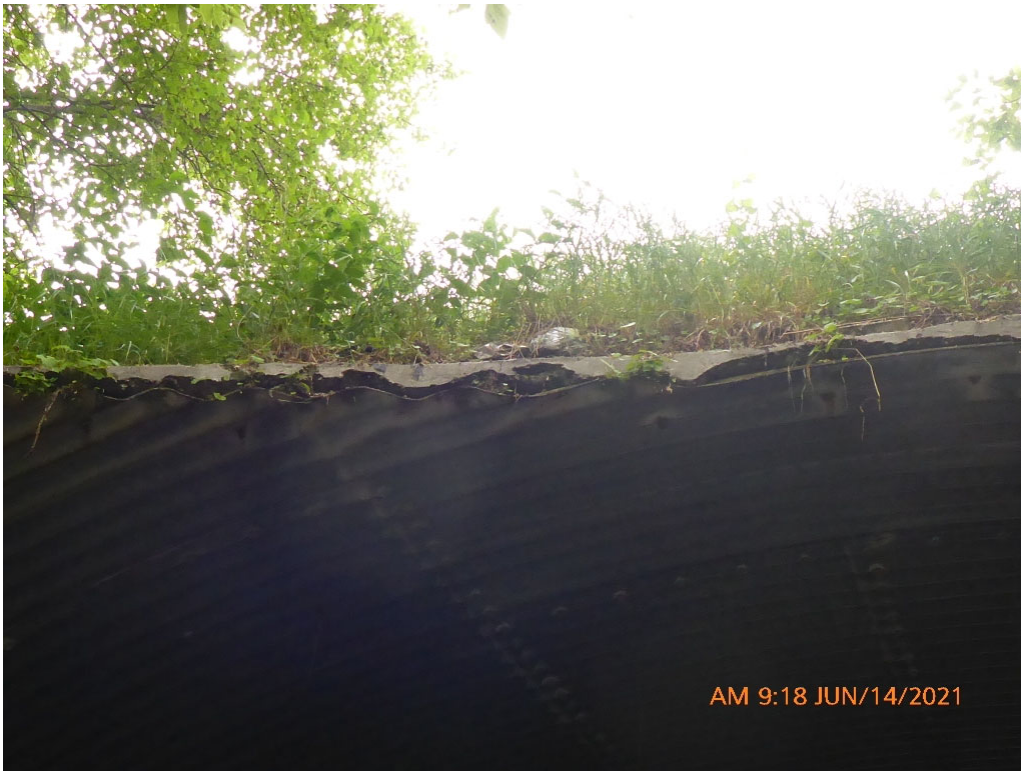
**Culverts - Outlet Components - Wide Crack in Stiffener - SE - Photo 33**

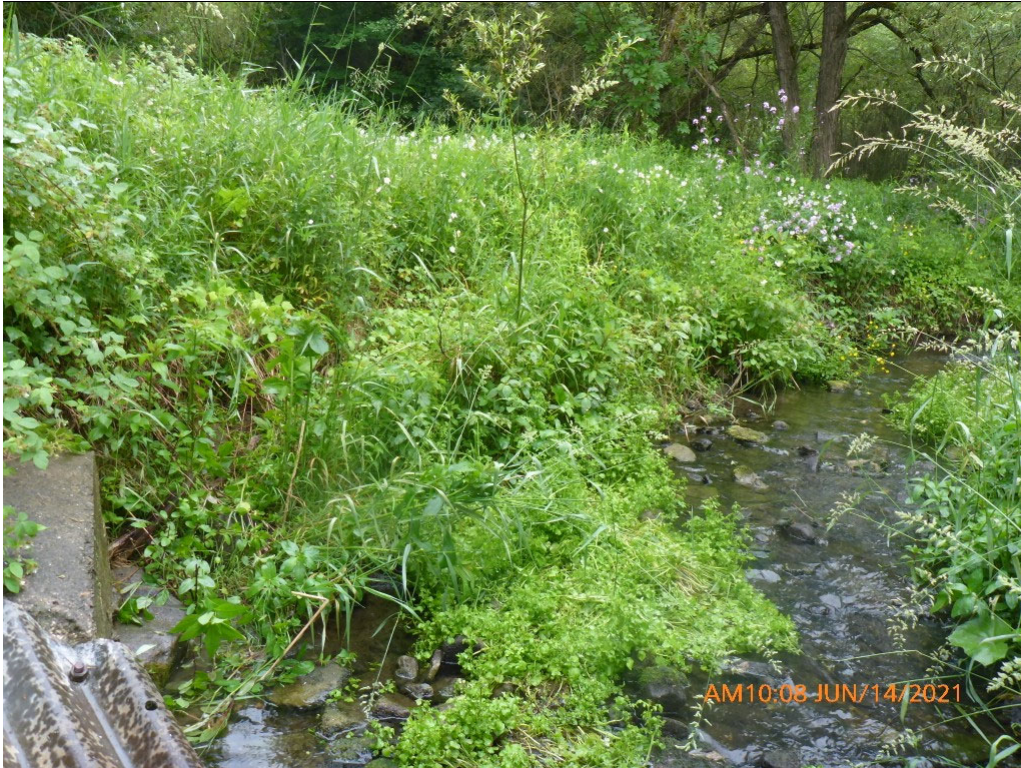
**Embankments and Streams - Streams\_Waterways - Severe Undermining of Barrel at West - Photo 38**
