**Re: Headwater Drainage Feature Assessments
12668 Dixie Road & 12892 Dixie Road
Town of Caledon, ON
GEO Morphix Project No. PN21015**

2021 Headwater Drainage Feature (HDF) Assessment

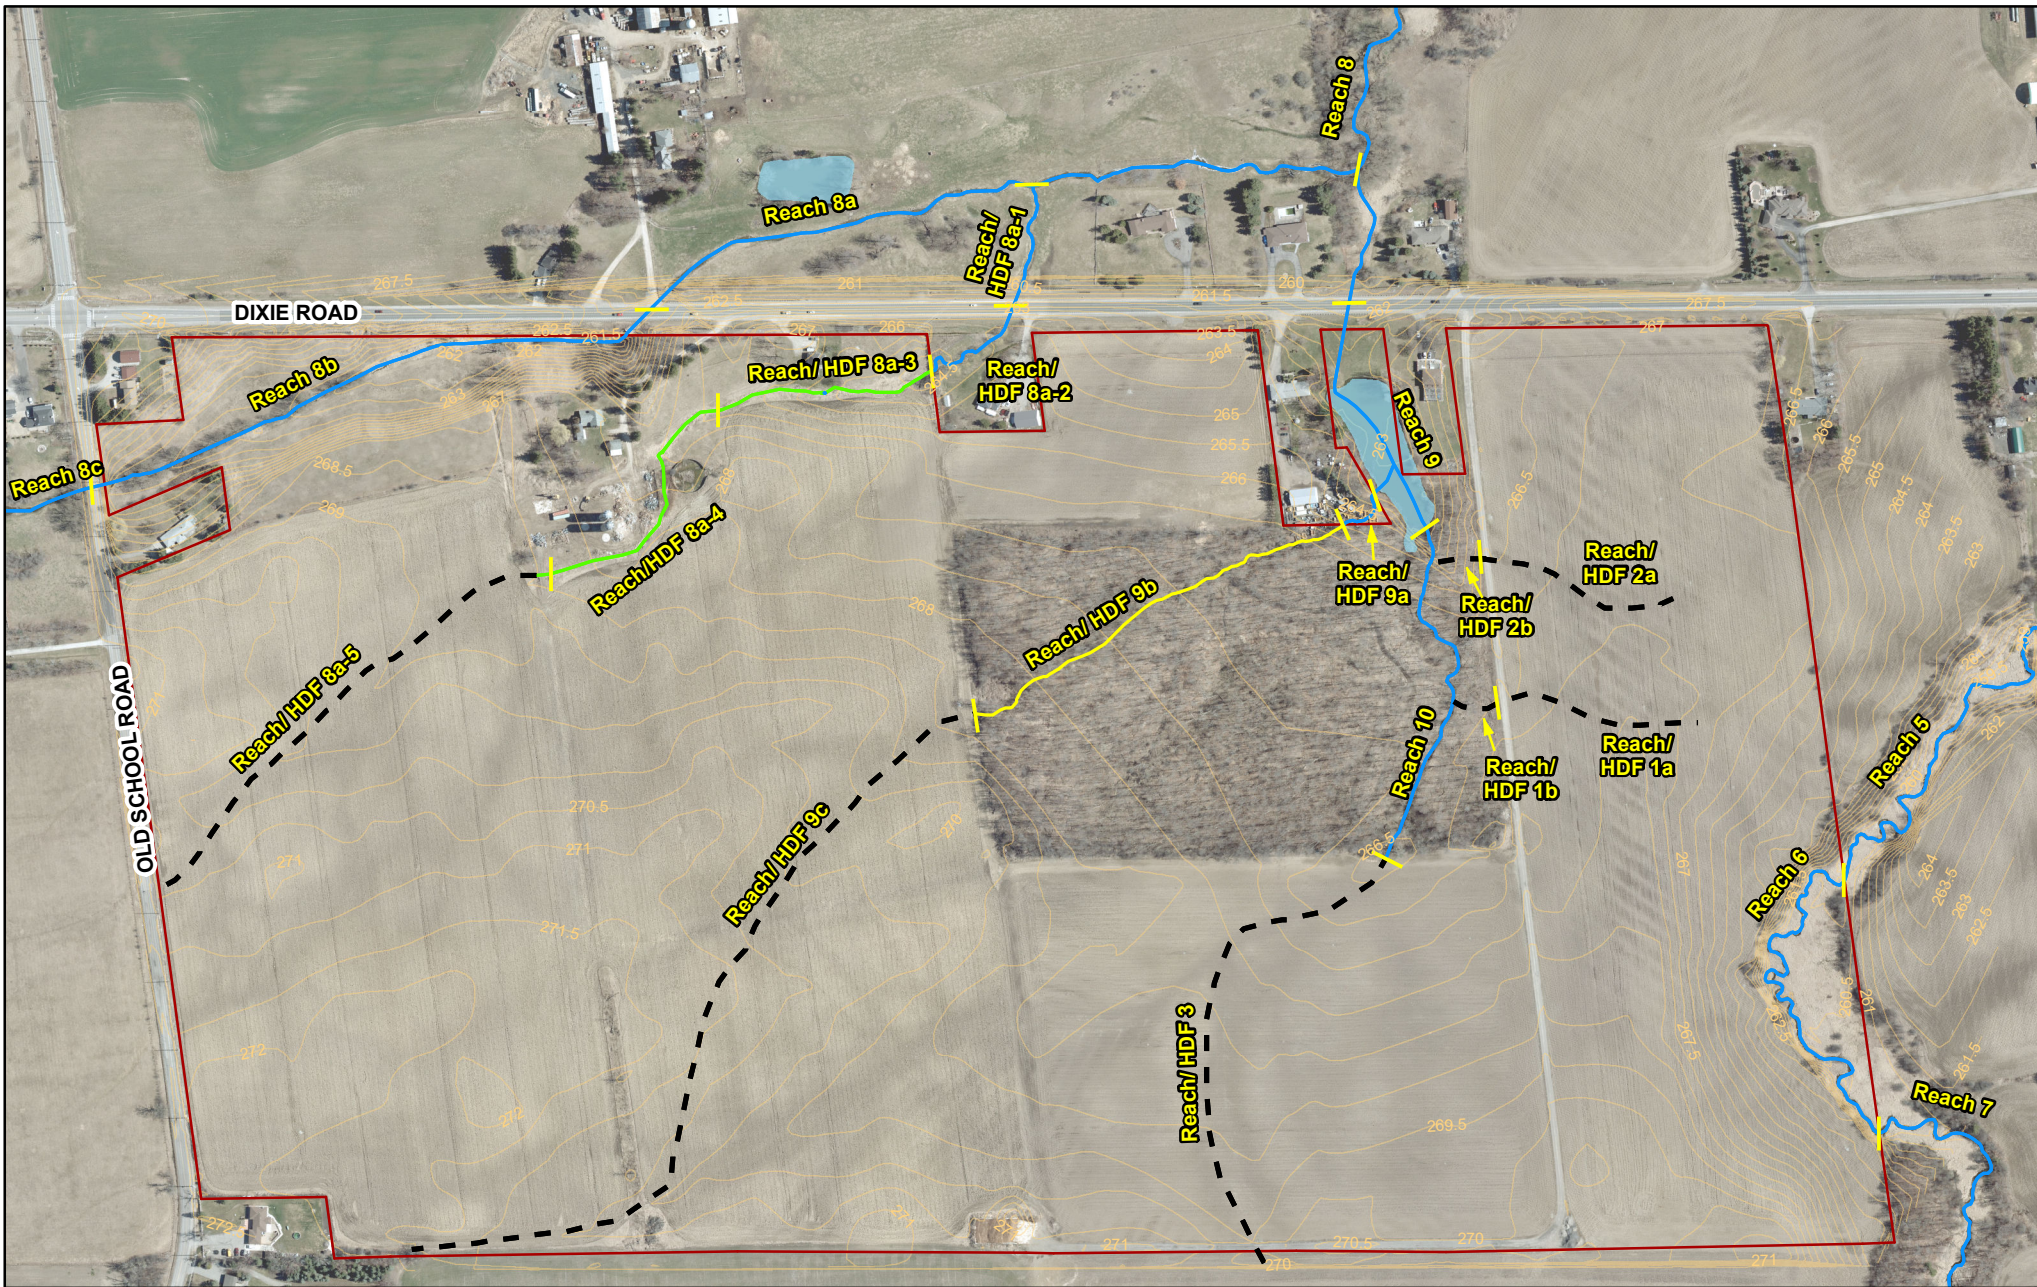
Note that for several of the reaches documented in the desktop mapping exercise, there was no discernible feature observed on site. We have recommended “No Management Required” for those features, which includes **Reach HDF 8a-5, HDF 9c, HDF 1a, HDF 1b, HDF 2a, HDF 2b, and HDF 3.**

The HDF management classification assigned to **Reach HDF 8a-3 and HDF 8a-4** is “Mitigation”, and the management classification assigned to **Reach HDF 9b** is “Conservation”. It should be noted that **HDF 9b** is situated within the central woodlot feature on the property. Based on our understanding of existing ecological data for the site, it is anticipated that the woodlot will be maintained in the future condition. As such, **HDF 9b** will likely remain protected in situ by virtue of its location within the existing woodlot.

We are also aware of potential wetland classifications along the **HDF 8a** tributary. **Reach HDF 8a-3 and HDF 8a-4** have been classified as “Mitigation”, which would indicate that these features could potentially be removed if their functions are maintained in the future condition. However, if there is any level of wetland feature that requires maintenance on site, then the associated HDF would likely remain in situ by virtue of its location within the potential wetland extent. Ultimately, the status of any woodlot or wetland features on site should be assessed and reviewed by a qualified ecologist/biologist.

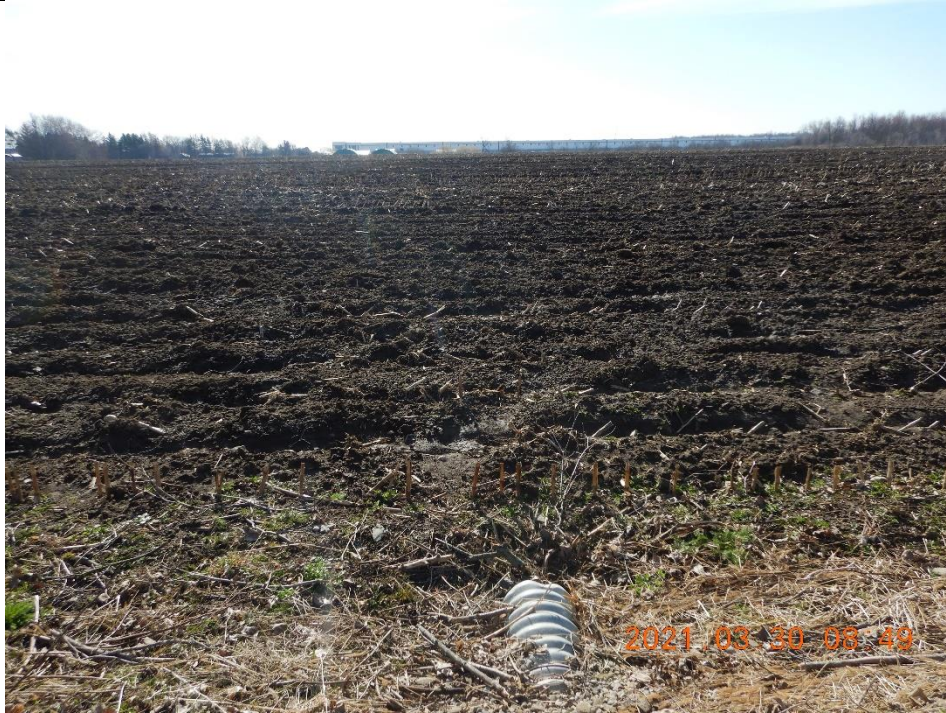
Photo 1

West Humber River Headwater Drainage Feature,
12892 Dixie Road, HDF 1a: Site Visit 1

Photograph taken looking upstream. **HDF 1a** was not observed in situ.

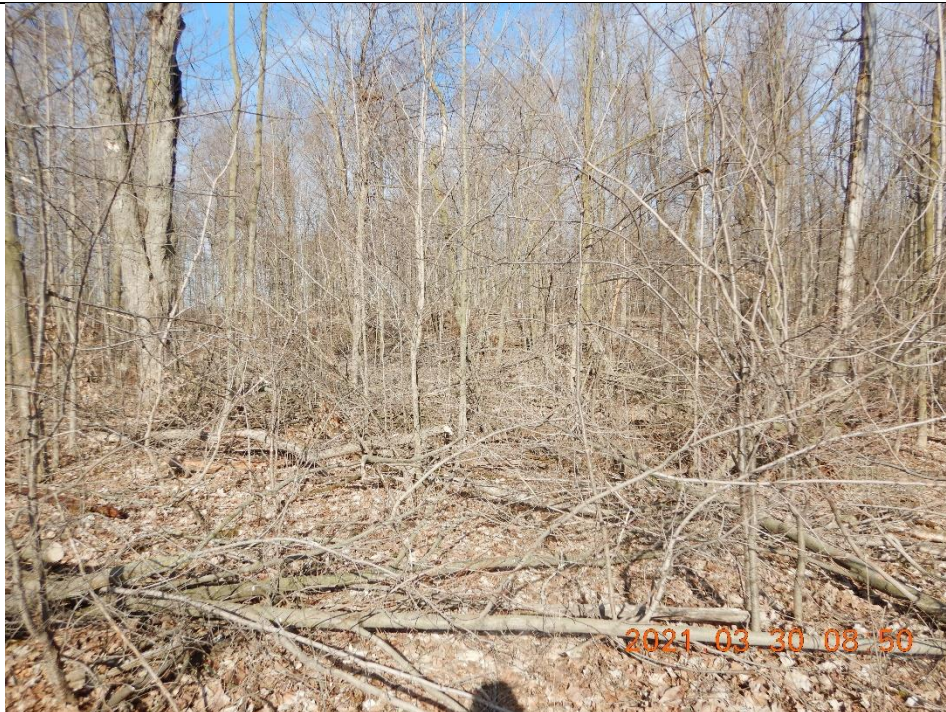
Photo 2

West Humber River Headwater Drainage Feature,
12892 Dixie Road, HDF 1b: Site Visit 1

Photograph taken looking downstream of **HDF 1b**. The area was dry, and no defined feature was observed.

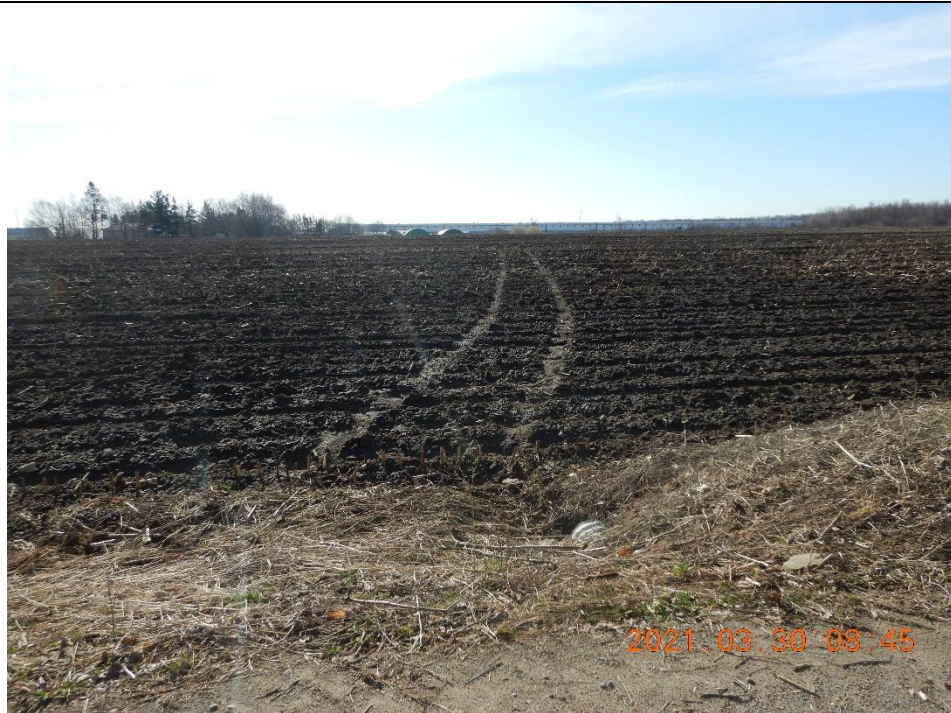
Photo 3

West Humber River Headwater Drainage Feature,
12892 Dixie Road, HDF 2a: Site Visit 1

Photograph taken looking upstream. **HDF 2a** was not observed in situ.

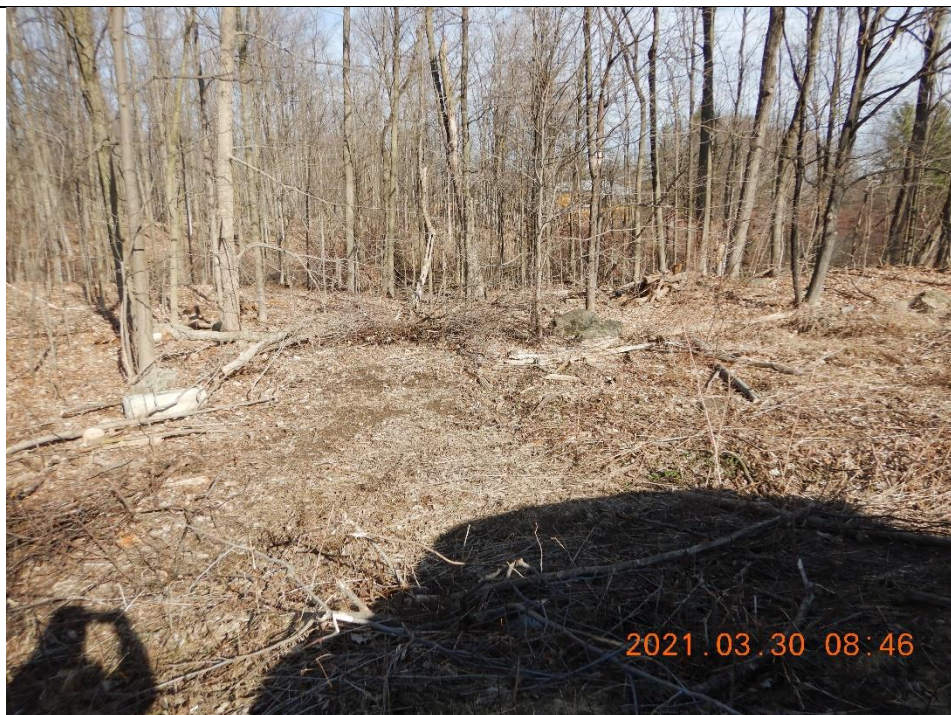
Photo 4

West Humber River Headwater Drainage Feature,
12892 Dixie Road, HDF 2b: Site Visit 1

Photograph taken looking downstream of **HDF 2b**. The area was dry, and no defined feature was observed.

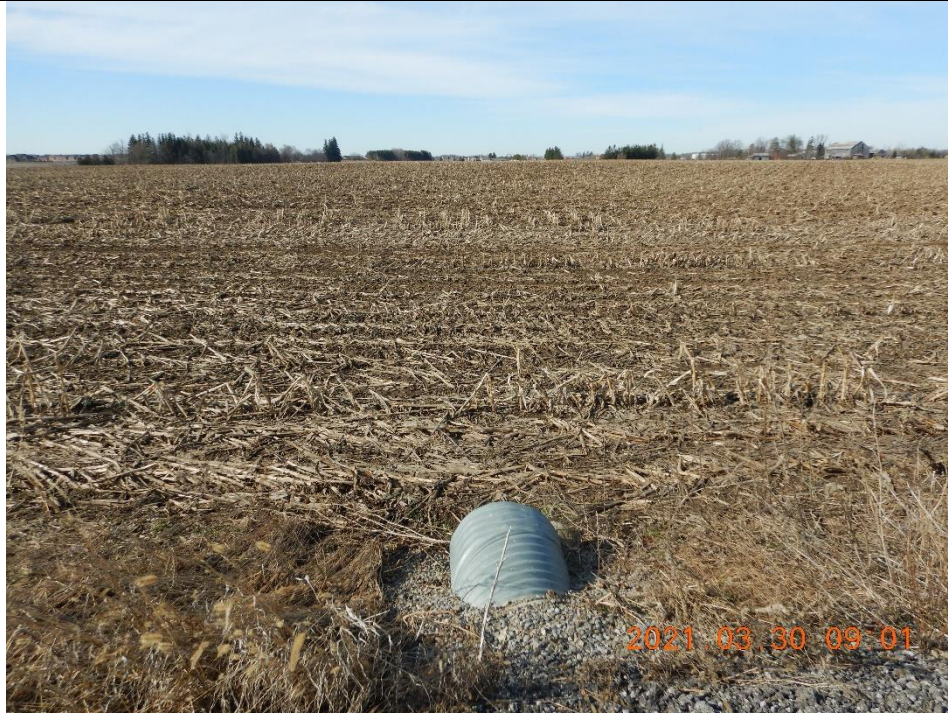
Photo 5

West Humber River Headwater Drainage Feature,
12892 Dixie Road, HDF 3: Site Visit 1

Photograph taken looking downstream, **HDF 3** was not observed in situ.

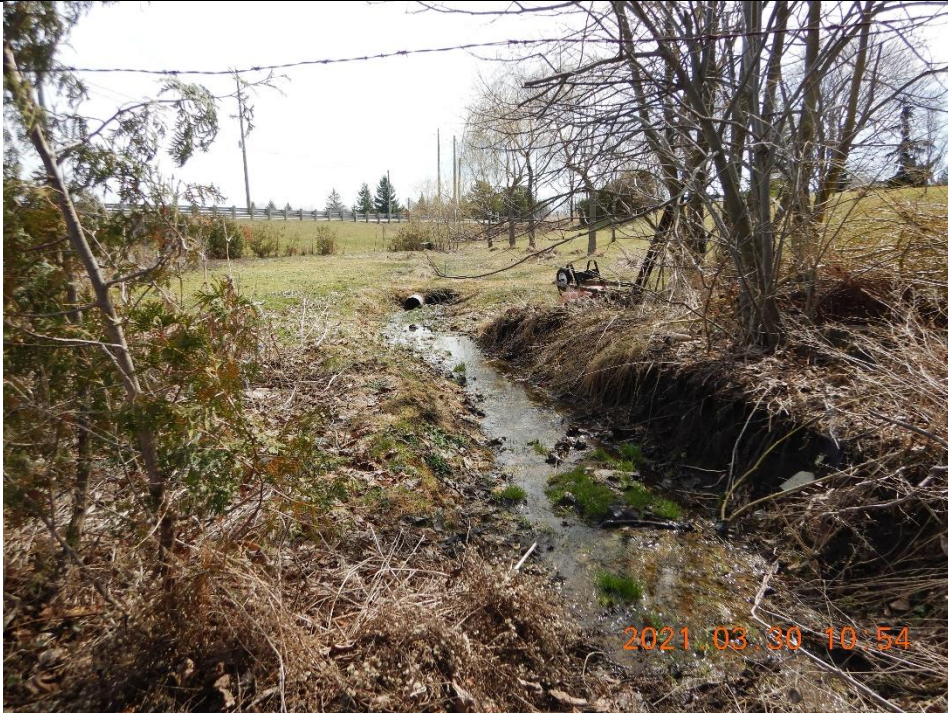
Photo 6

West Humber River Headwater Drainage Feature,
12892 Dixie Road, HDF 8a-2: Site Visit 1

HDF 8a-2 is located on a non-participating property. Photograph taken from property line, facing downstream. Photograph for information purposes only.

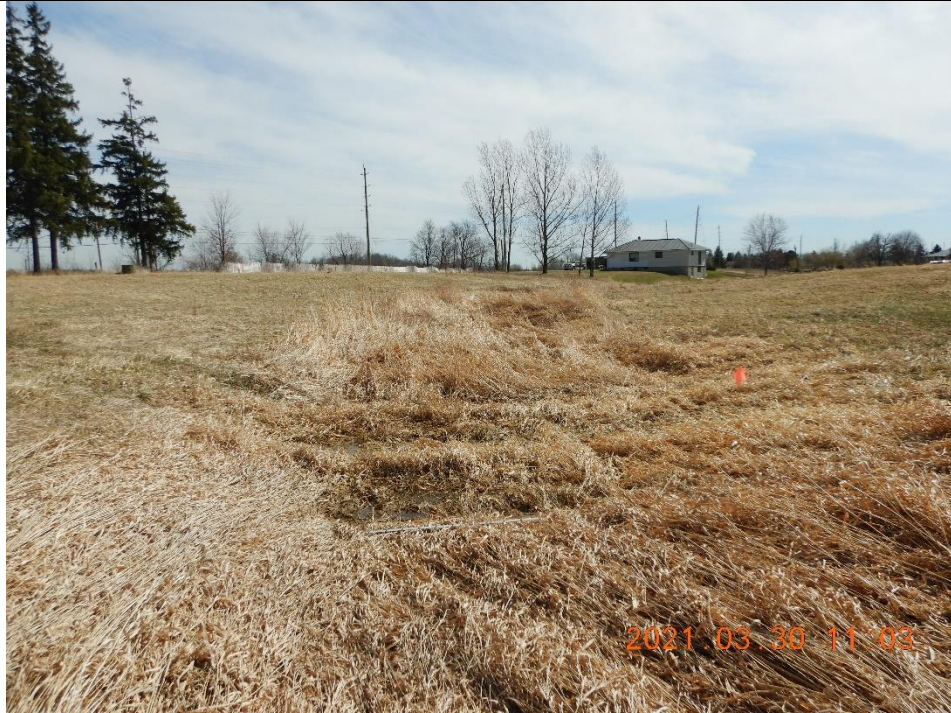
Photo 7

West Humber River Headwater Drainage Feature,
12892 Dixie Road, HDF 8a-3: Site Visit 1

HDF 8a-3 with standing water during Round 1 site observation. No defined channel. Looking downstream toward non-participating property.

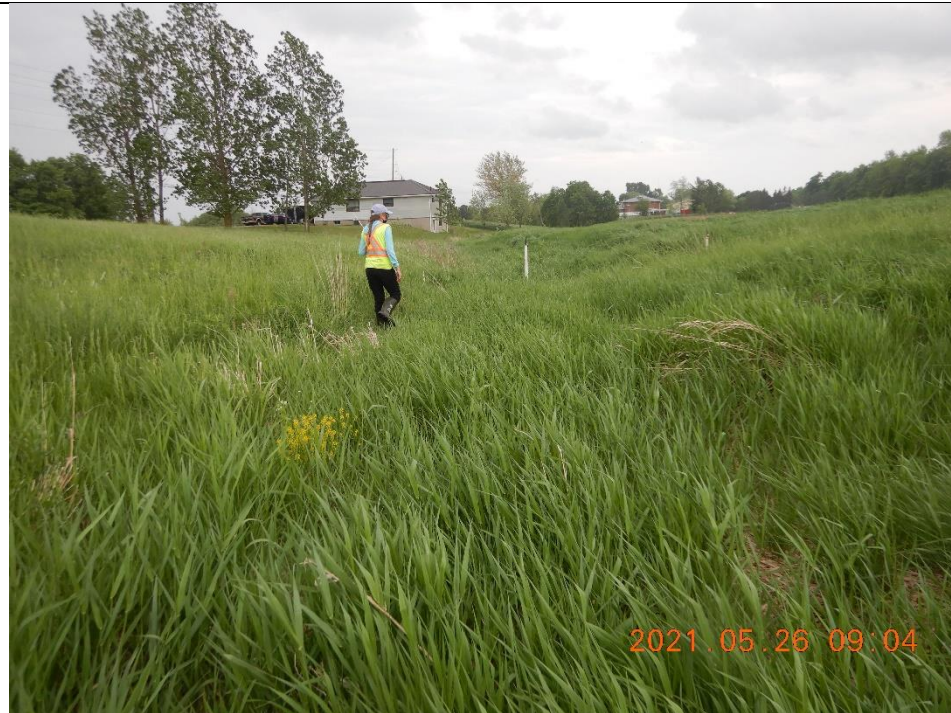
Photo 8

West Humber River Headwater Drainage Feature,
12892 Dixie Road, HDF 8a-3: Site Visit 2

HDF 8a-3 was observed to be dry at the time of the second round of observations. The feature type is a swale.

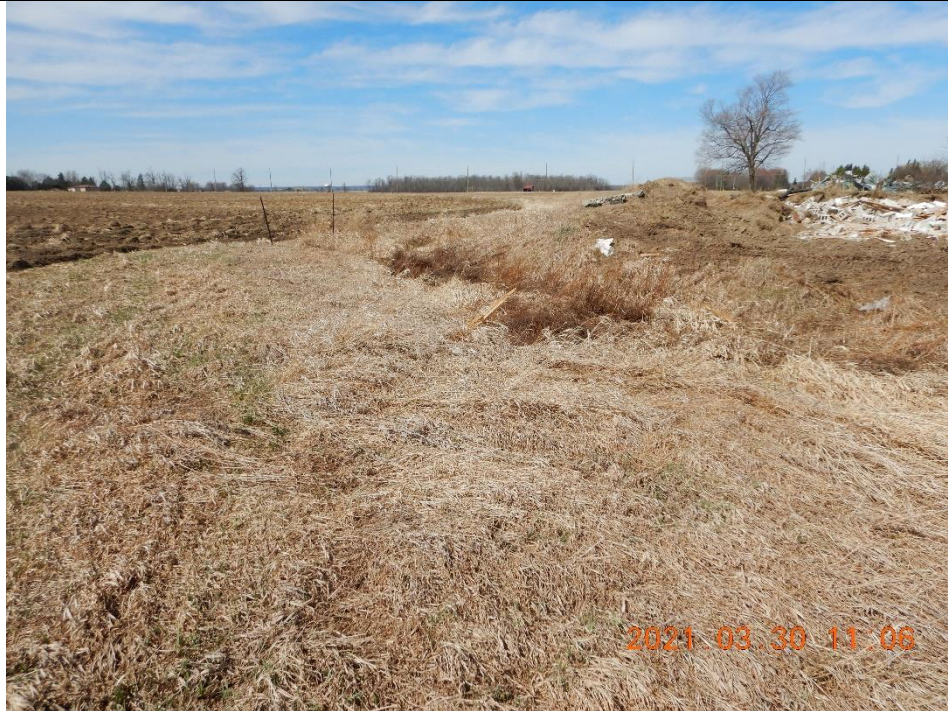
Photo 9

West Humber River Headwater Drainage Feature,
12892 Dixie Road, HDF 8a-4: Site Visit 1

HDF 8a-4 facing upstream during Round 1 site visit. Standing water observed only. No defined, single channel present.

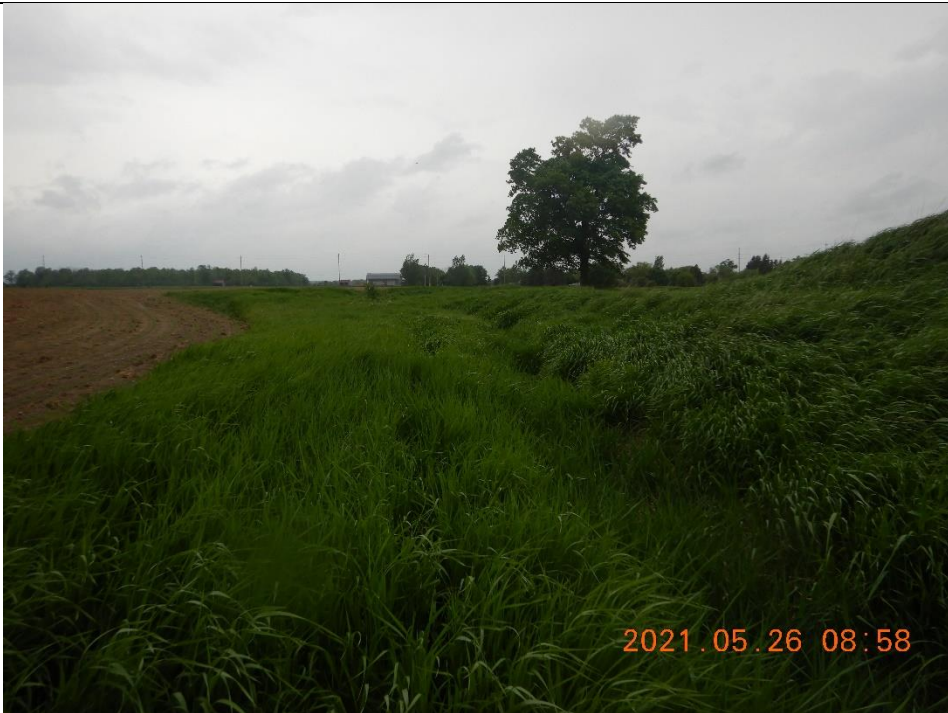
Photo 10

West Humber River Headwater Drainage Feature,
12892 Dixie Road, HDF 8a-4: Site Visit 2

HDF 8a-4 was observed to be dry at the time of the second round of observations. Swale feature with no defined, single channel.

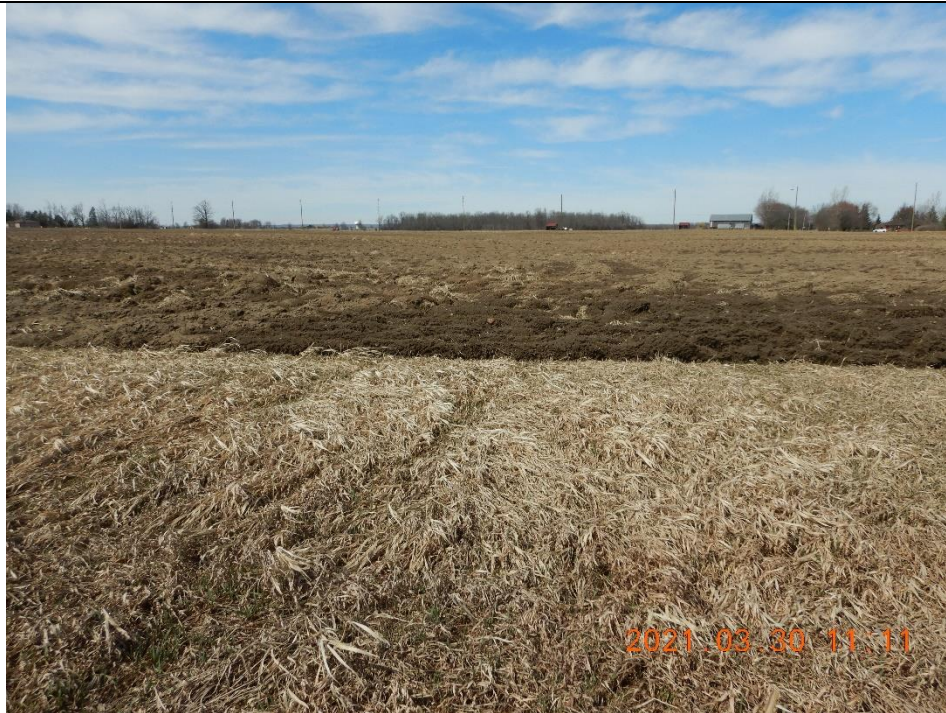
Photo 11

West Humber River Headwater Drainage Feature,
12892 Dixie Road, HDF 8a-5: Site Visit 1

HDF 8a-5 was not observed in situ.

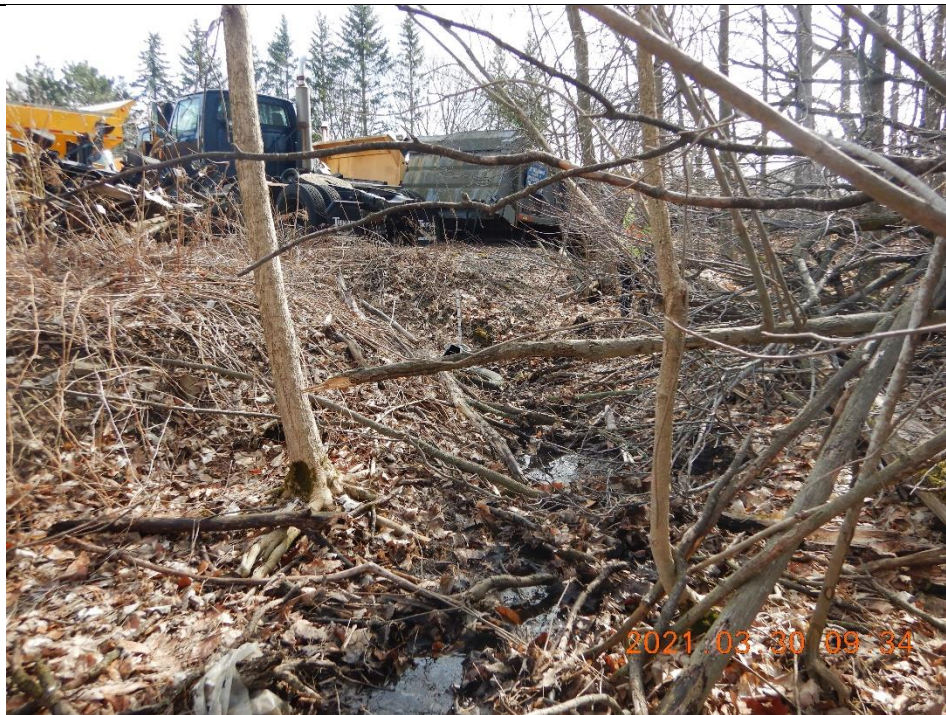
Photo 12

West Humber River Headwater Drainage Feature,
12892 Dixie Road, HDF 9b: Site Visit 1

Photograph taken at downstream extent of **HDF 9b**, facing downstream looking at property line. Standing water observed during Round 1 site visit.

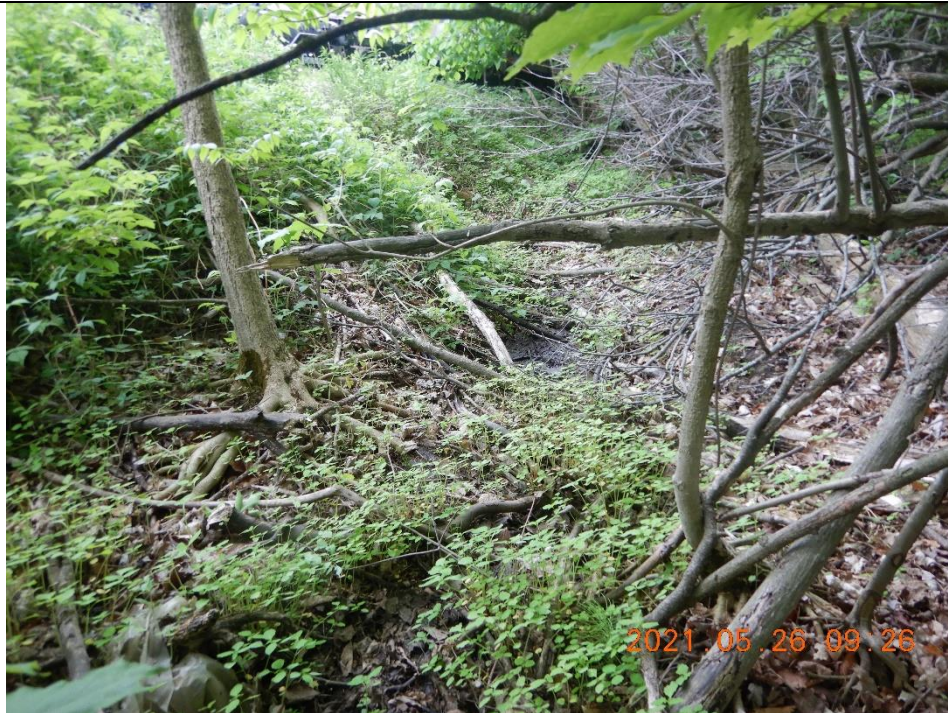
Photo 13

West Humber River Headwater Drainage Feature,
12892 Dixie Road, HDF 9b: Site Visit 2

Photograph taken at a similar location to Photo 12. No standing water was observed during the second-round observations. No single, defined channel present.

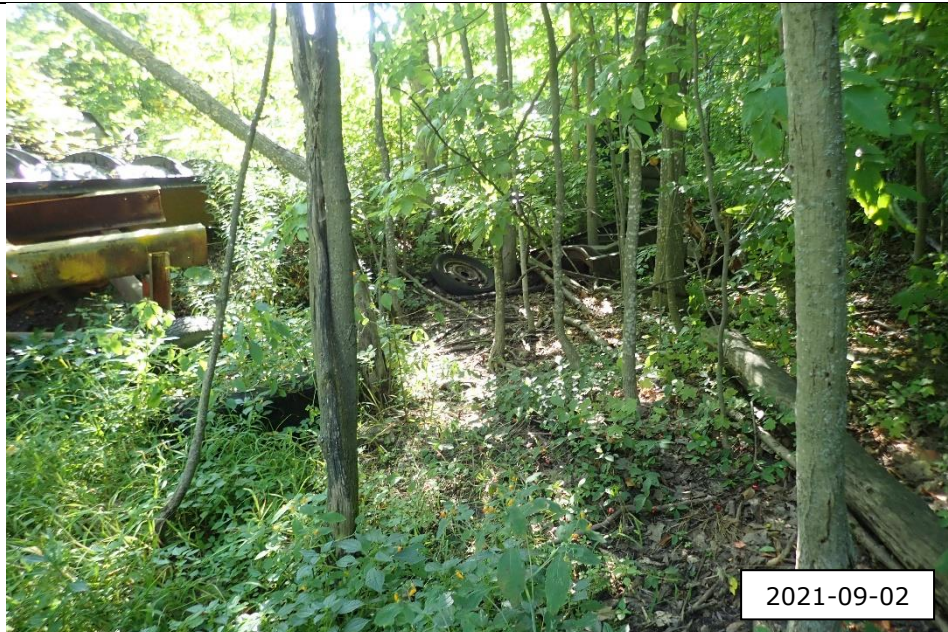
Photo 14

West Humber River Headwater Drainage Feature,
12892 Dixie Road, HDF 9b: Site Visit 3

Photograph taken during the third-round of observations. No standing water was observed throughout the multi-threaded feature. Channels are poorly defined.

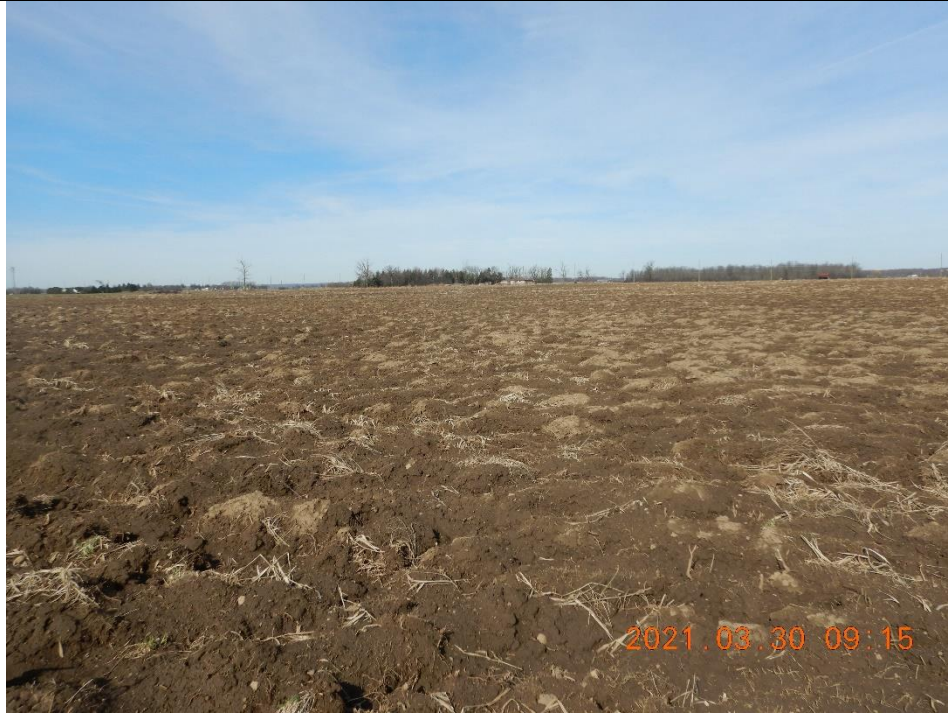
Photo 15

West Humber River Headwater Drainage Feature,
12892 Dixie Road, HDF 9c: Site Visit 1

Photograph taken from northern boundary of existing woodlot on site. No feature was observed in situ.
