**Cultural Heritage Impact Statement, 12455
Creditview Road, Part of Lot 20, Concession
3 West of Center Road, Chinguacousy
Township, now Town of Caledon, Regional
Municipality of Peel**

Project number: 2022-0041

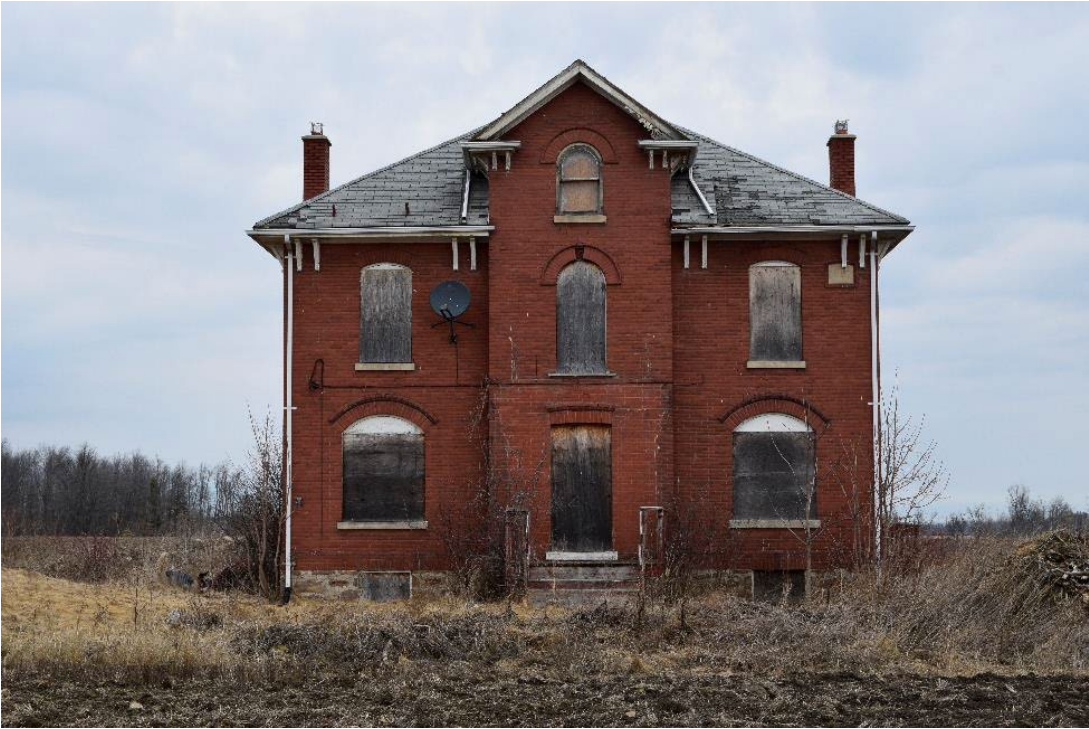
Figure 16: Front façade of structure

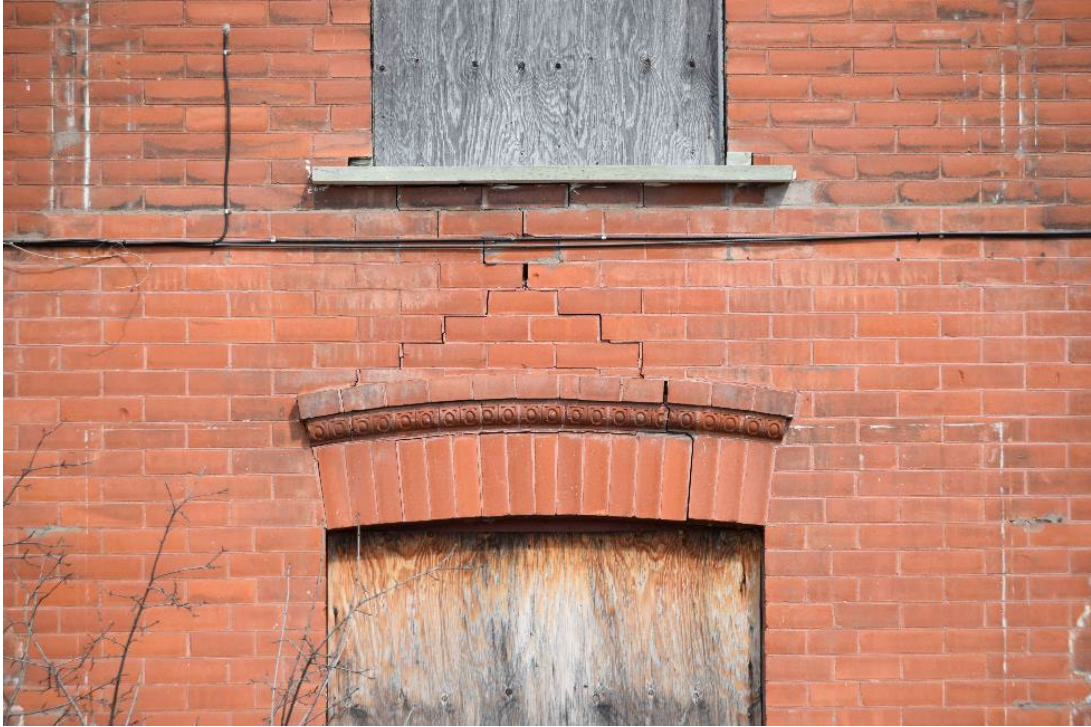
Figure 31: Example of typical brick failure associated with structural openings

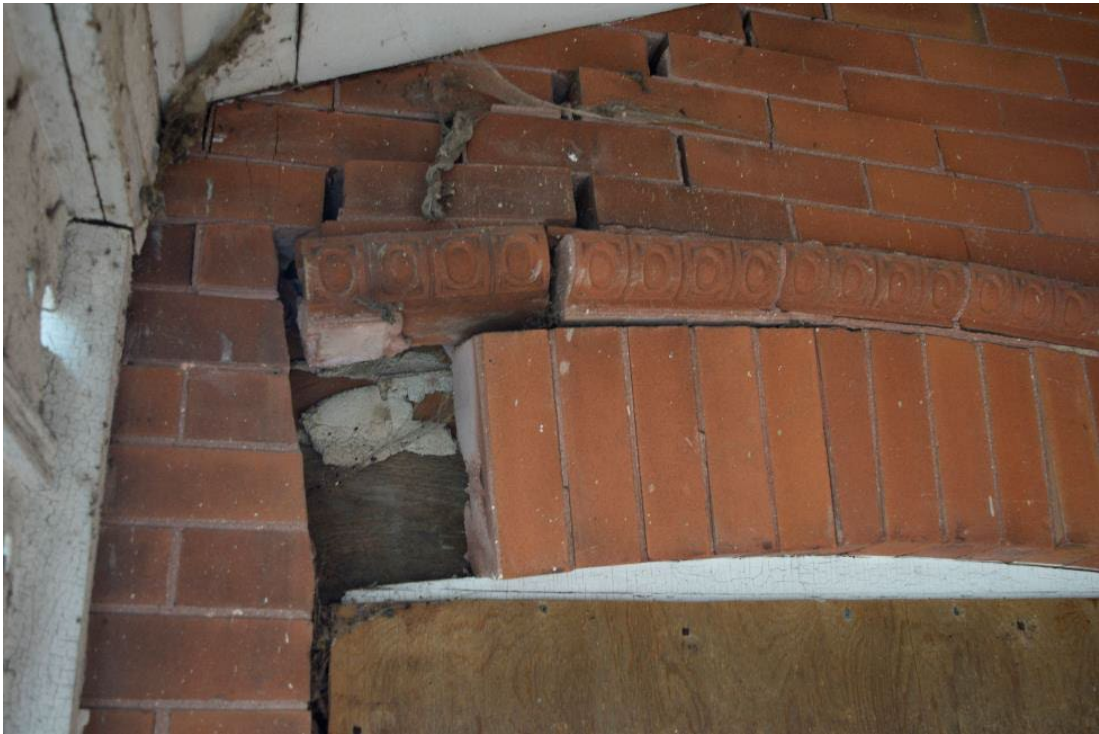
Figure 32: Closeup of typical failure of brick cladding

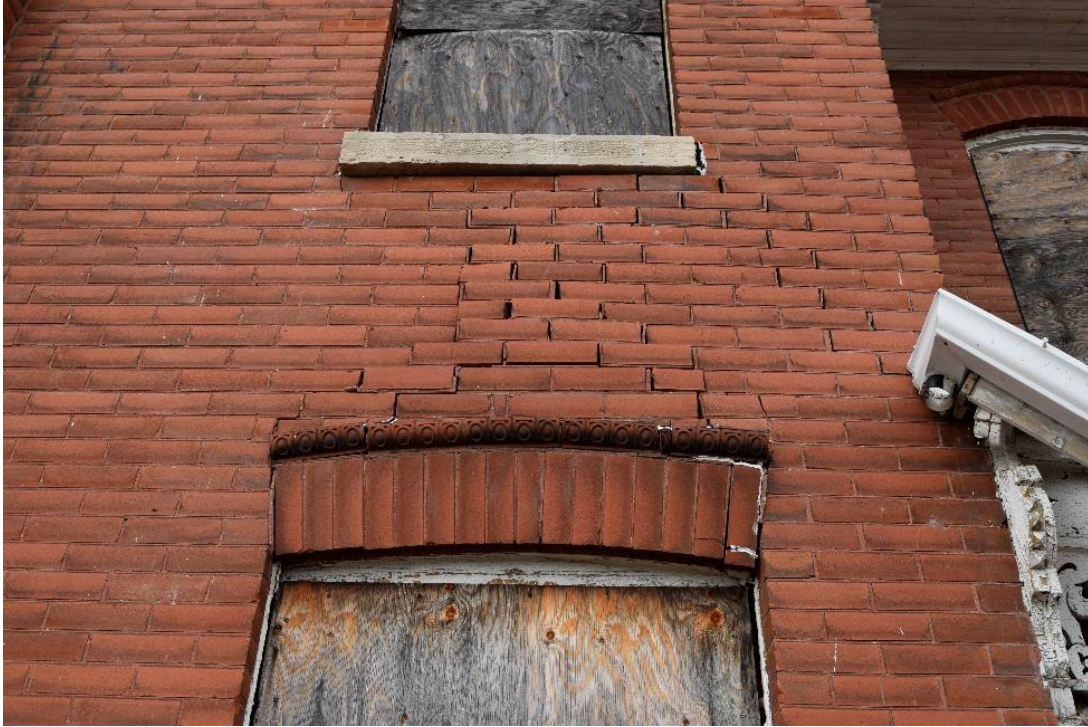
Figure 33: Extensive deformation in the brick finish associated with northeast corner of structure

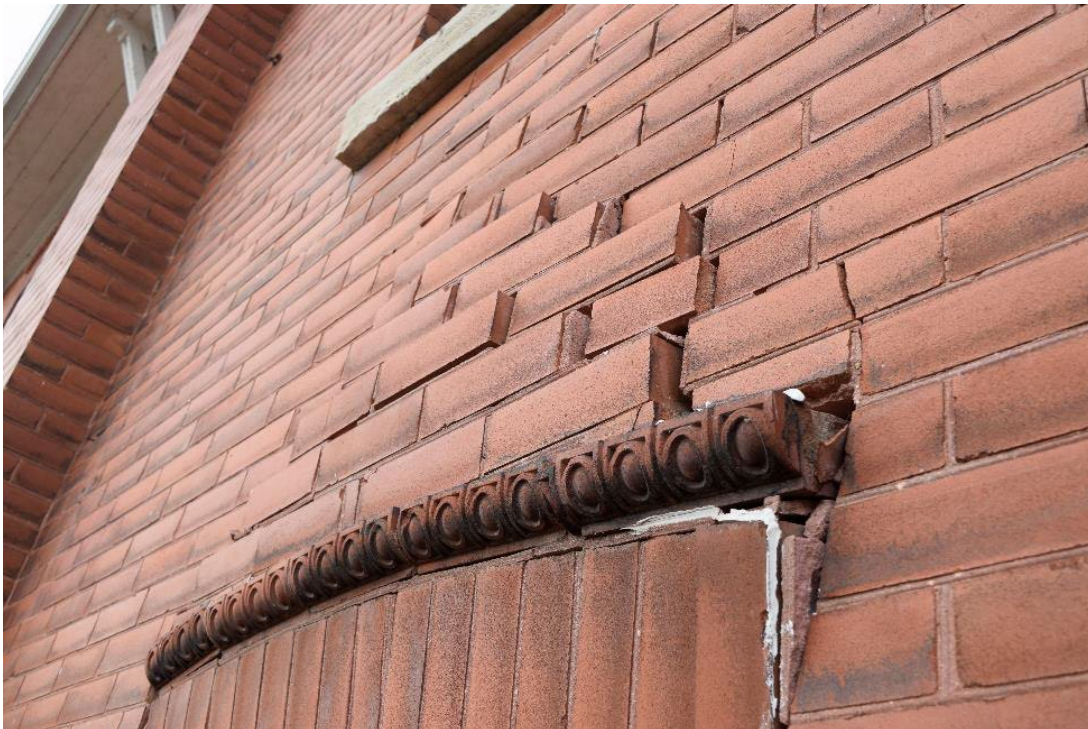
Figure 34: Close up of damage depicted in Figure 33

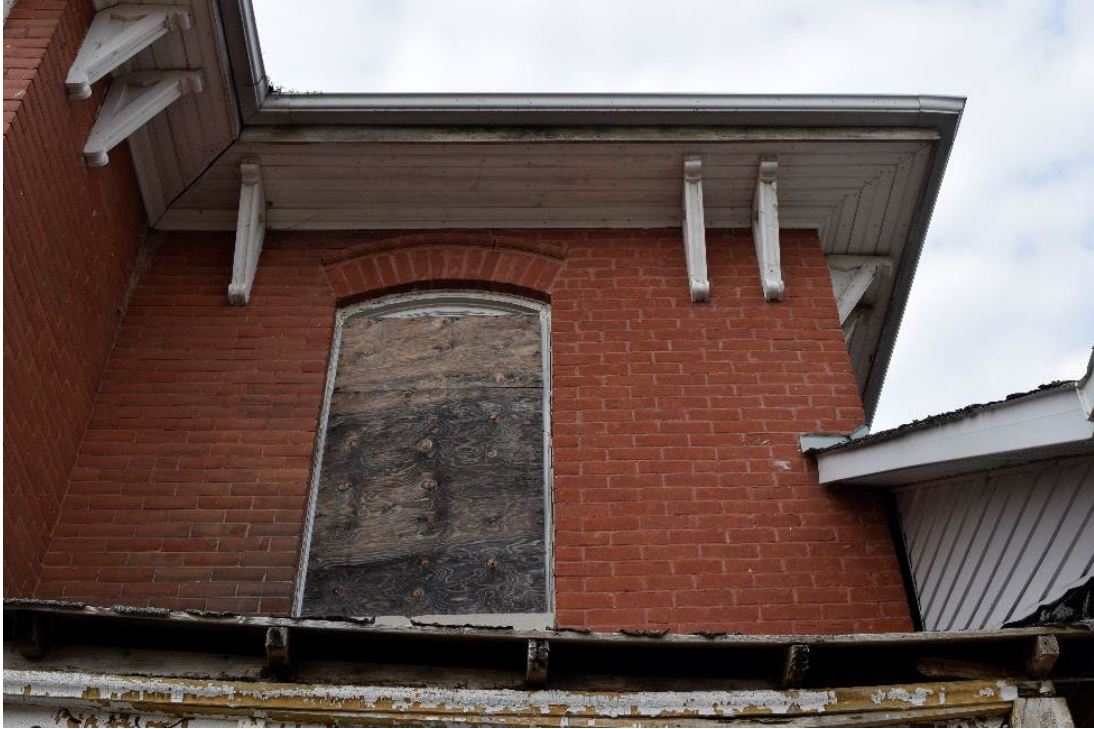
Figure 35: Past failure of the brick finish and replacement of the eaves, soffit and brackets on northwest corner, note mortar difference between right and left of image

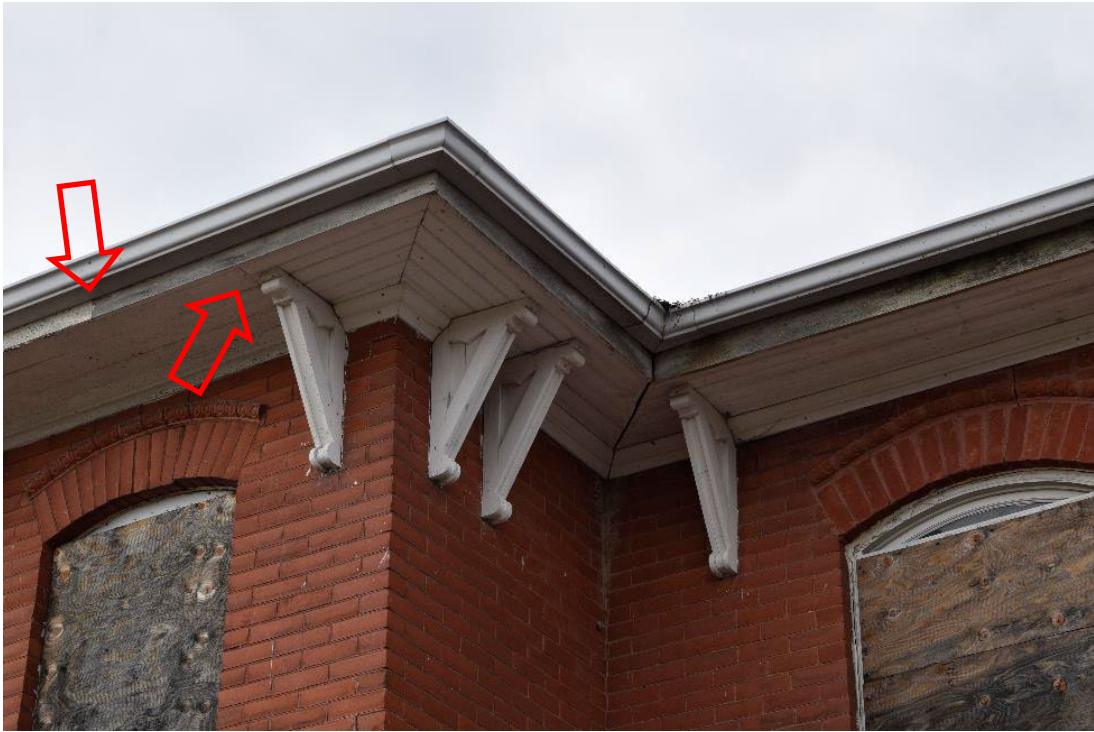
Figure 36: Close up of replacement fascia, soffit, and brackets, red arrows indicate seam between original and replacement materials

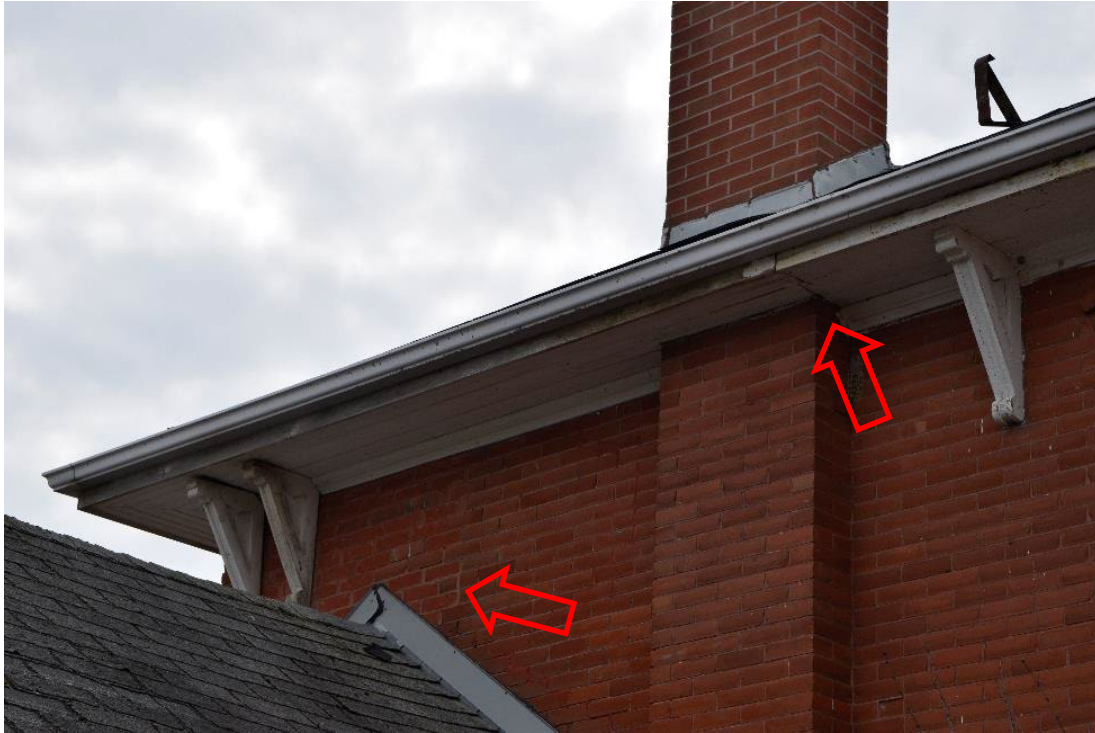
Figure 37: Damage in northeast corner of structure's north face, red arrows indicate transition between original material and replacement in both brick and soffit

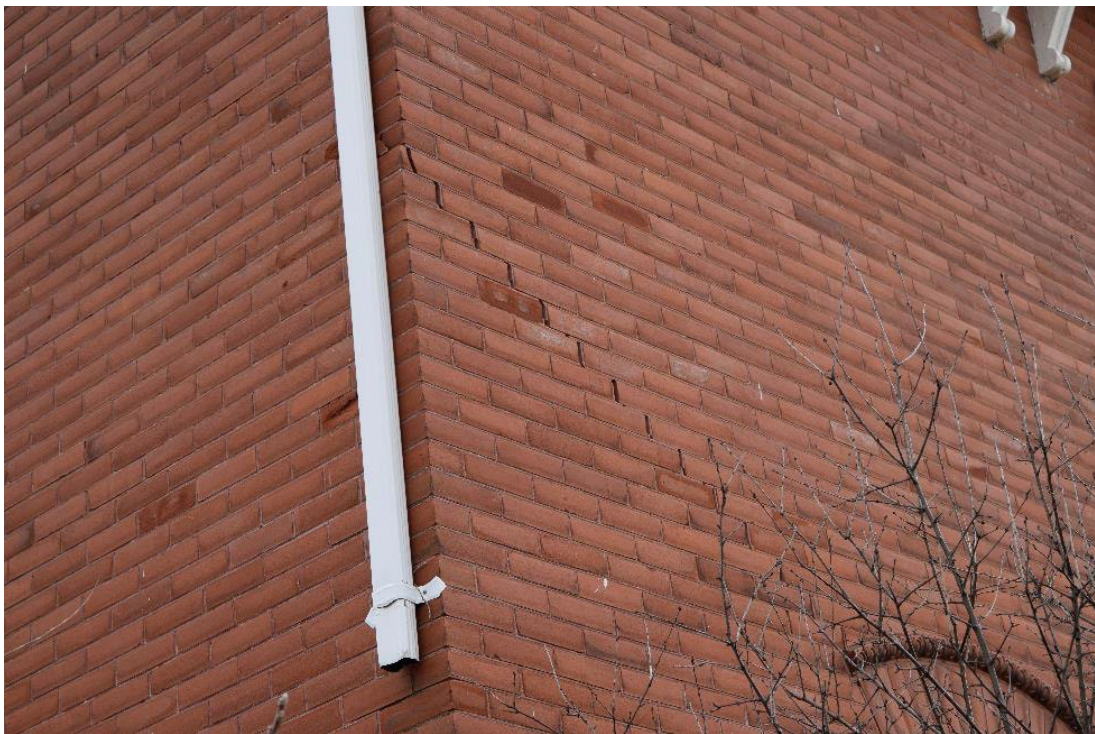
Figure 38: Stress crack in northwest corner indicative of foundation settlement

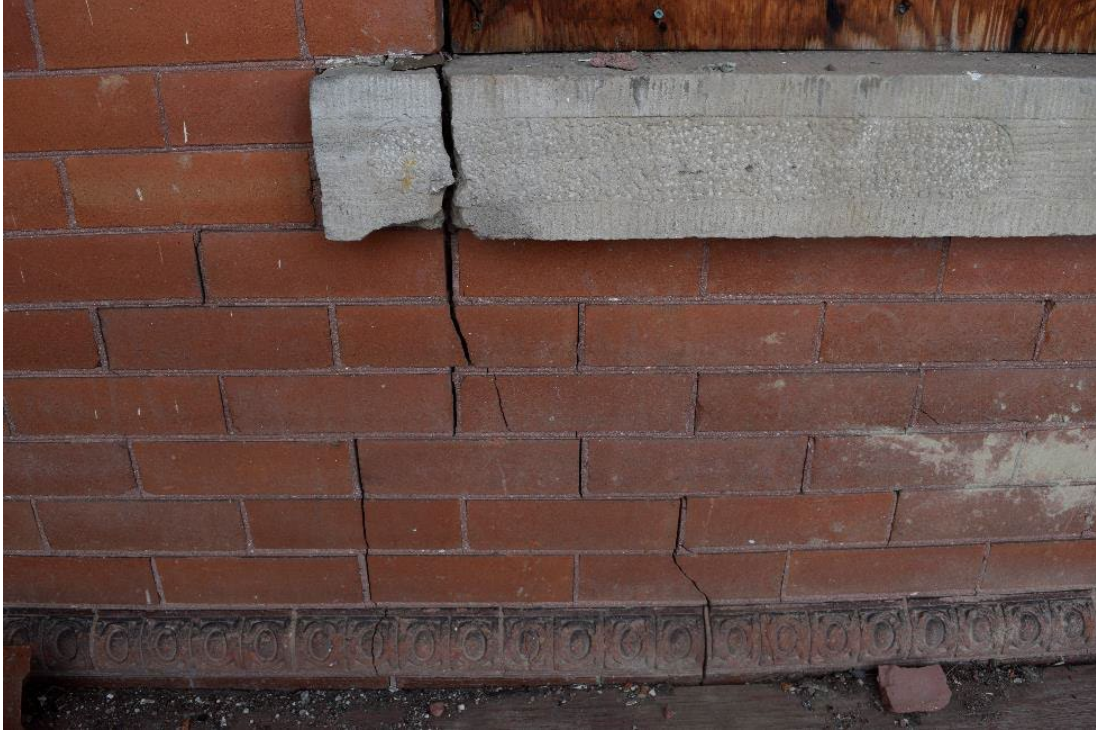
Figure 39: Stress crack in stone lug sill and brick work, east wall

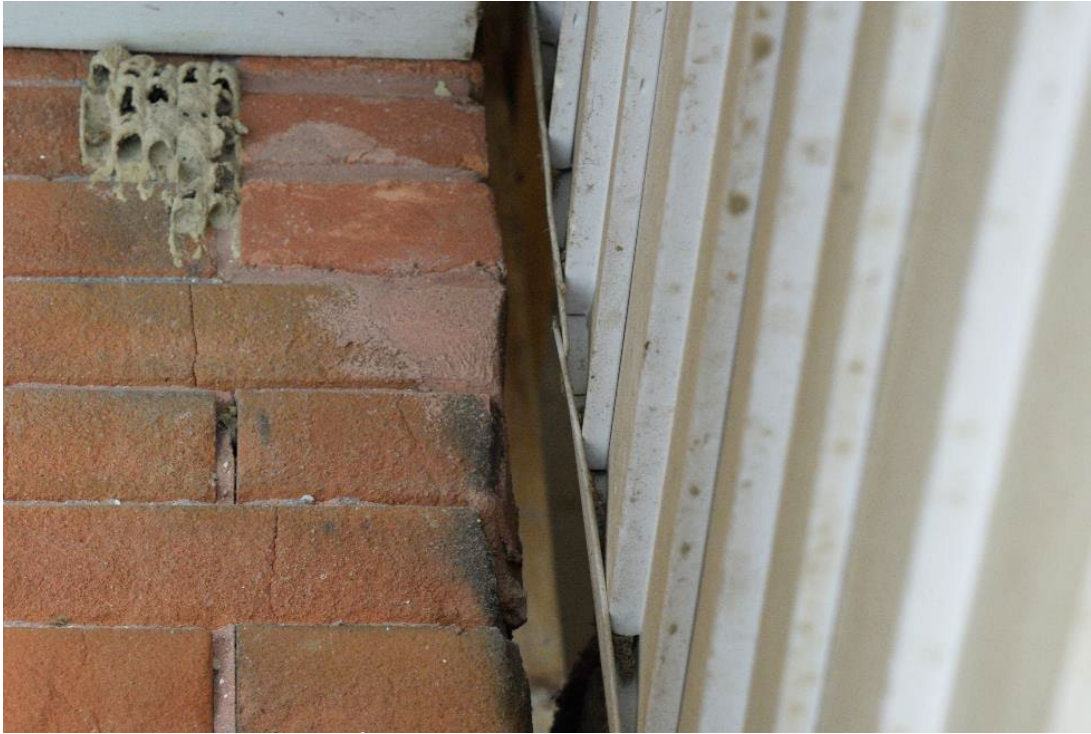
Figure 40: Large separation between modern addition and north wall of original structure, gap extends around structure and provides sight line to interior of structure

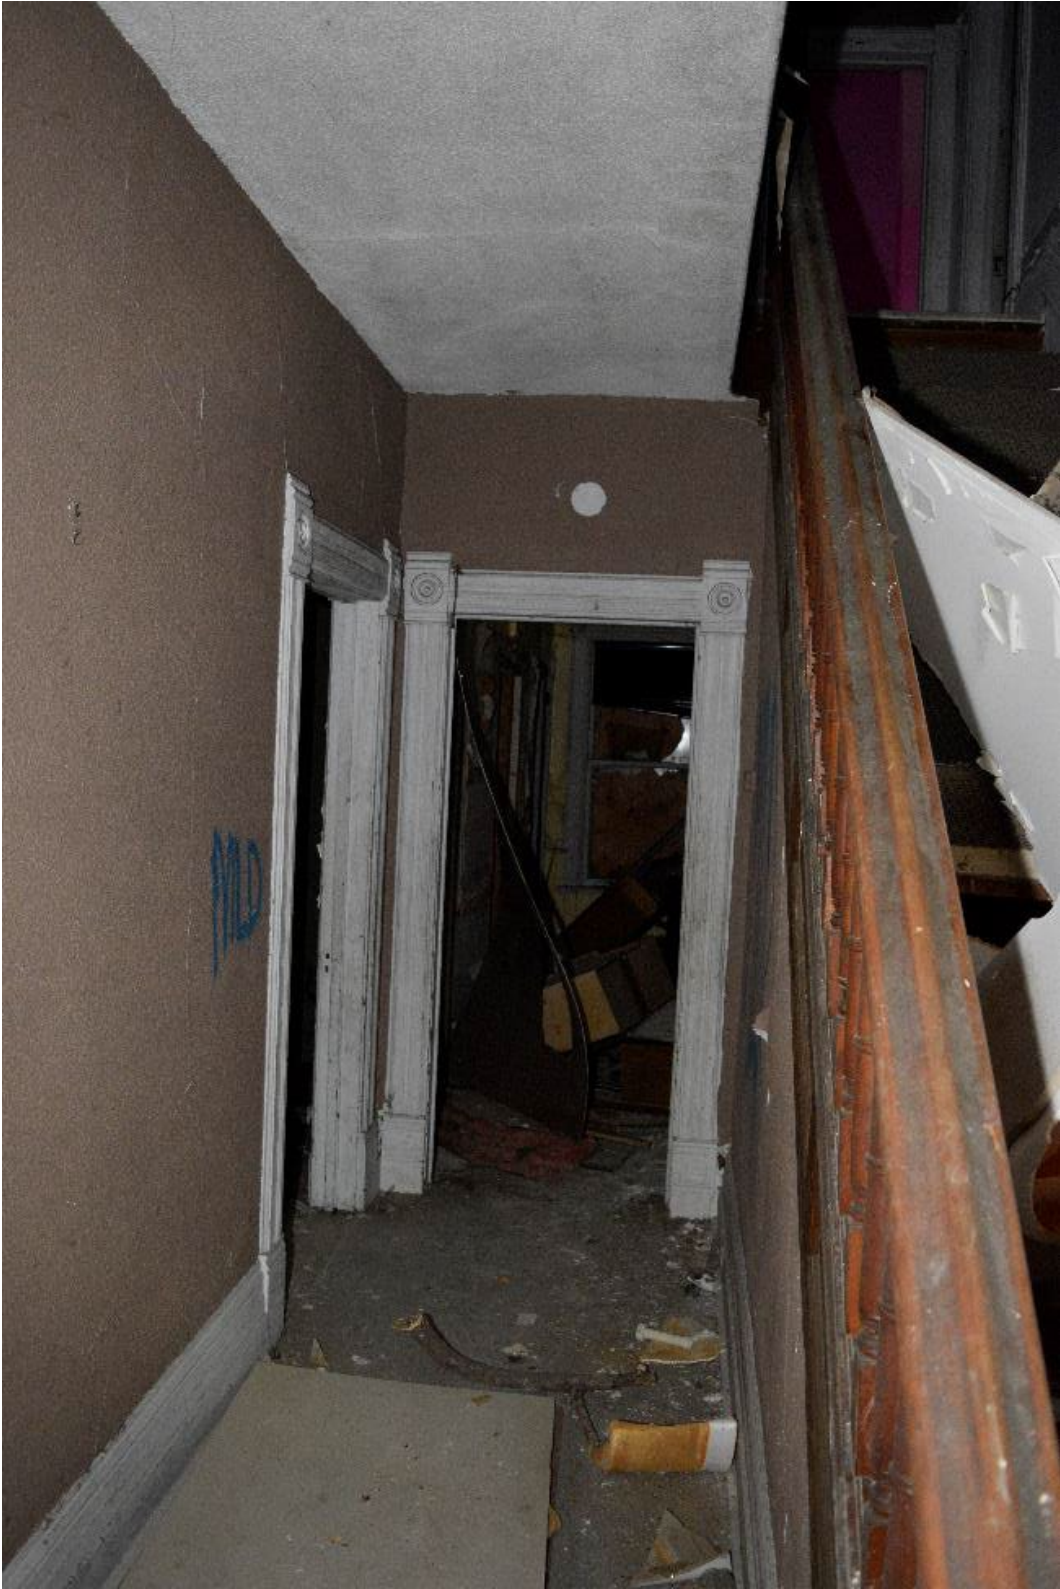
Figure 41: Centre hall first floor, facing north

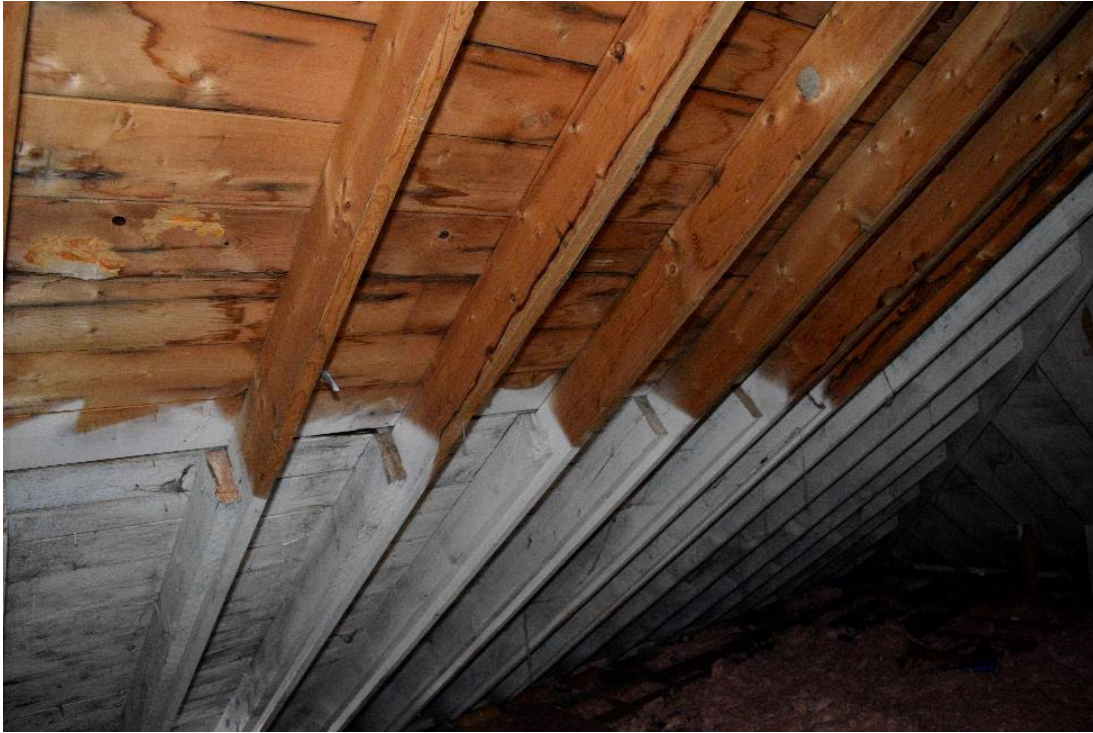
Figure 72: Evidence for extensive roof repair on west side of structure. The white line illustrates the connection between original framing and modern 2x6 rafters

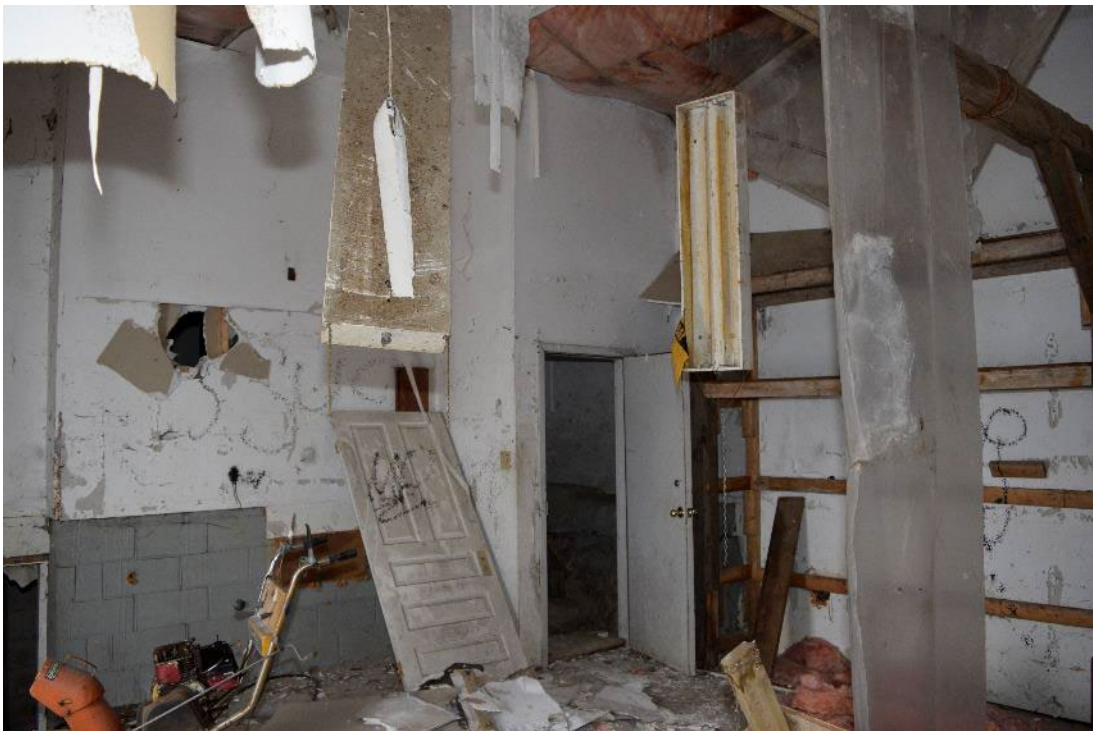
Figure 73: Interior of modern garage, facing southwest

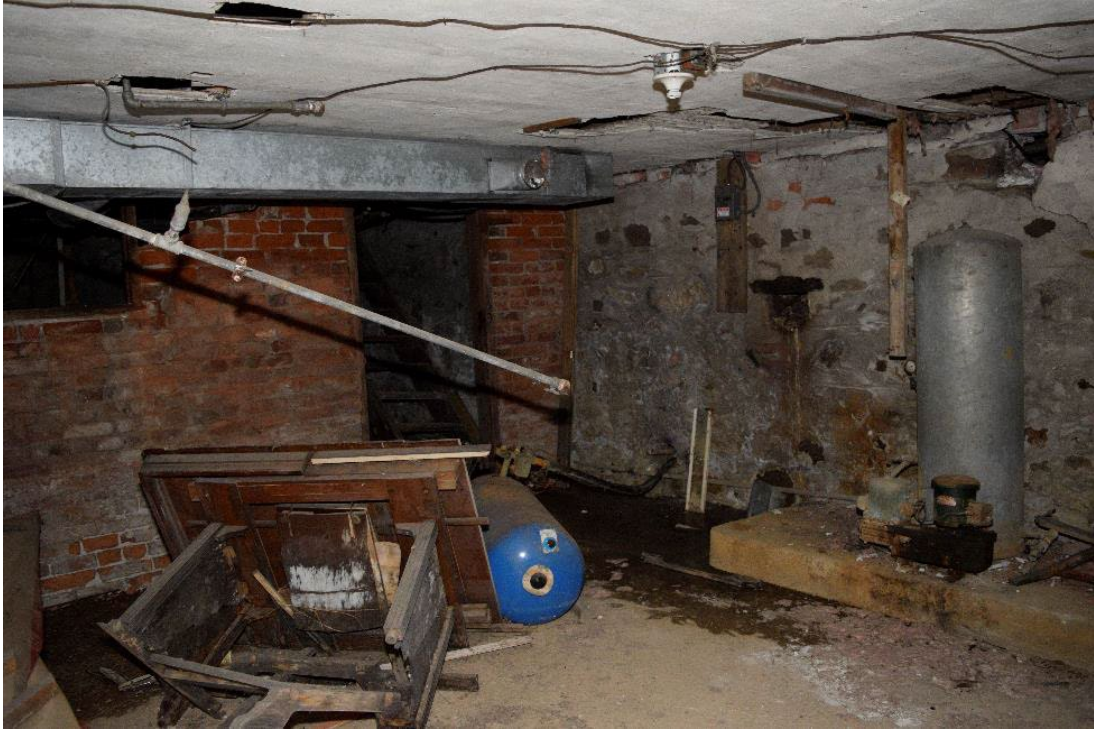
Figure 75: Basement, main foundation is of field stone with internal partitions of red brick

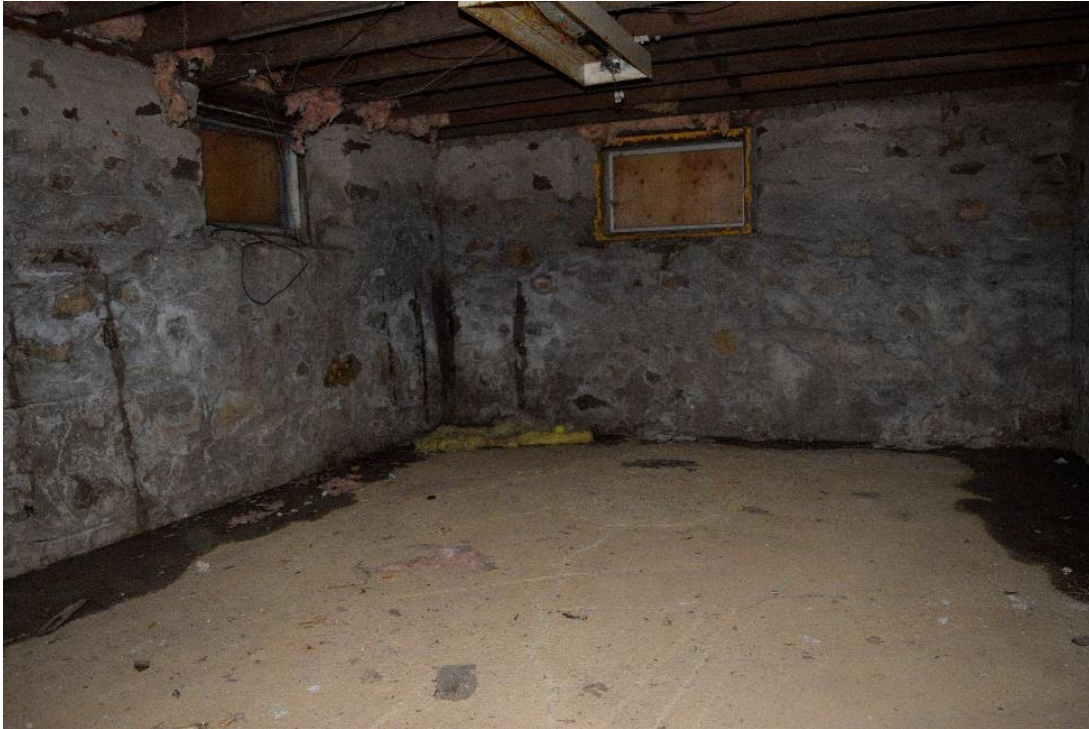
Figure 76: Southeast room of basement, facing southeast

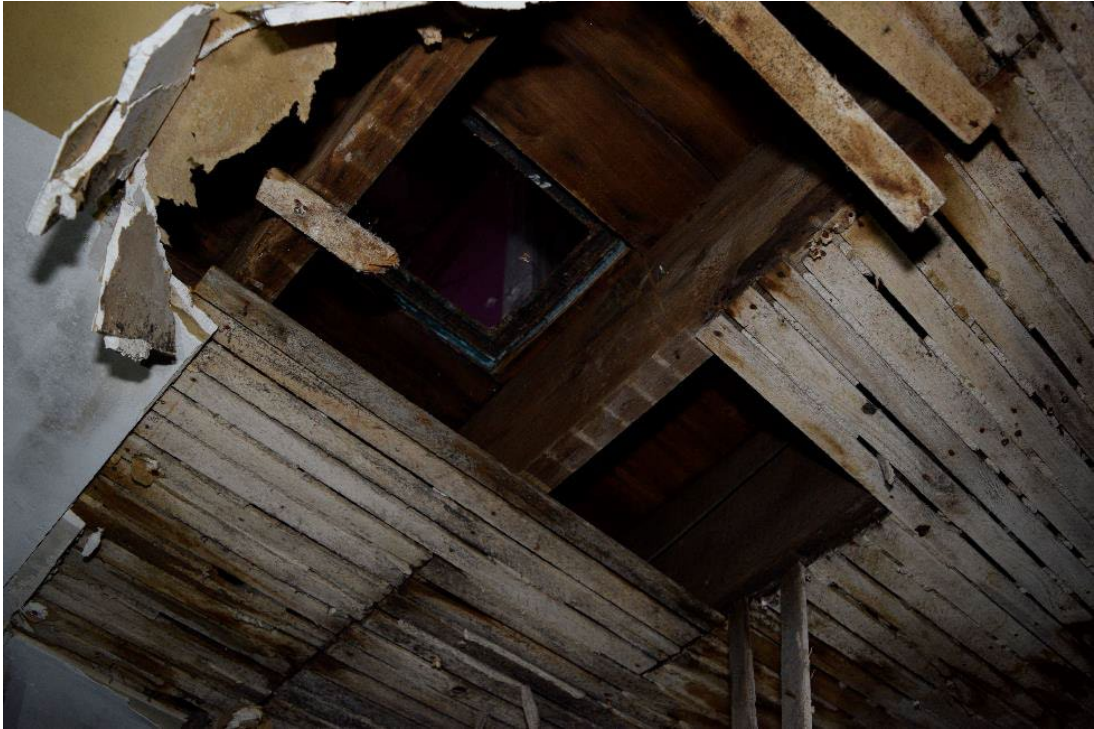
Figure 81: Example of extensive internal damage resulting from water and vandals

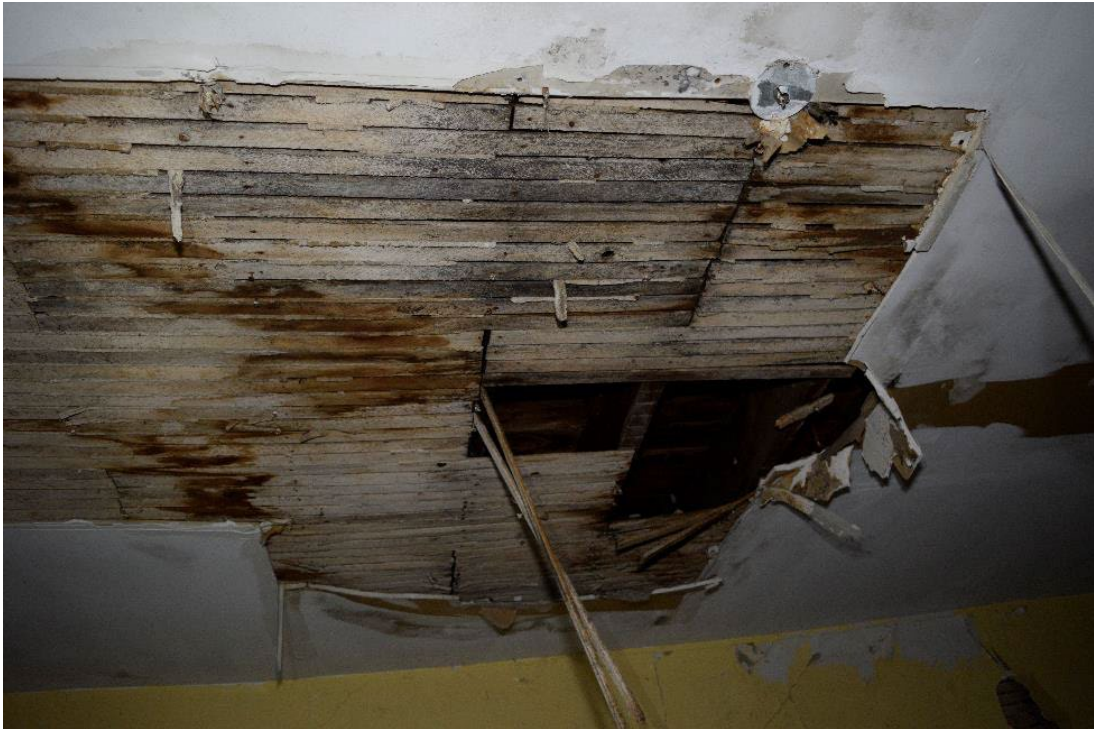
Figure 82: Drywall has been fastened over original lath; lath remains in most areas, but plaster has been removed thought house

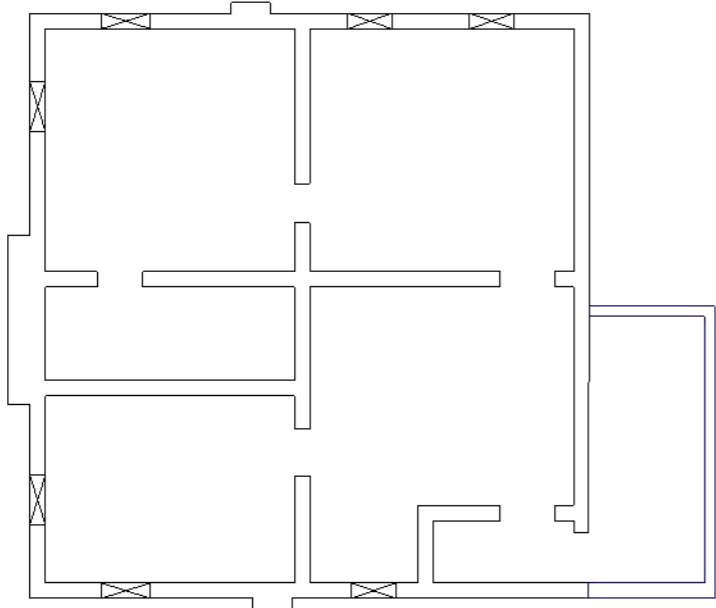
* Blue is a later field stone foundation addition

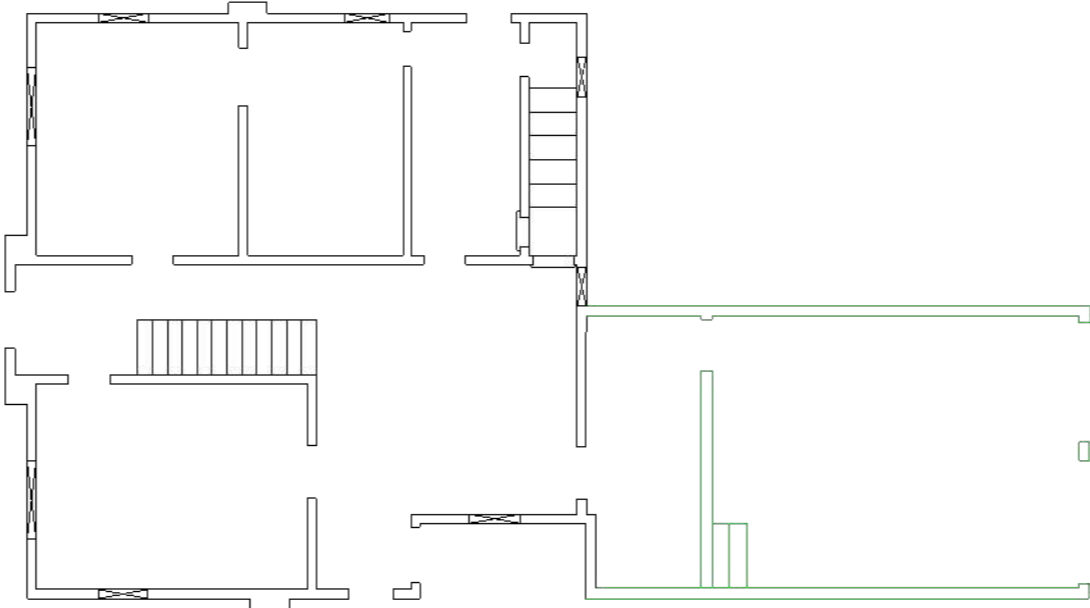
* Green is the modern Rear addition
