West Humber River Fluvial Geomorphological Assessment

12489 and 12861 Dixie Road
Caledon, Ontario

GEO Morphix Project No. 23012

Report Title: West Humber River Erosion Hazard Delineation
12489 and 12861 Dixie Road, Caledon, Ontario

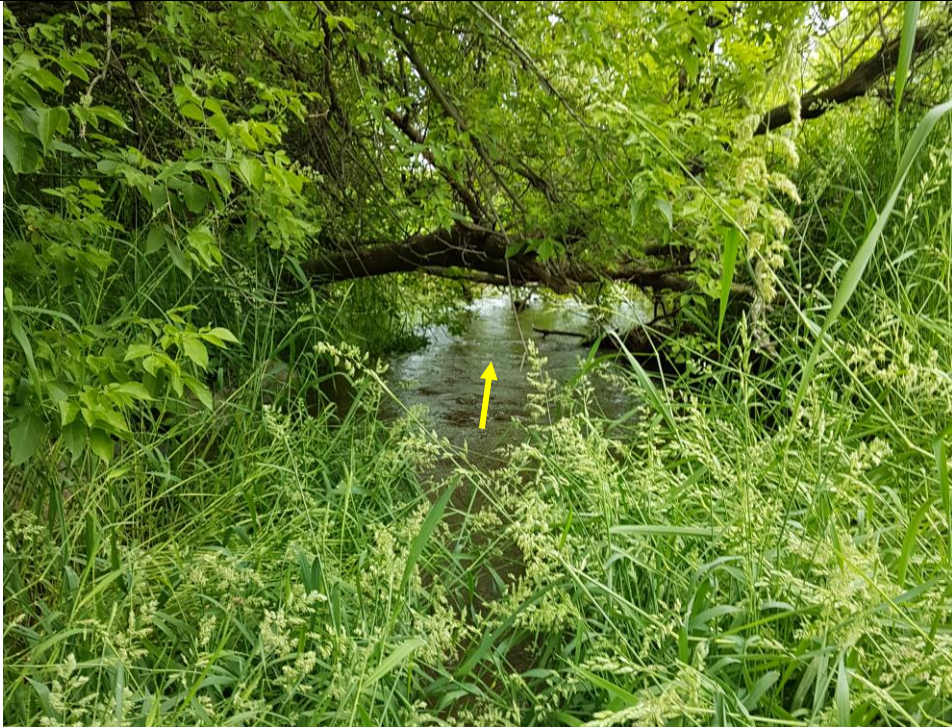
Photo 1
Kilamanagh Creek - Reach 4b, Caledon, Ontario

Photograph taken at the upstream extent of **Reach 4b**. The reach enters the subject property through a culvert along Dixie Road (yellow arrow indicates flow direction).

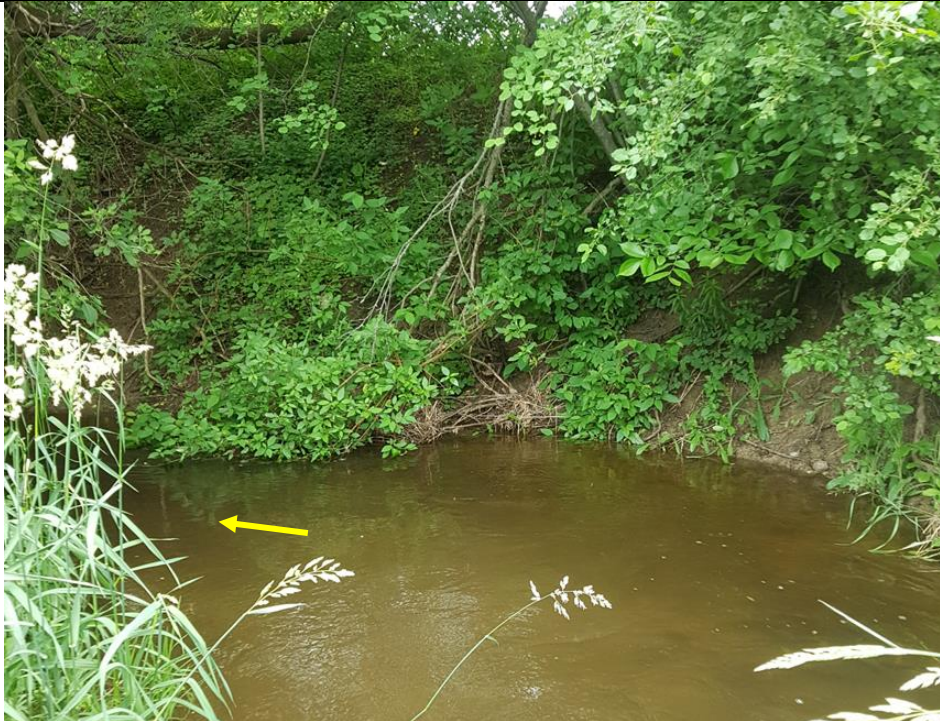
Photo 2
Kilamanagh Creek - Reach 4b, Caledon, Ontario

The reach flows through a partially confined valley, with multiple valley wall contacts. The riparian area consists primarily of grasses with few mature trees.

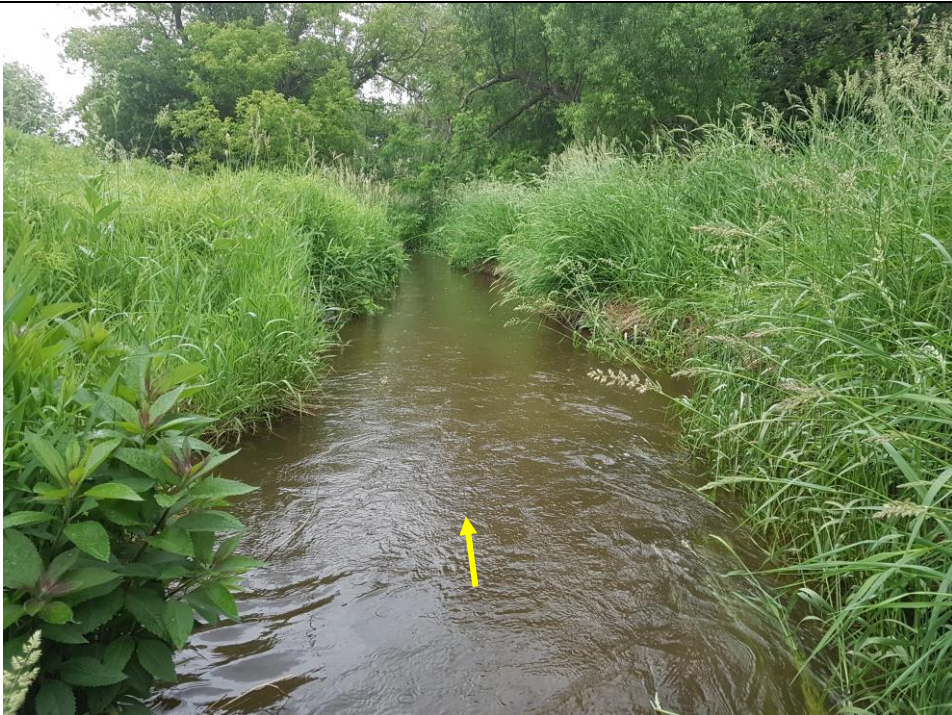
Photo 3
Kilamanagh Creek - Reach 4b, Caledon, Ontario

Average bankfull width and depth were 3.25 m and 0.66 m, respectively. At the time of assessment, high flows were noted, and the channel was near bankfull capacity.

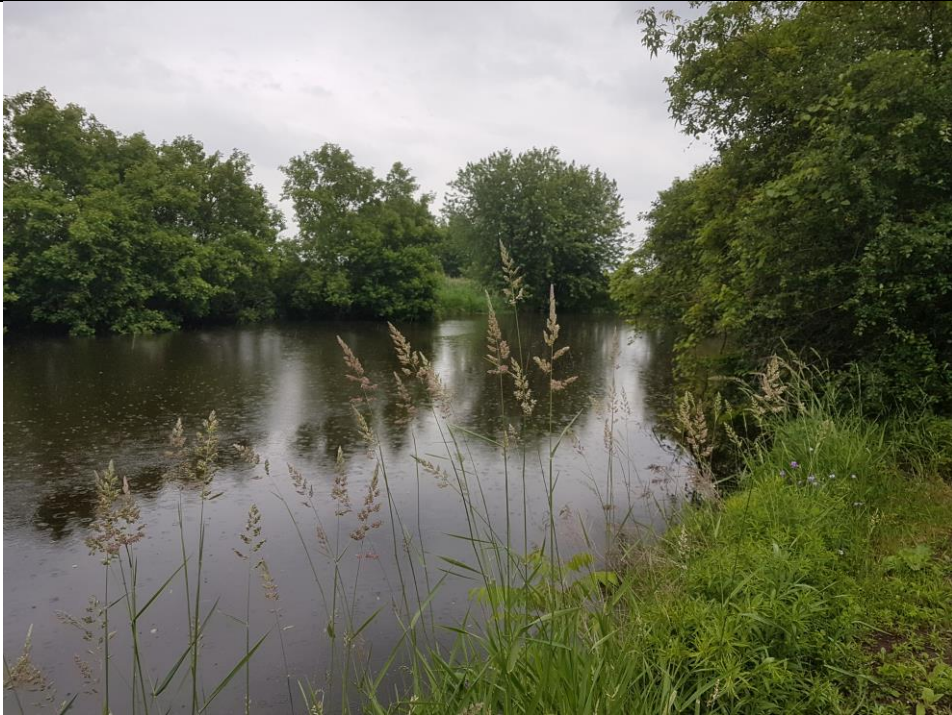
Photo 4
Kilamanagh Creek - Reach 4b, Caledon, Ontario

A large offline pond was present adjacent to the channel, separated by a tall berm. During high flows a small flow path connects the pond to the channel.

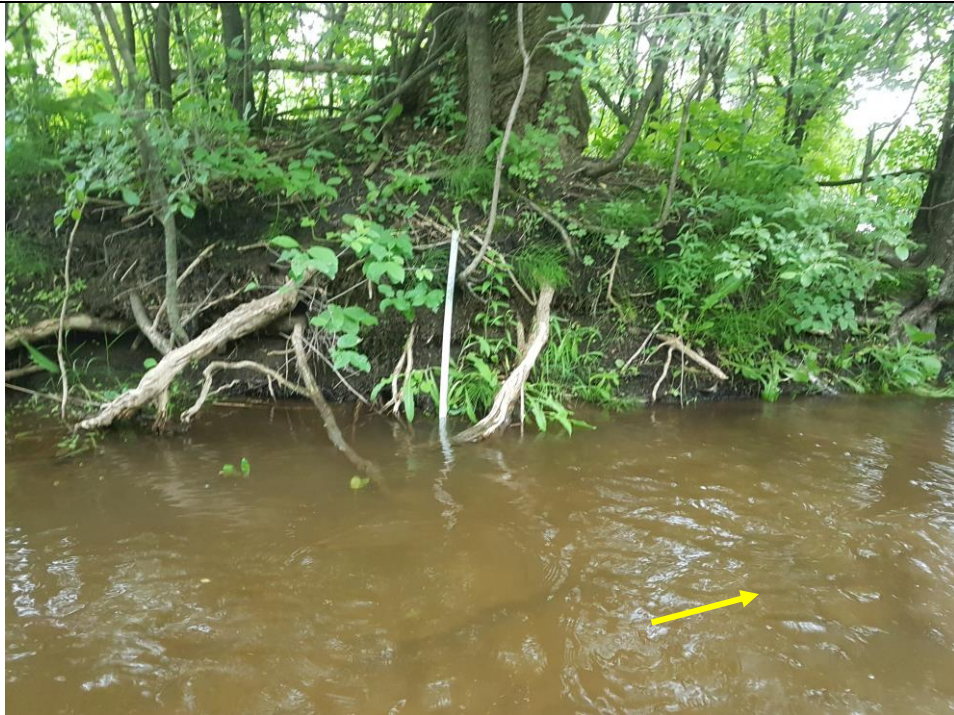
Photo 5
Kilamanagh Creek - Reach 4b, Caledon, Ontario

Bank erosion was observed throughout the channel as undercuts, basal scour, exposed tree roots, and fallen or leaning trees.

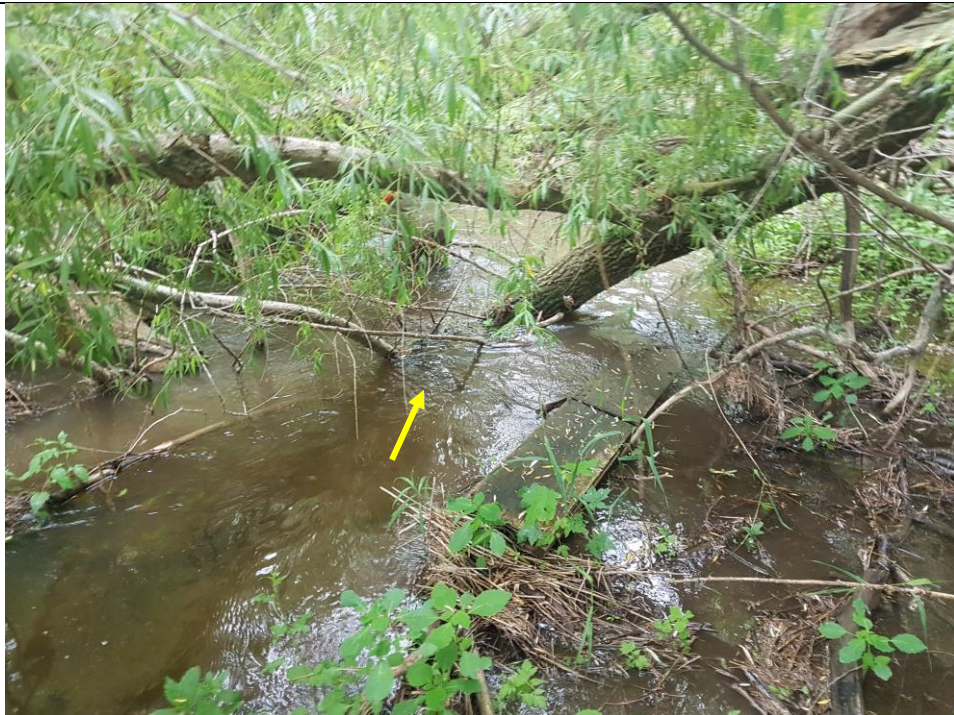
Photo 6
Kilamanagh Creek - Reach 4b, Caledon, Ontario

Photograph taken near the downstream extent of the reach. A low density of woody debris was present in the channel and cutbanks.

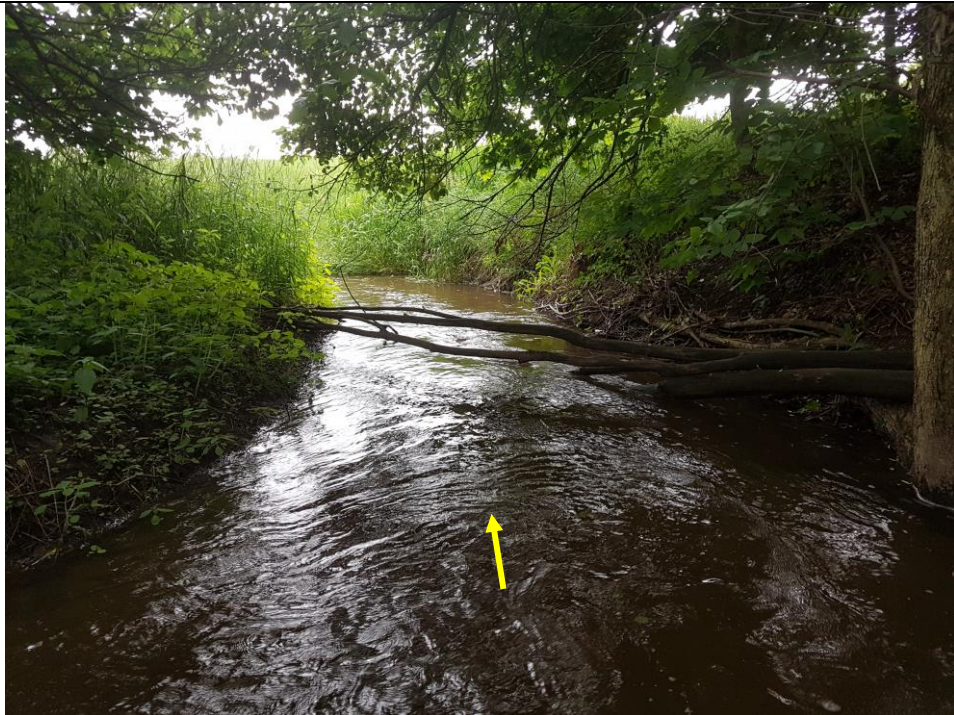
Photo 7
Kilamanagh Creek - Reach 4a, Caledon, Ontario

Photograph taken at the upstream extent of **Reach 4a**. The reach was characterized as irregularly meandering through a partially confined valley.

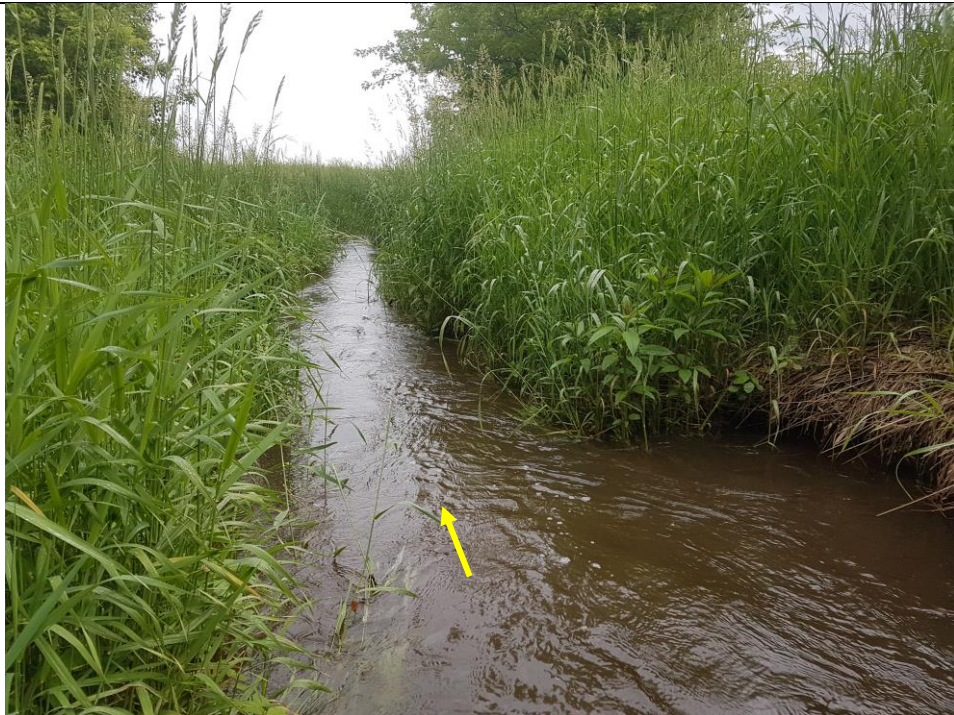
Photo 8
Kilamanagh Creek - Reach 4a, Caledon, Ontario

The riparian zone was dominated by a continuous coverage of herbaceous vegetation and grasses, with few mature trees present.

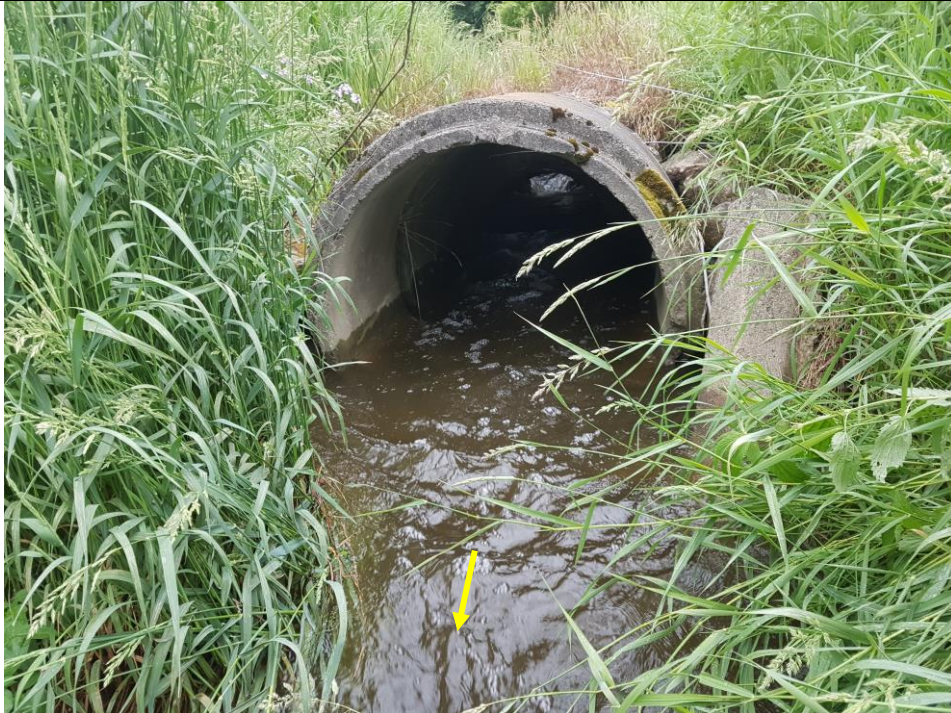
Photo 9
Kilmanagh Creek - Reach 4a, Caledon, Ontario

A degraded tractor crossing was present within the reach. The concrete culvert was separated through the middle and flows were undermining the feature.

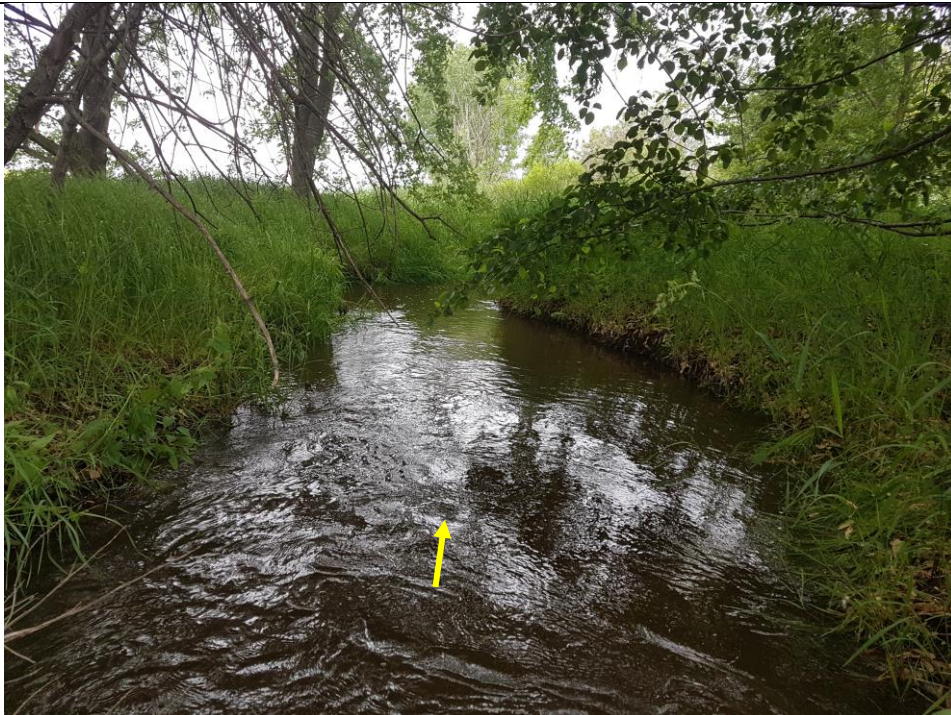
Photo 10
Kilmanagh Creek - Reach 4a, Caledon, Ontario

Bank angles ranged from 30° to 60° with minor undercutting observed. Average bankfull width and depth was 3.36 m and 0.65 m, respectively.

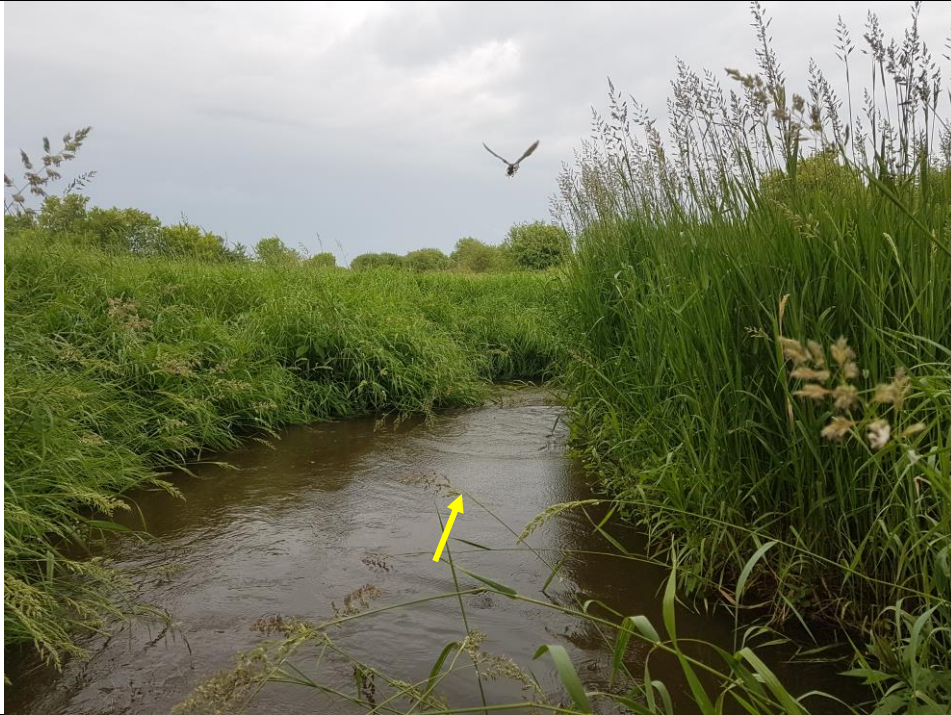
Photo 11
Kilamanagh Creek - Reach 4a, Caledon, Ontario

The reach was dominated by runs with few deep pools observed. Bed substrate was comprised of clay/silt, sand, gravel and cobbles.

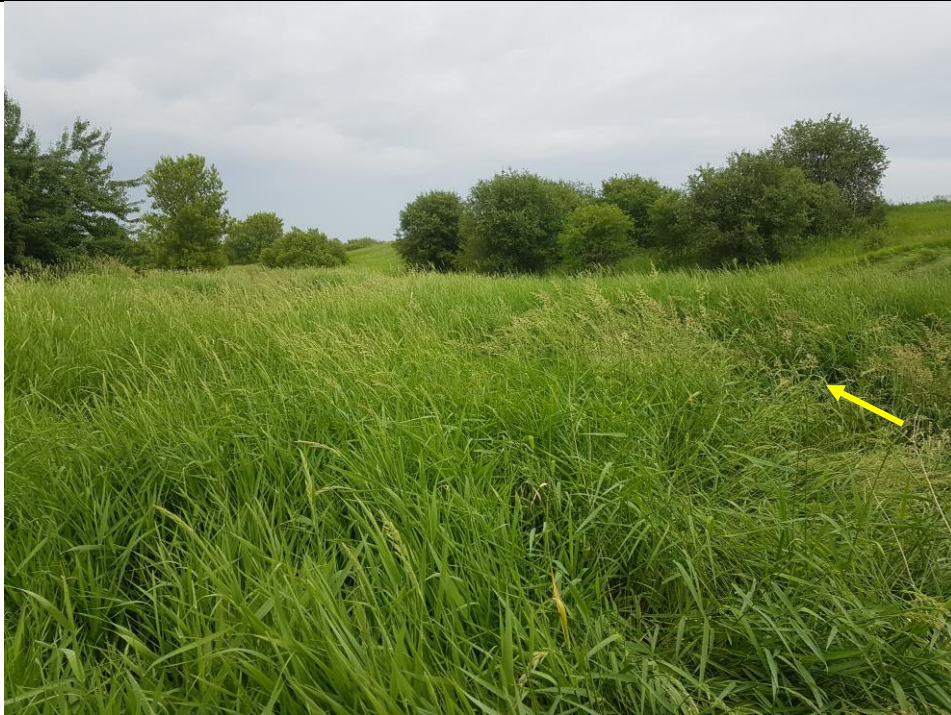
Photo 12
Kilamanagh Creek - Reach 4a, Caledon, Ontario

Photograph taken at the downstream extent of the reach. Canopy cover was limited, and bank slumping was frequently observed in this section.

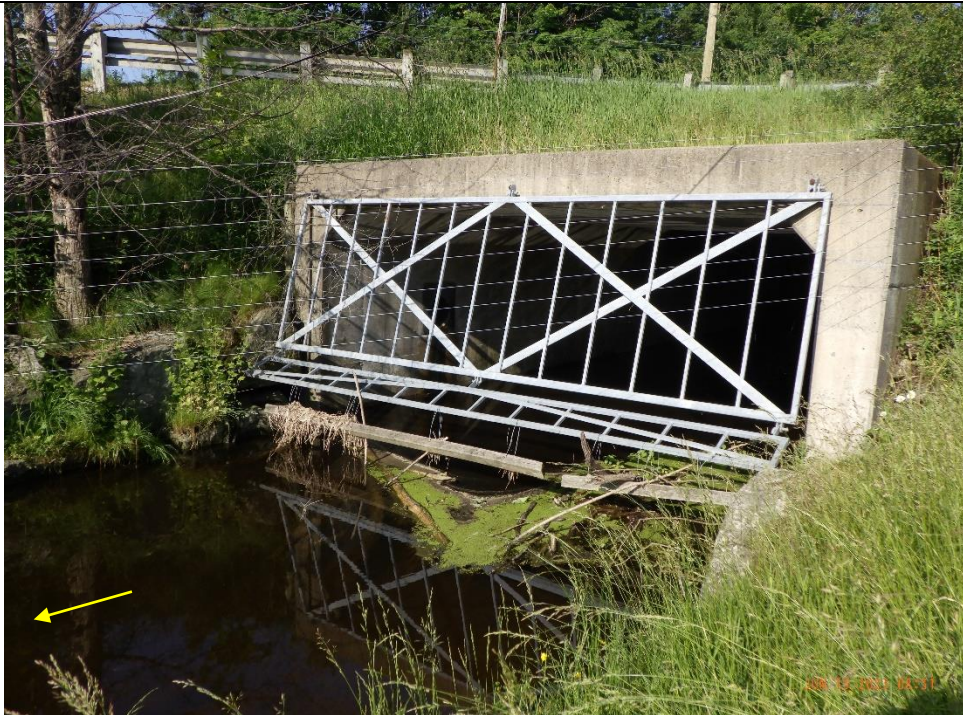
Photo 13
Tributary of the West Humber River- Reach 8a, Caledon,
Ontario

Photograph taken at the upstream extent of **Reach 8a**. The reach enters the subject property through a culvert along Dixie Road (yellow arrow indicates flow direction).

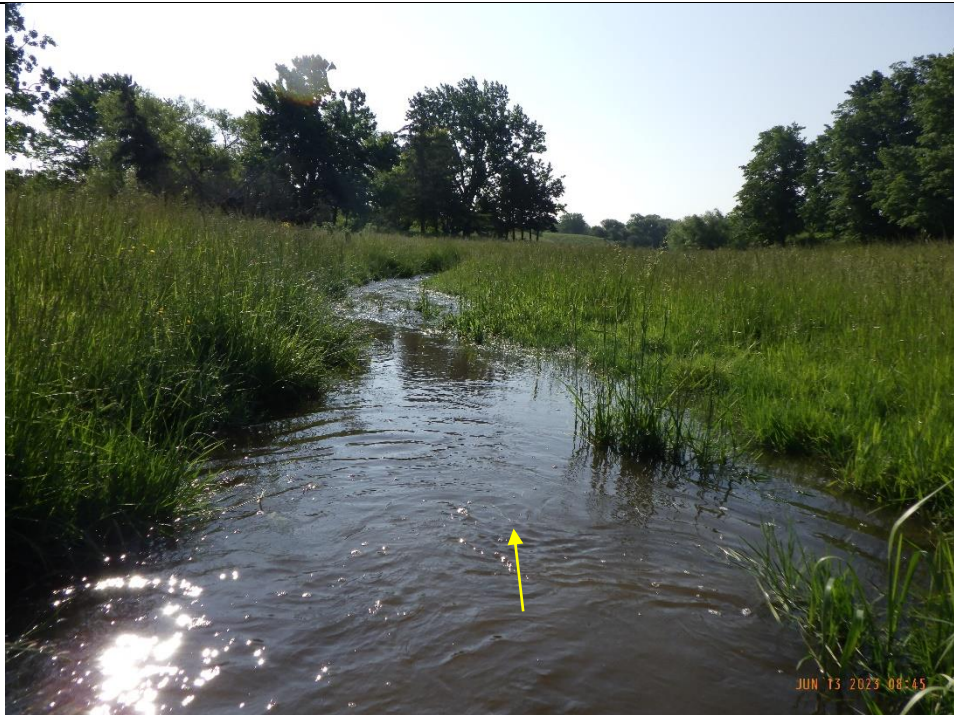
Photo 14
Tributary of the West Humber River- Reach 8a, Caledon,
Ontario

The reach flows through a pasture in a partially confined valley. The riparian area consists primarily of grasses with few mature trees.

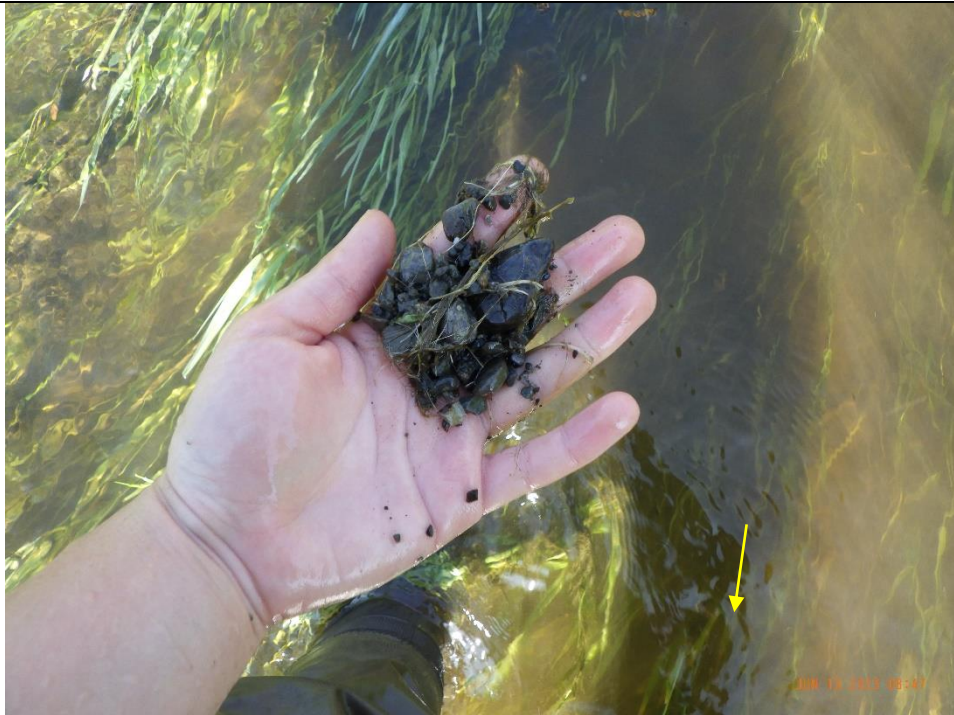
Photo 15
Tributary of the West Humber River- Reach 8a, Caledon,
Ontario

Riffle-pool morphology was observed. Bed substrate consisted primarily of clay/silt, sand, and gravel in pools and gravel and cobbles in riffles.

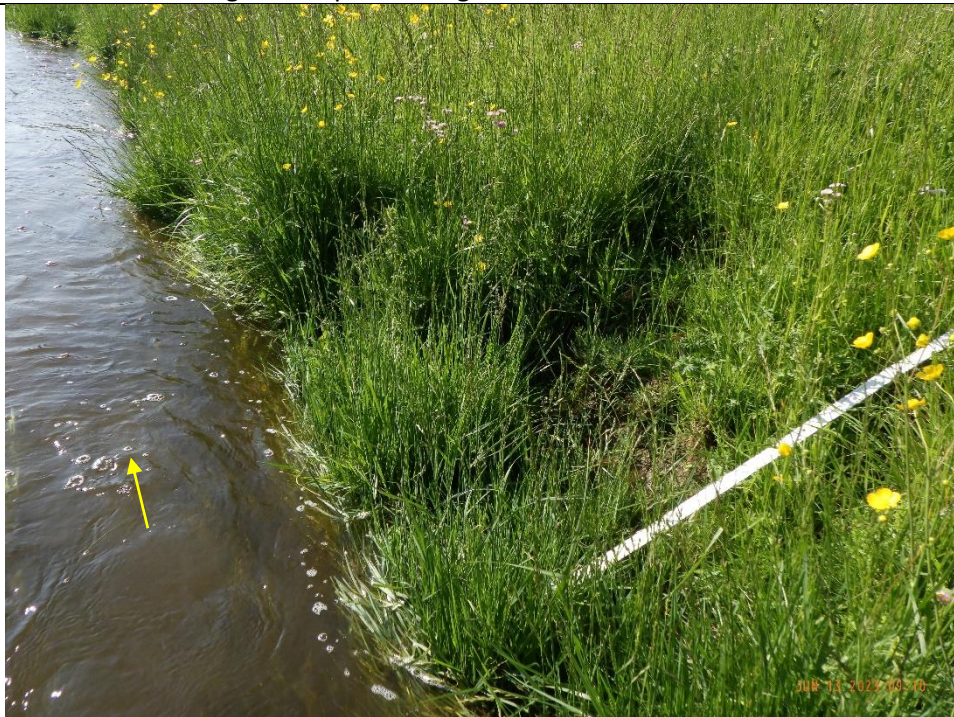
Photo 16
Tributary of the West Humber River- Reach 8a, Caledon,
Ontario

Bank slumps and undercutting were noted throughout the reach. Bank material was primarily silt, sand, and some clay.

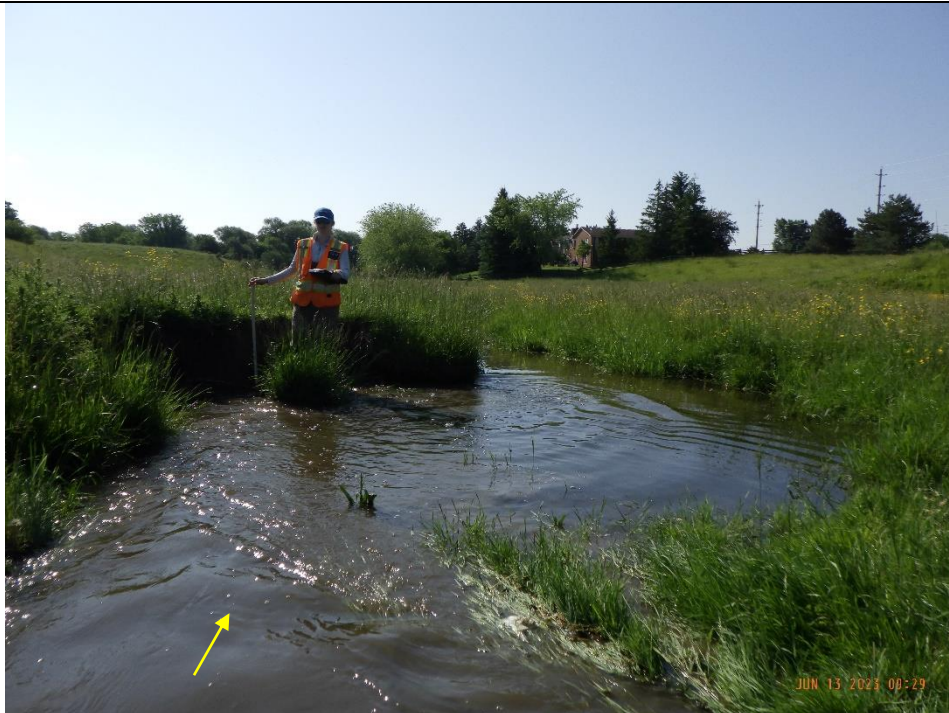
Photo 17
Tributary of the West Humber River- Reach 8a, Caledon,
Ontario

Bank erosion was high in the channel ranging from 60% to 100% of the banks eroded. Large bank slumps, undercutting, and basal scour were most frequently observed.

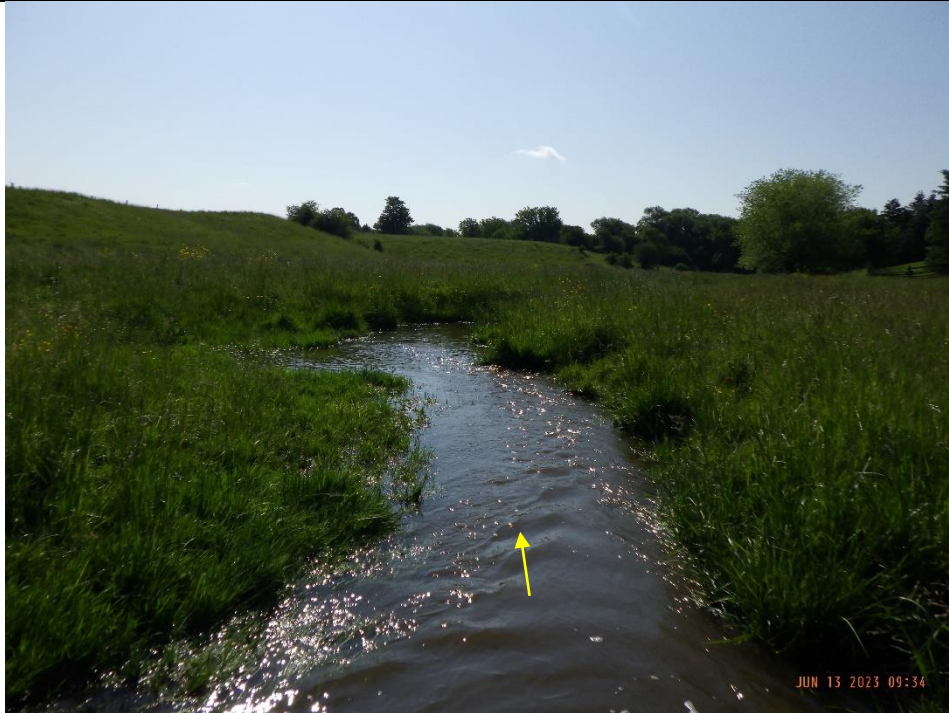
Photo 18
Tributary of the West Humber River- Reach 8a, Caledon,
Ontario

Photograph taken near the downstream extent of the reach. Average bankfull width and depth were 4.59 m and 0.79 m, respectively.

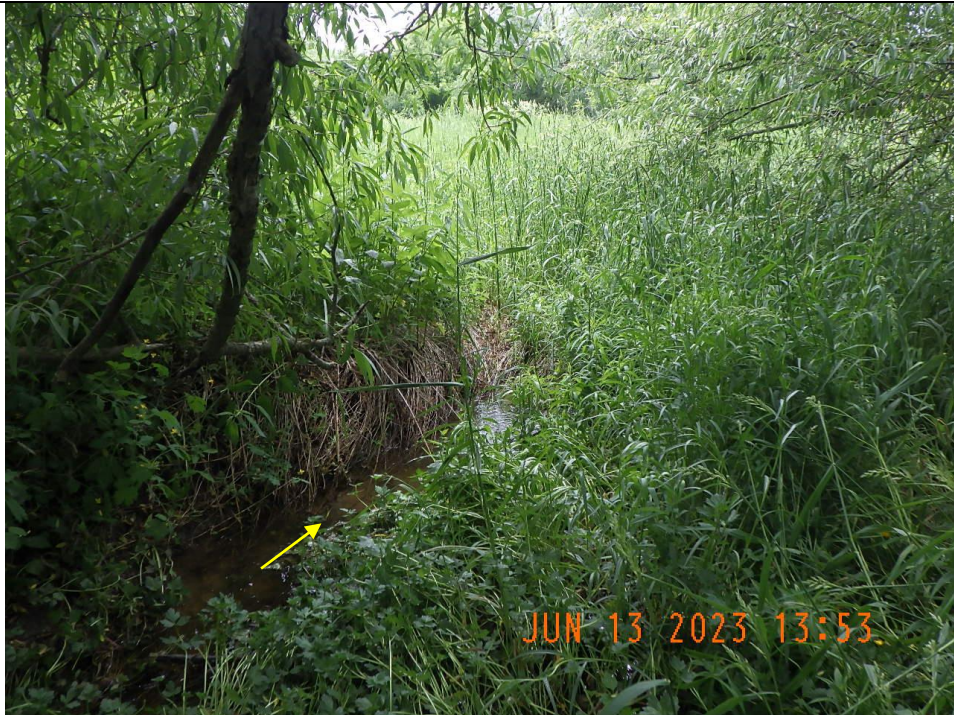
Photo 19
Tributary of the West Humber River- Reach 8, Caledon,
Ontario

Photograph taken at the upstream extent of **Reach 8**. The reach was characterized as an irregularly meandering, low gradient channel within a partially confined valley.

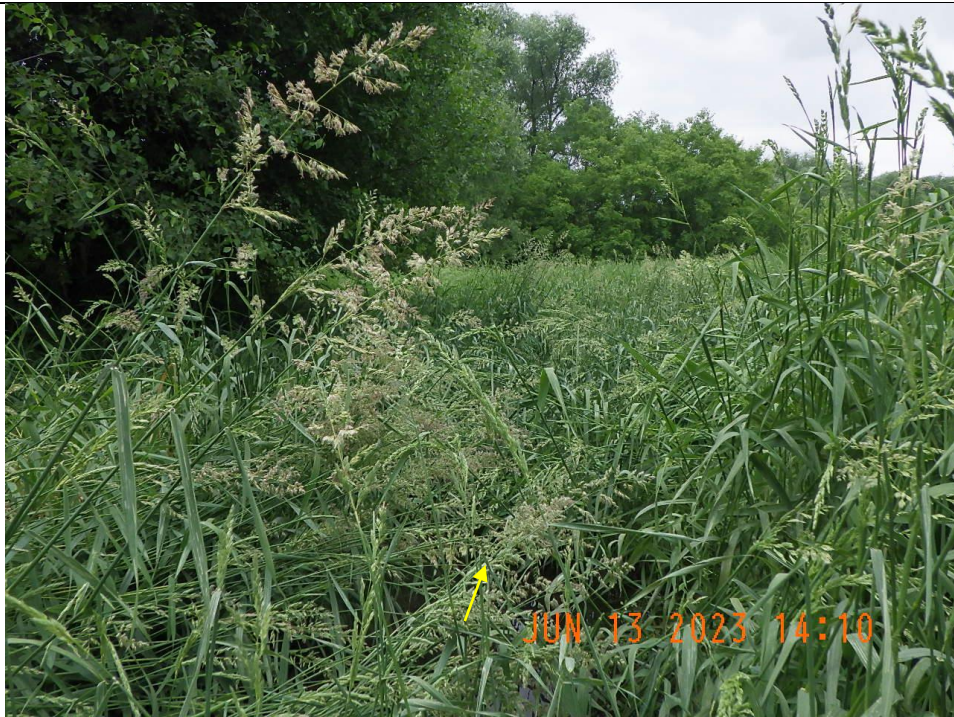
Photo 20
Tributary of the West Humber River- Reach 8 Caledon,
Ontario

At the upstream extent the riparian zone was dominated by grasses that heavily encroached the channel.

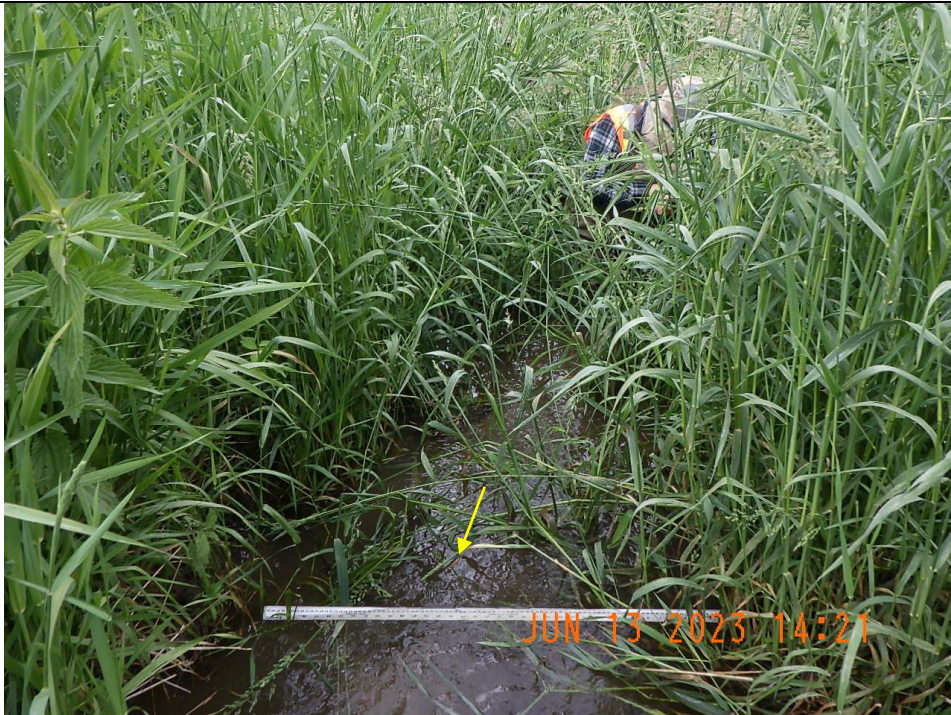
Photo 21
Tributary of the West Humber River- Reach 8, Caledon,
Ontario

Bank angles ranged from 30° to 60° and bank material was comprised of clay/silt, and sand. Average bankfull width and depth was 4.10 m and 0.67 m, respectively.

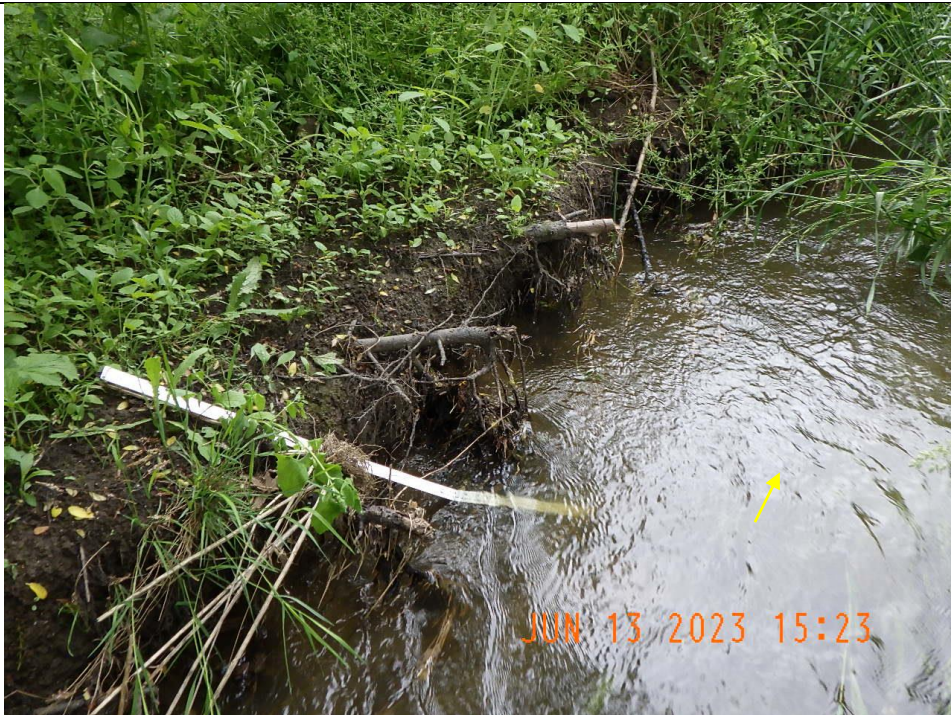
Photo 22
Tributary of the West Humber River- Reach 8, Caledon,
Ontario

Bank erosion was observed through 30% to 60% of the reach. Undercuts, exposed tree roots, and fallen/leaning trees were observed indicating the channel is widening.

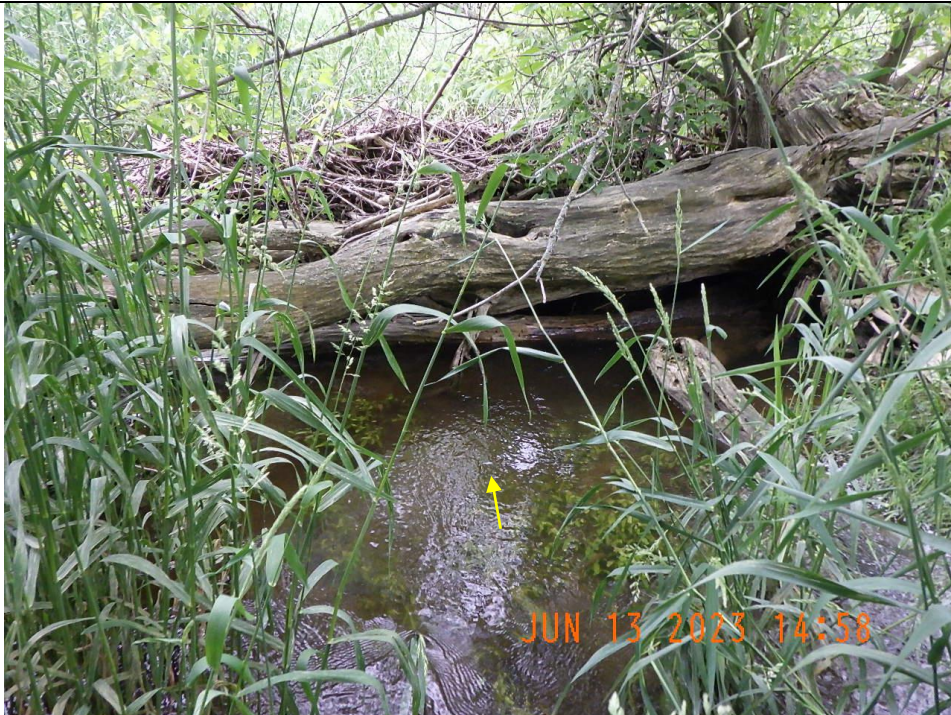
Photo 23
Tributary of the West Humber River- Reach 8, Caledon,
Ontario

A moderate density of large woody debris jams were present within the channel and the cutbank.

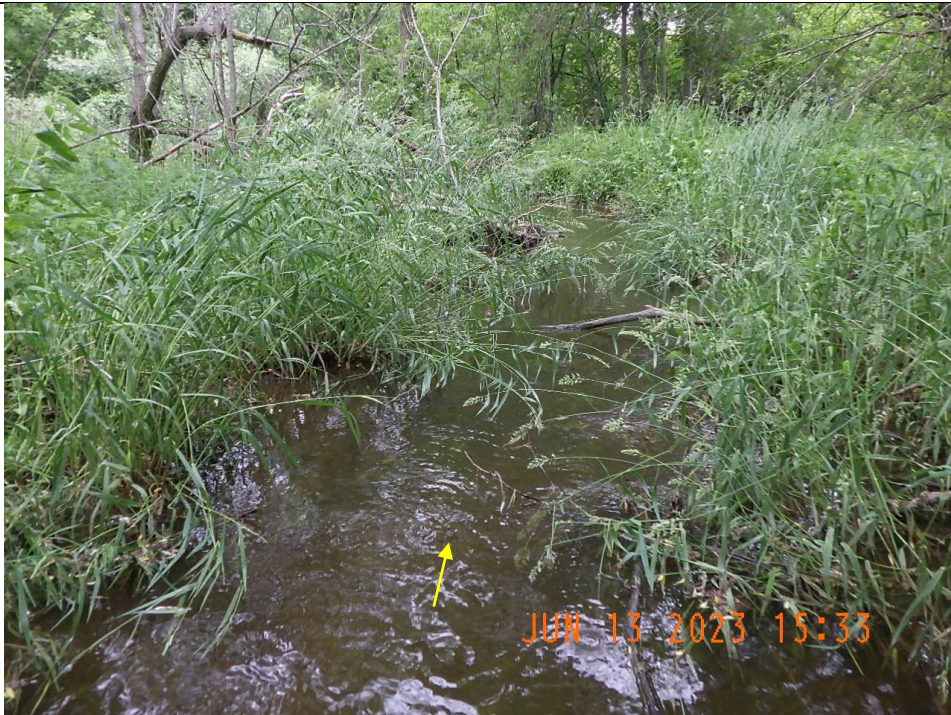
Photo 24
Tributary of the West Humber River- Reach 8, Caledon,
Ontario

Photograph taken at the downstream extent of **Reach 8**. The reach was dominated by runs with few deep pools and bed substrate ranged from clay/silt, and sand to cobbles.

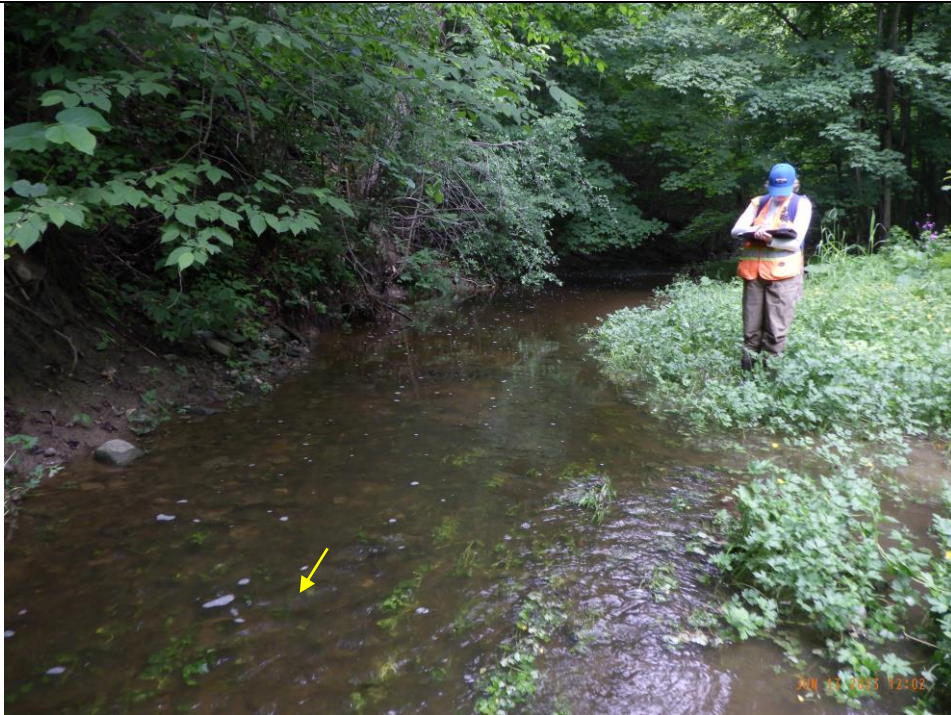
Photo 25
Tributary of the West Humber River- Reach 7, Caledon,
Ontario

Photograph taken at the upstream extent of the **Reach 7**. Riparian vegetation was dominated by a continuous, dense coverage of mature trees.

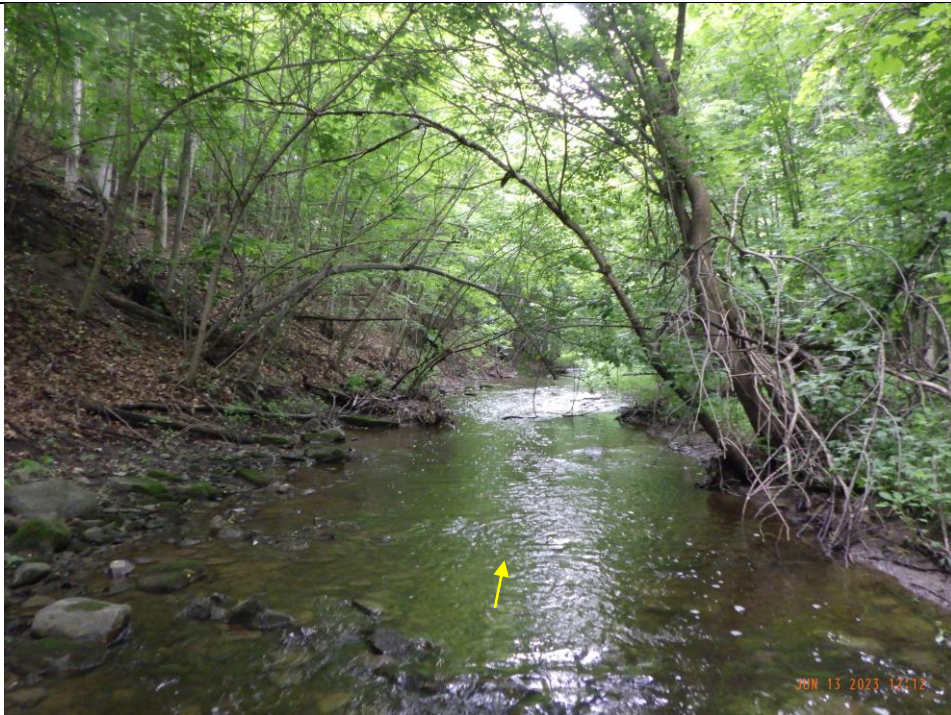
Photo 26
Tributary of the West Humber River- Reach 7, Caledon,
Ontario

The reach was characterized as irregularly meandering situated in a partially confined valley with valley wall contacts frequently observed.

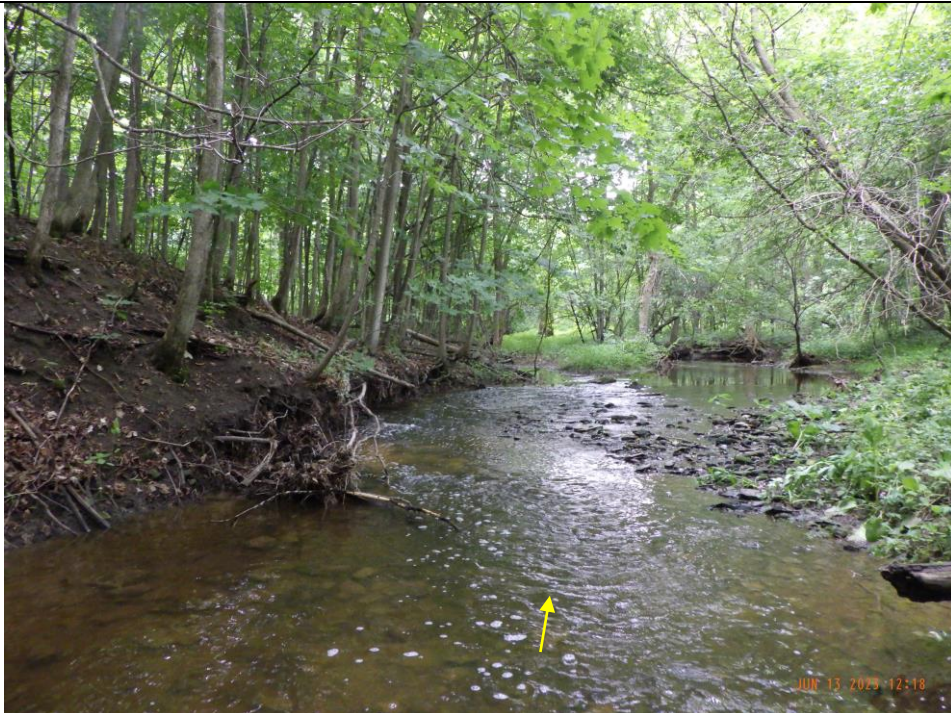
Photo 27
Tributary of the West Humber River- Reach 7, Caledon,
Ontario

Riffle-pool sequencing was well developed with bed substrate ranging from clay/silt, sand, and exposed parent material (till) in pools and sand, gravel, and cobbles in riffles.

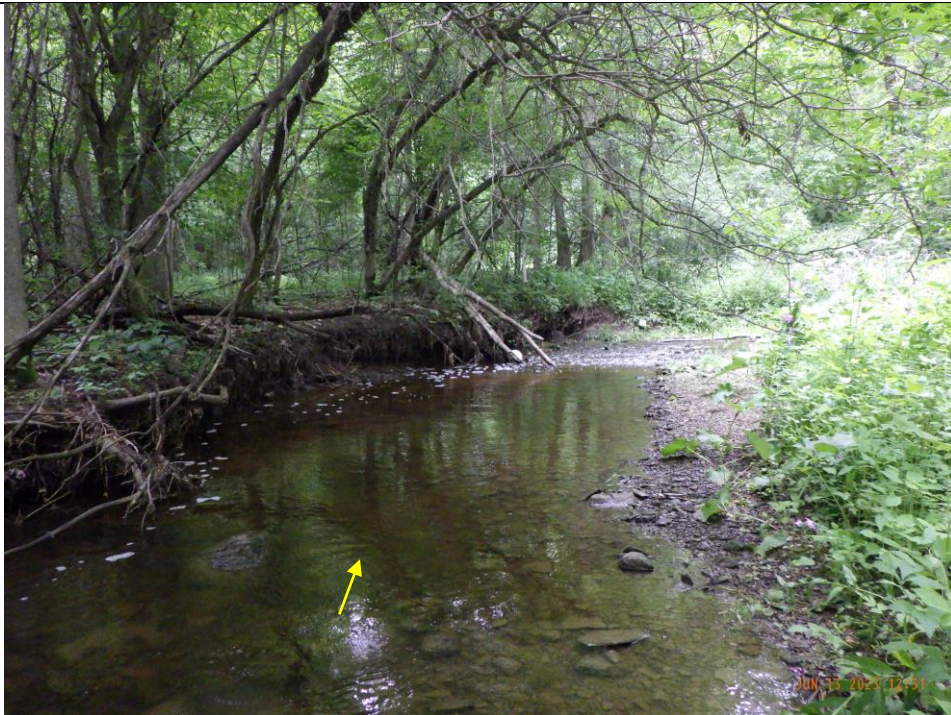
Photo 28
Tributary of the West Humber River- Reach 7, Caledon, Ontario

Evidence of bank erosion was observed throughout 60% to 100% of the reach. Undercuts measured up to 0.82 m and exposed till, fallen/leaning trees, and exposed tree roots were common.

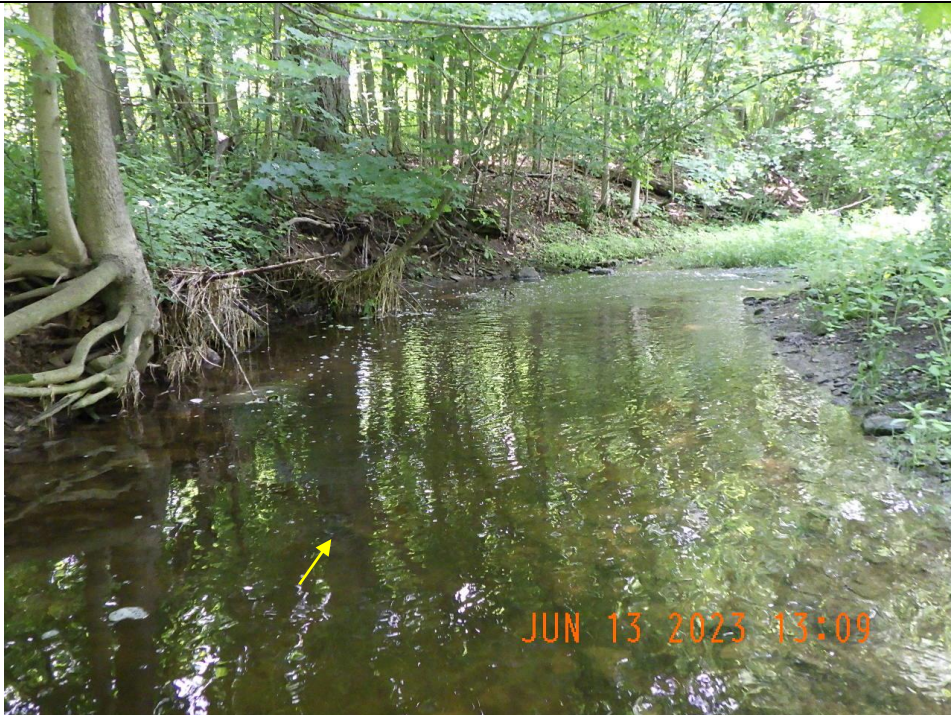
Photo 29
Tributary of the West Humber River- Reach 7, Caledon,
Ontario

Bank angles ranged from 0° to 30° at the inside of bends and 60° to 90° along the rest of the reach. Average bankfull width and depth were 7.17 m and 0.85 m, respectively.

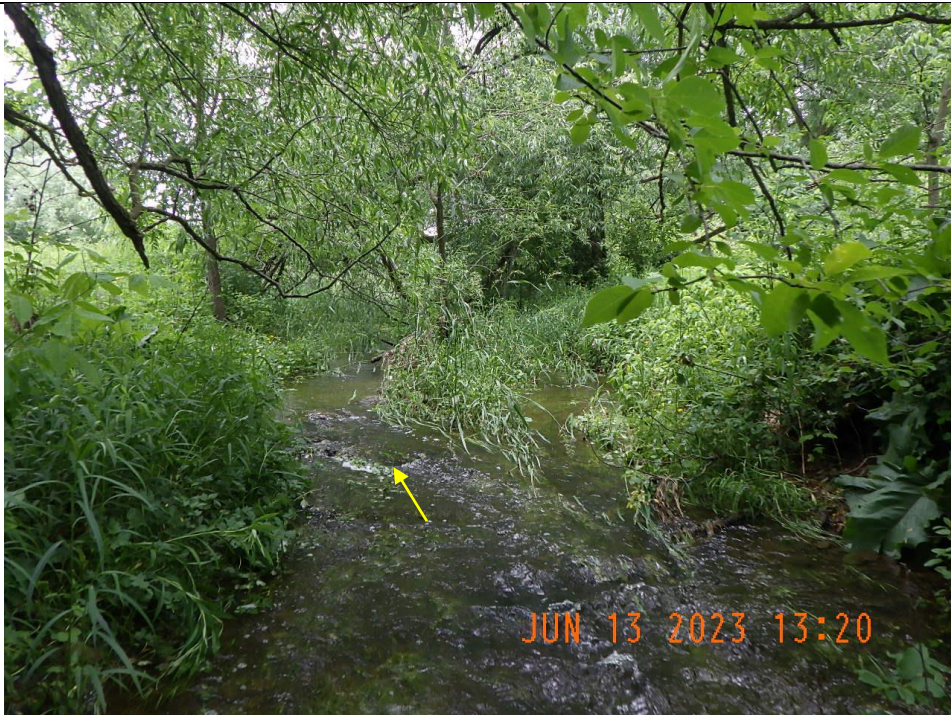
Photo 30
Tributary of the West Humber River- Reach 7, Caledon, Ontario

Photograph was taken at the downstream extent. Aquatic vegetation was present along 45% of the reach. Watercress was commonly observed indicating evidence of potential groundwater inputs.
