# Geomorphic Assessment for Part of Lots 19, 20 and 21 Concession 5, Town of Caledon, Region of Peel

**Mayfield Golf Course Inc. and  
Tullamore Industrial GP Limited**

**Beacon Environmental Limited**

**222239**

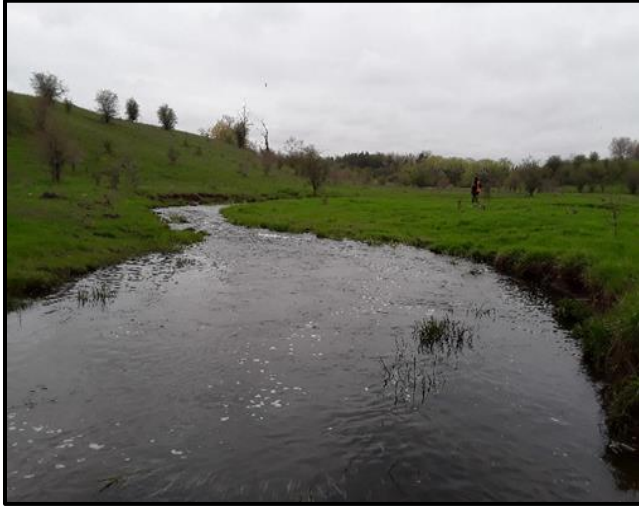
**Photograph 1. Location 1.**  
**Reach WHT-1A West Humber River Tributary**  
Upstream view from property limit. Note bank erosion on left bank (photo right) and valley wall contact and outer bank erosion on right bank (photo left).

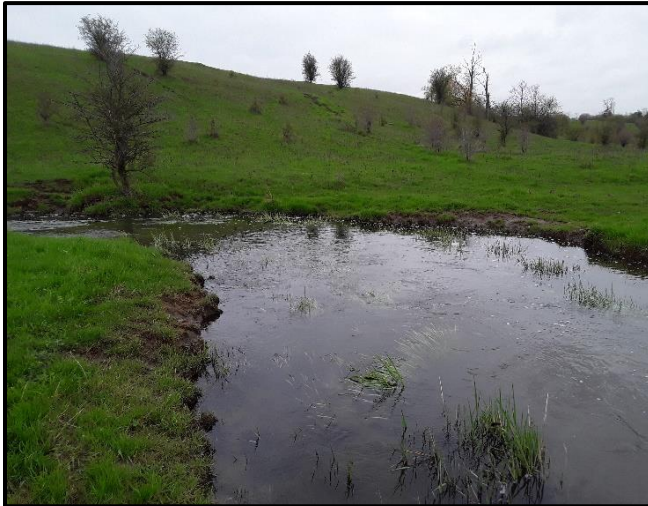
**Photograph 3. Location 3.**  
**Reach WHT-1A West Humber River Tributary**  
Downstream view of meander bend and valley wall contact.

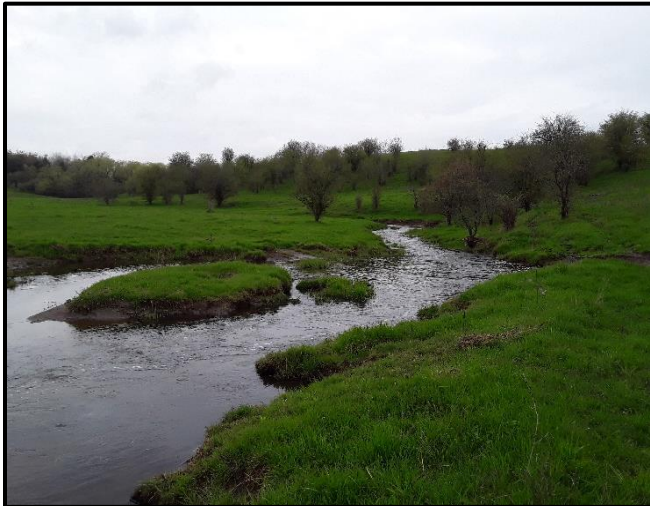
<p><b>Photograph 5. Location 5.</b>  <b>Reach WHT-1A West Humber River</b>  <b>Tributary.</b>                  Upstream view of channel conditions.                  Note multiple flow paths observed.</p>	<p><b>View: US</b></p>
<p><b>Date Taken: May 5, 2023</b></p>	
<p><b>Site: 12522 &amp; 12306 Torbram Rd, Caledon ON</b></p>

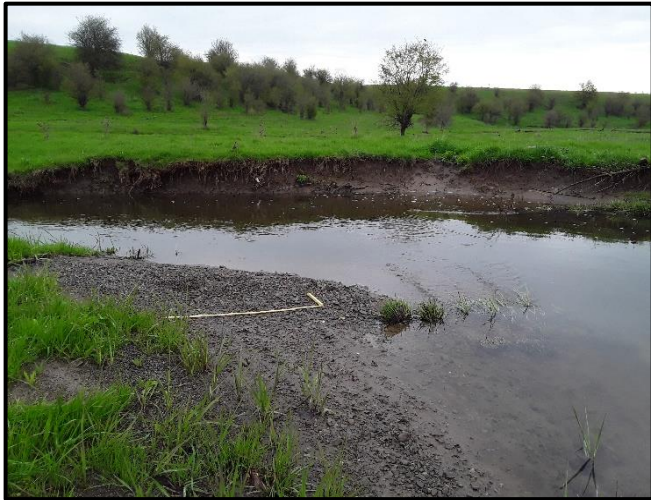
<p><b>Photograph 6. Location 6.</b>  <b>Reach WHT-1A West Humber River</b>  <b>Tributary</b>                  Downstream view of channel meander bend. Gravel point bar observed on inner bank with outer bank erosion.</p>	<p><b>View: DS</b></p>
<p><b>Date Taken: May 5, 2023</b></p>	
<p><b>Site: 12522 &amp; 12306 Torbram Rd, Caledon ON</b></p>

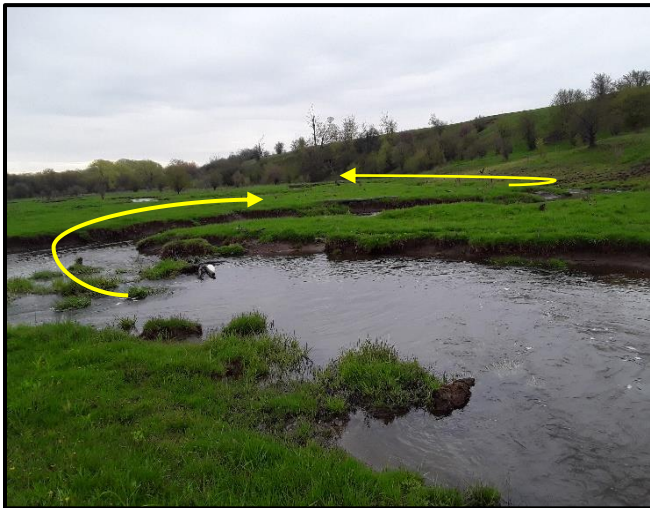
<p><b>Photograph 7. Location 7.</b>  <b>Reach WHT-1A West Humber River</b>  <b>Tributary.</b>                  Downstream view of meander bend. Scour observed on inside meander bend.</p>	<p><b>View: DS</b></p>
<p><b>Date Taken: May 5, 2023</b></p>	
<p><b>Site: 12522 &amp; 12306 Torbram Rd, Caledon ON</b></p>

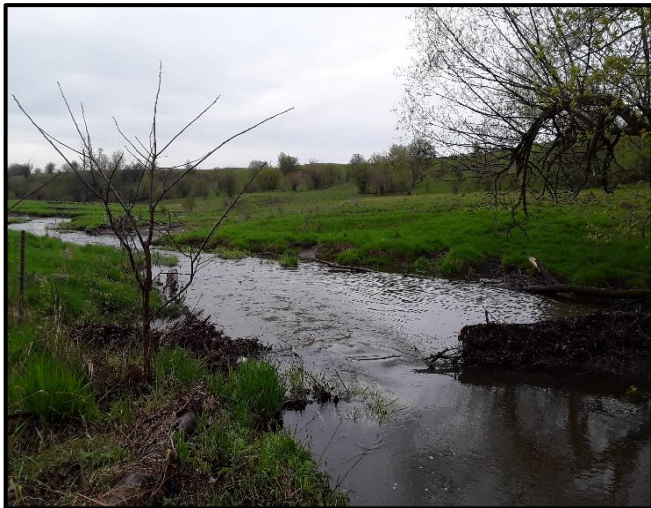
<p><b>Photograph 8. Location 8.</b>  <b>Reach WHT-1A West Humber River</b>  <b>Tributary</b>                  Downstream view of channel from reach break. Note right bank erosion and instream debris.</p>	<p><b>View: DS</b></p>
<p><b>Date Taken: May 5, 2023</b></p>	
<p><b>Site: 12522 &amp; 12306 Torbram Rd, Caledon ON</b></p>

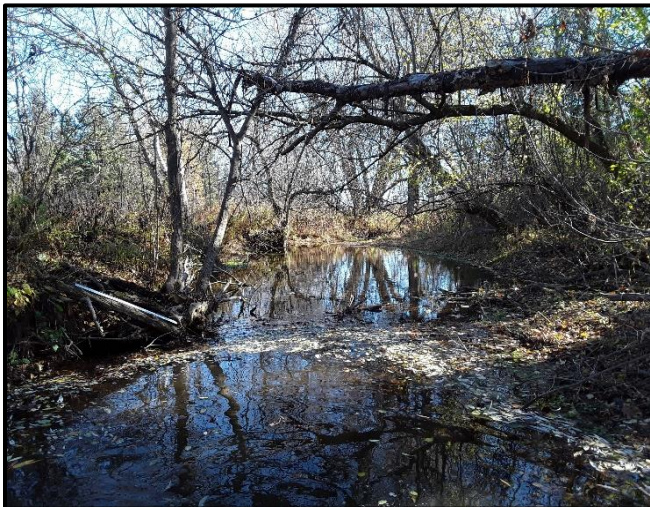
<p><b>Photograph 11. Location 10.</b>  <b>Reach WHT-1 West Humber River</b>  <b>Tributary</b>                  Downstream view – evidence of widening.</p>	<p><b>View: DS</b></p>
<p><b>Date Taken: November 8, 2022</b></p>	
<p><b>Site: 12522 &amp; 12306 Torbram Rd, Caledon ON</b></p>

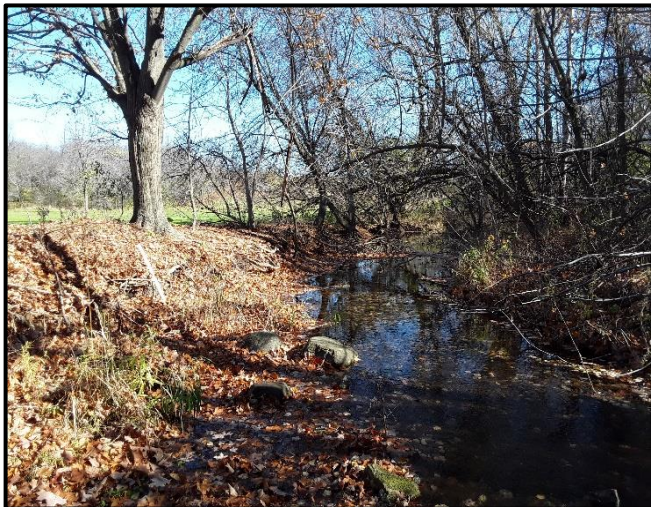
<p><b>Photograph 12. Location 11.</b>  <b>Reach WHT-1 West Humber River</b>  <b>Tributary</b>                  Upstream view of general channel conditions. Note proximity of left bank to Golf Course green.</p>	<p><b>View: US</b></p>
<p><b>Date Taken: November 8, 2022</b></p>	
<p><b>Site: 12522 &amp; 12306 Torbram Rd, Caledon ON</b></p>

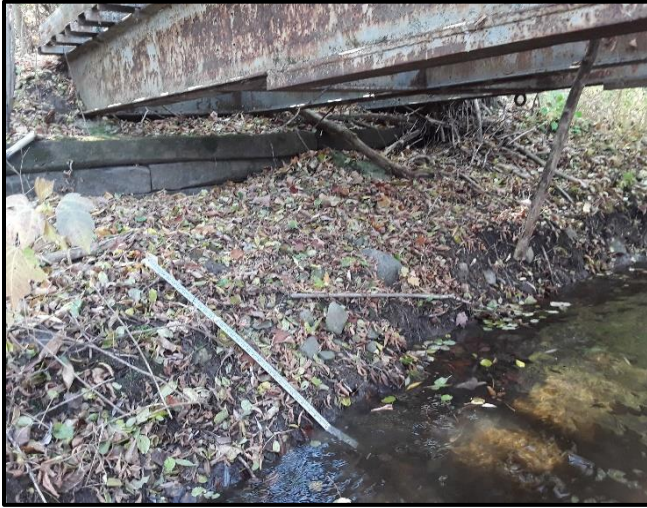
<p><b>Photograph 13. Location 12.</b>  <b>Reach WHT-1 West Humber River</b>  <b>Tributary.</b>                  Upstream view of right bank under pedestrian bridge. Bridge footings exposed.</p>	<p><b>View: US</b></p>
<p><b>Date Taken: November 8, 2022</b></p>	
<p><b>Site: 12522 &amp; 12306 Torbram Rd, Caledon ON</b></p>

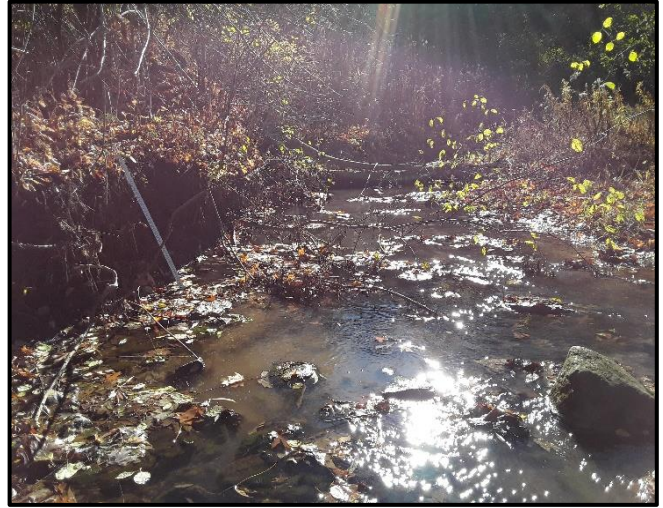
<p><b>Photograph 14. Location 13.</b>  <b>Reach WHT-1 West Humber River</b>  <b>Tributary</b>                  Upstream view of valley wall contact on right bank. Scour on inside meander bend was observed.</p>	<p><b>View: US</b></p>
<p><b>Date Taken: November 8, 2022</b></p>	
<p><b>Site: 12522 &amp; 12306 Torbram Rd, Caledon ON</b></p>

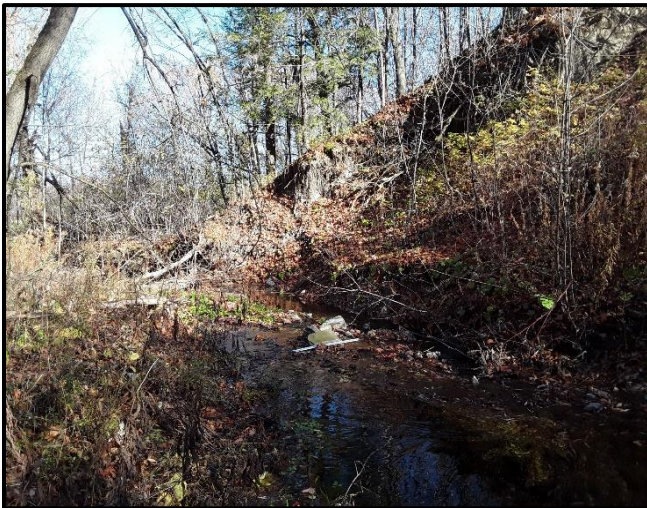
<p><b>Photograph 15. Location 14.</b>  <b>Reach WHT-1 West Humber River</b>  <b>Tributary</b>                  Downstream view of general conditions and valley wall contact on right bank.</p>	<p><b>View: DS</b></p>
<p><b>Date Taken: November 8, 2022</b></p>	
<p><b>Site: 12522 &amp; 12306 Torbram Rd, Caledon ON</b></p>

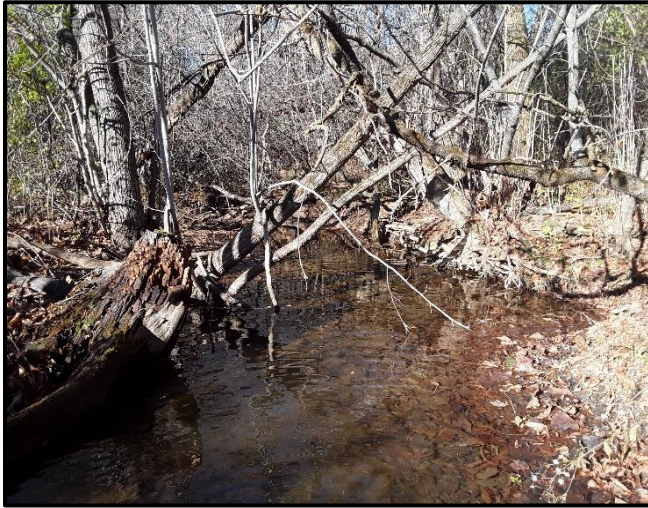
<p><b>Photograph 21. Location 18.</b>  <b>Reach WHT-2 North-South Tributary</b>                  Downstream view of channel bank erosion. Note leaning trees and exposed tree roots on left bank.</p>	<p><b>View: DS</b></p>
<p><b>Date Taken: November 8, 2022</b></p>	
<p><b>Site: 12522 &amp; 12306 Torbram Rd, Caledon ON</b></p>

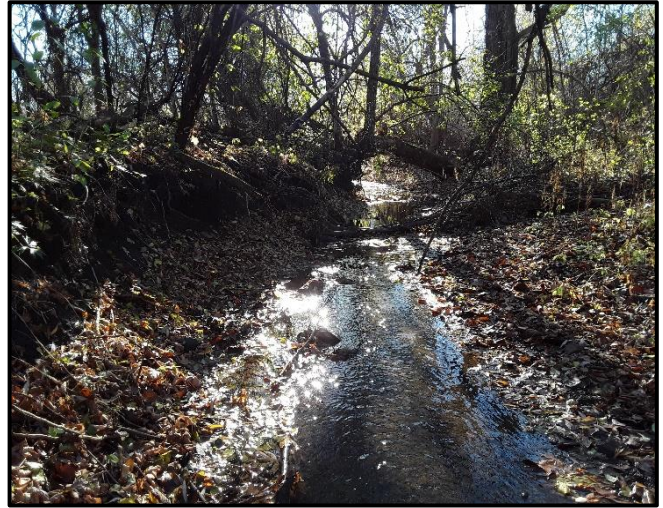
<p><b>Photograph 22. Location 19.</b>  <b>Reach WHT-2 North-South Tributary</b>                  Downstream view of channel conditions. Note entrenchment and falling/leaning trees on left bank.</p>	<p><b>View: DS</b></p>
<p><b>Date Taken: November 8, 2022</b></p>	
<p><b>Site: 12522 &amp; 12306 Torbram Rd, Caledon ON</b></p>

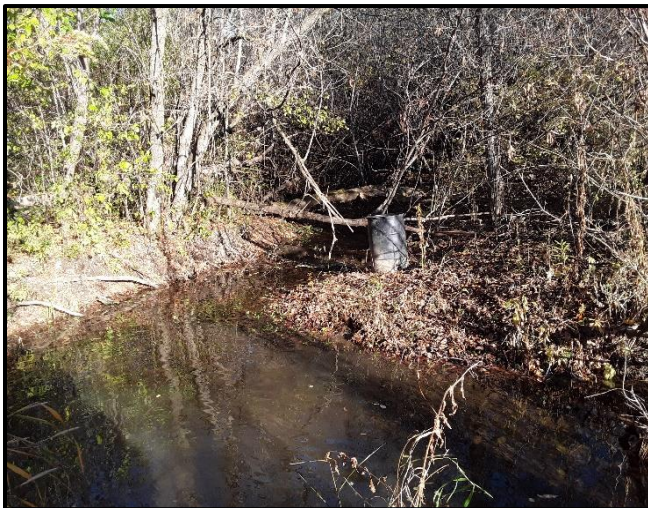
<p><b>Photograph 23. Location 20.</b>  <b>Reach WHT-2 North-South Tributary</b>                  Downstream view of meander bend. Point bar development on right bank. Entrenchment observed on left bank.</p>	<p><b>View: DS</b></p>
<p><b>Date Taken: November 8, 2022</b></p>	
<p><b>Site: 12522 &amp; 12306 Torbram Rd, Caledon ON</b></p>

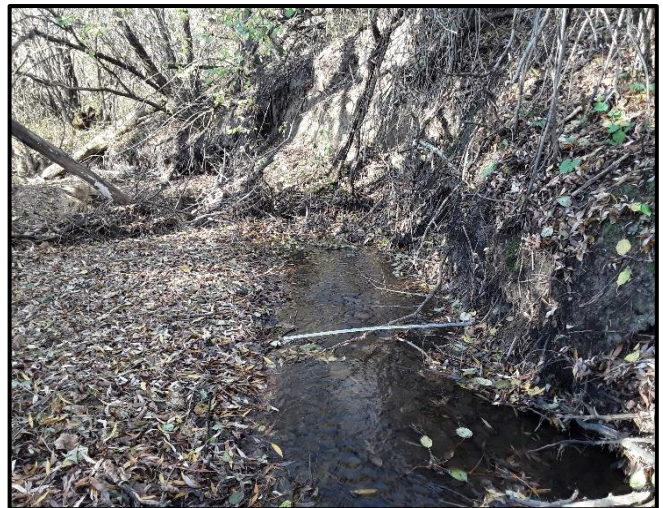
<p><b>Photograph 24. Location 21.</b>  <b>Reach WHT-2 North-South Tributary</b>                  Downstream view of valley wall contact on right bank. Undercutting and till observed at the valley toe.</p>	<p><b>View: US</b></p>
<p><b>Date Taken: November 8, 2022</b></p>	
<p><b>Site: 12522 &amp; 12306 Torbram Rd, Caledon ON</b></p>

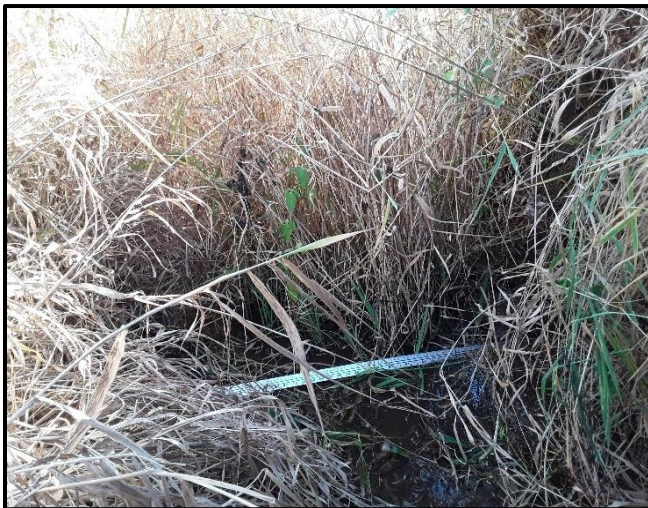
<p><b>Photograph 27. Location 24.</b>  <b>Reach WHT-3 North-South Tributary</b>                  Downstream view of channel conditions. Multiple flow paths observed; poorly developed riffle-pool morphology.</p>	<p><b>View: DS</b></p>
<p><b>Date Taken: November 8, 2022</b></p>	
<p><b>Site: 12522 &amp; 12306 Torbram Rd, Caledon ON</b></p>

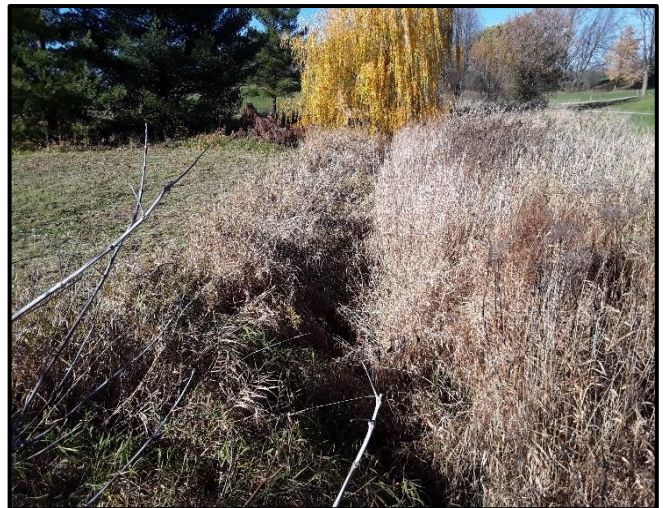
<p><b>Photograph 28. Location 25.</b>  <b>Reach WHT-3 North-South Tributary</b>                  Upstream view of channel conditions from golf cart crossing. Note narrow riparian buffer.</p>	<p><b>View: US</b></p>
<p><b>Date Taken: November 8, 2022</b></p>	
<p><b>Site: 12522 &amp; 12306 Torbram Rd, Caledon ON</b></p>
