Headwater Drainage Feature Assessments

GEO Morphix, June 28, 2024

**Re: Headwater Drainage Feature Assessments
Alloa Secondary Plan Area, Local Subwatershed Study
Town of Caledon, Ontario
GEO Morphix Project No. PN24009**

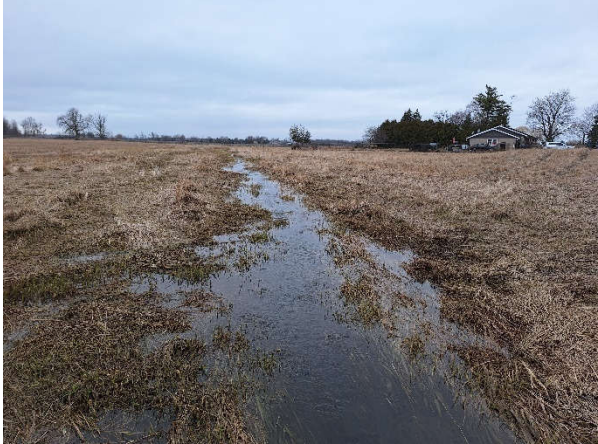
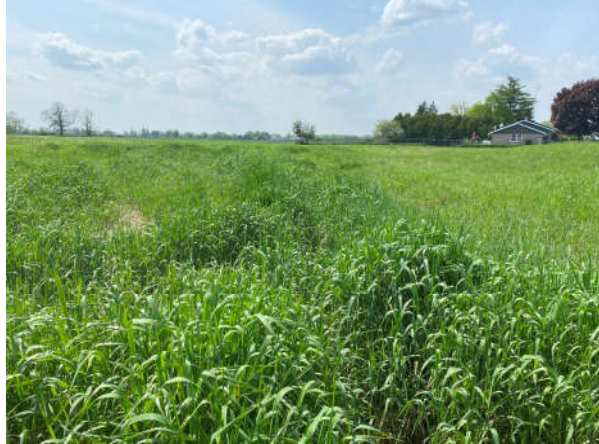
Location: Mayfield Road, Caledon		Watershed: Etobicoke Creek	
Round 1 Hydrology: Water flowing	Round 2 Hydrology: Standing water	Round 3 Hydrology: To be completed	
Riparian Classification: Feature flowing through a meadow.			
Fish Observed: No	Upstream of HDF: Agricultural field	Downstream of HDF: Chinguacousy Road	
Notes: The feature lacks definition and will be impacted based on future Highway 413.			
GEO Morphix Management Recommendation: Mitigation <i>*Subject to change following round 3 HDFA*</i>

Round 1: Photograph facing upstream.		Round 2: Photograph facing upstream.	
Round 3: To be completed

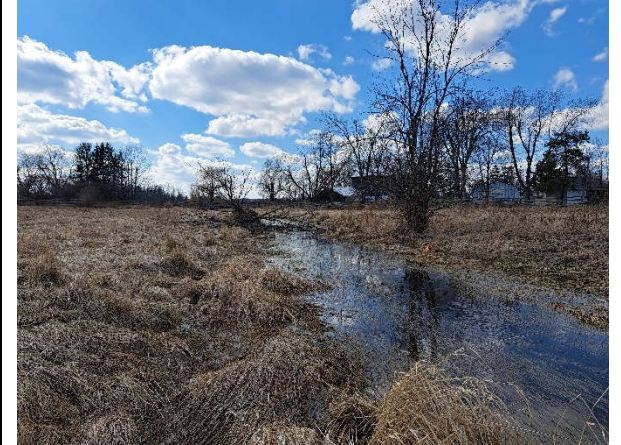
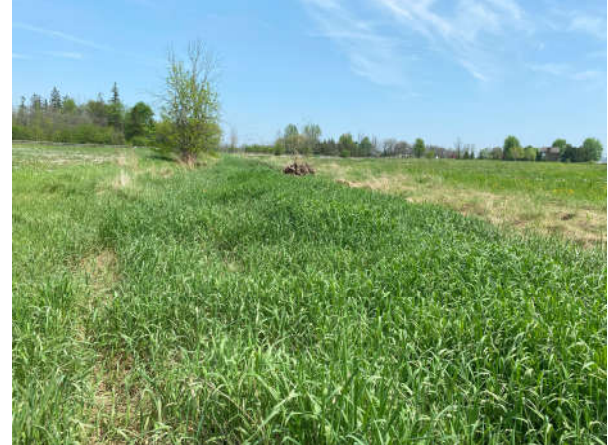
Reach AD1-2A

Location: Mayfield Road, Caledon		Watershed: Etobicoke Creek	
Round 1 Hydrology: Water flowing	Round 2 Hydrology: Standing water	Round 3 Hydrology: To be completed	
Riparian Classification: Feature flowing through a meadow.			
Fish Observed: No	Upstream of HDF: Agricultural field	Downstream of HDF: Chinguacousy Road and Alloa Drain	
Notes: Feature lacks definition and approximately half of the feature downstream flows through a wetland. Approximately half of the feature would be impacted based on the future Highway 413 with a lack of remaining upstream connection.			
GEO Morphix Management Recommendation: Mitigation (future Highway 413 footprint upstream) / Conservation (downstream portion flowing through wetland) <i>*Subject to change following round 3 HDFA*</i>

Round 1: Photograph facing upstream.		Round 2: Photograph facing downstream.	
Round 3: To be completed

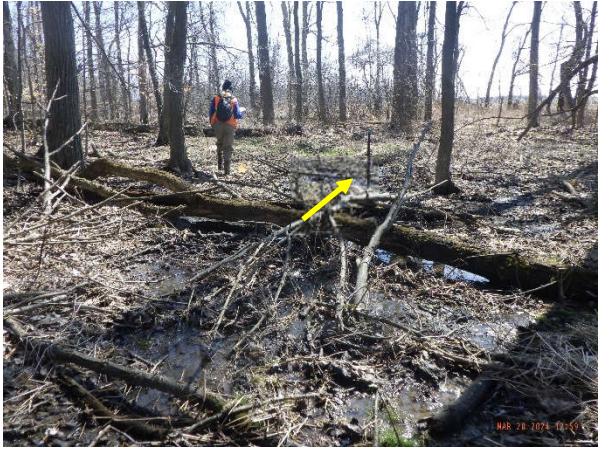
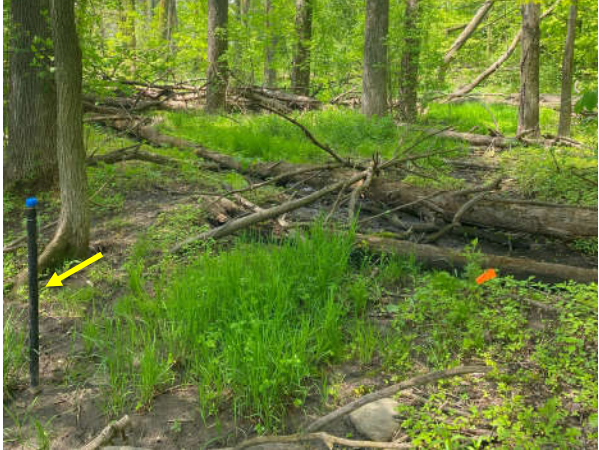
Location: Mayfield Road, Caledon		Watershed: Etobicoke Creek	
Round 1 Hydrology: Standing water	Round 2 Hydrology: Dry	Round 3 Hydrology: Round 3 site visit will not be completed as the Round 2 site visit was dry.	
Riparian Classification: Feature through forested wetland.			
Fish Observed: No	Upstream of HDF: Agricultural field	Downstream of HDF: Wetland and forest	
Notes: Feature lacks definition and flows through a wetland and woodlot. This feature would be protected based on its location within a woodlot however, it will also be impacted based on the future Highway 413 footprint. Due to the future Highway 413, the Management recommendation has been lowered to mitigation.			
GEO Morphix Management Recommendation: Mitigation <i>*Subject to change following round 3 HDFA*</i>

Round 1: Photograph facing downstream.		Round 2: Photograph facing upstream.	
Round 3: Round 3 site visit will not be completed as the Round 2 site visit was dry.

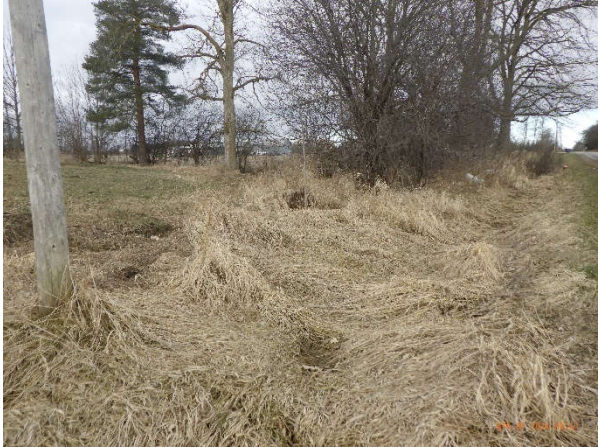
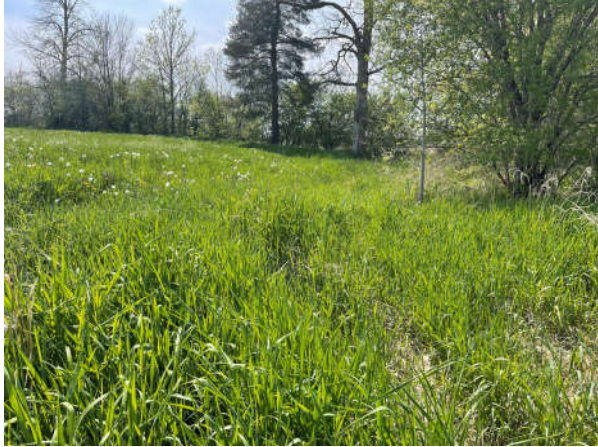
Reach AD2-1

Location: Mayfield Road, Caledon		Watershed: Etobicoke Creek	
Round 1 Hydrology: Standing water	Round 2 Hydrology: Dry	Round 3 Hydrology: Round 3 site visit will not be completed as the Round 2 site visit was dry.	
Riparian Classification: Feature through meadow vegetation with primarily grasses.			
Fish Observed: No	Upstream of HDF: Agricultural field	Downstream of HDF: Alloa Drain and Chinguacousy Road	
Notes: Limited feature development with no water during the Round 2 site visit.			
GEO Morphix Management Recommendation: No Management

Round 1: Photograph facing upstream.		Round 2: Photograph facing upstream.	
Round 3: Round 3 site visit will not be completed as the Round 2 site visit was dry.

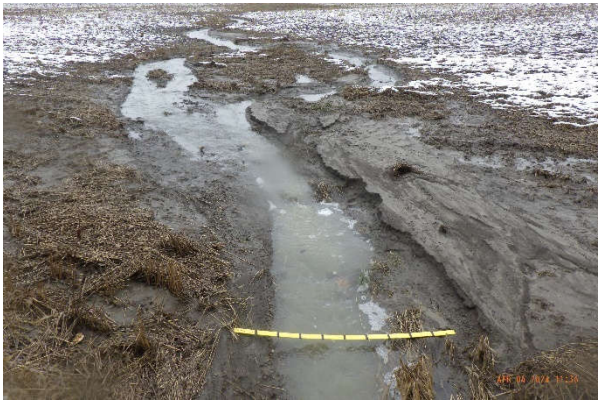
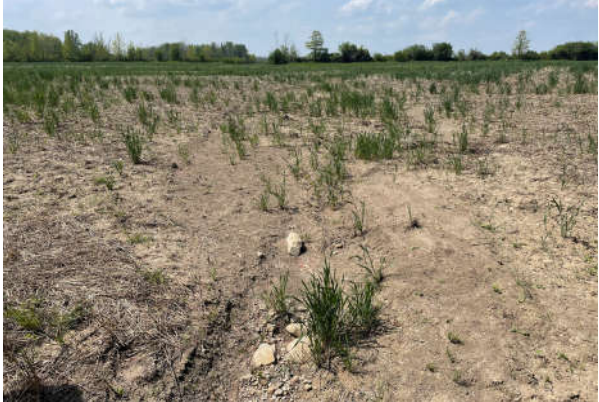
Reach AD3-1

Location: Mayfield Road, Caledon		Watershed: Etobicoke Creek	
Round 1 Hydrology: Flowing water	Round 2 Hydrology: Dry	Round 3 Hydrology: Round 3 site visit will not be completed as the Round 2 site visit was dry.	
Riparian Classification: Feature through an agricultural field			
Fish Observed: No	Upstream of HDF: Agricultural field	Downstream of HDF: Alloa Drain	
Notes: Limited feature development present with a lack of natural vegetation and lack of water or feature definition in Round 2.			
GEO Morphix Management Recommendation: No Management

Round 1: Photograph facing upstream.		Round 2: Photograph facing upstream.	
Round 3: Round 3 site visit will not be completed as the Round 2 site visit was dry.

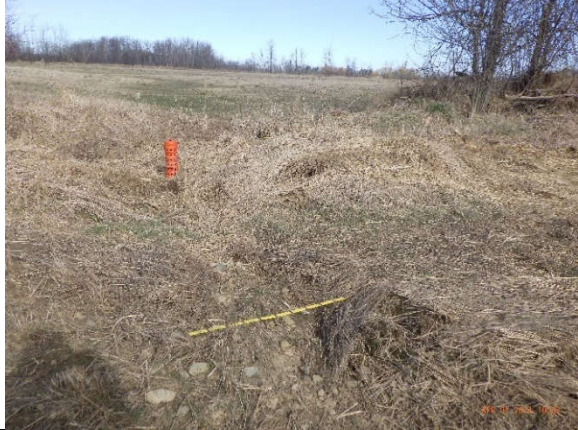
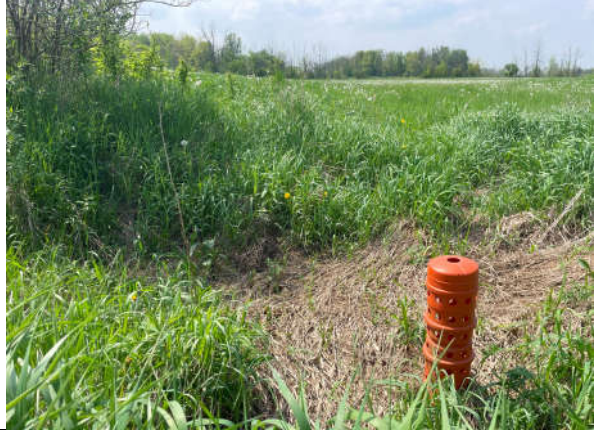
Reach AD3-1B

Location: Mayfield Road, Caledon		Watershed: Etobicoke Creek	
Round 1 Hydrology: Standing water at the tile drain	Round 2 Hydrology: Dry	Round 3 Hydrology: Round 3 site visit will not be completed as the Round 2 site visit was dry.	
Riparian Classification: Feature through a meadow.			
Fish Observed: No	Upstream of HDF: Agricultural field	Downstream of HDF: Alloa Drain	
Notes: Tile drain feature was identified with a lack of surface flows in the Round 1 and 2 site visits. Minor standing water was present at the tile drain during Round 1.			
GEO Morphix Management Recommendation: No Management

Round 1: Photograph facing upstream.		Round 2: Photograph facing upstream.	
Round 3: Round 3 site visit will not be completed as the Round 2 site visit was dry.

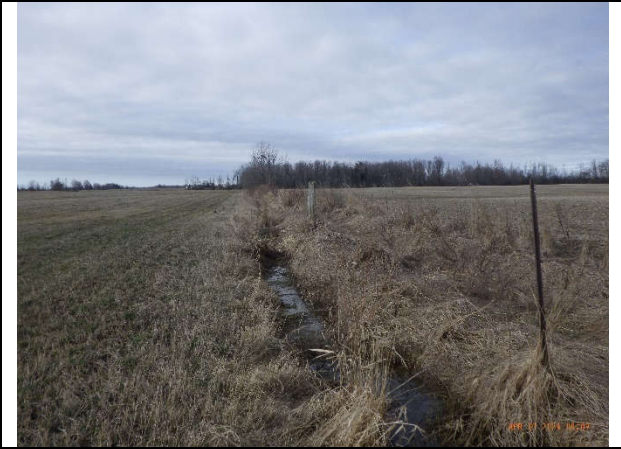
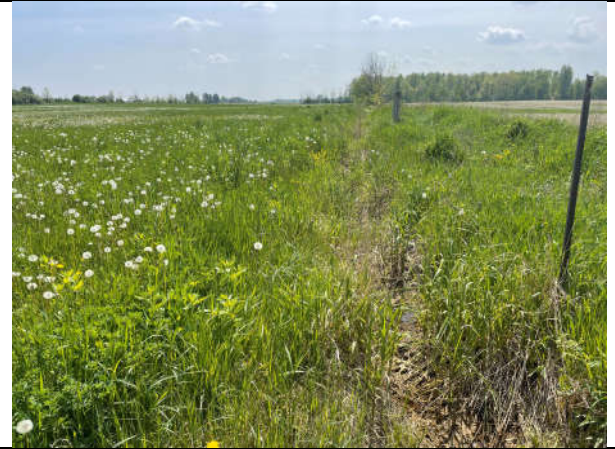
Reach AD3-1C

Location: Mayfield Road, Caledon		Watershed: Etobicoke Creek	
Round 1 Hydrology: Standing water	Round 2 Hydrology: Standing water	Round 3 Hydrology: To be completed	
Riparian Classification: Immediate riparian vegetation consists of meadow vegetation with some trees. Past the immediate riparian vegetation is agricultural fields.			
Fish Observed: No	Upstream of HDF: Agricultural field	Downstream of HDF: Woodlot, but with no observed connection between feature and woodlot	
Notes: Limited feature form identified with the feature occurring along a hedgerow with isolated pockets of standing water present in both Round 1 and 2. It also lacks a downstream connection./			
GEO Morphix Management Recommendation: No Management <i>*Note subject to change following round 3*</i>

Round 1: Photograph facing downstream.		Round 2: Photograph facing downstream.	
Round 3: To be completed

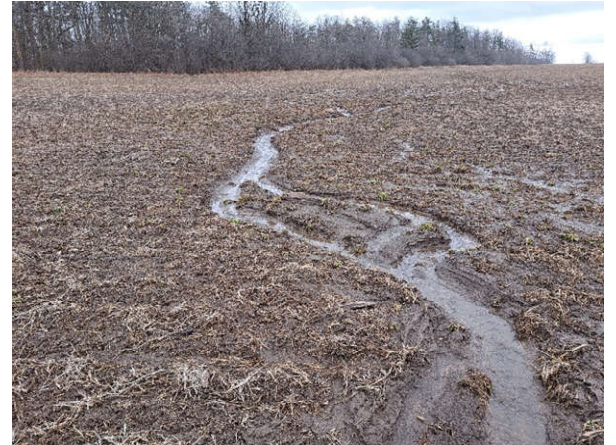
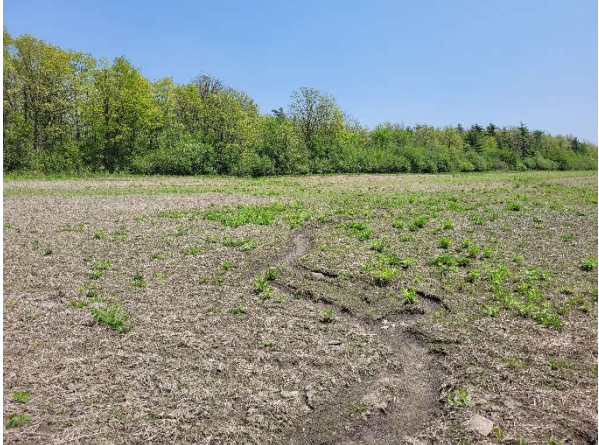
Reach AD3-2

Location: Mayfield Road, Caledon		Watershed: Etobicoke Creek	
Round 1 Hydrology: Flowing water	Round 2 Hydrology: Dry	Round 3 Hydrology: Round 3 site visit will not be completed as the Round 2 site visit was dry.	
Riparian Classification: Through an agricultural field.			
Fish Observed: No	Upstream of HDF: Agricultural field	Downstream of HDF: Alloa Drain	
Notes: Limited feature development identified with a lack of water in Round 2 of the site assessment.			
GEO Morphix Management Recommendation: No Management

Round 1: Photograph facing upstream.		Round 2: Photograph facing upstream.	
Round 3: Round 3 site visit will not be completed as the Round 2 site visit was dry.

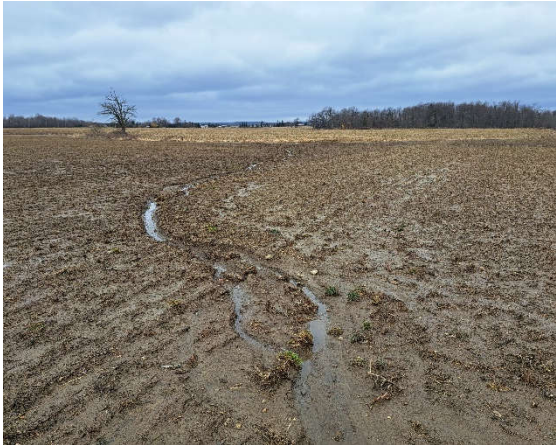
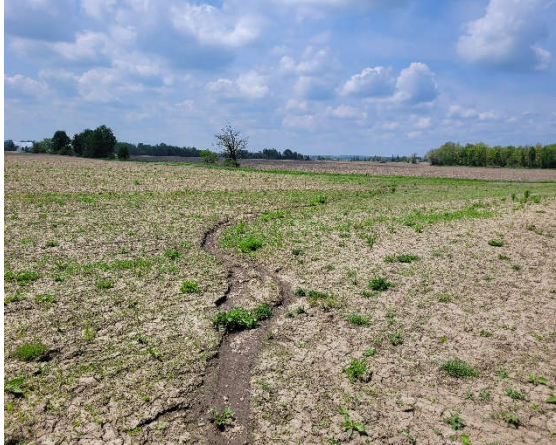
Reach AD3-3

Location: Mayfield Road, Caledon		Watershed: Etobicoke Creek	
Round 1 Hydrology: Flowing water	Round 2 Hydrology: Dry	Round 3 Hydrology: Round 3 site visit will not be completed as the Round 2 site visit was dry.	
Riparian Classification: Through an agricultural field.			
Fish Observed: No	Upstream of HDF: Agricultural field	Downstream of HDF: Alloa Drain	
Notes: Limited feature development identified with a lack of water in Round 2 of the site assessment.			
GEO Morphix Management Recommendation: No Management

Round 1: Photograph facing downstream.		Round 2: Photograph facing downstream.	
Round 3: Round 3 site visit will not be completed as the Round 2 site visit was dry.

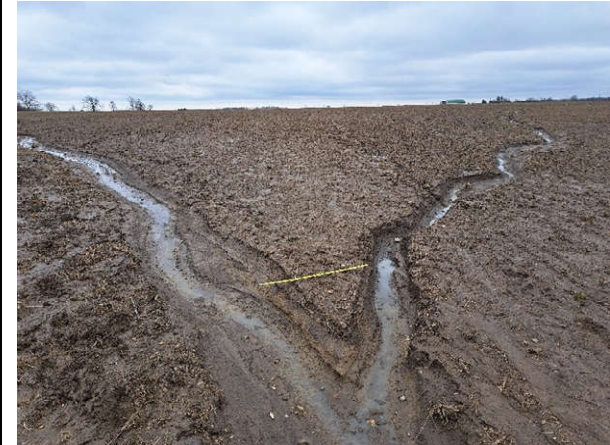
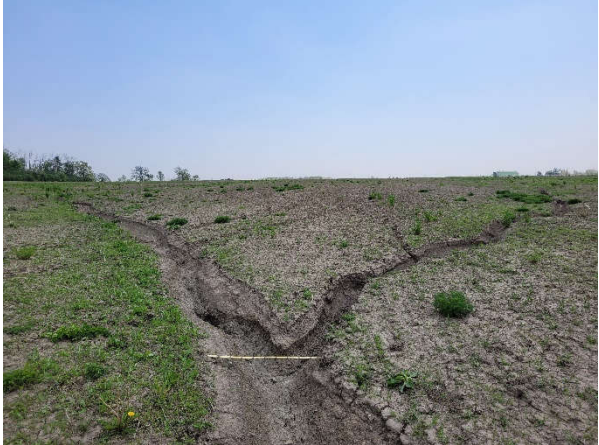
Reach AD3-4

Location: Mayfield Road, Caledon		Watershed: Etobicoke Creek	
Round 1 Hydrology: Flowing water	Round 2 Hydrology: Dry	Round 3 Hydrology: Round 3 site visit will not be completed as the Round 2 site visit was dry.	
Riparian Classification: Through an agricultural field.			
Fish Observed: No	Upstream of HDF: Agricultural field	Downstream of HDF: Alloa Drain	
Notes: Limited feature development identified with a lack of water in Round 2 of the site assessment.			
GEO Morphix Management Recommendation: No Management

Round 1: Photograph facing upstream.		Round 2: Photograph facing upstream.	
Round 3: Round 3 site visit will not be completed as the Round 2 site visit was dry.

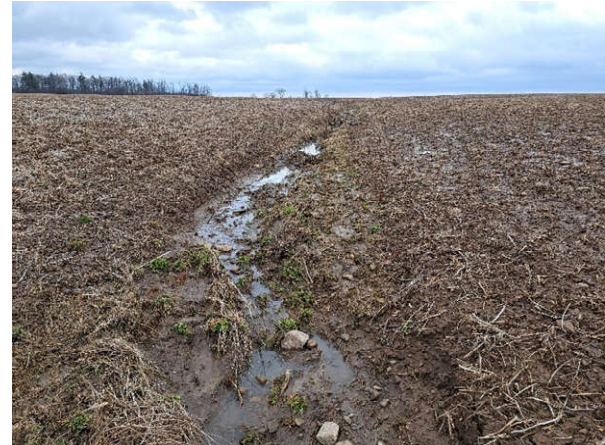
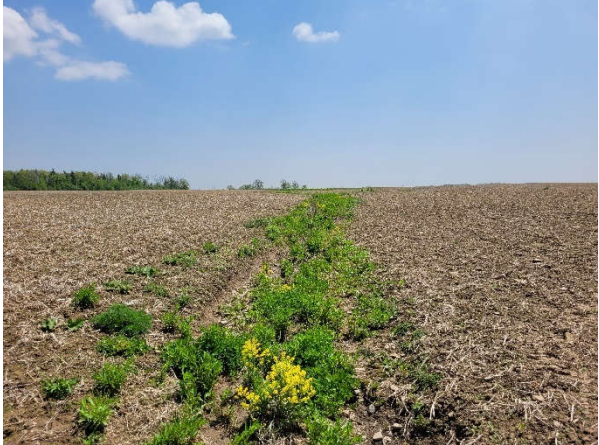
Reach AD3-5

Location: Mayfield Road, Caledon		Watershed: Etobicoke Creek	
Round 1 Hydrology: Flowing water	Round 2 Hydrology: Dry	Round 3 Hydrology: Round 3 site visit will not be completed as the Round 2 site visit was dry.	
Riparian Classification: Through an agricultural field.			
Fish Observed: No	Upstream of HDF: Agricultural field	Downstream of HDF: Alloa Drain	
Notes: Limited feature development identified with a lack of water in Round 2 of the site assessment.			
GEO Morphix Management Recommendation: No Management

Round 1: Photograph facing upstream.		Round 2: Photograph facing upstream.	
Round 3: Round 3 site visit will not be completed as the Round 2 site visit was dry.

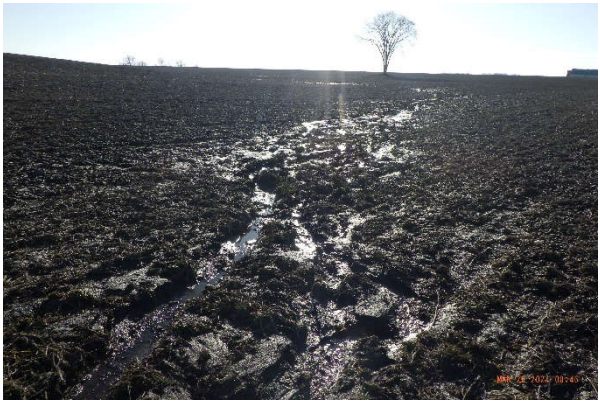
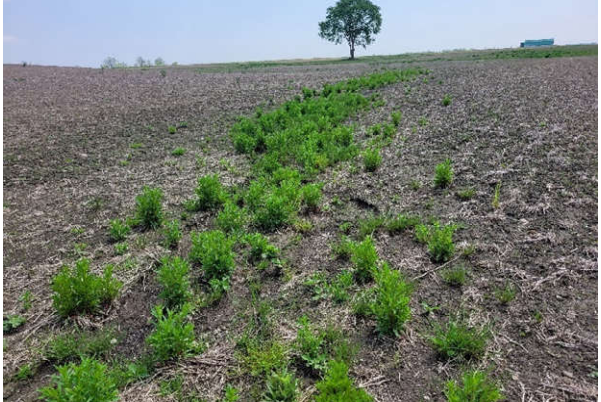
Location: Mayfield Road, Caledon		Watershed: Etobicoke Creek	
Round 1 Hydrology: Flowing water	Round 2 Hydrology: Dry	Round 3 Hydrology: Round 3 site visit will not be completed as the Round 2 site visit was dry.	
Riparian Classification: Through an agricultural field.			
Fish Observed: No	Upstream of HDF: Agricultural field	Downstream of HDF: Alloa Drain	
Notes: Limited feature development identified with a lack of water in Round 2 of the site assessment.			
GEO Morphix Management Recommendation: No Management

Round 1: Photograph facing upstream.		Round 2: Photograph facing upstream.	
Round 3: Round 3 site visit will not be completed as the Round 2 site visit was dry.

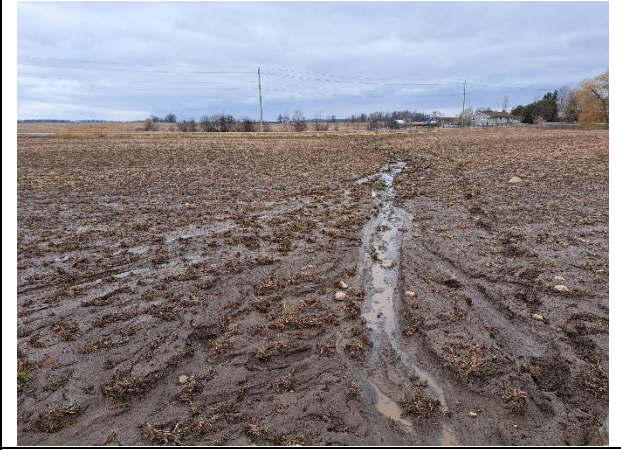
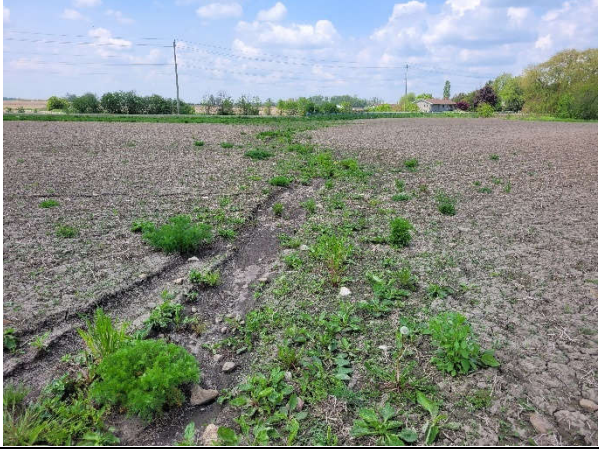
Reach AD3-8

Location: Mayfield Road, Caledon		Watershed: Etobicoke Creek	
Round 1 Hydrology: Flowing water	Round 2 Hydrology: Dry	Round 3 Hydrology: Round 3 site visit will not be completed as the Round 2 site visit was dry.	
Riparian Classification: Through an agricultural field.			
Fish Observed: No	Upstream of HDF: Agricultural field	Downstream of HDF: Alloa Drain	
Notes: Limited feature development identified with a lack of water in Round 2 of the site assessment.			
GEO Morphix Management Recommendation: No Management

Round 1: Photograph facing downstream.		Round 2: Photograph facing downstream.	
Round 3: Round 3 site visit will not be completed as the Round 2 site visit was dry.

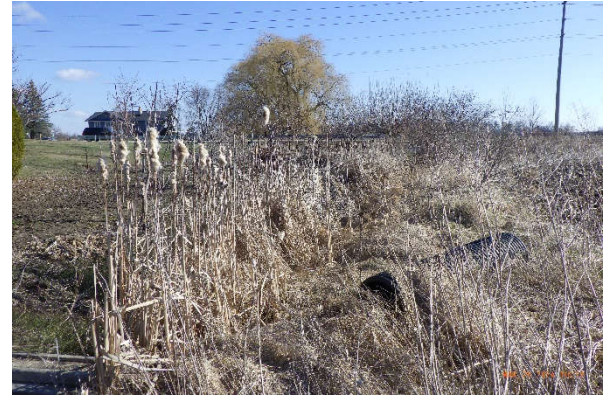
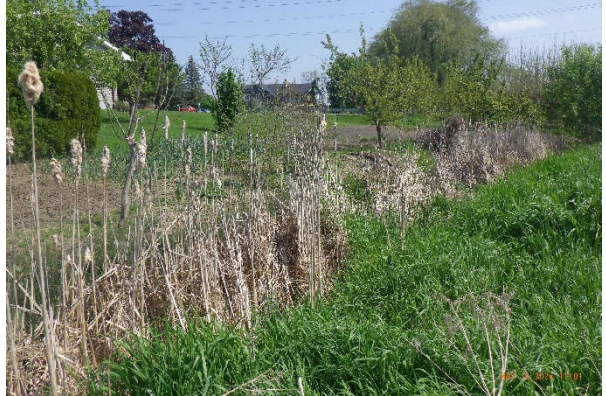
Location: Mayfield Road, Caledon		Watershed: Etobicoke Creek	
Round 1 Hydrology: Standing water	Round 2 Hydrology: Standing water	Round 3 Hydrology: To be completed	
Riparian Classification: Immediate riparian area consists of wetland vegetation with an agricultural field south of the feature. North of the feature is a manicured lawn and driveway for a residential property.			
Fish Observed: No	Upstream of HDF: Agricultural field	Downstream of HDF: Alloa Drain	
Notes: Defined feature with water in Round 1 and 2 with an established riparian buffer along portions of the reach.			
GEO Morphix Management Recommendation: Conservation <i>*Subject to change following round 3 HDFA*</i>

Round 1: Photograph facing upstream.		Round 2: Photograph facing downstream.	
Round 3: To be completed

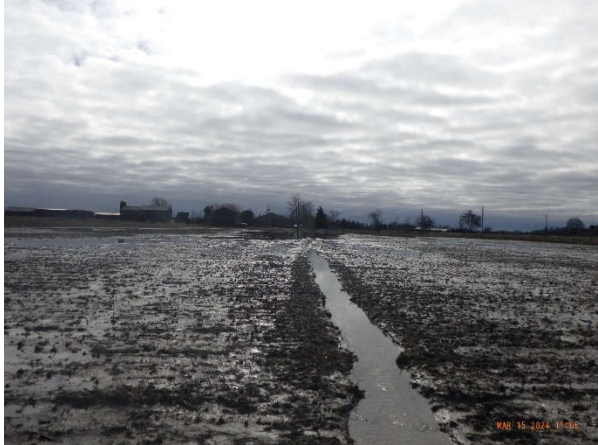
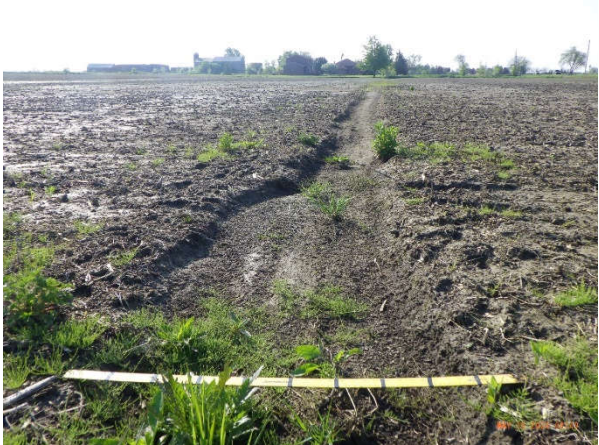
Location: Mayfield Road, Caledon		Watershed: Etobicoke Creek	
Round 1 Hydrology: Flowing water minimally	Round 2 Hydrology: Dry	Round 3 Hydrology: Round 3 site visit will not be completed as the Round 2 site visit was dry.	
Riparian Classification: Through an agricultural field.			
Fish Observed: No	Upstream of HDF: Agricultural field	Downstream of HDF: Alloa Drain	
Notes: Limited feature development and with a lack of water in Round 2.			
GEO Morphix Management Recommendation: No Management

Round 1: Photograph facing downstream.		Round 2: Photograph facing downstream.	
Round 3: Round 3 site visit will not be completed as the Round 2 site visit was dry.

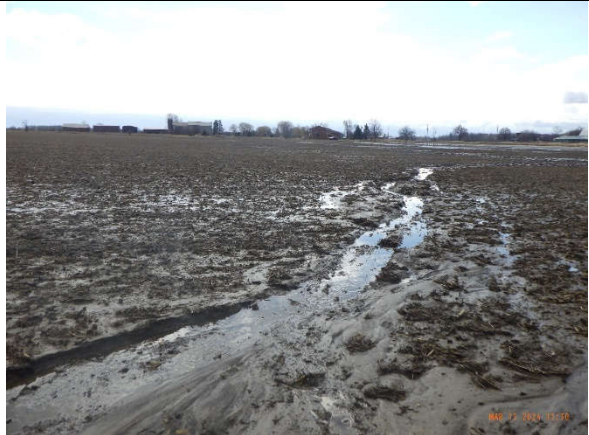
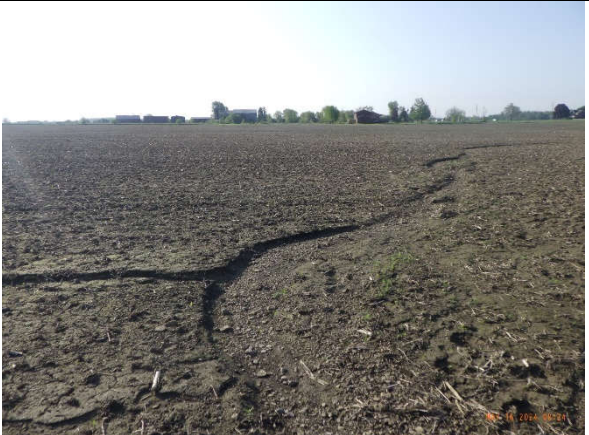
Location: Mayfield Road, Caledon		Watershed: Etobicoke Creek	
Round 1 Hydrology: Flowing water minimally	Round 2 Hydrology: Dry	Round 3 Hydrology: Round 3 site visit will not be completed as the Round 2 site visit was dry.	
Riparian Classification: Feature flowing through an agricultural field.			
Fish Observed: No	Upstream of HDF: Agricultural field	Downstream of HDF: Agricultural field	
Notes: Limited feature development and a lack of water in Round 2.			
GEO Morphix Management Recommendation: No Management

Round 1: Photograph facing downstream.		Round 2: Photograph facing downstream.	
Round 3: Round 3 site visit will not be completed as the Round 2 site visit was dry.

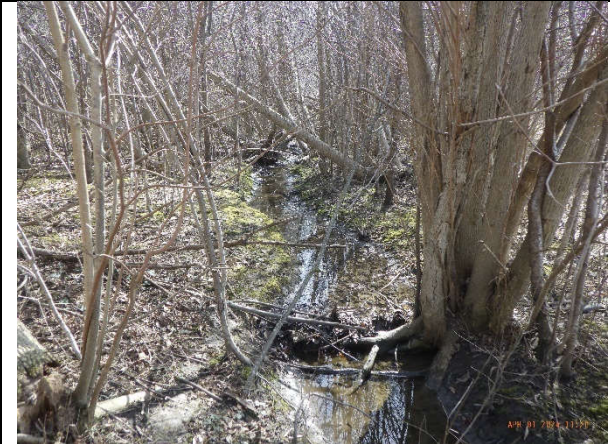
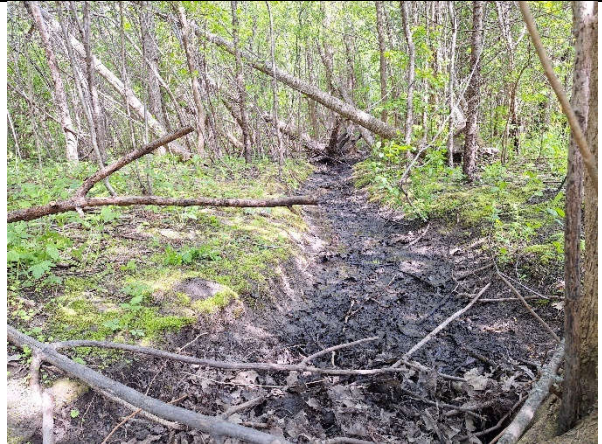
Location: Mayfield Road, Caledon		Watershed: Etobicoke Creek	
Round 1 Hydrology: Flowing water	Round 2 Hydrology: Standing water	Round 3 Hydrology: To be completed	
Riparian Classification: Flowing through a woodlot			
Fish Observed: No	Upstream of HDF: Woodlot and wetland	Downstream of HDF: Alloa Drain	
Notes: Defined feature through a woodlot and wetland area.			
GEO Morphix Management Recommendation: Protection

Round 1: Photograph facing upstream.		Round 2: Photograph facing upstream.	
Round 3: To be completed

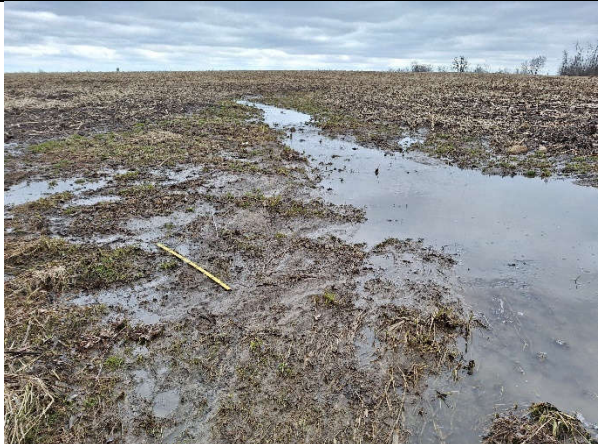
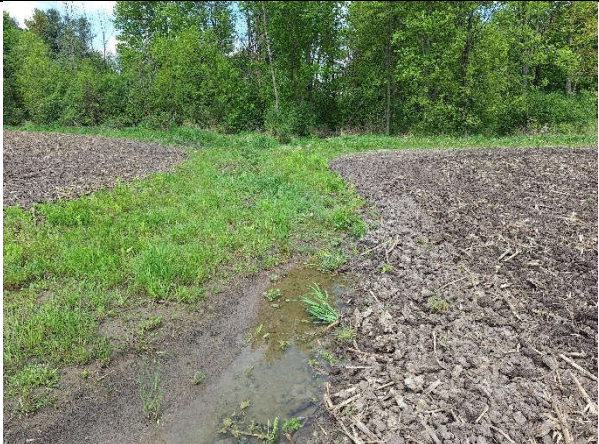
Location: Mayfield Road, Caledon		Watershed: Etobicoke Creek	
Round 1 Hydrology: Flowing water	Round 2 Hydrology: Standing water	Round 3 Hydrology: To be completed	
Riparian Classification: Feature flows through agricultural fields.			
Fish Observed: No	Upstream of HDF: Woodlot and wetland	Downstream of HDF: Woodlot and wetland	
Notes: Limited feature form through active agricultural field. Upstream classification status would result in this feature being classified as Protection; however, given the impacted existing condition, it is classified as Conservation.			
GEO Morphix Management Recommendation: Conservation <i>*Subject to change following round 3 HDFA*</i>

Round 1: Photograph facing upstream.		Round 2: Photograph facing downstream.	
Round 3: To be completed

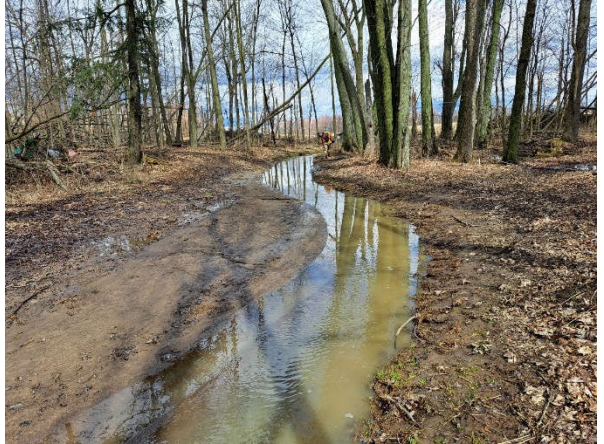
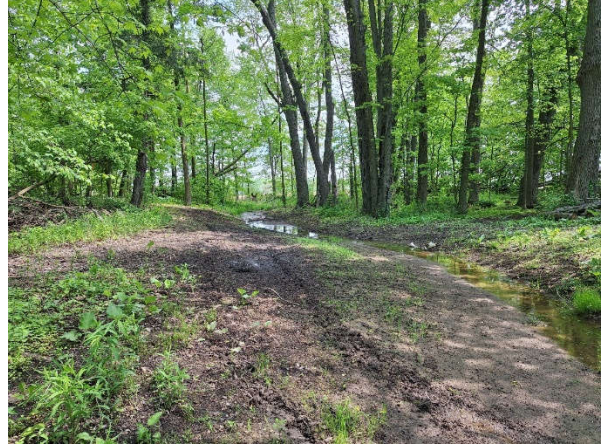
Location: Mayfield Road, Caledon		Watershed: Etobicoke Creek	
Round 1 Hydrology: Flowing water	Round 2 Hydrology: Standing water	Round 3 Hydrology: To be completed	
Riparian Classification: Flowing through a woodlot and wetland			
Fish Observed: No	Upstream of HDF: Woodlot and wetland	Downstream of HDF: Alloa Drain	
Notes: Defined feature through a woodlot and wetland area.			
GEO Morphix Management Recommendation: Protection

Round 1: Photograph facing downstream.		Round 2: Photograph facing downstream.	
Round 3: To be completed

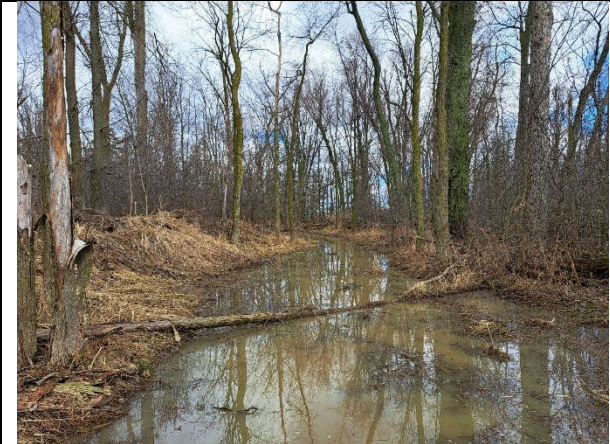
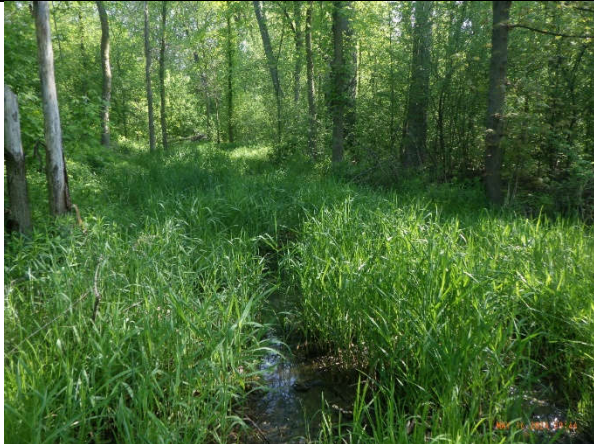
Location: Mayfield Road, Caledon		Watershed: Etobicoke Creek	
Round 1 Hydrology: Flowing water	Round 2 Hydrology: Standing water	Round 3 Hydrology: To be completed	
Riparian Classification: Flowing through a woodlot and wetland			
Fish Observed: No	Upstream of HDF: Agricultural field	Downstream of HDF: Woodlot and wetland	
Notes: Defined feature through a woodlot and wetland area.			
GEO Morphix Management Recommendation: Protection

Round 1: Photograph facing downstream.		Round 2: Photograph facing downstream.	
Round 3: To be completed

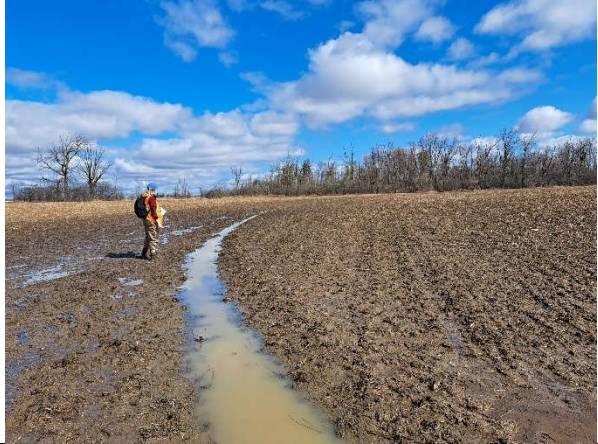
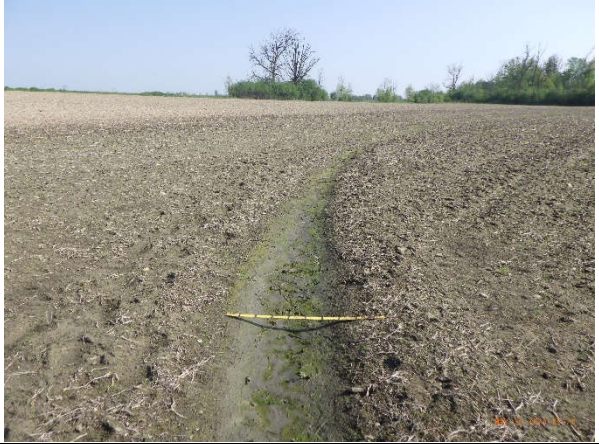
Location: Mayfield Road, Caledon		Watershed: Etobicoke Creek	
Round 1 Hydrology: Flowing water	Round 2 Hydrology: Dry	Round 3 Hydrology: Round 3 site visit will not be completed as the Round 2 site visit was dry.	
Riparian Classification: Feature flows through agricultural fields.			
Fish Observed: No	Upstream of HDF: Agricultural fields	Downstream of HDF: Woodlot and wetland	
Notes: Limited feature form through agricultural fields.			
GEO Morphix Management Recommendation: Mitigation <i>*Subject to change following round 3*</i>

Round 1: Photograph facing downstream.		Round 2: Photograph facing downstream.	
Round 3: Round 3 site visit will not be completed as the Round 2 site visit was dry.

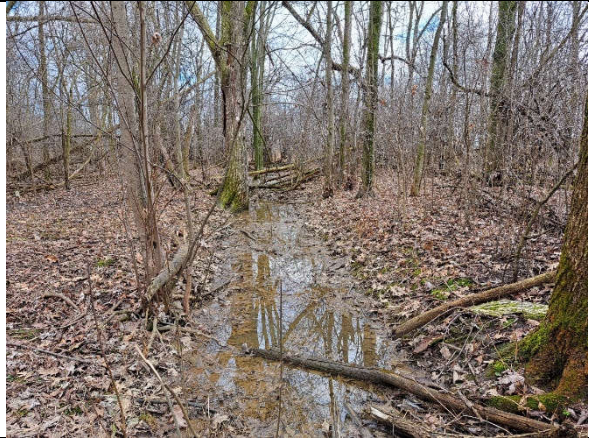
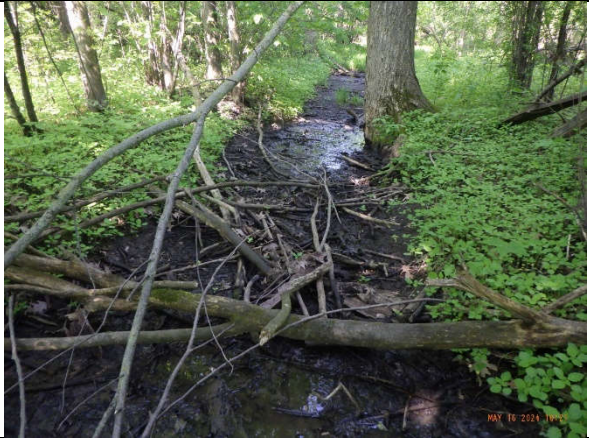
Location: Mayfield Road, Caledon		Watershed: Etobicoke Creek	
Round 1 Hydrology: Standing water	Round 2 Hydrology: Standing water	Round 3 Hydrology: To be completed	
Riparian Classification: Feature flows through a mature forest and wetland.			
Fish Observed: No	Upstream of HDF: Agricultural field	Downstream of HDF: Forest and wetland	
Notes: Feature through woodlot and wetland area classified as protection due to its location.			
GEO Morphix Management Recommendation: Protection

Round 1: Photograph facing upstream.		Round 2: Photograph facing downstream.	
Round 3: To be completed

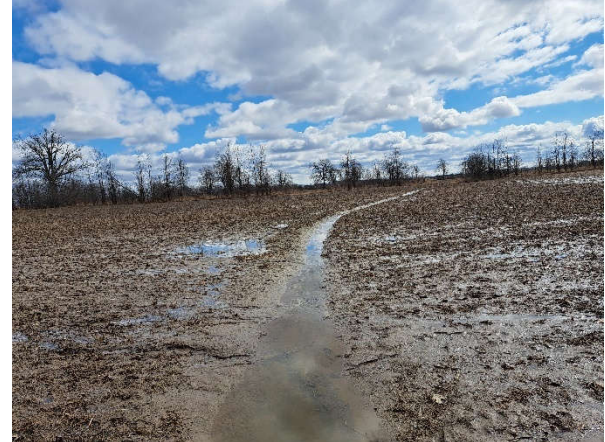
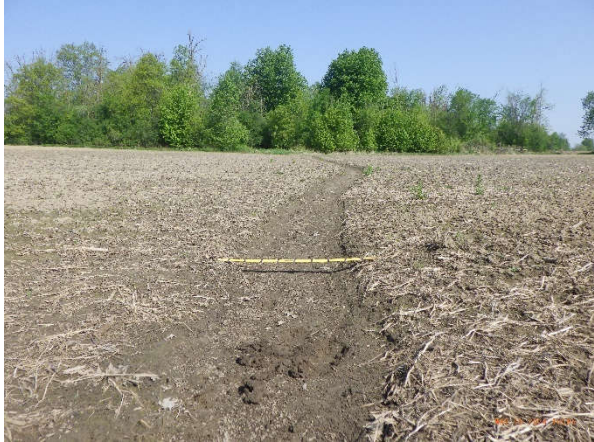
Location: Mayfield Road, Caledon		Watershed: Etobicoke Creek	
Round 1 Hydrology: Flowing water	Round 2 Hydrology: Dry	Round 3 Hydrology: Round 3 site visit will not be completed as the Round 2 site visit was dry.	
Riparian Classification: Feature flows through agricultural fields.			
Fish Observed: No	Upstream of HDF: Agricultural field	Downstream of HDF: Woodlot and wetland	
Notes: Feature poorly defined through agricultural field.			
GEO Morphix Management Recommendation: Mitigation <i>*Subject to change following round 3*</i>

Round 1: Photograph facing upstream.		Round 2: Photograph facing downstream.	
Round 3: Round 3 site visit will not be completed as the Round 2 site visit was dry.

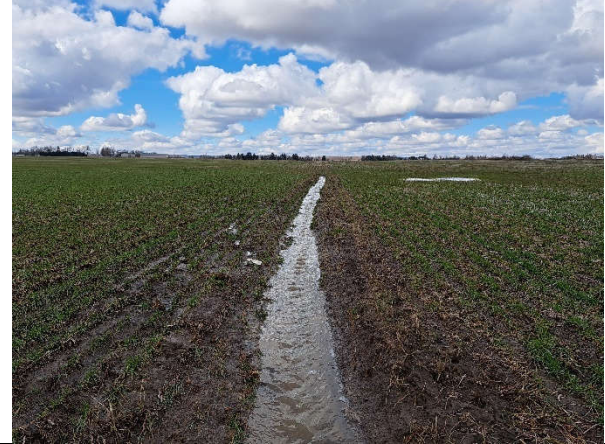
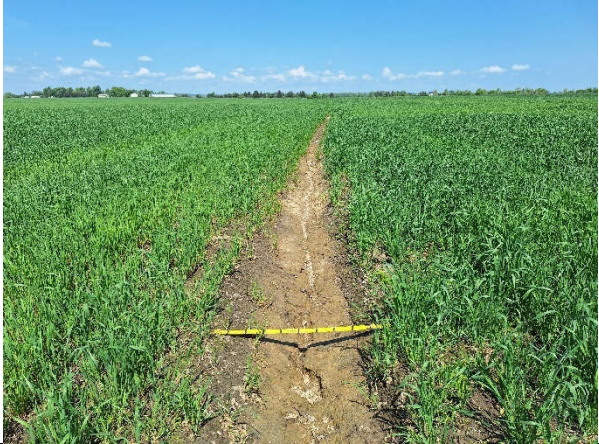
Location: Mayfield Road, Caledon		Watershed: Etobicoke Creek	
Round 1 Hydrology: Flowing water	Round 2 Hydrology: Dry	Round 3 Hydrology: Round 3 site visit will not be completed as the Round 2 site visit was dry.	
Riparian Classification: Feature flows through agricultural fields.			
Fish Observed: No	Upstream of HDF: Agricultural field	Downstream of HDF: Woodlot and wetland	
Notes: Feature poorly defined through agricultural field.			
GEO Morphix Management Recommendation: Mitigation <i>*Subject to change following round 3*</i>

Round 1: Photograph facing upstream.		Round 2: Photograph facing downstream.	
Round 3: Round 3 site visit will not be completed as the Round 2 site visit was dry.

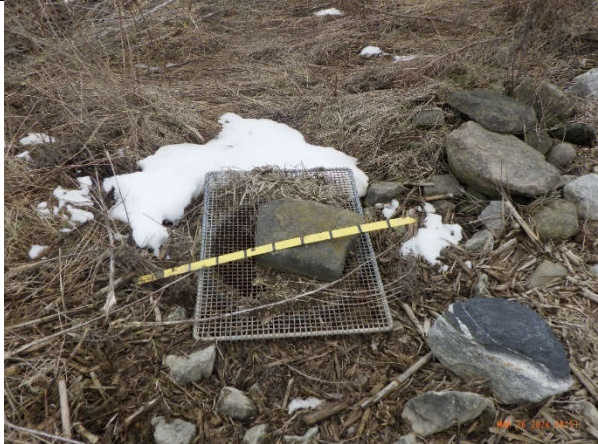
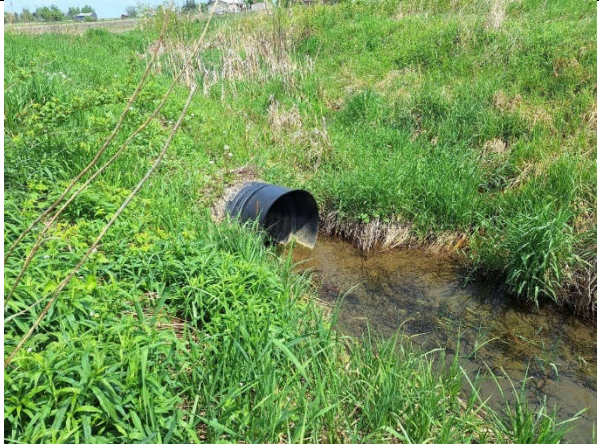
Location: Mayfield Road, Caledon		Watershed: Etobicoke Creek	
Round 1 Hydrology: Water flowing in drain	Round 2 Hydrology: Water flowing in drain	Round 3 Hydrology: Round 3 site visit will not be completed as a surface feature was not identified	
Riparian Classification: Feature through a meadow.			
Fish Observed: No	Upstream of HDF: Agricultural field	Downstream of HDF: Lyons Drain	
Notes: Tile drain feature was identified with a lack of surface flows in the Round 1 and 2 site visits. Requires a Mitigation status due to it inputting flows into the top of watercourse. Feature may also be impacted by the future Highway 413.			
GEO Morphix Management Recommendation: Mitigation

Round 1: Photograph of upstream inlet.		Round 2: Photograph of downstream outlet.	
Round 3: Round 3 site visit will not be completed as a surface feature was not identified

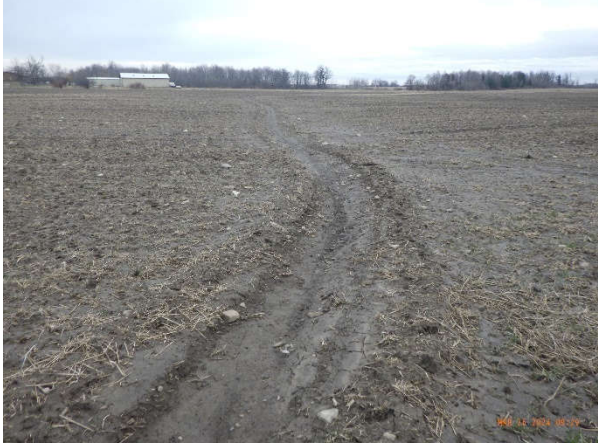
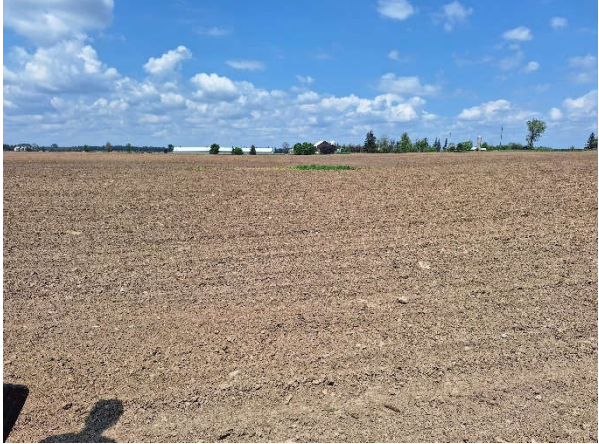
Location: Mayfield Road, Caledon		Watershed: Etobicoke Creek	
Round 1 Hydrology: Dry	Round 2 Hydrology: Dry	Round 3 Hydrology: Round 3 site visit will not be completed as the Round 2 site visit was dry.	
Riparian Classification: Feature through agricultural fields.			
Fish Observed: No	Upstream of HDF: Agricultural field	Downstream of HDF: Tile drain and ultimately Lyons Drain	
Notes: Tile drain feature was identified with evidence of surface flows. The defined surface feature was dry during both site visits.			
GEO Morphix Management Recommendation: Mitigation

Round 1: Photograph facing downstream.		Round 2: Photograph facing upstream.	
Round 3: Round 3 site visit will not be completed as the Round 2 site visit was dry.
