**Appendix A:
Study Area**

Reach Delineation
Alloa Secondary Plan Area
 Caledon, Ontario

**Appendix C:
Photographic Record**

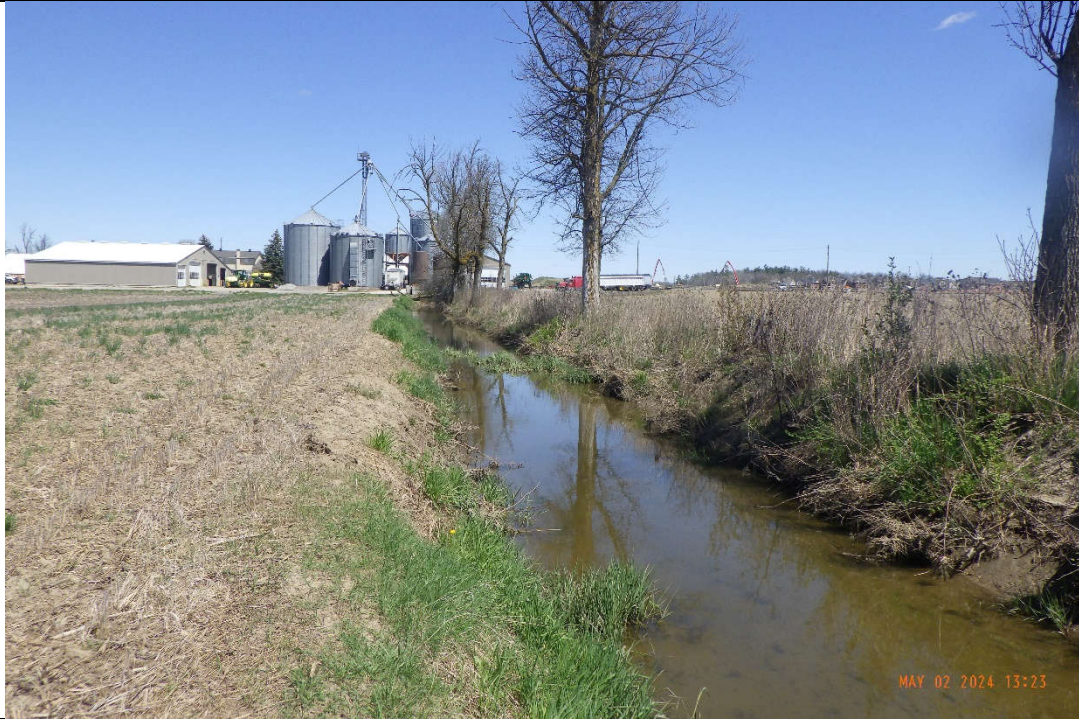
Photo 1
Alloa Drain - Reach AD2, Caledon, Ontario

The bed and bank substrate consisted of clay/silt and sand. The reach was run-dominant, with very few riffles and pools.

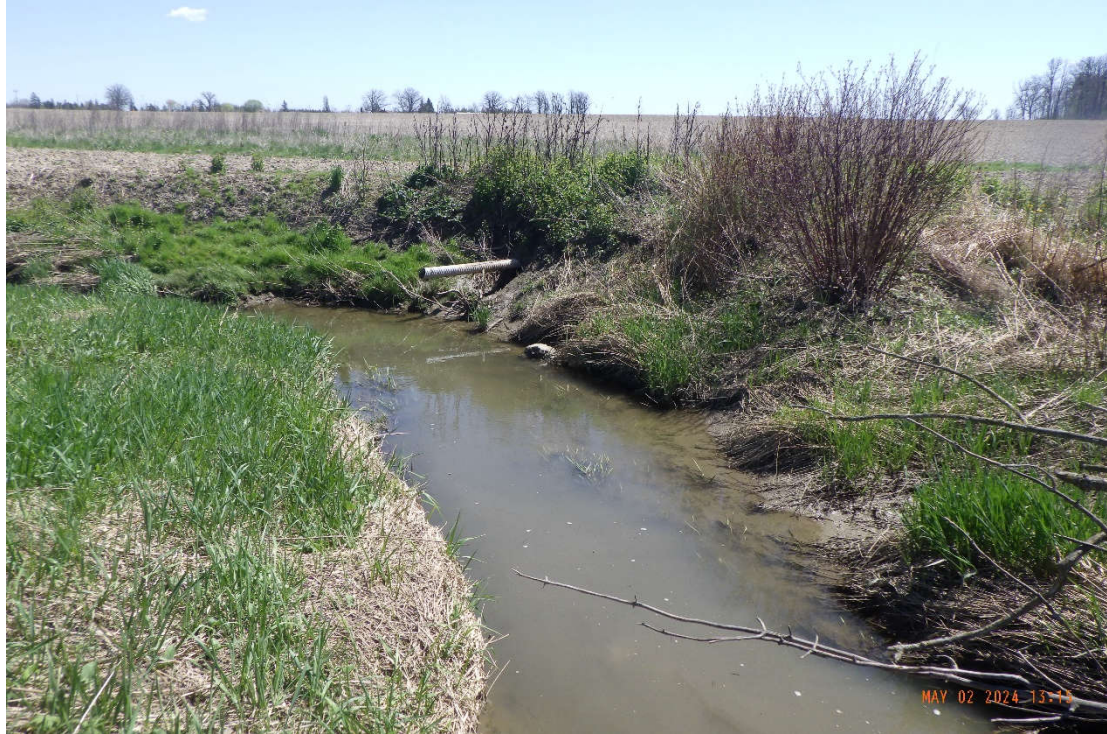
Photo 2
Alloa Drain - Reach AD2, Caledon, Ontario

An exposed tile drain that was previously buried was observed at an outer bank of a meander bend and was in poor condition.

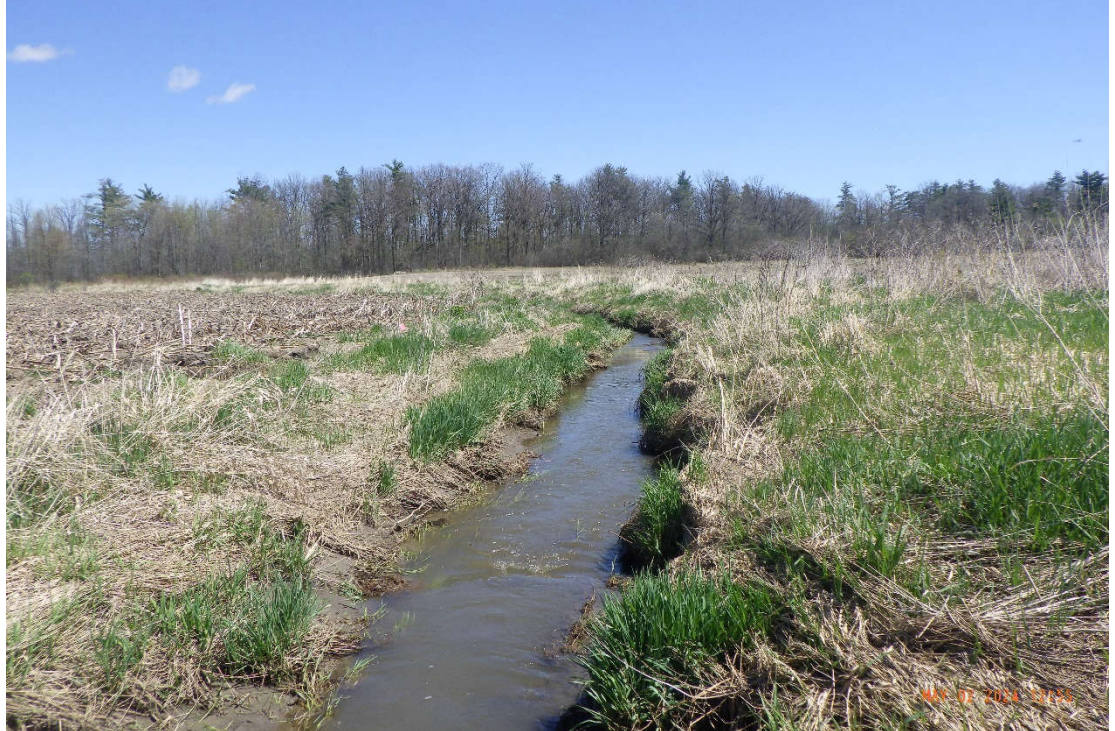
Photo 5
Alloa Drain - Reach AD3, Caledon, Ontario

Generally, the reach was run-dominant; however, approximately 25% of the reach contained riffles.

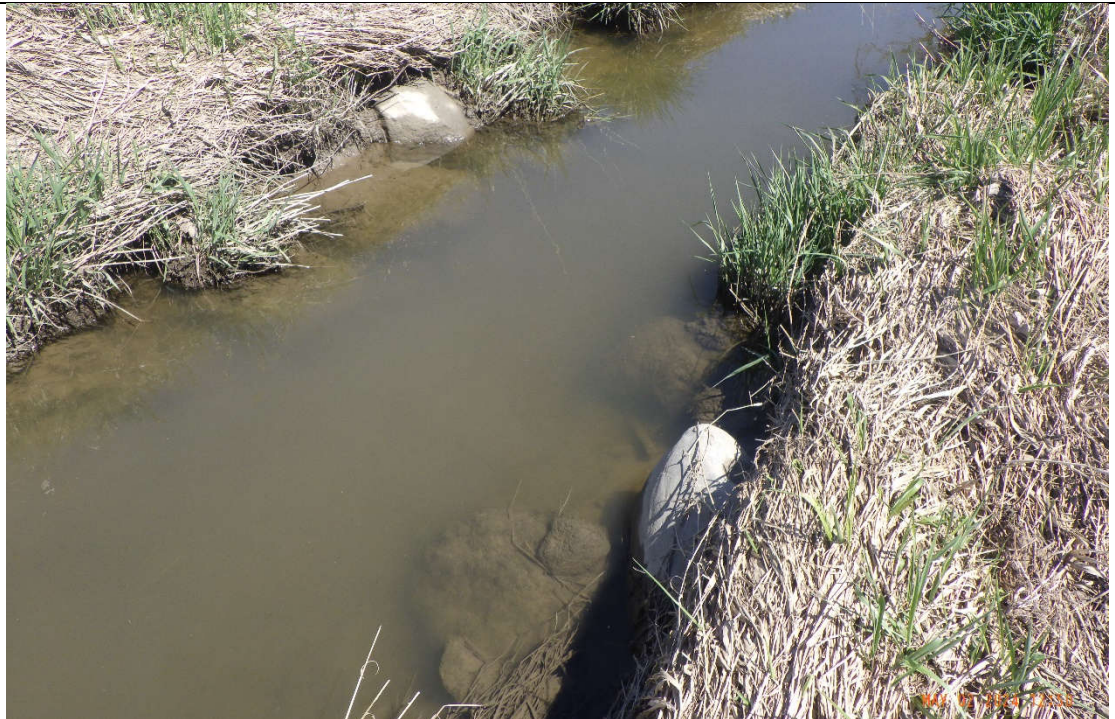
Photo 6
Alloa Drain - Reach AD3, Caledon, Ontario

Poor longitudinal sorting of bed materials was observed throughout the reach, with bed substrate ranging from clay/silt to cobbles. A few boulders were also present.

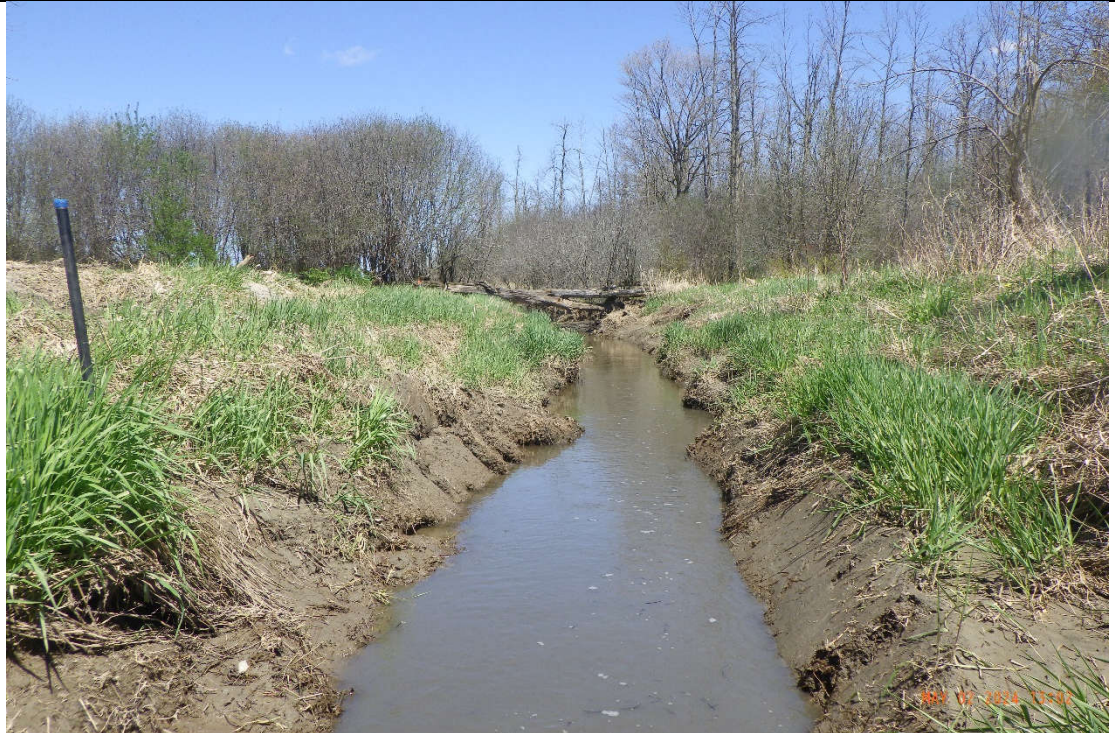
Photo 7
Alloa Drain - Reach AD3, Caledon, Ontario

One localized area in the downstream portion of the reach showed evidence of recent dredging (sloped bare banks).

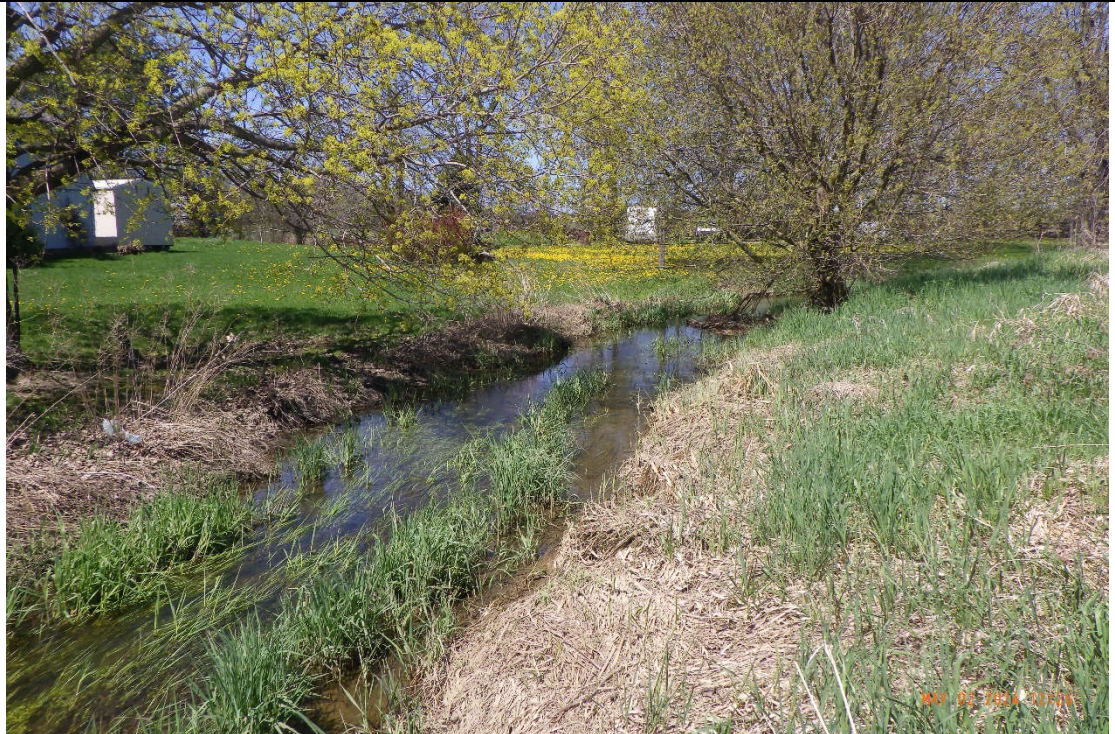
Photo 8
Alloa Drain - Reach AD3, Caledon, Ontario

The riparian vegetation consisted of primarily grasses and shrubs. The grasses encroached into the channel in various locations throughout the reach. A few trees were also present, located primarily in the upstream portion of the reach.

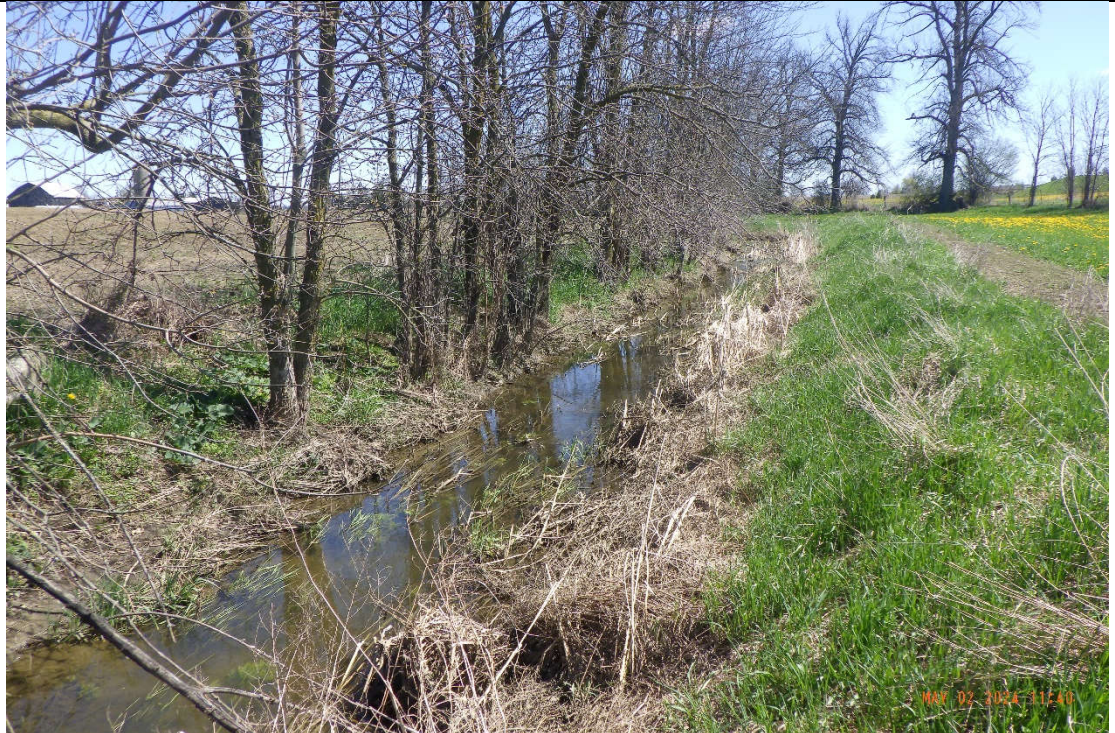
Photo 9
Alloa Drain - Reach AD4, Caledon, Ontario

In the upstream portion of the reach a localized row of trees was present along the banks, some of which were leaning or had fallen into the channel.

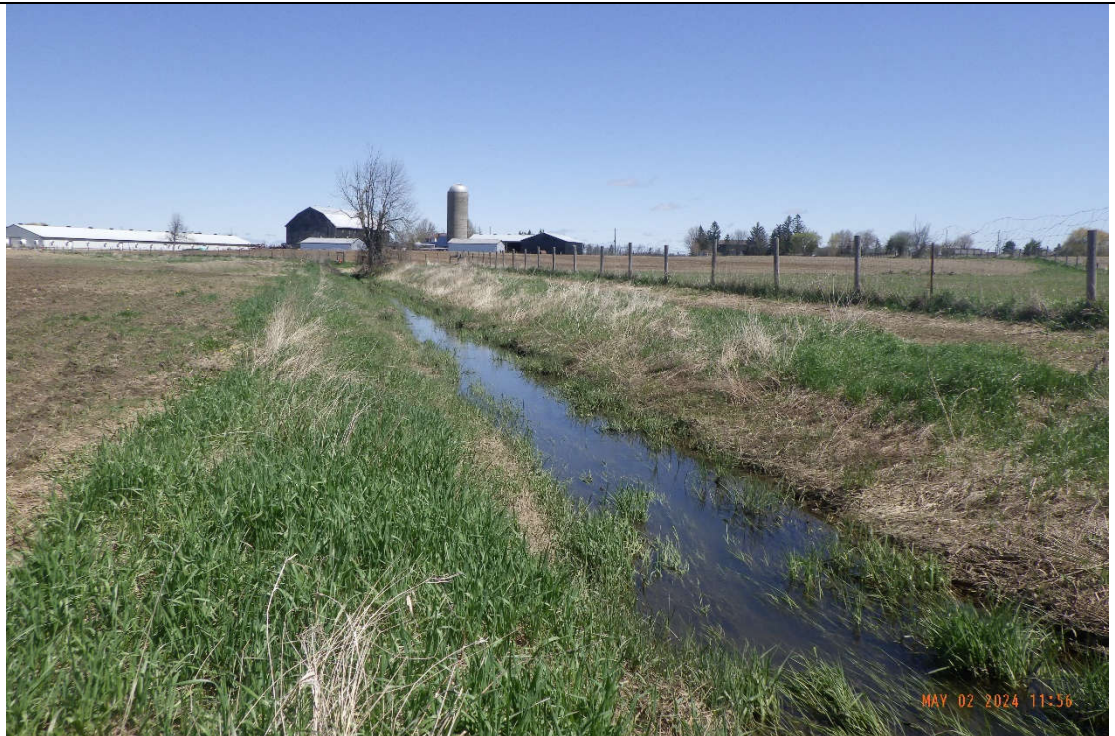
Photo 10
Alloa Drain - Reach AD4, Caledon, Ontario

The constructed channel was straightened and flowed between agricultural fields. The channel was entrenched, had a low gradient and lacked canopy cover.

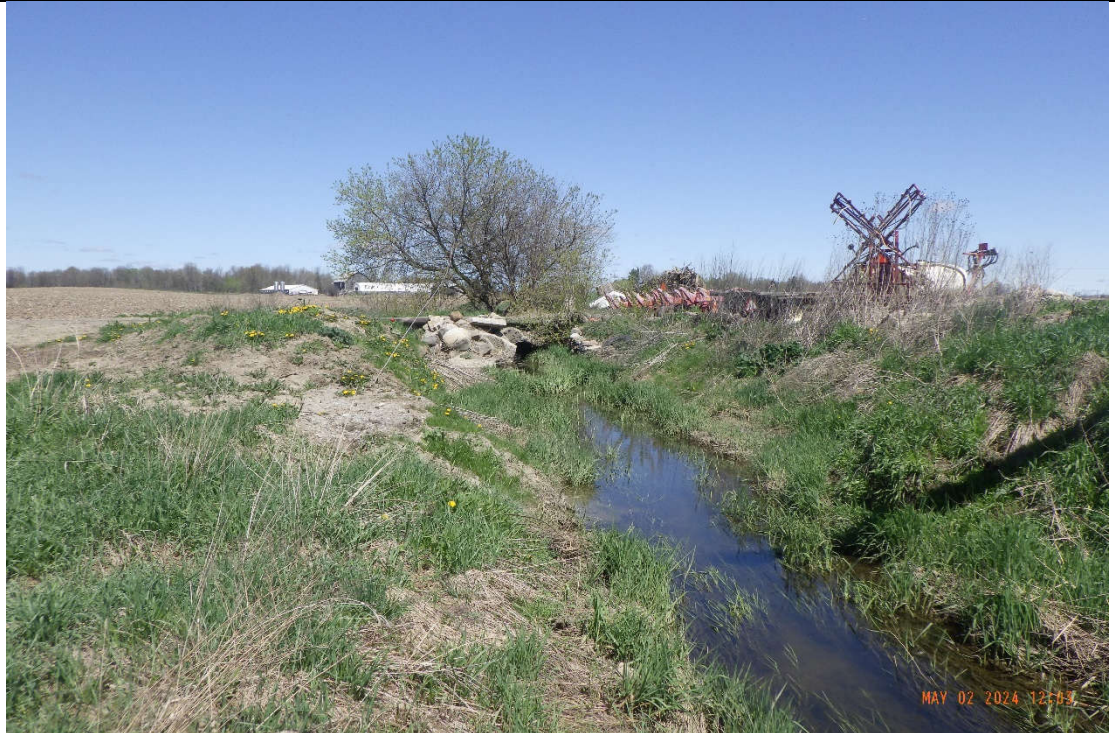
Photo 11
Alloa Drain - Reach AD4, Caledon, Ontario

Multiple farm crossings were observed throughout the reach. The crossings were generally heavily armored and in poor condition. Scour pools were observed along the downstream sides of the culverts.

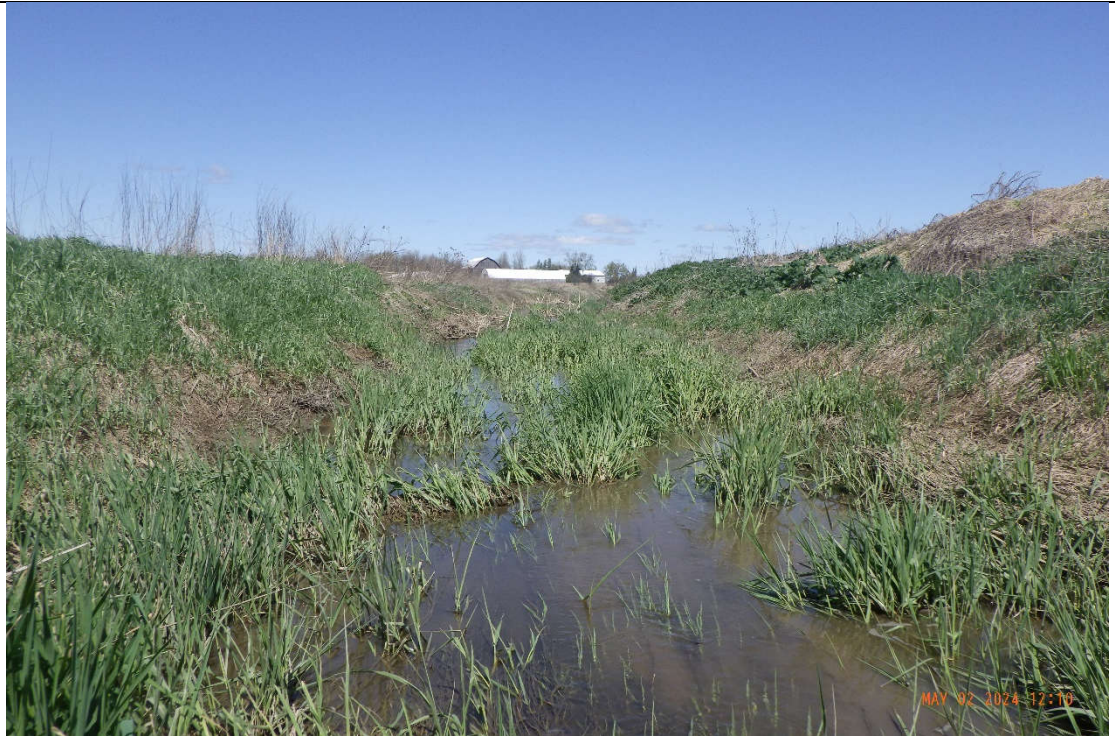
Photo 12
Alloa Drain - Reach AD4, Caledon, Ontario

Riparian vegetation generally consisted of grasses, which encroached on the channel. Along approximately 20% of the reach, instream vegetation consisted of cattails.

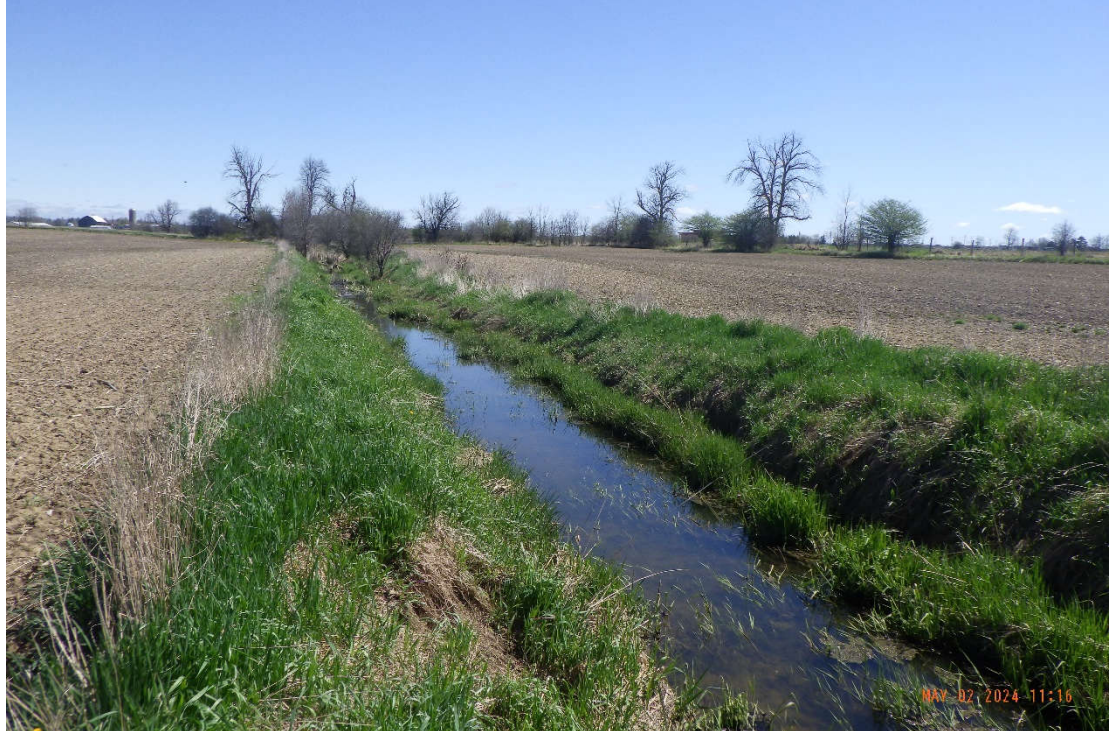
Photo 13
Alloa Drain - Reach AD5, Caledon, Ontario

The banks throughout the reach were generally steep, with angles ranging from 60 – 90 degrees.

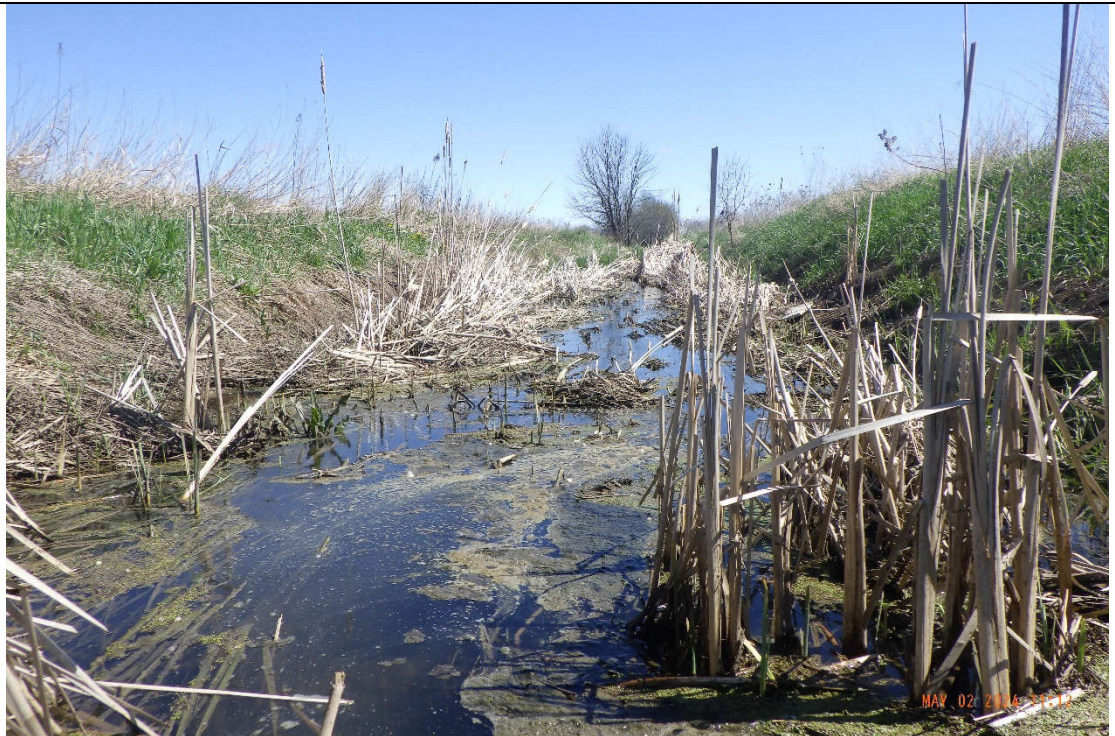
Photo 14
Alloa Drain - Reach AD5, Caledon, Ontario

Cattails were observed along 25% of the reach, with the highest concentration immediately downstream of the culvert at Mississauga Road.

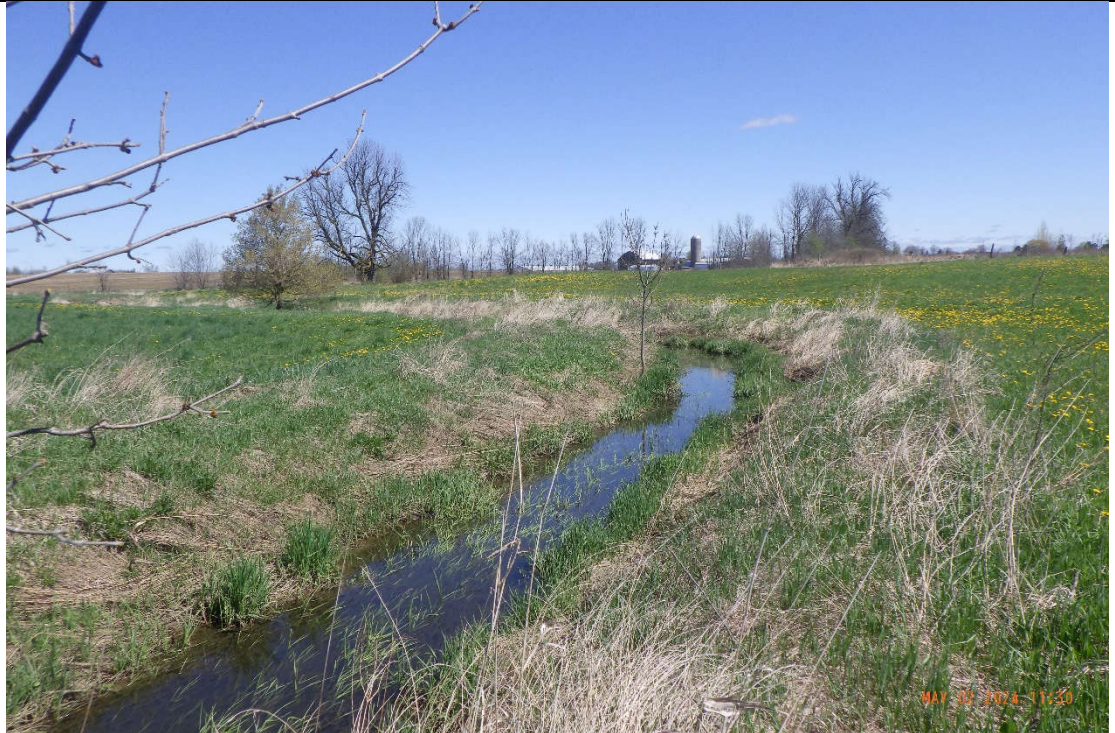
Photo 15
Alloa Drain - Reach AD5, Caledon, Ontario

The reach was run-dominant, with the bed and bank substrates consisting of clay/silt and sand.

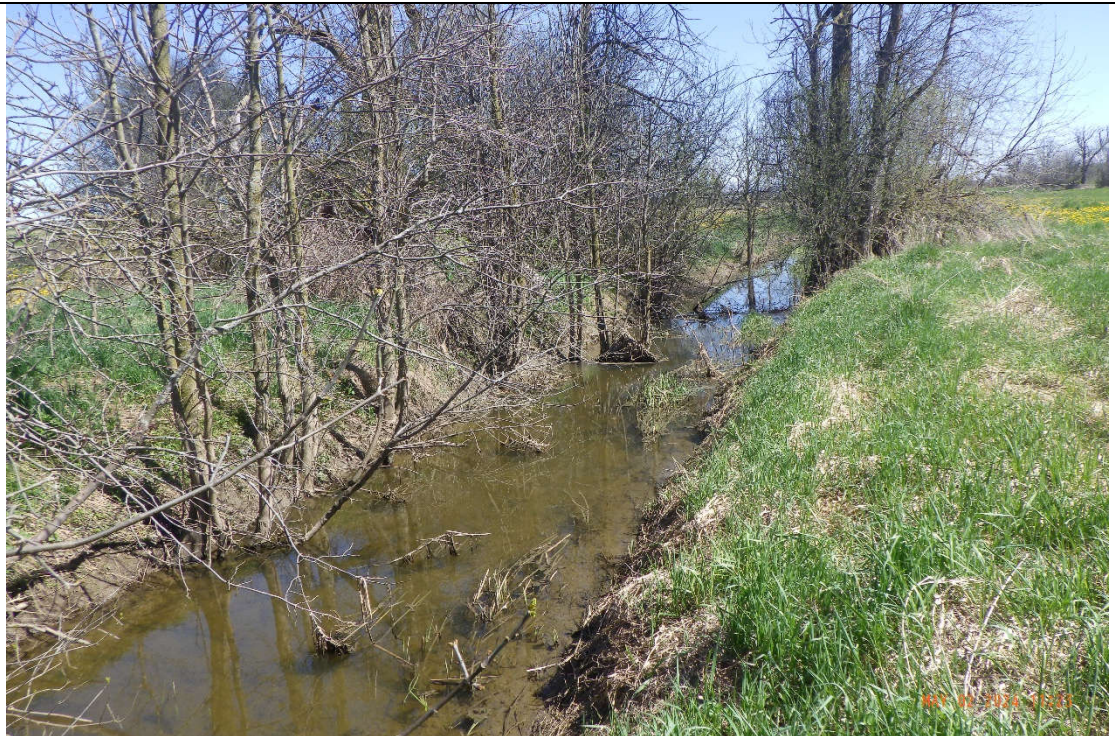
Photo 16
Alloa Drain - Reach AD5, Caledon, Ontario

A leaning fence crossed the channel. Leaning trees were also present in this portion of the reach.

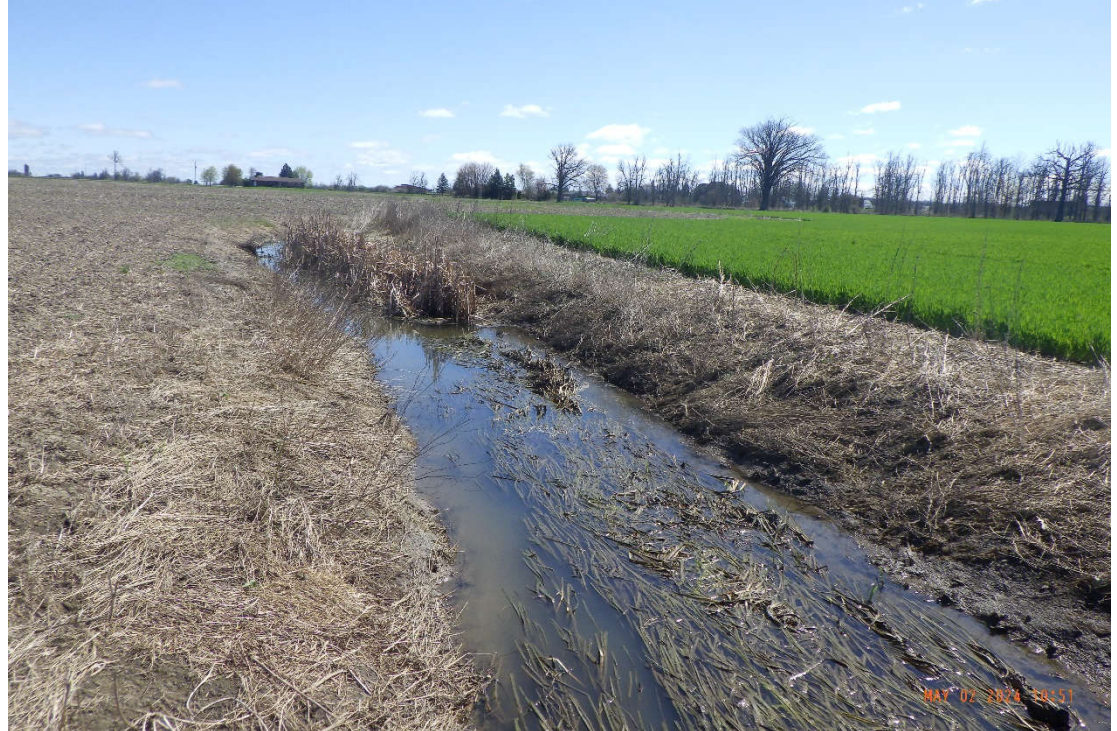
Photo 17
Alloa Drain - Reach AD6, Caledon, Ontario

Rooted emergent instream vegetation was observed along 45% of the reach. Woody debris was not present in the channel or cutbank.

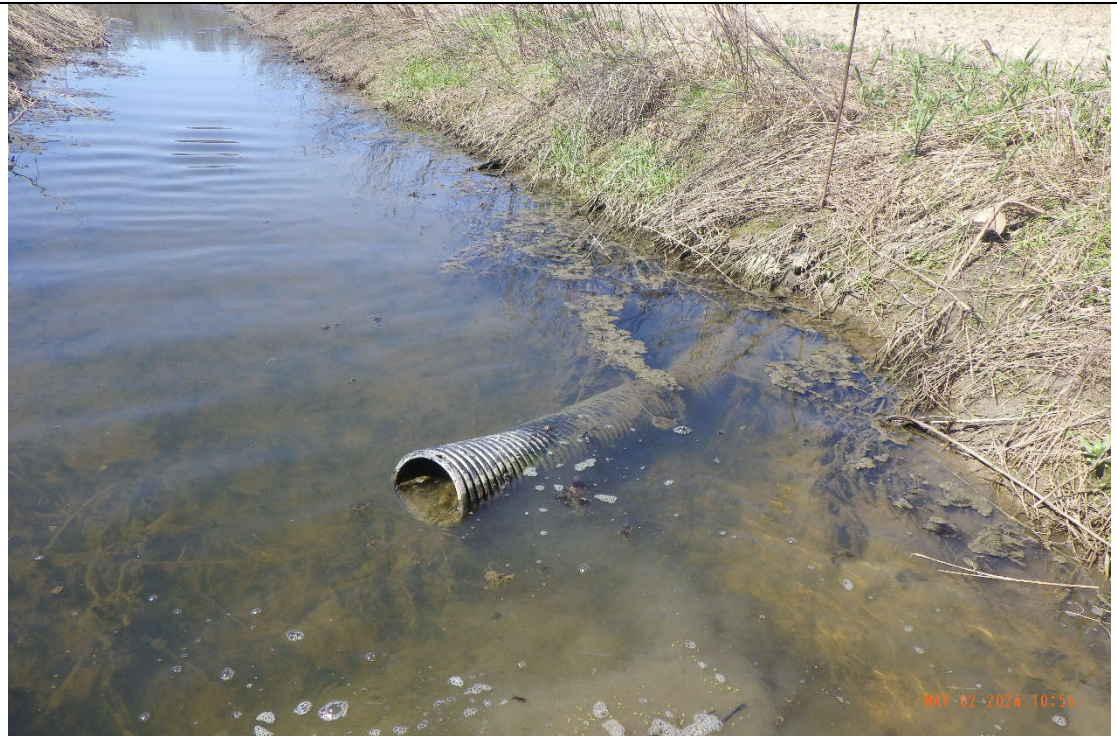
Photo 18
Alloa Drain - Reach AD6, Caledon, Ontario

The channel flowed through agricultural fields and multiple tile drains were observed throughout the reach.

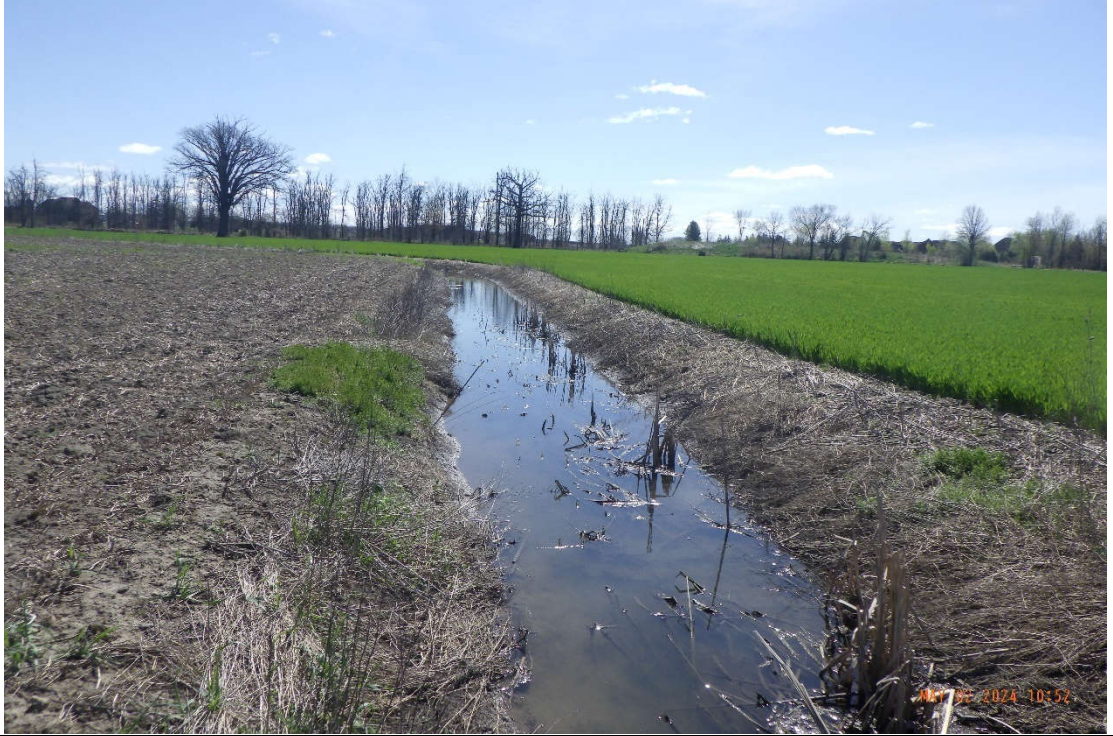
Photo 19
Alloa Drain - Reach AD6, Caledon, Ontario

The channel was straight, with minimal erosion present.

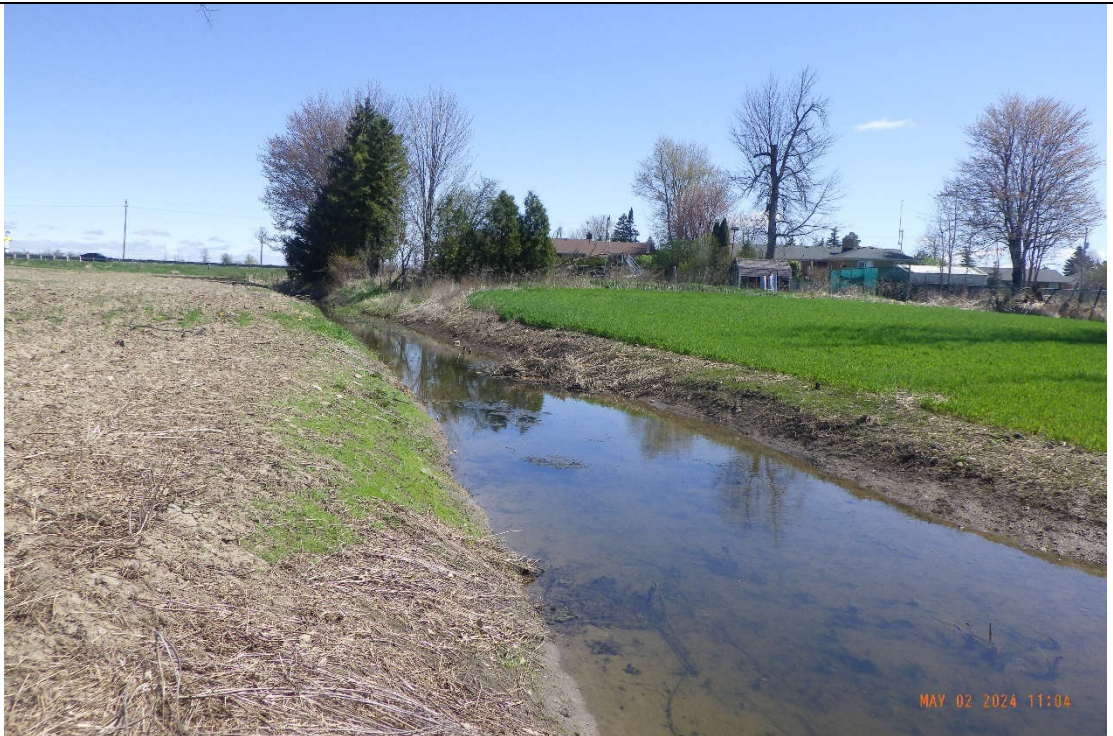
Photo 20
Alloa Drain - Reach AD6, Caledon, Ontario

The bed was heavily silted and run-dominant. Bar forms were absent throughout the reach.

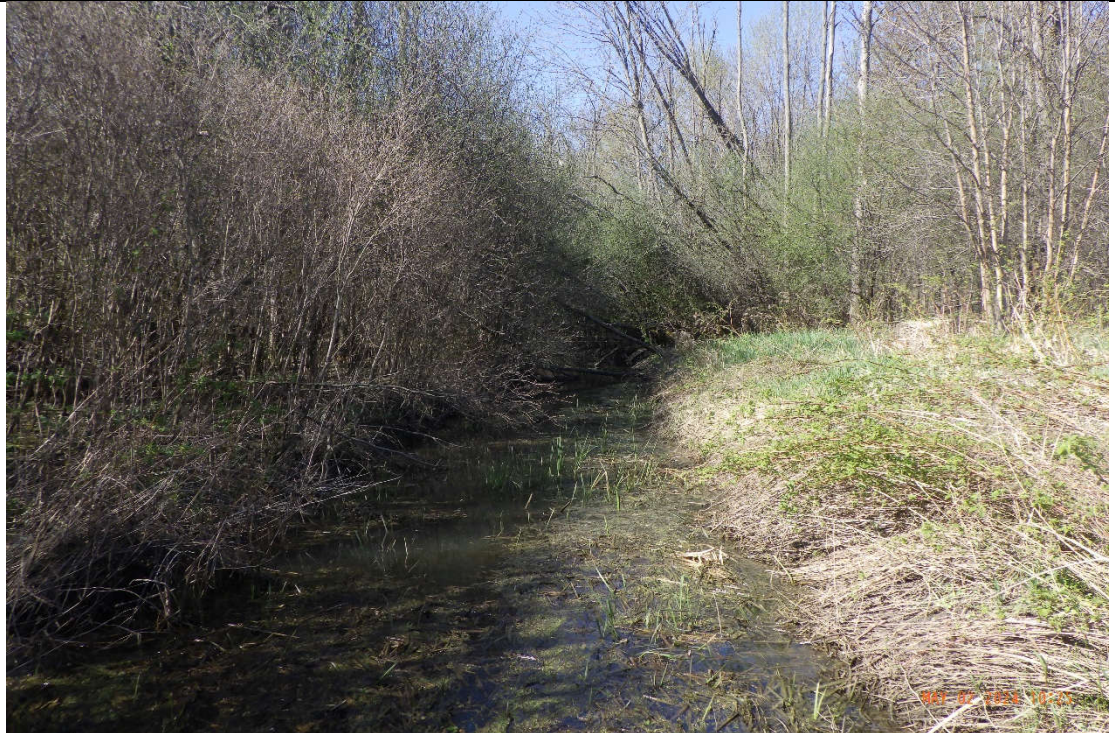
Photo 21
Alloa Drain - Reach AD7, Caledon, Ontario

The reach flowed through a mature forest containing trees and shrubs.

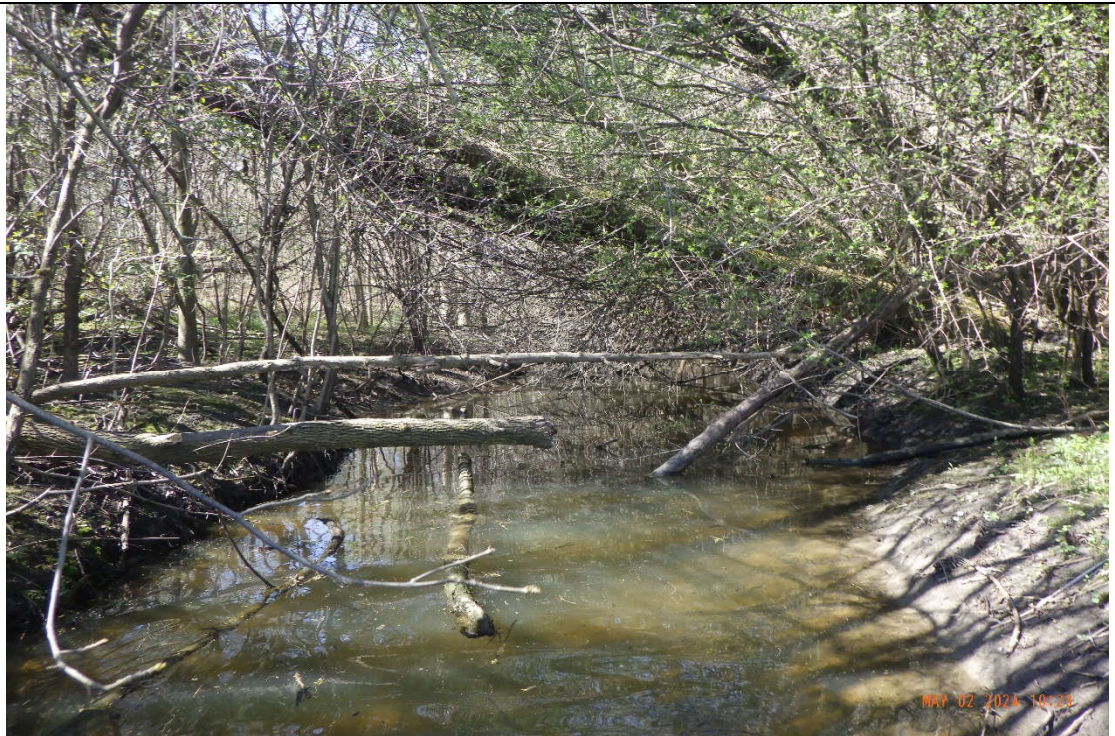
Photo 22
Alloa Drain - Reach AD7, Caledon, Ontario

The reach was run-dominant and lacked riffle-pool morphology. The channel bed was highly silted and organic debris was present. The bed and bank substrate consisted of clay/silt, and sand.

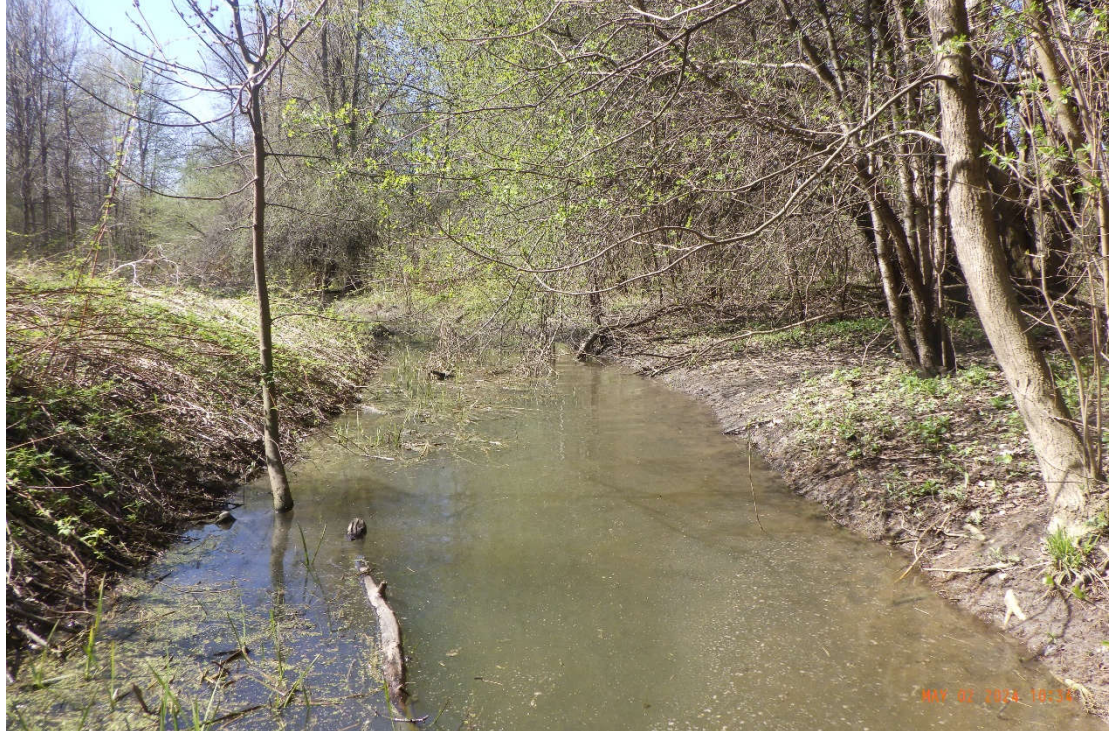
Photo 23
Alloa Drain - Reach AD7, Caledon, Ontario

Standing water was present that had a strong organic odour.

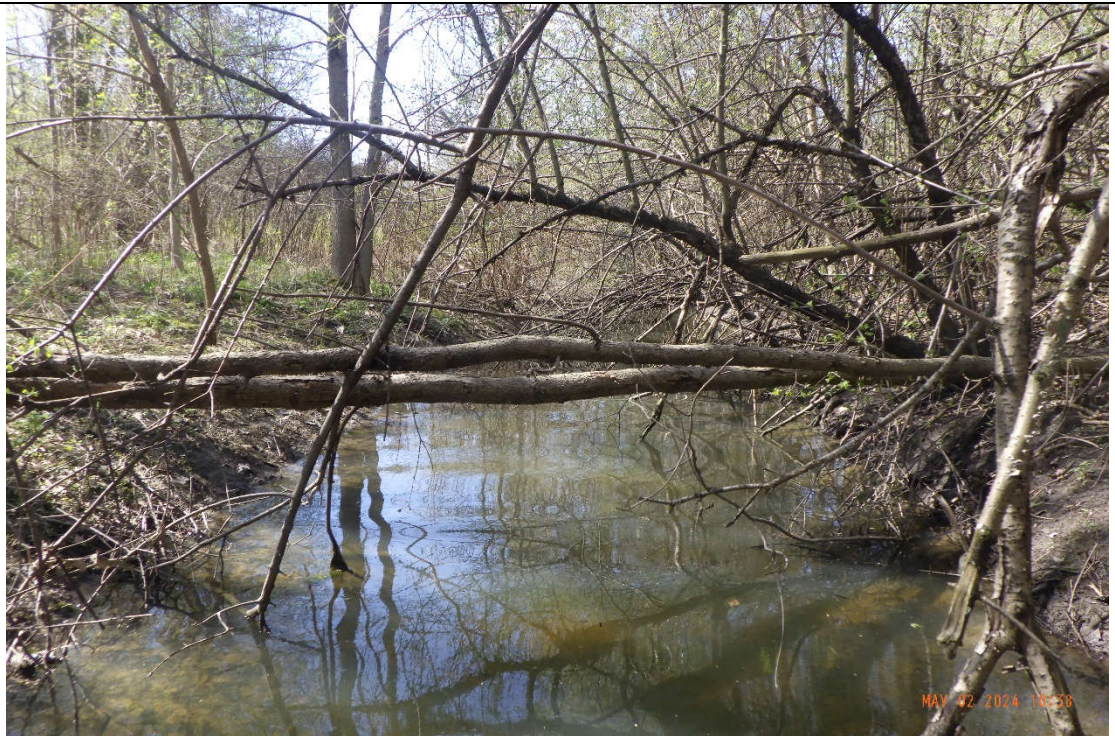
Photo 24
Alloa Drain - Reach AD7, Caledon, Ontario

Woody debris was present in moderate density, as well as multiple fallen and leaning trees.

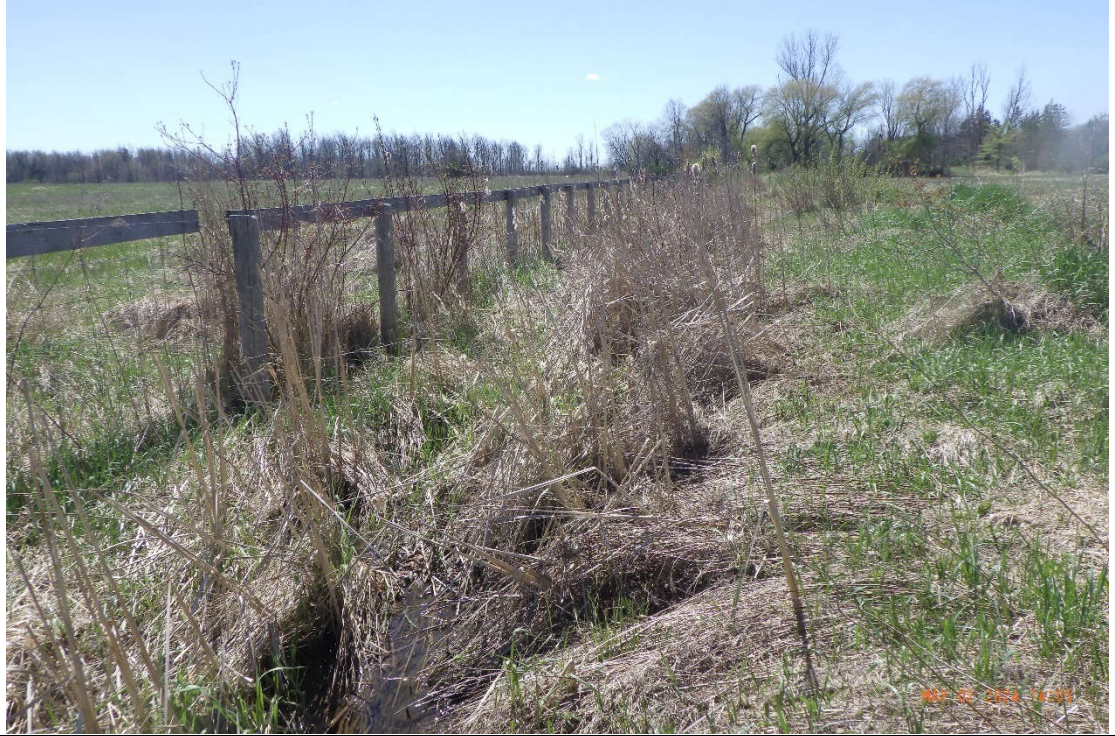
Photo 25
Tributary of the Alloa Drain - Reach AD1-2, Caledon, Ontario

The downstream portion of the reach had rooted emergent instream vegetation. This vegetation was present from the forest edge to the downstream reach break.

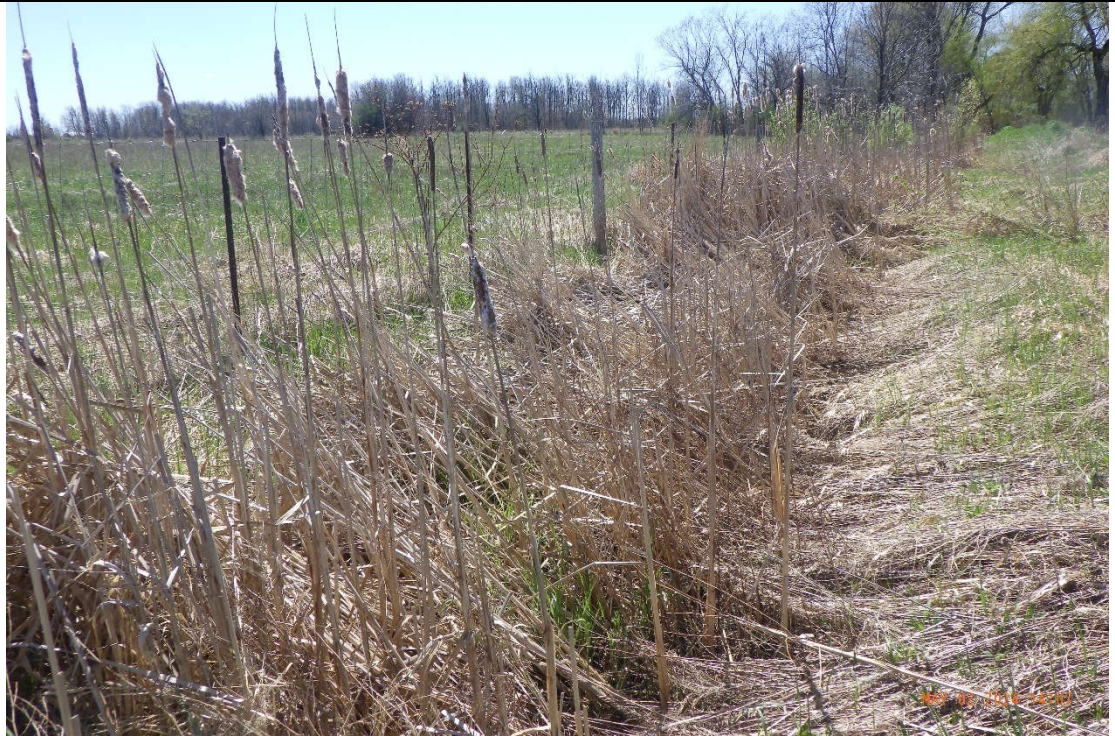
Photo 26
Tributary of the Alloa Drain - Reach AD1-2, Caledon, Ontario

The channel banks were defined, with low bank angles of up to 30 degrees.

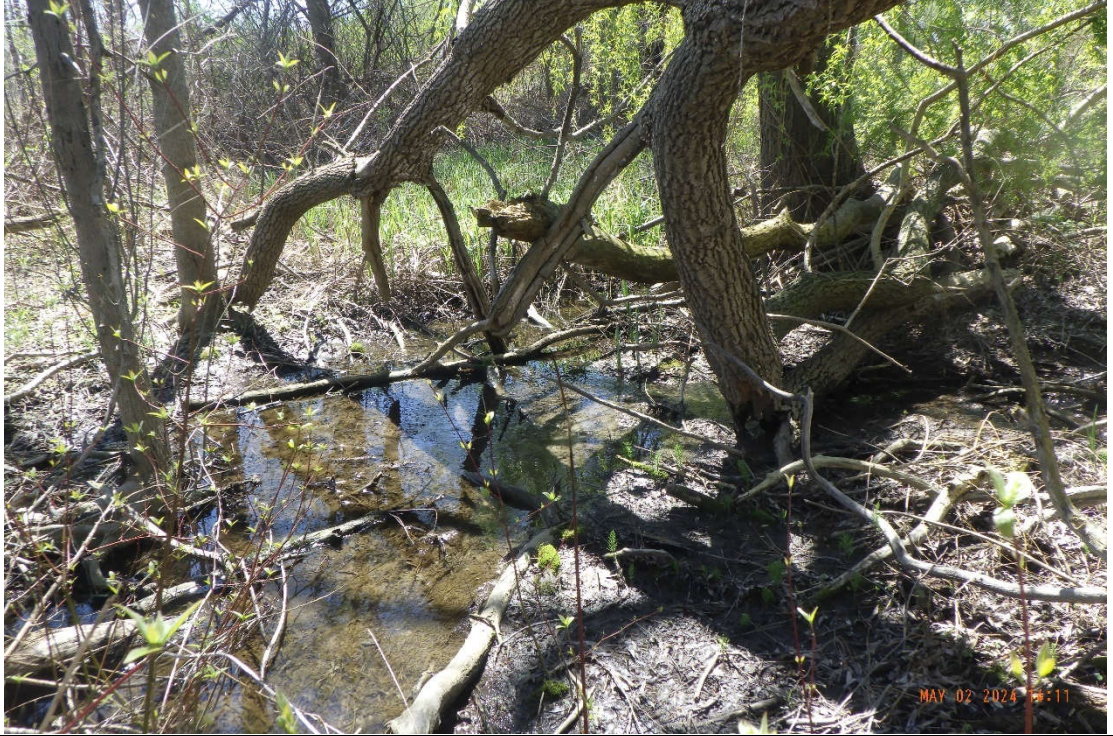
Photo 27
Tributary of the Alloa Drain - Reach AD1-2, Caledon, Ontario

The upstream portion of the reach had multiple leaning and fallen trees that contributed woody debris to the channel.

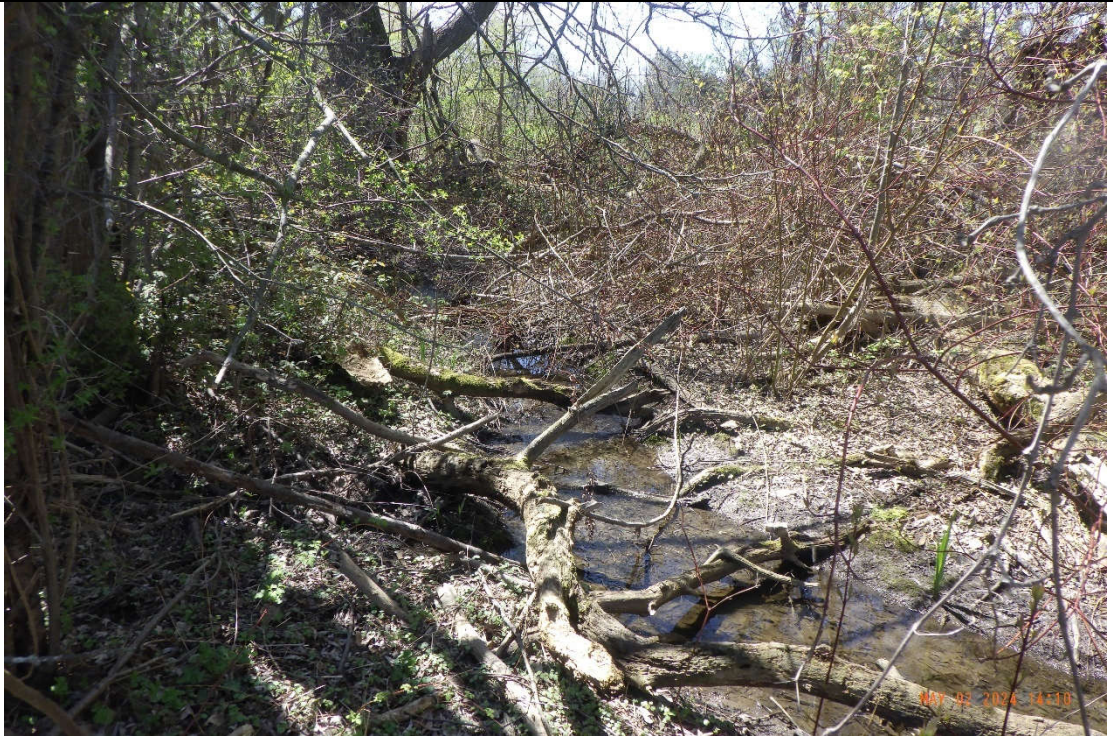
Photo 28
Tributary of the Alloa Drain - Reach AD1-2, Caledon, Ontario

The bed and bank substrates consisted of clay/silt and sand, with organic debris on the channel bed.
