**Appendix A:
Study Area**

Reach Delineation
Alloa Secondary Plan Area
 Caledon, Ontario

**Appendix C:
Photographic Record**

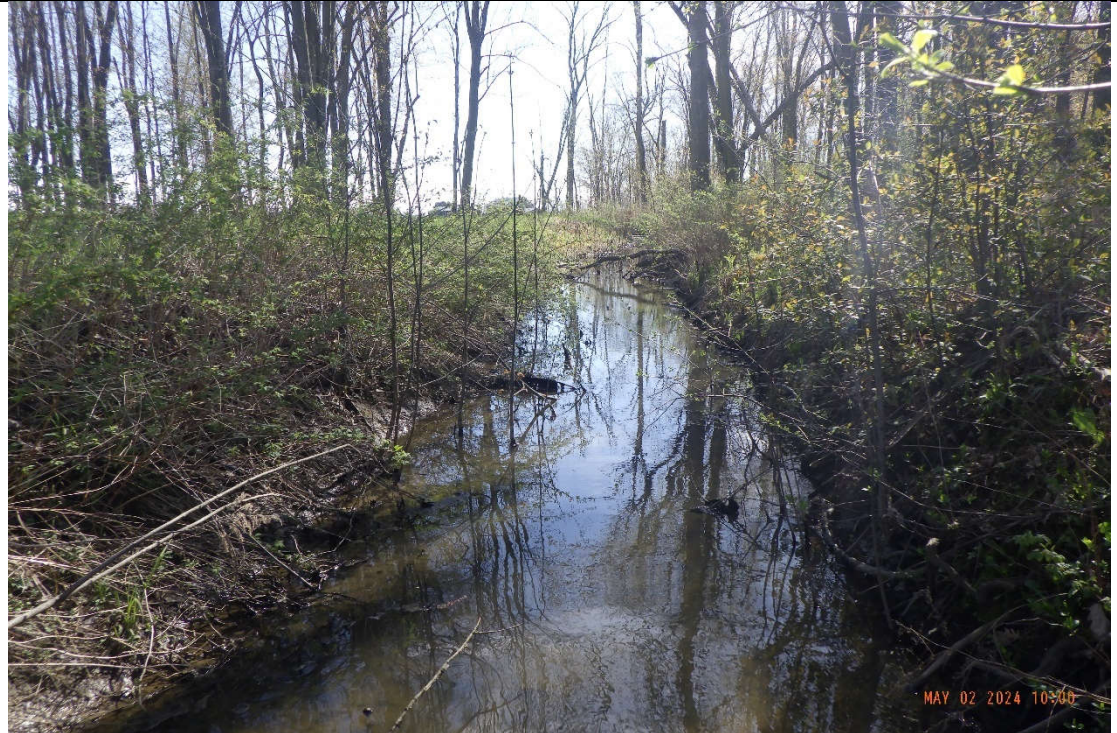
Photo 29
Fraser Drain - Reach FD1, Caledon, Ontario

The riparian vegetation consisted of mature forest on both banks in the upstream portion and along one bank in the downstream portion of the reach.

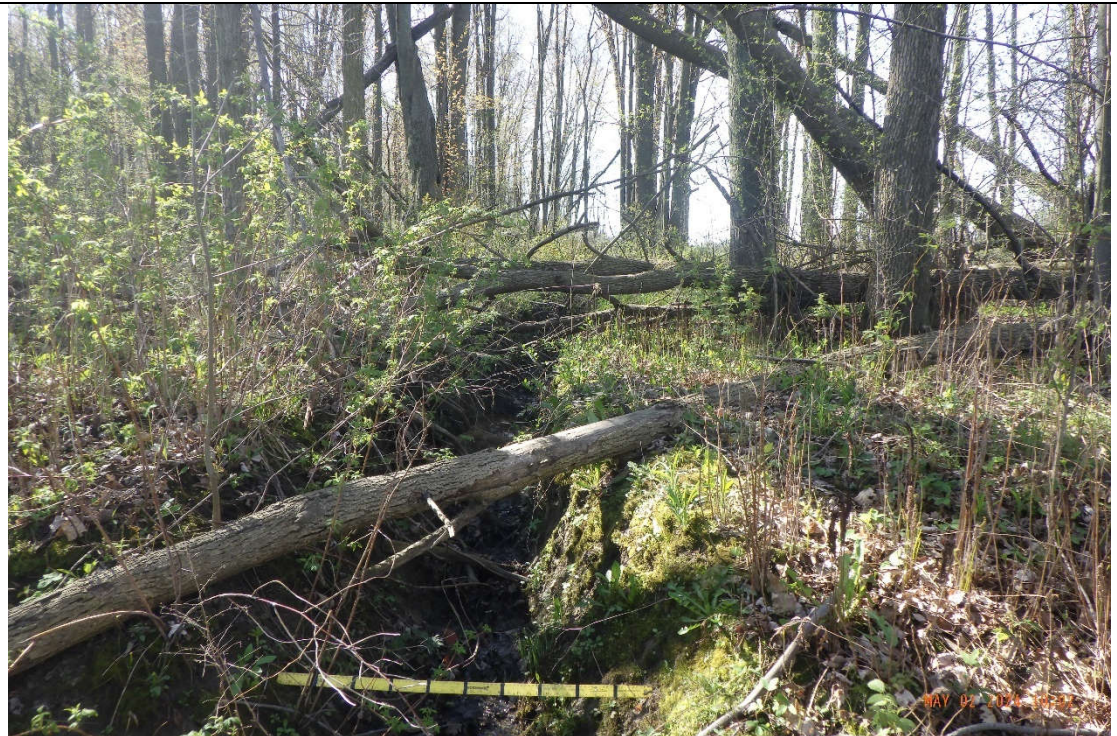
Photo 30
Fraser Drain - Reach FD1, Caledon, Ontario

Gullies were often observed along the banks but were dry at the time of the assessment.

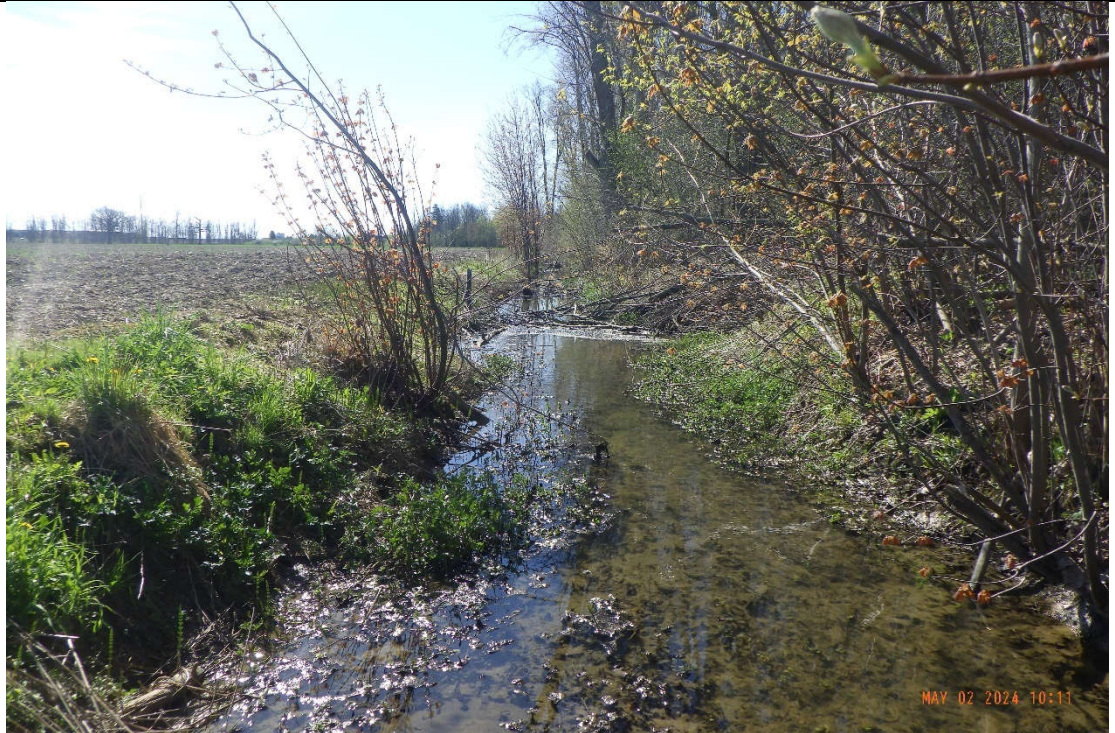
Photo 31
Fraser Drain - Reach FD1, Caledon, Ontario

Organic and woody debris were present throughout the reach.

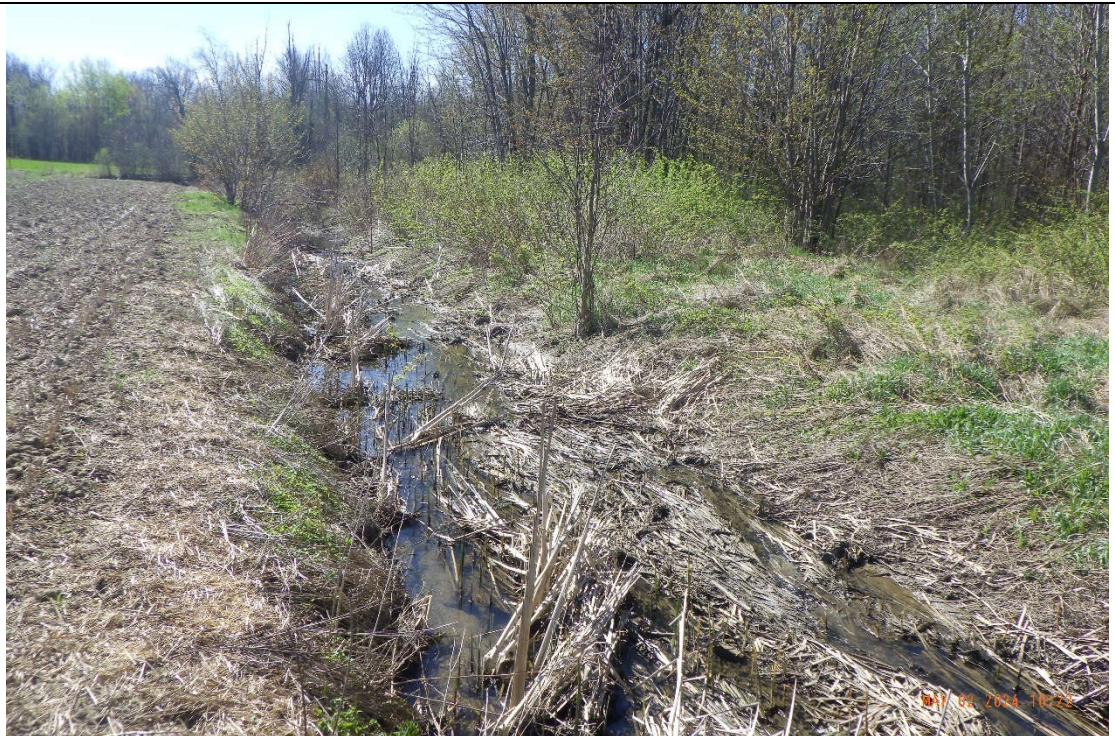
Photo 32
Fraser Drain - Reach FD1, Caledon, Ontario

Rooted emergent and submergent instream vegetation was observed, particularly in the downstream portion of the reach.

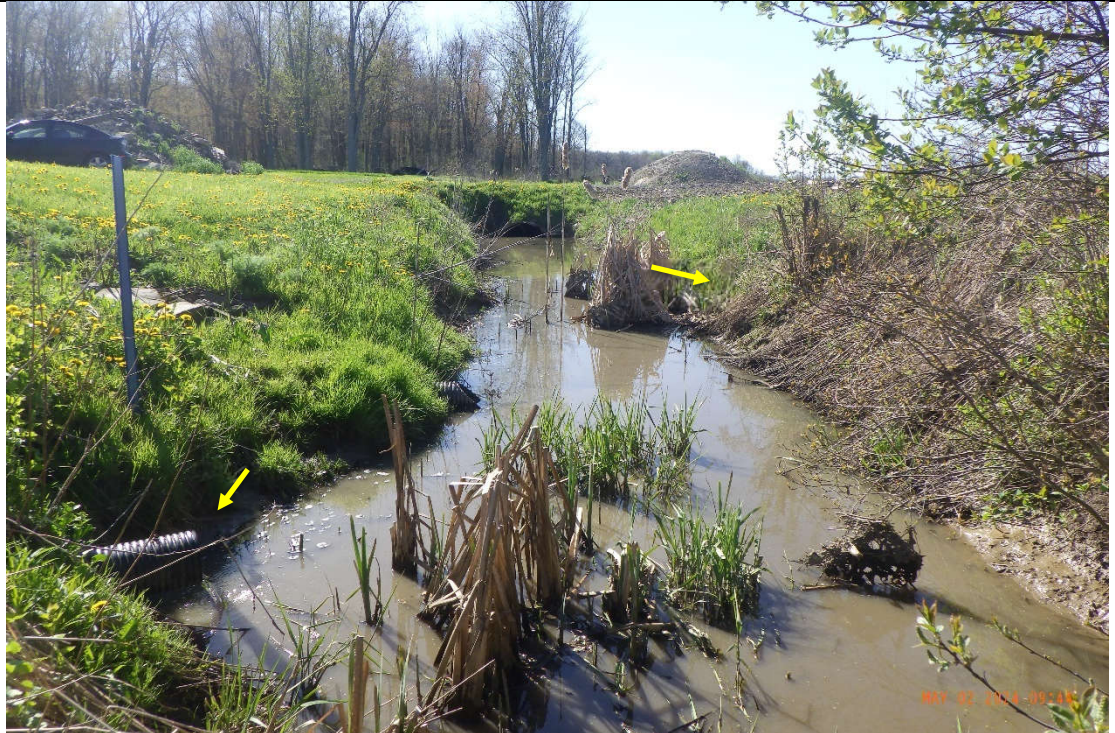
Photo 33
Fraser Drain - Reach FD2, Caledon, Ontario

Multiple features (yellow arrows) outlet into the reach, including tile drains and HDF Reach FD2-1.

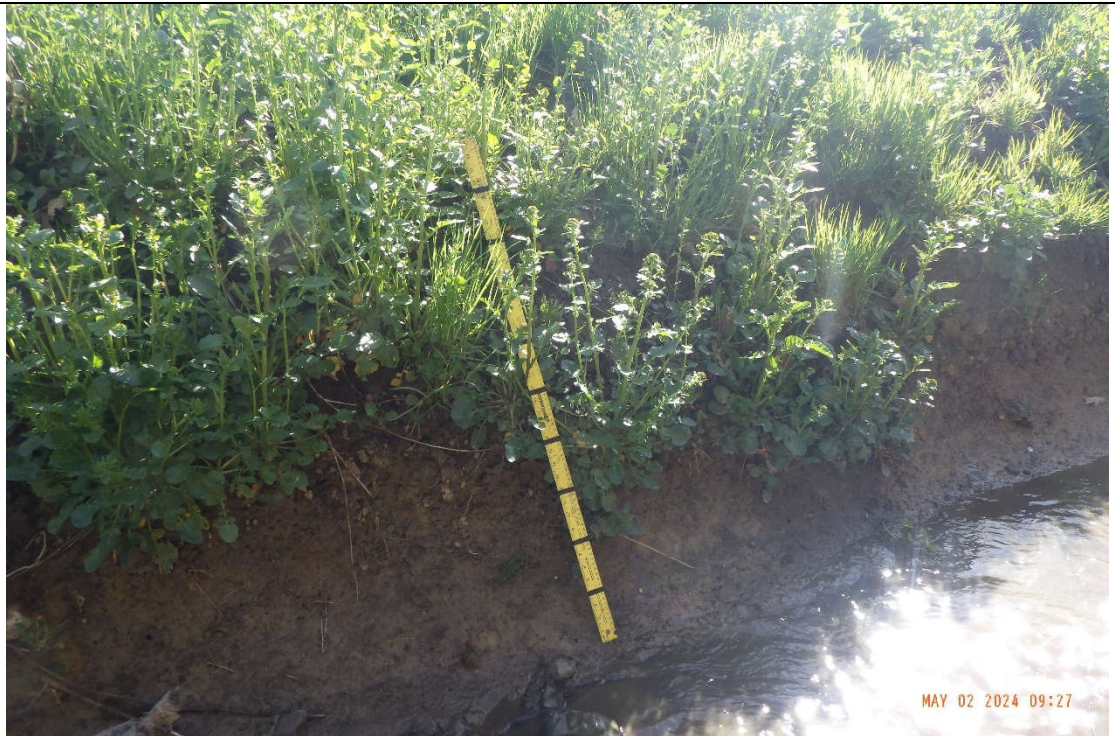
Photo 34
Fraser Drain - Reach FD2, Caledon, Ontario

The bank substrate consisted of clay/silt and sand. Bank angles ranged from 60 – 90 degrees.

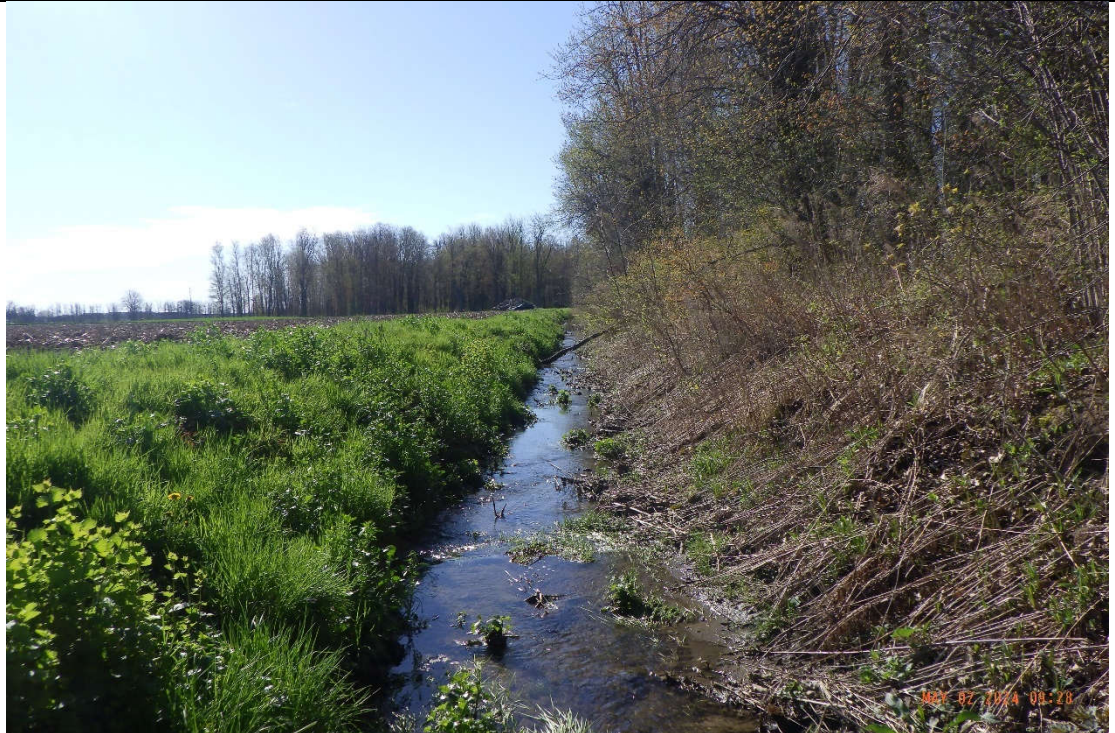
Photo 35
Fraser Drain - Reach FD2, Caledon, Ontario

The reach was a straight channel with moderate entrenchment and lacked bar forms.

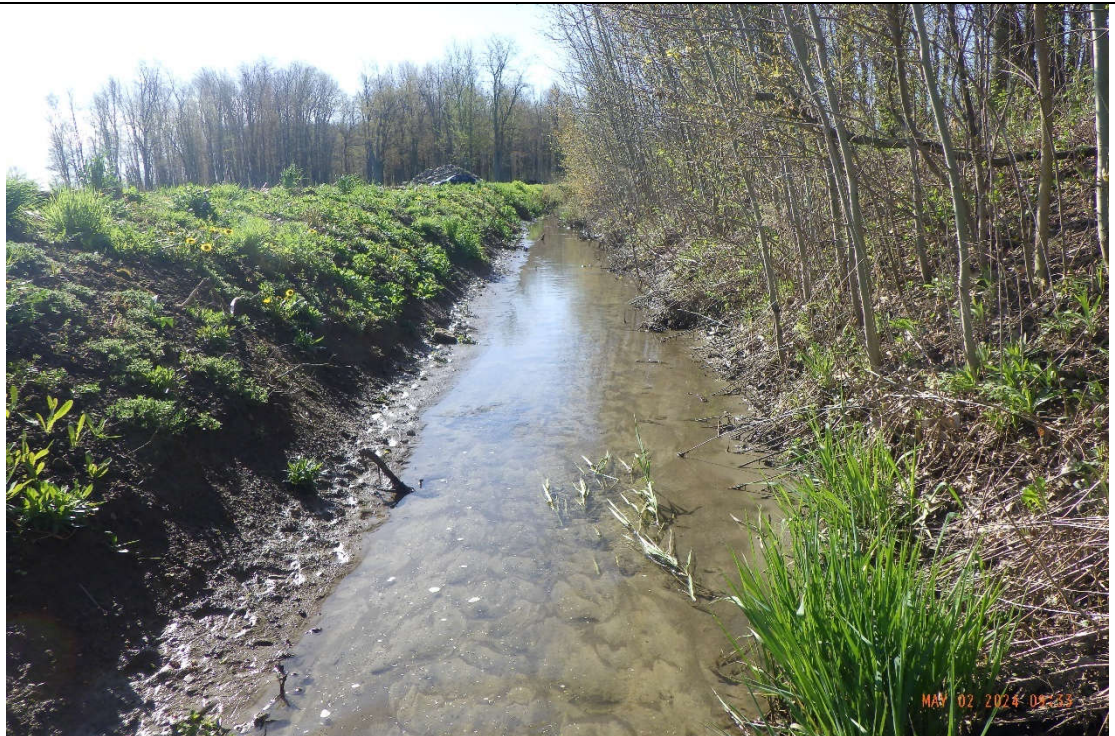
Photo 36
Fraser Drain - Reach FD2, Caledon, Ontario

The reach was run-dominant, with riffles observed along approximately 20% of the reach. The substrate within the riffles was primarily composed of gravel and cobbles.

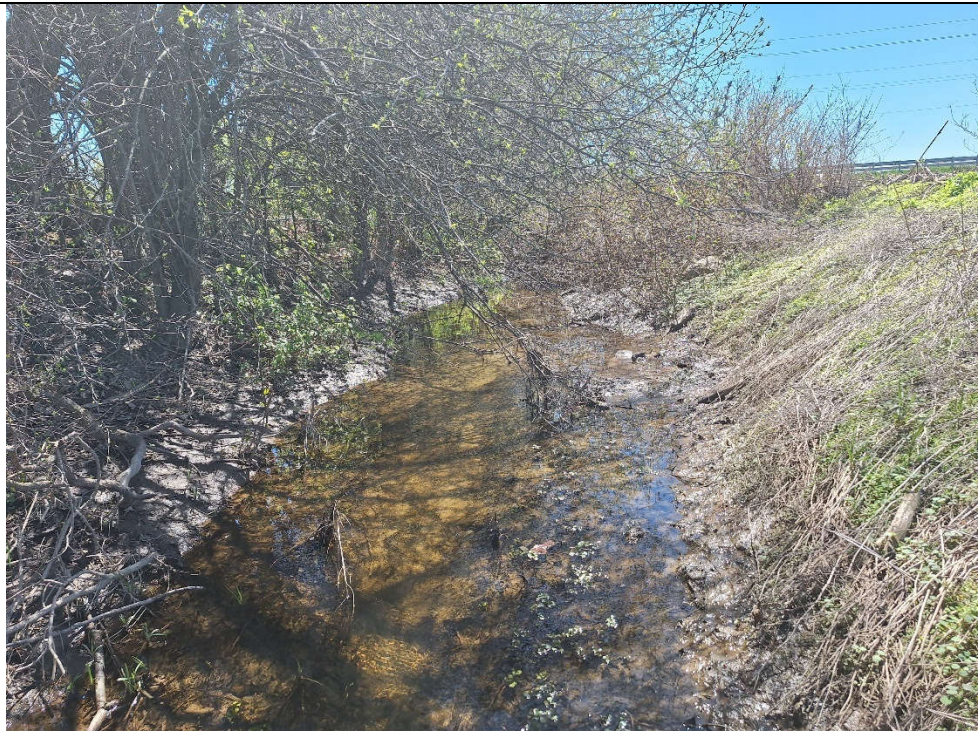
Photo 40
Lyons Drain - Reach LD1, Caledon, Ontario

The reach was short and contained a straight channel that had minimal erosion and moderate entrenchment.

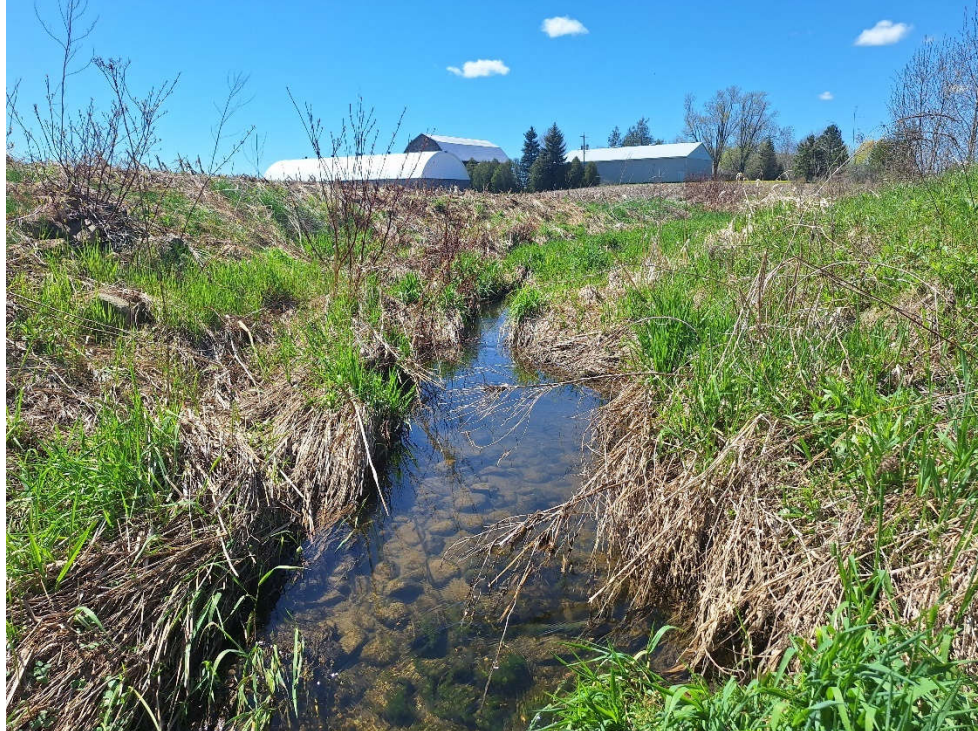
Photo 41
Lyons Drain - Reach LD2, Caledon, Ontario

The reach was generally run-dominant with riffles present along approximately 30% of the reach. The riffles substrate was composed of clay, silt, gravel, and cobbles.

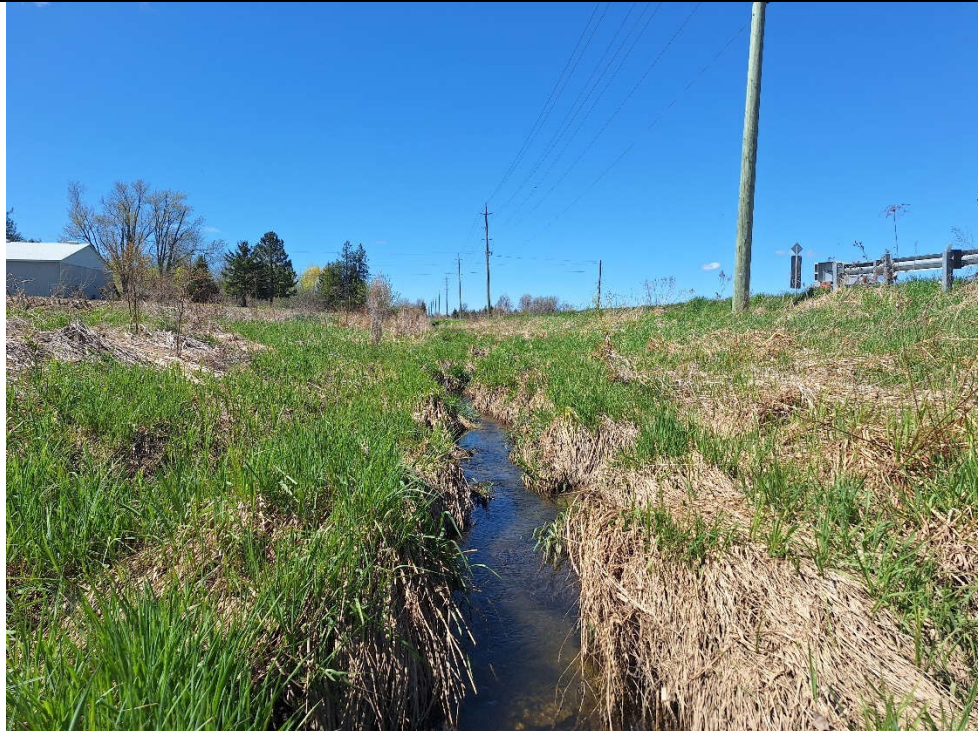
Photo 42
Lyons Drain - Reach LD2, Caledon, Ontario

Undercutting was observed throughout the reach and measured up to 0.55 m.

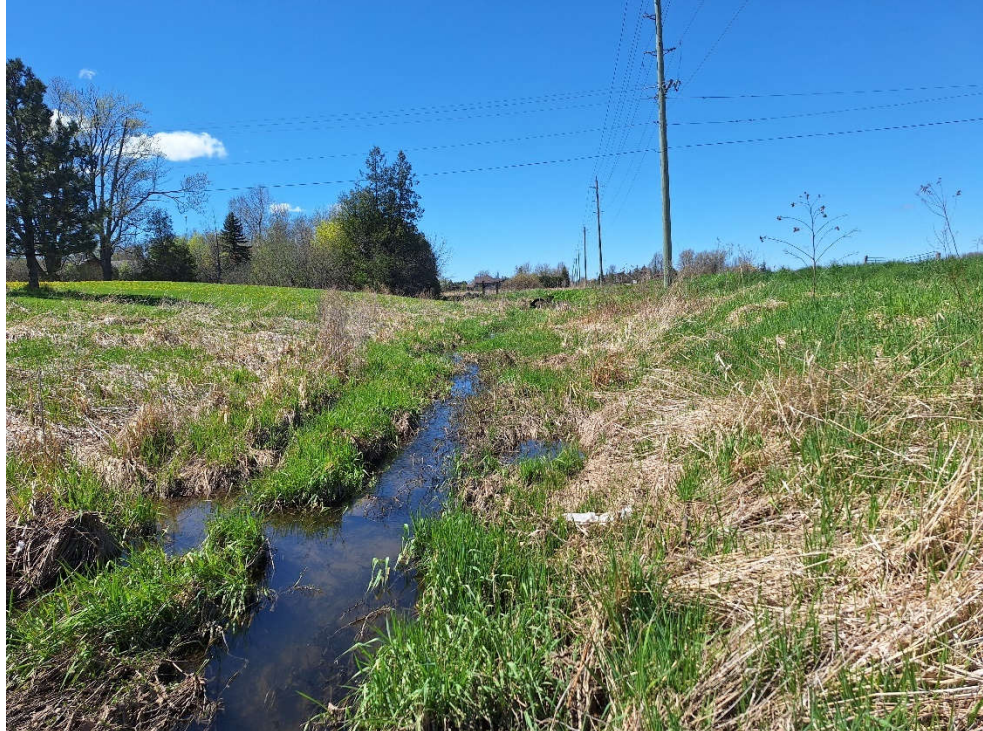
Photo 43
Lyons Drain - Reach LD2, Caledon, Ontario

Multiple flow paths were observed in some locations.

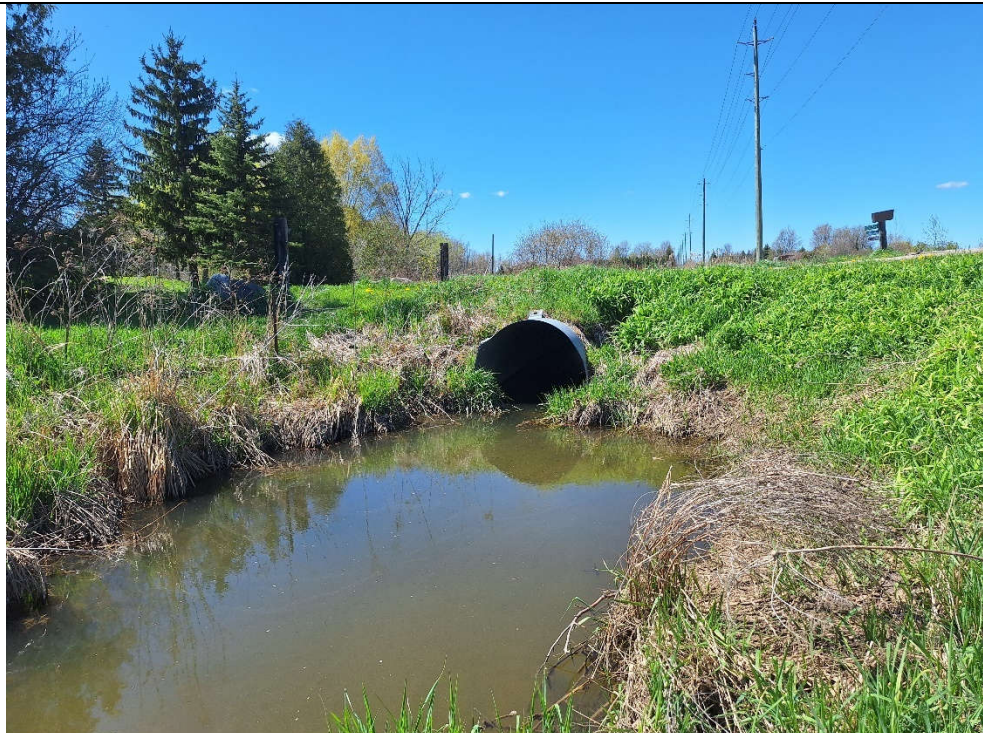
Photo 44
Lyons Drain - Reach LD2, Caledon, Ontario

A scour pool was present downstream of the culvert at the upstream reach break.

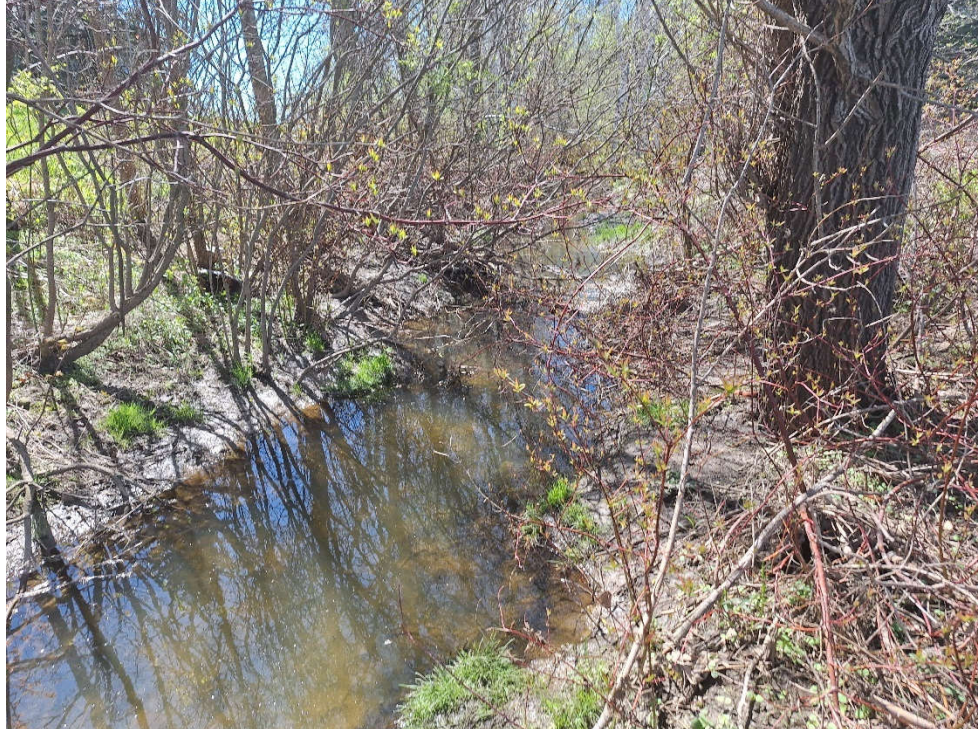
Photo 45
Lyons Drain - Reach LD3, Caledon, Ontario

The riparian vegetation consisted of a mature forest on both banks in the downstream portion and along one bank in the upstream portion of the reach.

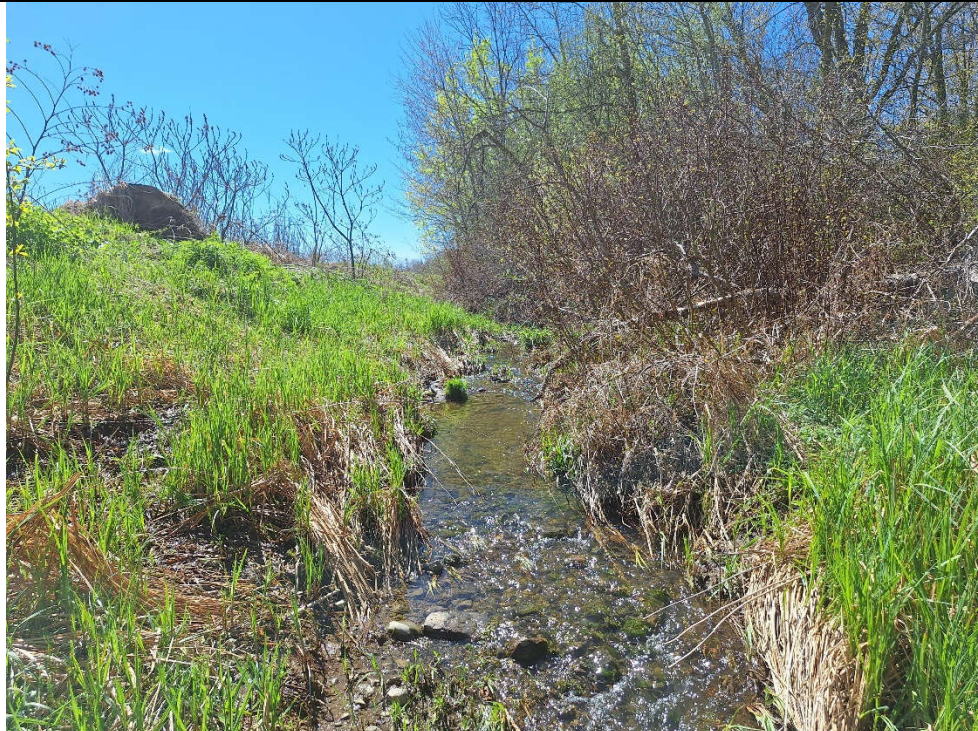
Photo 46
Lyons Drain - Reach LD3, Caledon, Ontario

A few riffles were present and were composed primarily of gravel and cobbles; however, runs were dominant.

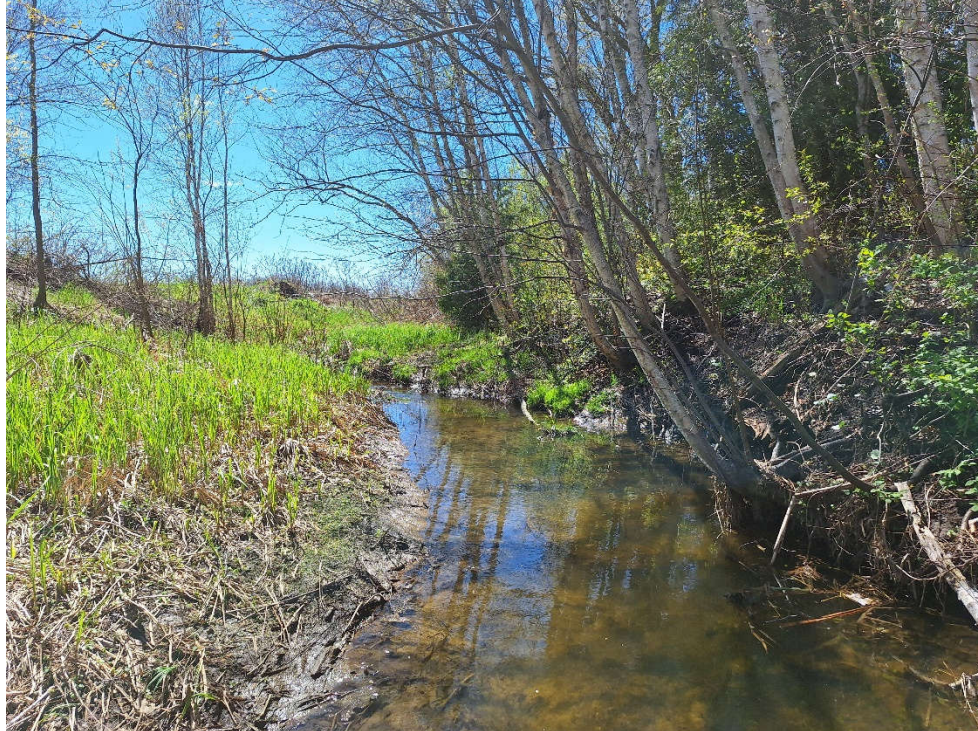
Photo 47
Lyons Drain - Reach LD3, Caledon, Ontario

Localized areas of erosion and undercutting were present primarily mid-reach. Undercuts measured up to 0.54 m.

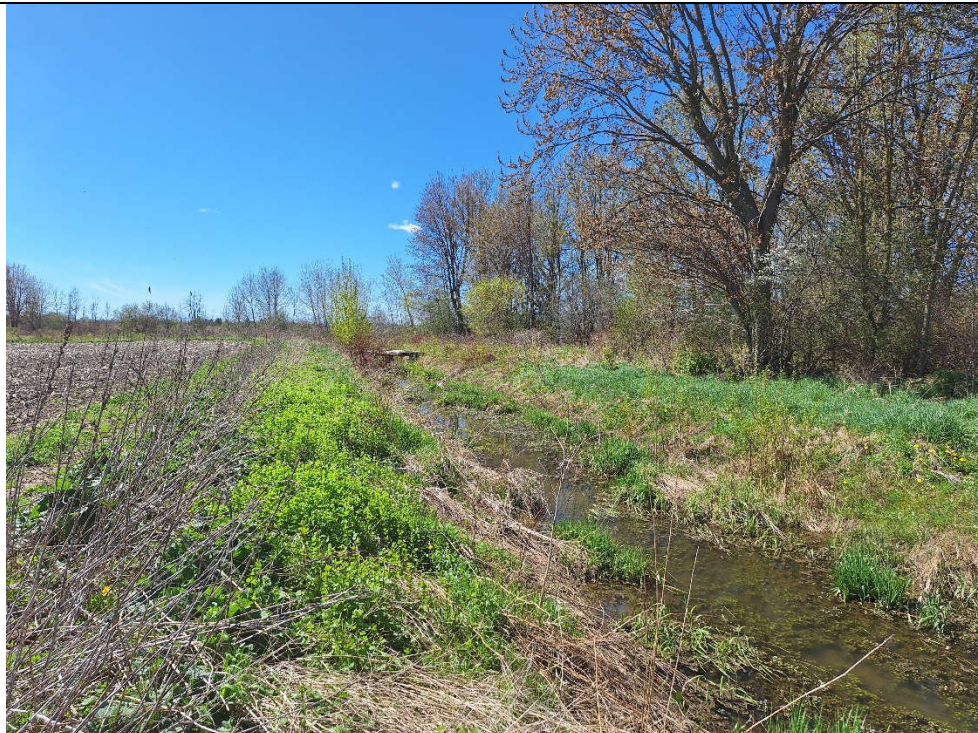
Photo 48
Lyons Drain - Reach LD3, Caledon, Ontario

The channel banks were steep and high in the upstream portion of the reach. Lower bank angles were present in the downstream portion of the reach.

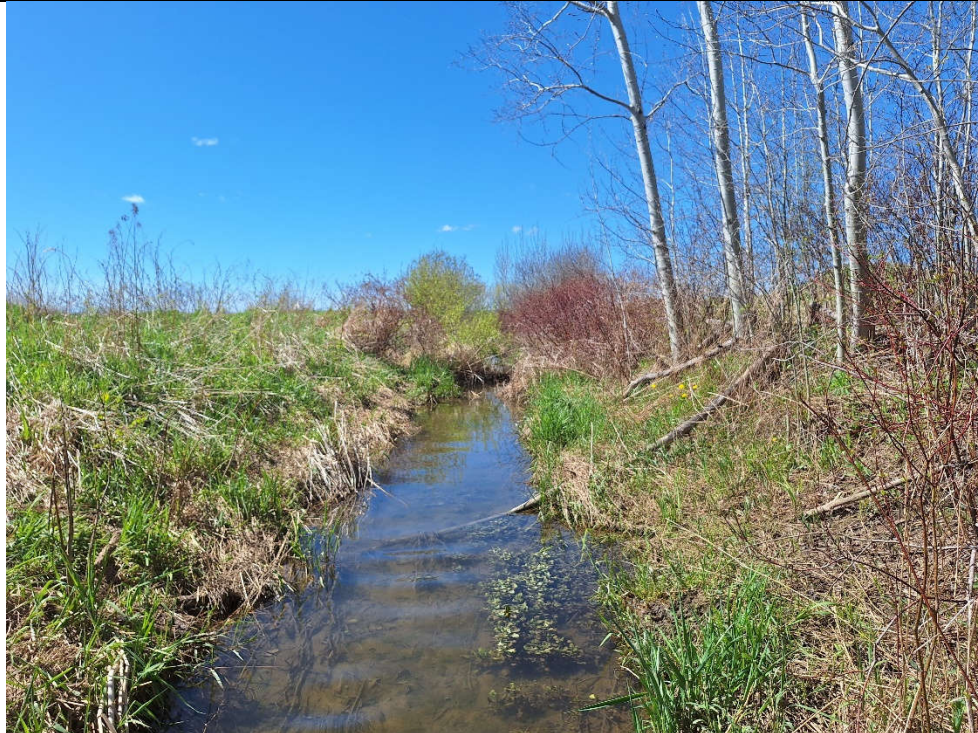
Photo 49
Lyons Drain - Reach LD4, Caledon, Ontario

This reach was relatively short and contained a straight channel with a low gradient and was moderately entrenched.

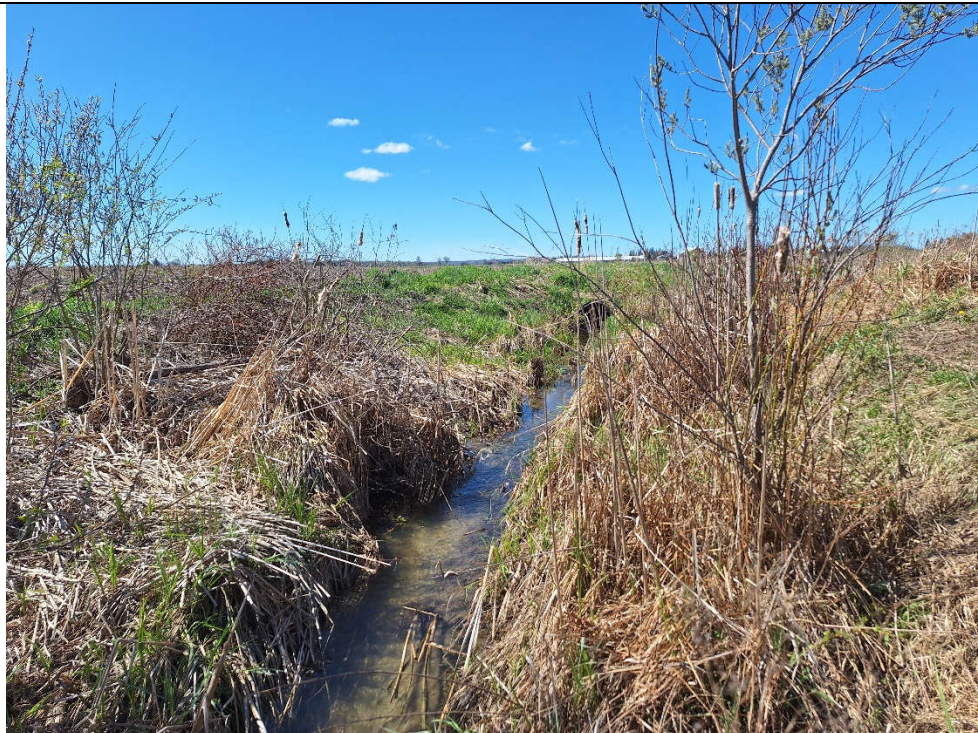
Photo 50
Lyons Drain - Reach LD4, Caledon, Ontario

Rooted emergent and submergent instream vegetation was present along approximately 35% of the reach.

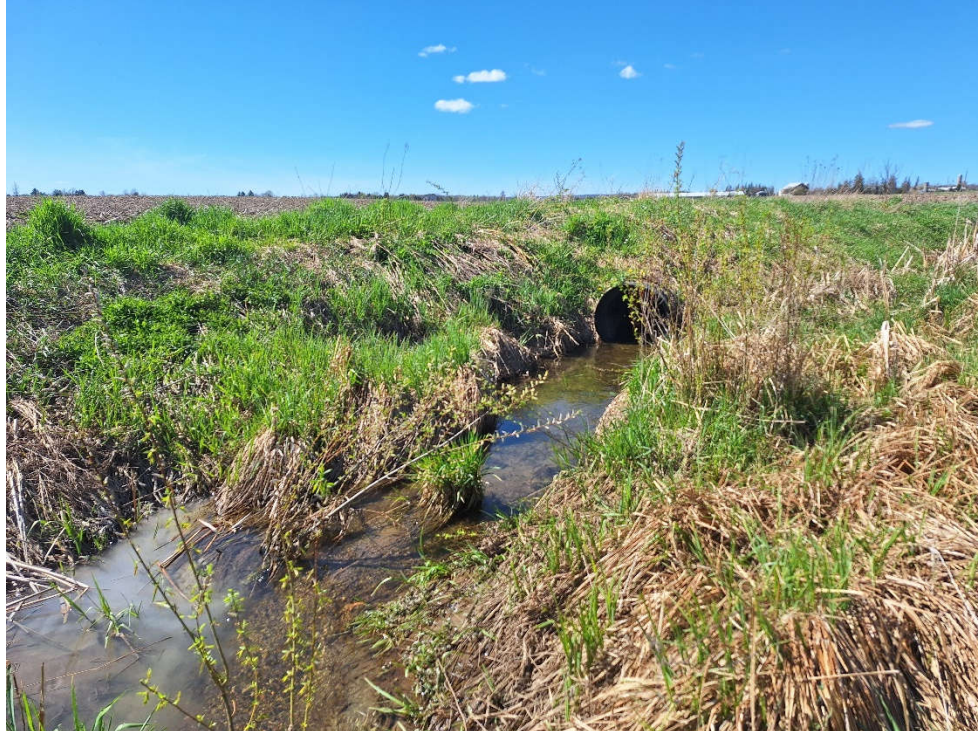
Photo 51
Lyons Drain - Reach LD4, Caledon, Ontario

The riparian vegetation primarily consisted of grasses with some trees. The grasses were moderately encroaching into the channel.

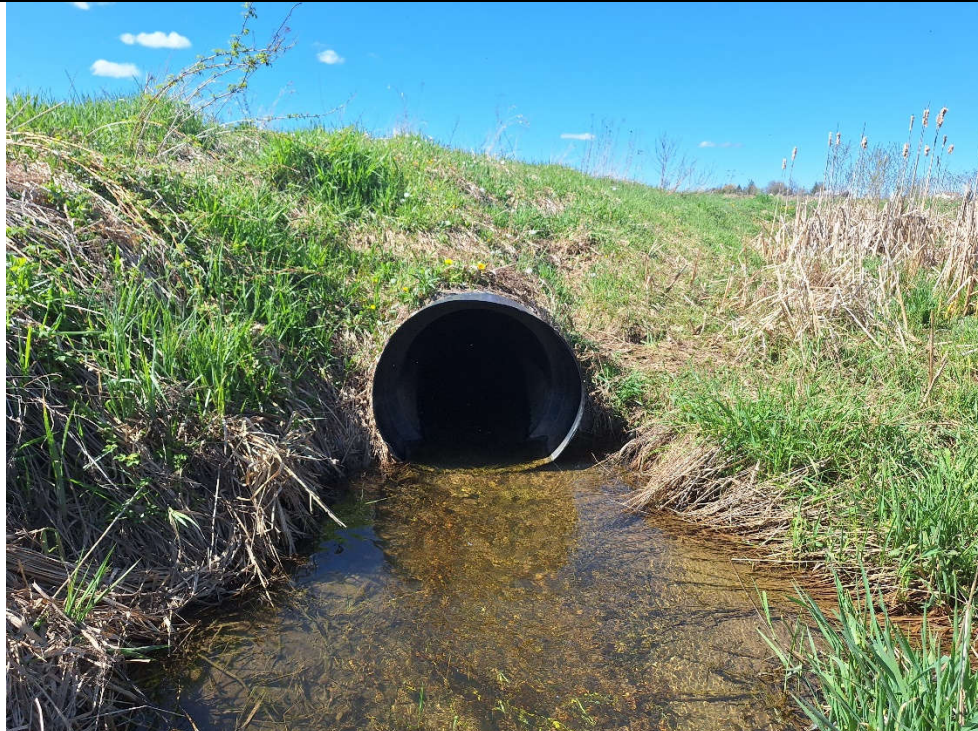
Photo 52
Lyons Drain - Reach LD4, Caledon, Ontario

A tile drain (Reach LD5) was observed to discharge at the upstream extent of the reach.

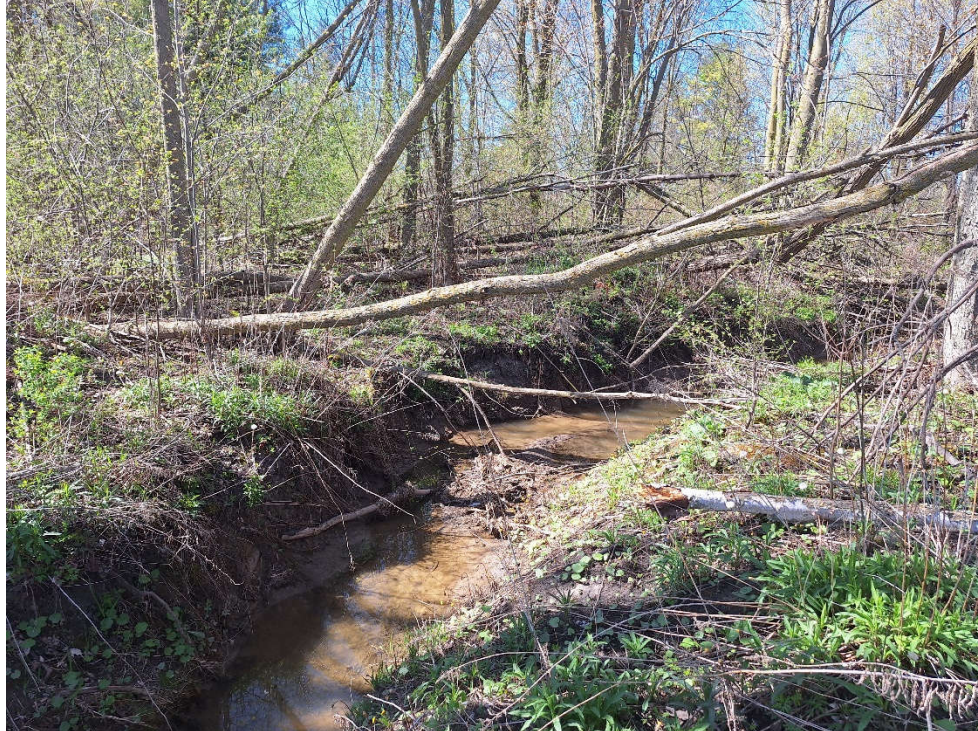
Photo 53
Lyons Drain - Reach LD4-1, Caledon, Ontario

The upstream portion of the reach had multiple leaning and fallen trees, contributing woody debris to the channel.

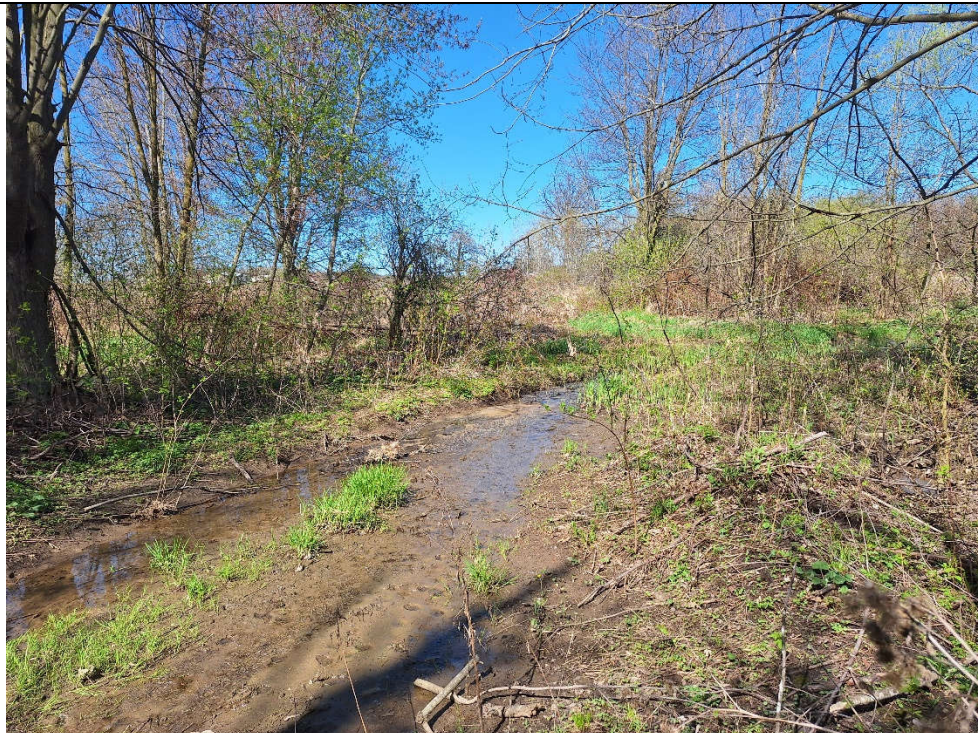
Photo 54
Lyons Drain - Reach LD4-1, Caledon, Ontario

Poor longitudinal sorting of bed materials was noted, with bed substrate ranging from clay/silt to cobbles. Accretion on point bars was also observed.

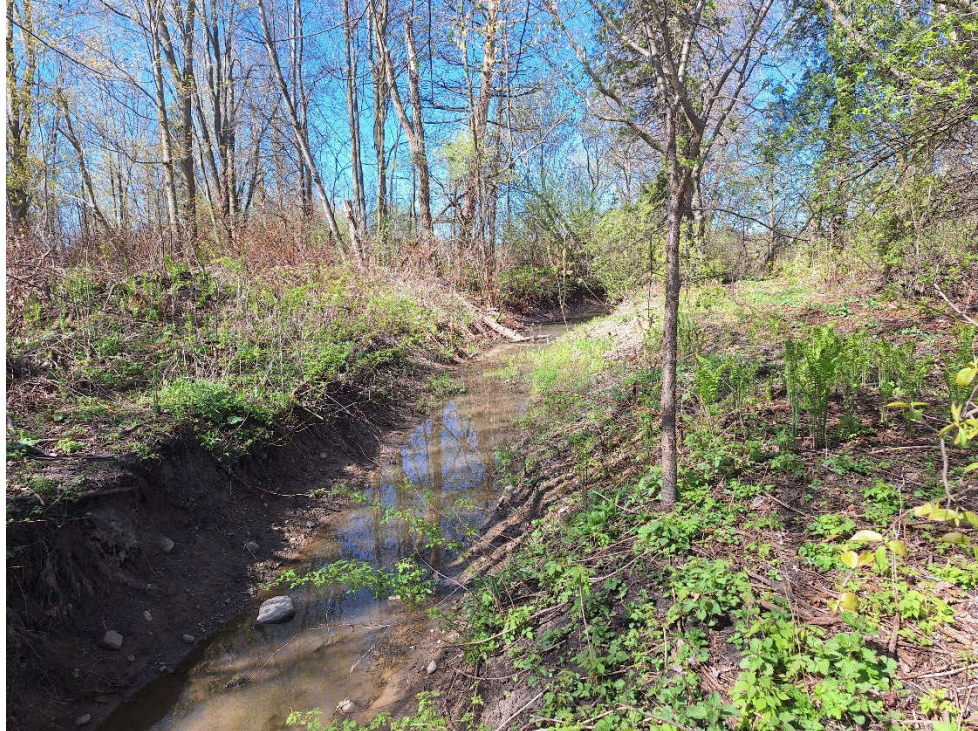
Photo 55
Lyons Drain - Reach LD4-1, Caledon, Ontario

Erosion was commonly observed along 30 – 60% of the reach, with minimal undercutting (up to 0.32 m) present.

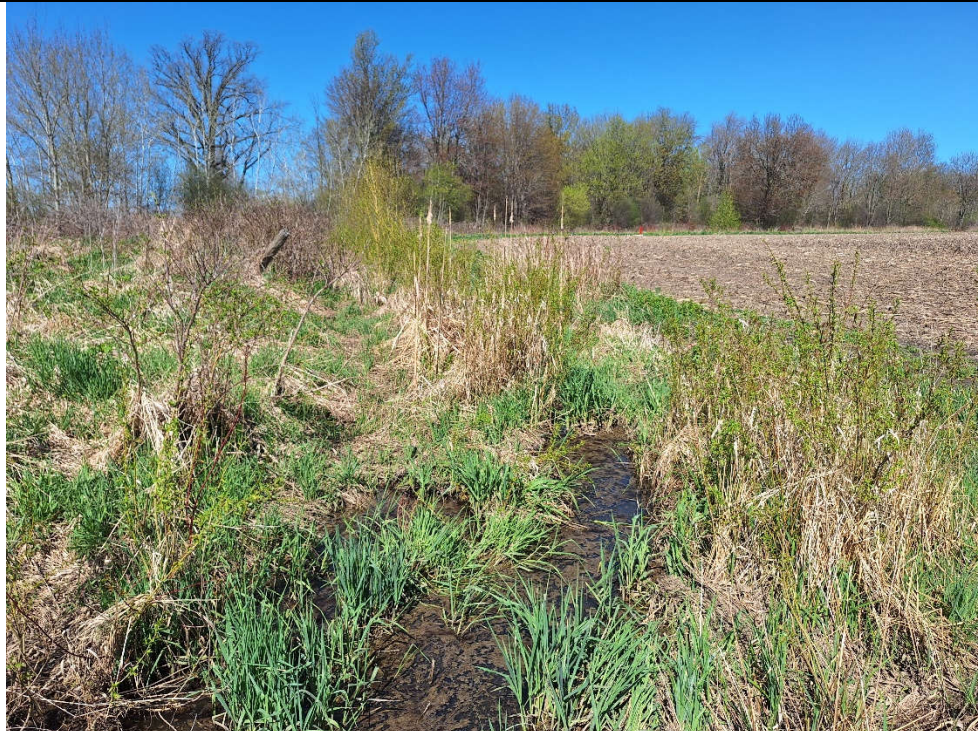
Photo 56
Lyons Drain - Reach LD4-1, Caledon, Ontario

The downstream portion of the reach was less defined, with lower bank angles ranging up to 30 degrees. Bank materials consisted of clay, silt, sand, and gravel.
