12861 Dixie Road, Caledon

Phase I Environmental Site Assessment Report

MTE Consultants Inc.
1016 Sutton Drive, Unit A
Burlington, ON L7L 6B8

April 25, 2022

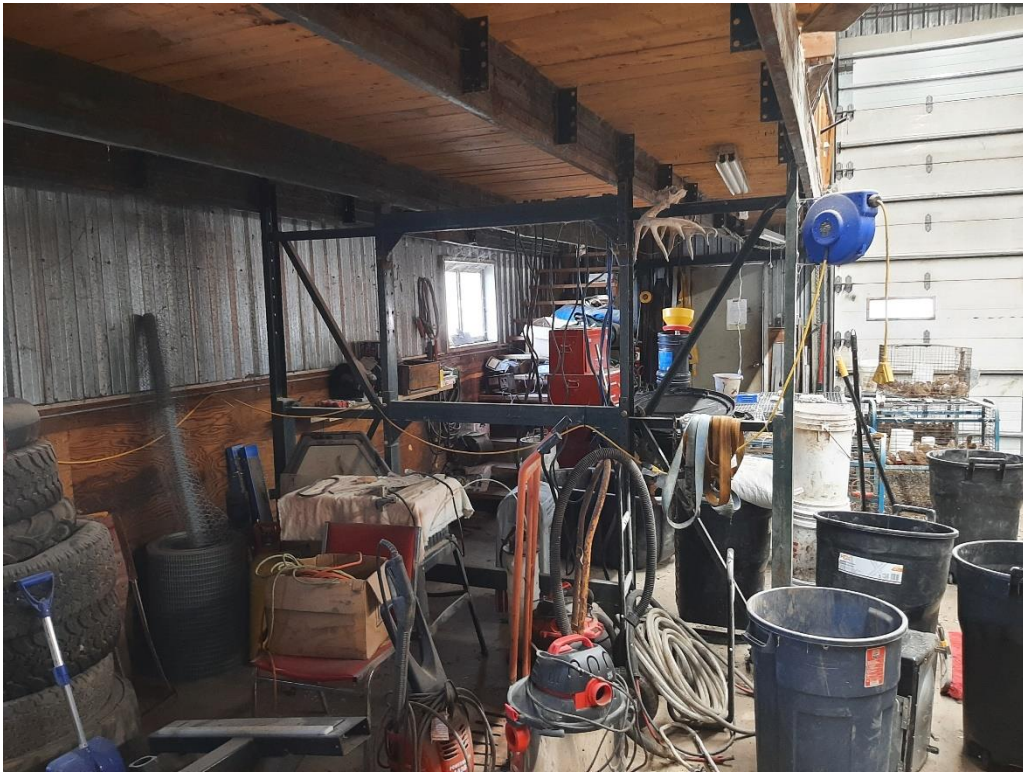
Photograph No. 11 – View of the interior of the workshop.

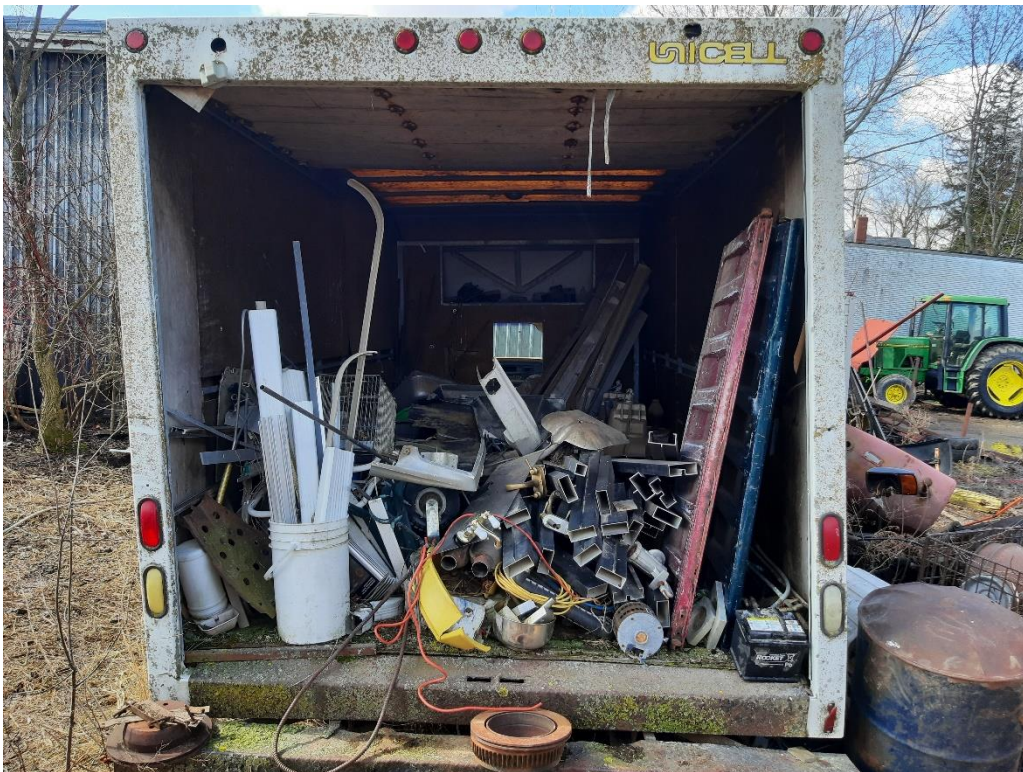
No hazardous wastes are currently generated on the Site. Household and agricultural waste was observed in the workshop. Scrap metal items were observed throughout the Site. Some manure was observed in the cattle yard and to the north of the storage barn. No potentially hazardous wastes were observed during the Site visit.

Photograph No. 12 – View of the miscellaneous scrap metal stored to the east of the workshop facing west.

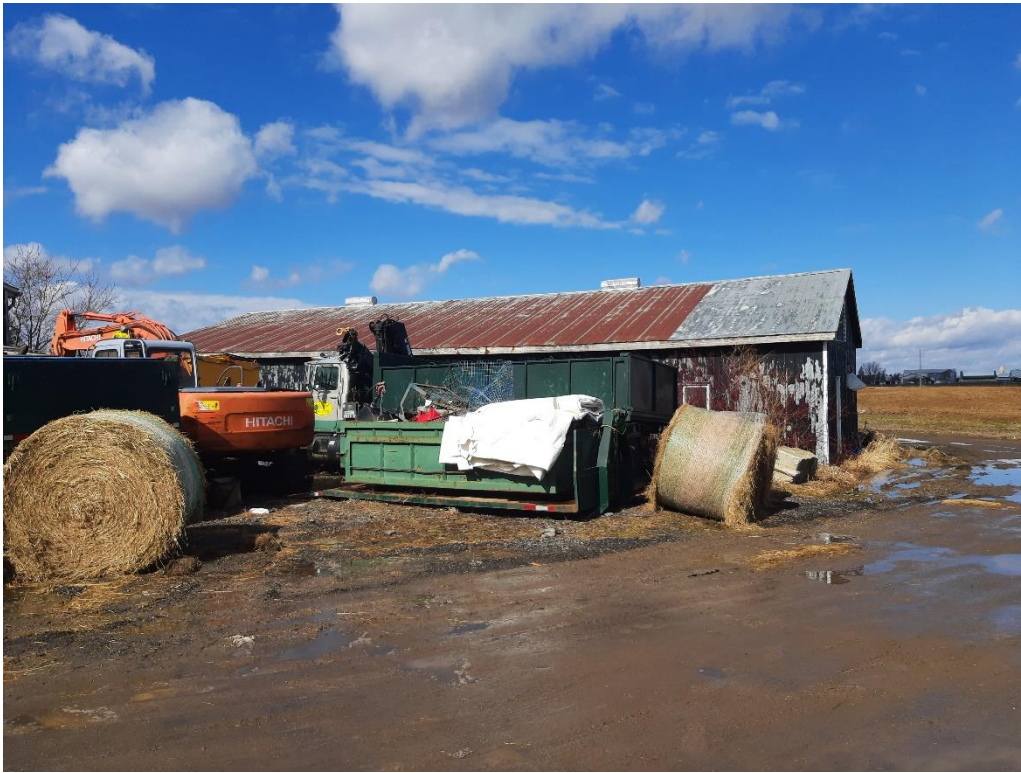
Photograph No. 13 – View of the miscellaneous scrap metal bin stored to the south of the north storage barn, facing north.

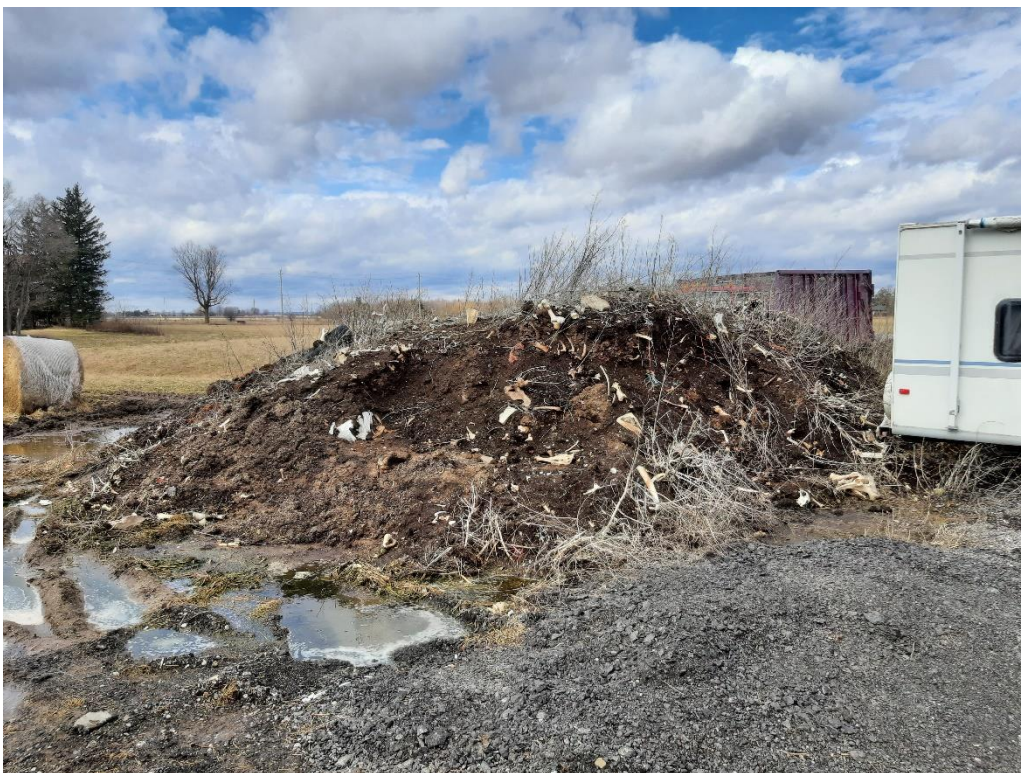
Photograph No. 14 – Fill materials adjacent to the north of the storage shed, facing northwest. The source of the fill is not known.

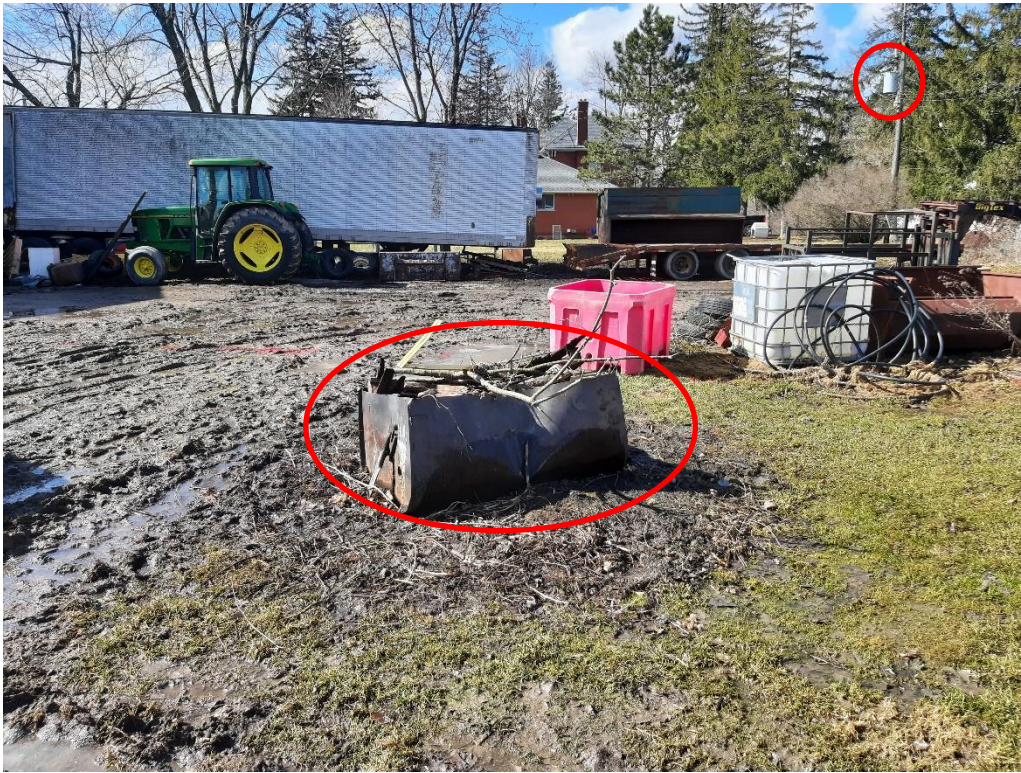
A pole mounted transformer is located centrally on Site east of the farmhouse and south of the southeast corner of the storage shed. No other suspected PCB-containing equipment was observed during the Site visit.

Photograph No. 15 – View of the fire pit in a half cut out steel barrel at the central portion of the Site and the pole mounted transformer, facing west.

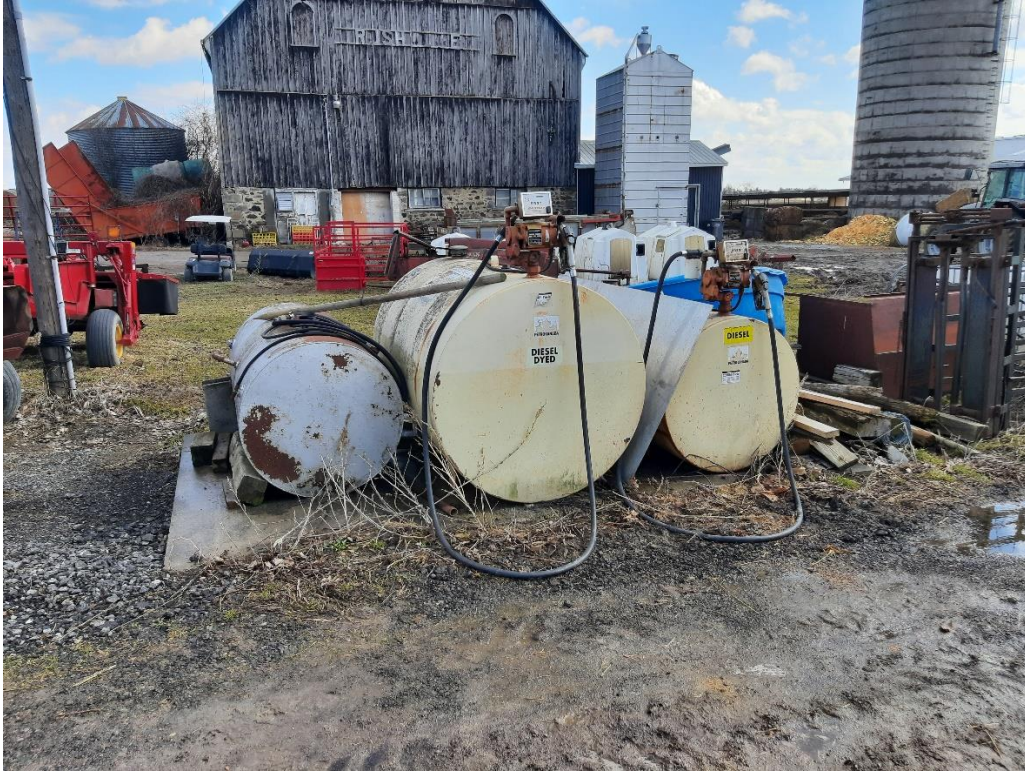
- A 1,360L active dyed diesel tank;
 - A 1,360L inactive dyed diesel tank; and
 - A 2,200L active dyed diesel tank.
- A former in-ground pool was located to the south of the farmhouse that was historically backfilled. The foundation/slab are reportedly still in place.

Photograph No. 17 – View of the 2,200L dyed diesel AST in use and two 1,360L dye diesel ASTs facing east from the gravel driveway.

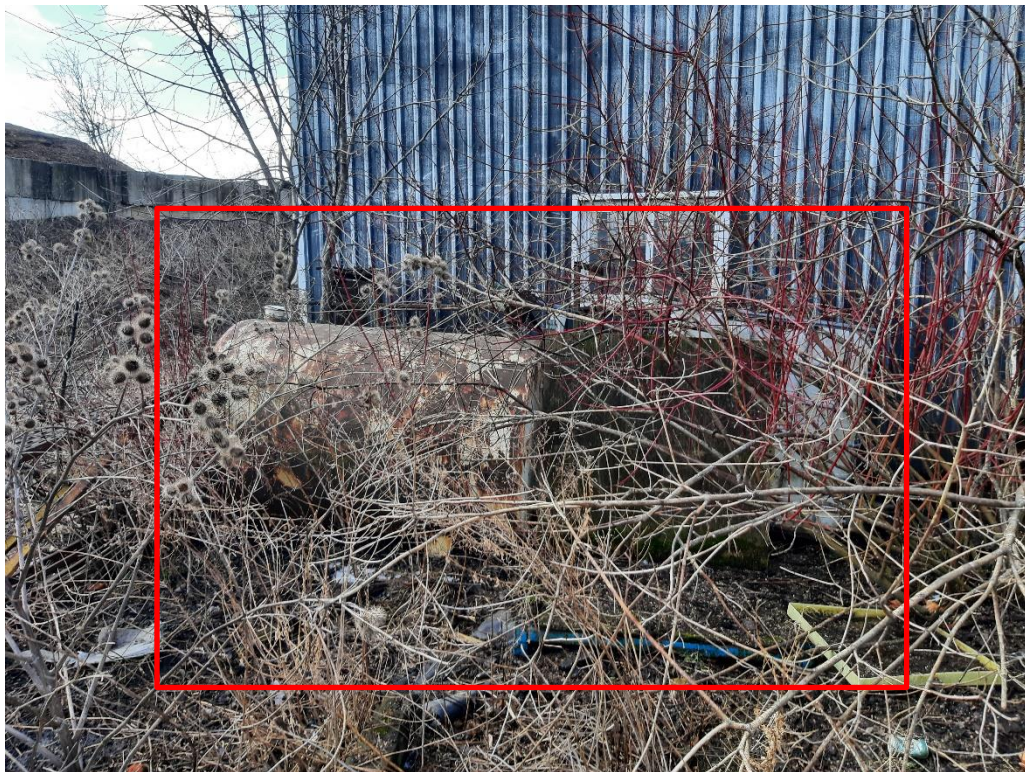
It is noted that two abandoned ASTs are observed west adjacent to the workshop.

Photograph No. 18 – View of the two abandoned approximately 2,200L ASTs, unknown content, located adjacent the workshop building, facing west.

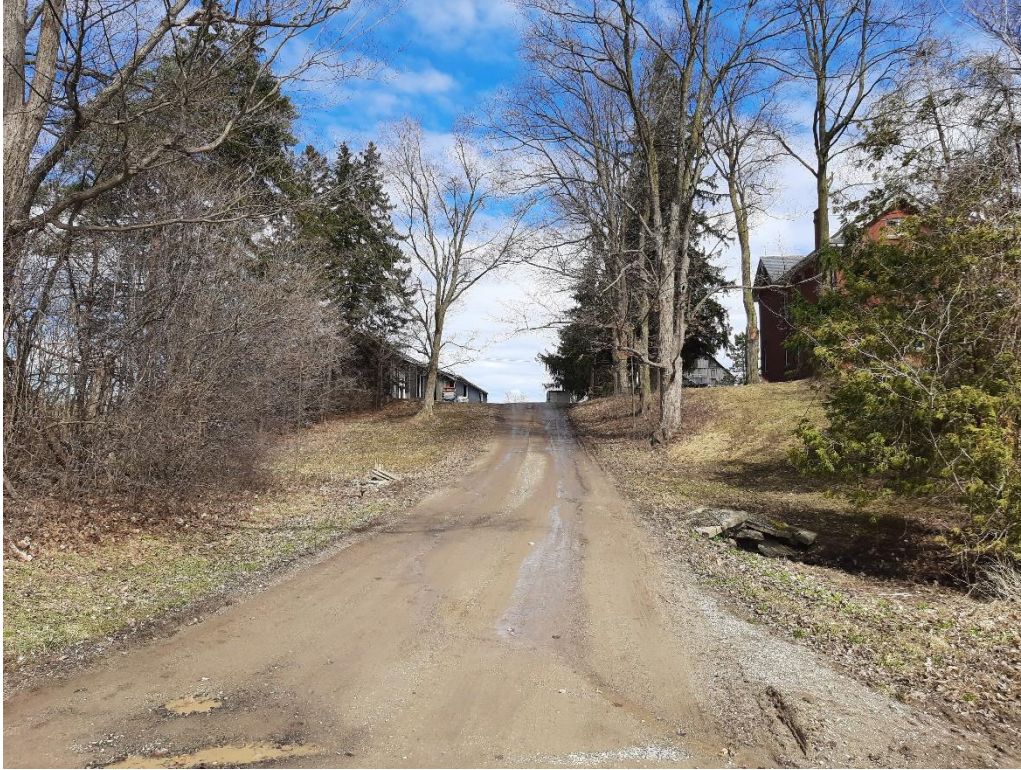
Photograph No. 19 – View of the reported area of de-icing salt application to the hill up the driveway, facing east.

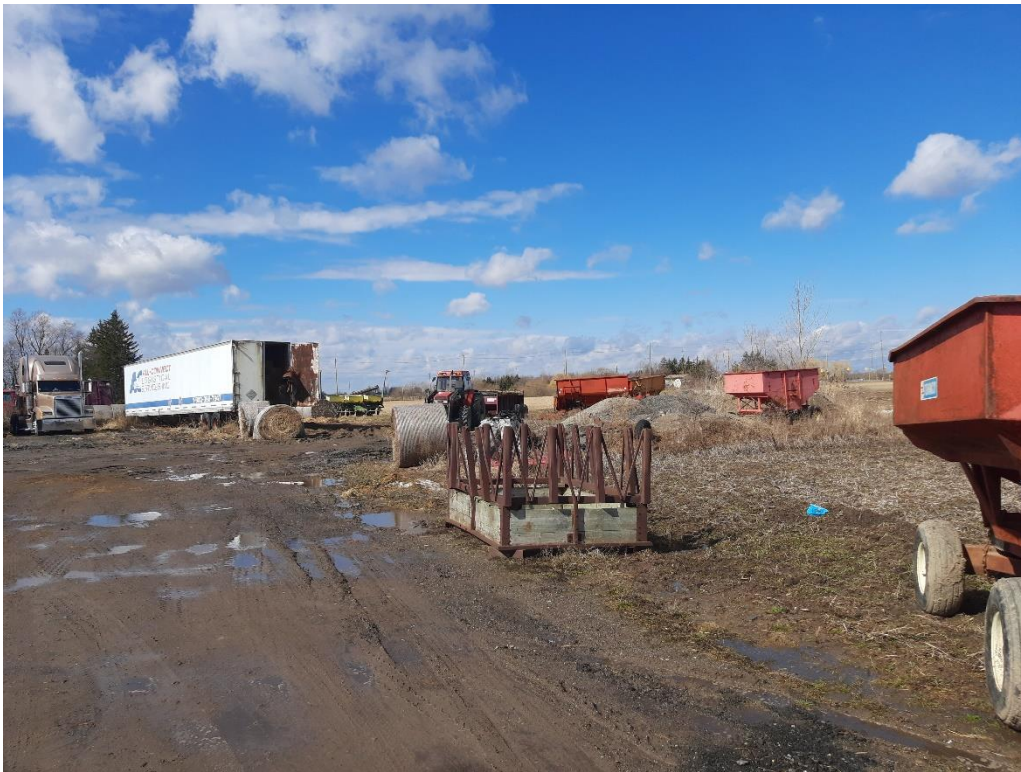
Photograph No. 20 – View of unknown fill piles and the agricultural fields on the Site, facing north.
