**Due Diligence
Geotechnical and Hydrogeological
Assessment Report
Mayfield Golf Course Redevelopment
Caledon, Ontario**

GEMTEC Project: 101987.001(2)

September 26, 2024
GEMTEC Project: 101987.001(2)

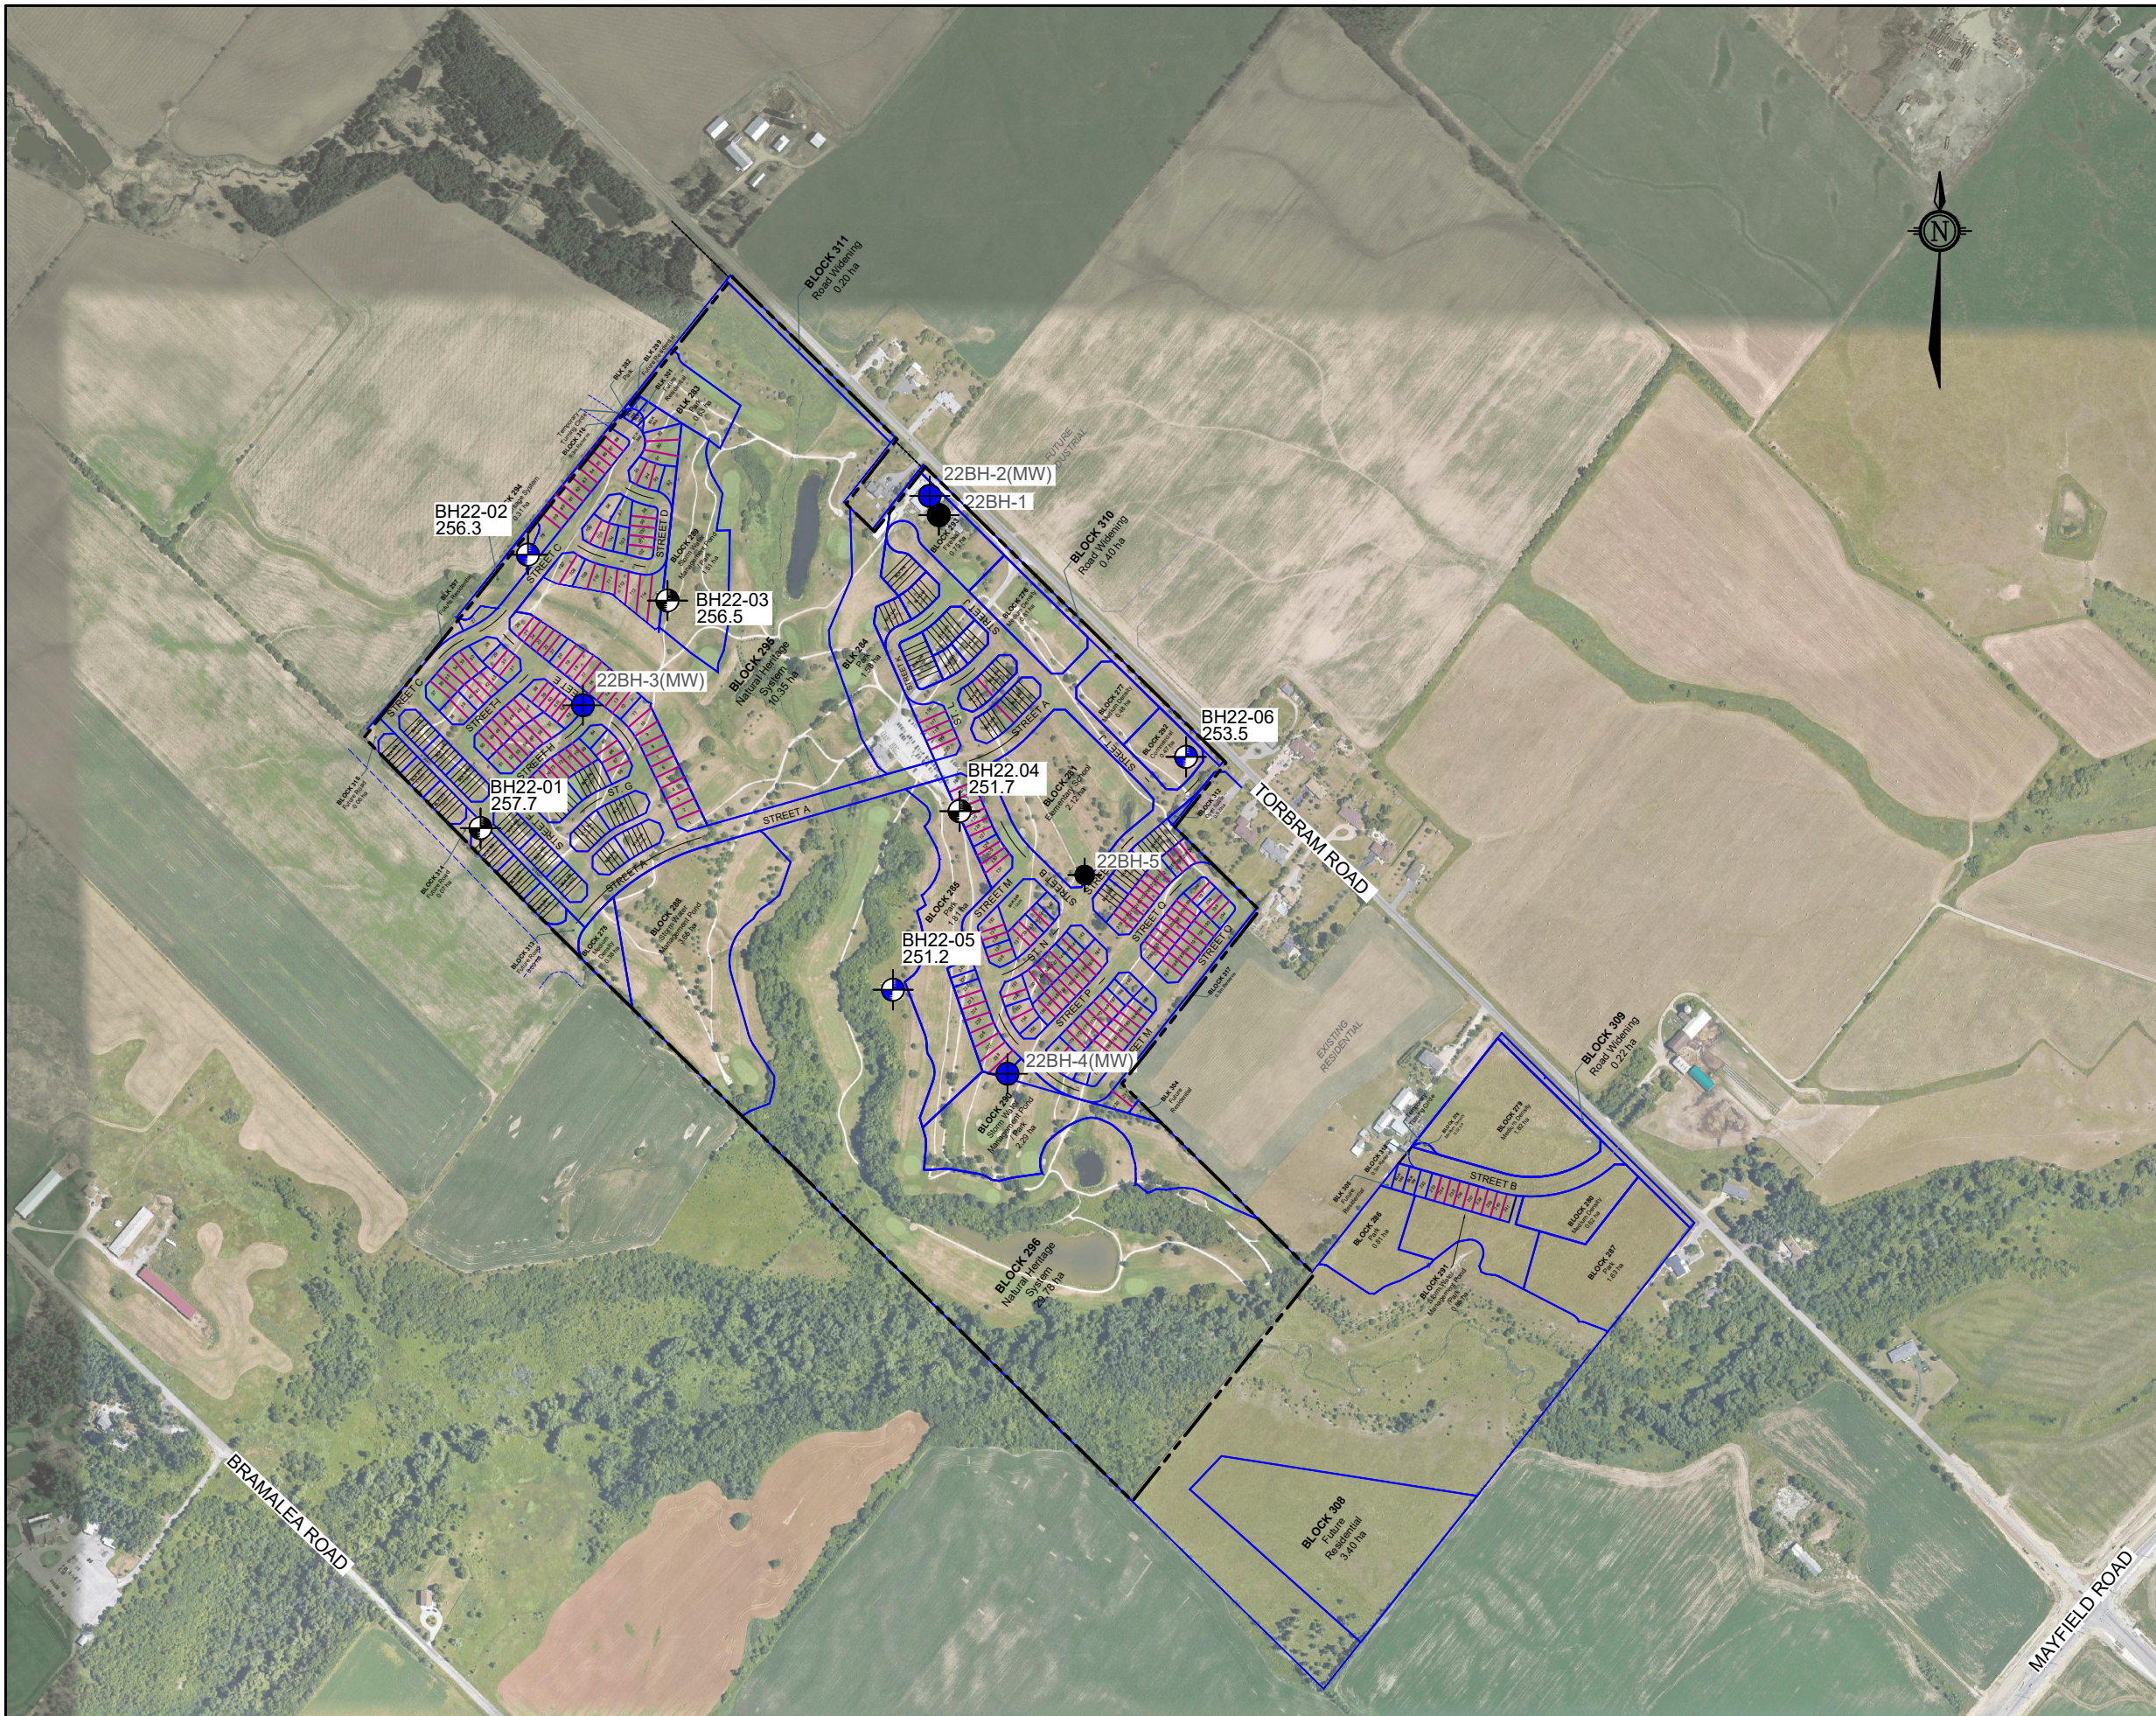
Date	OCTOBER 2024	Rev.	0	FIGURE 1
------	--------------	------	---	-----------------

Drwn by	Chkd by	BOREHOLE LOCATION PLAN	
SJ/ S.L.	D.M.F.

The field work for this investigation was carried out on July 12 and 13, 2022. At that time, six boreholes, noted as Boreholes 22-1 to 22-6, were advanced at the site to depths ranging between about 7.8 m and 8.1 m bgs.

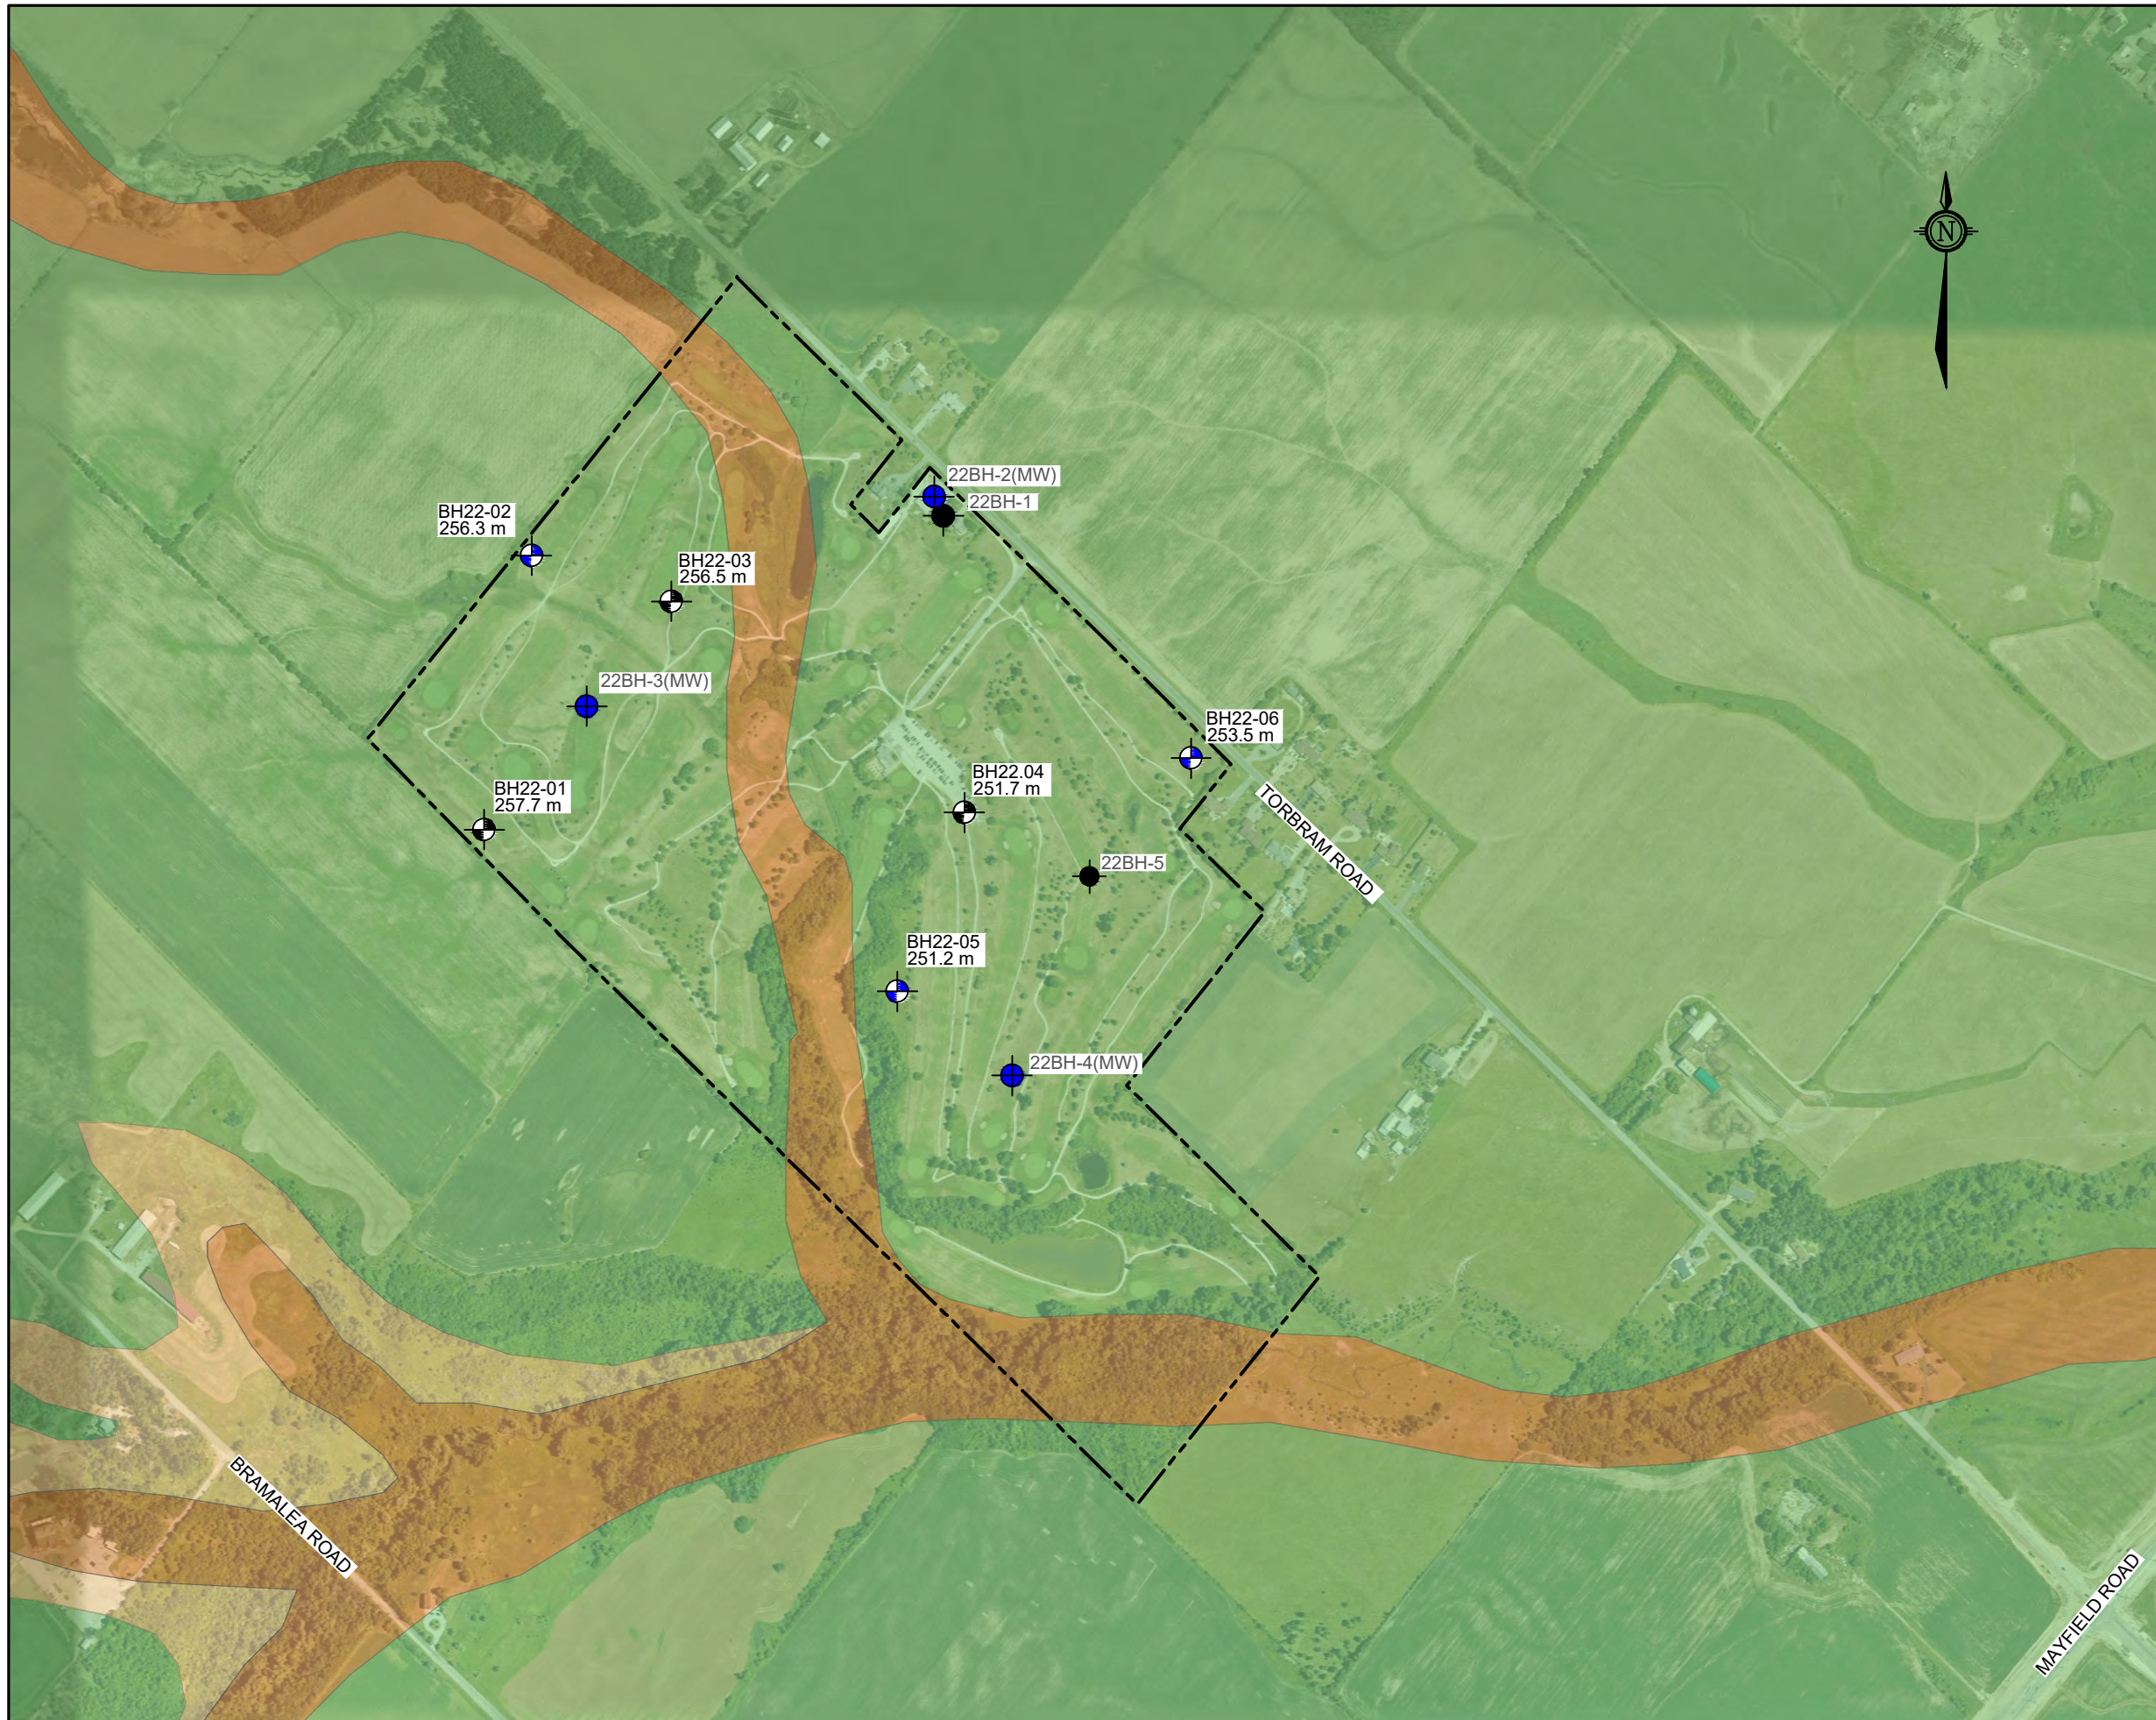
Date AUGUST 2022	Rev. 0	FIGURE 2
---------------------	-----------	-----------------

Drwn by S.L.	Chkd by D.M.F.	SURFICIAL GEOLOGY
-----------------	-------------------	-------------------

Surficial geology maps indicate that the site is near a borderline Physiographic Region between the South Slope and Peel Plain which typically consists of extensive clayey silt to silty clay till plains and occasional sand to silt zones. Shallow, localized deposits of loose sand / silt and / or soft clay can overlie this uppermost till sheet, and these generally represent relatively recent deposits formed in small glacial meltwater ponds scattered throughout the Peel Plain and concentrated near river valleys. The recent sand, silt, and clay as well as the upper-most till deposits in this area overlie and are interbedded with stratified deposits of sand, silt, and clay, all

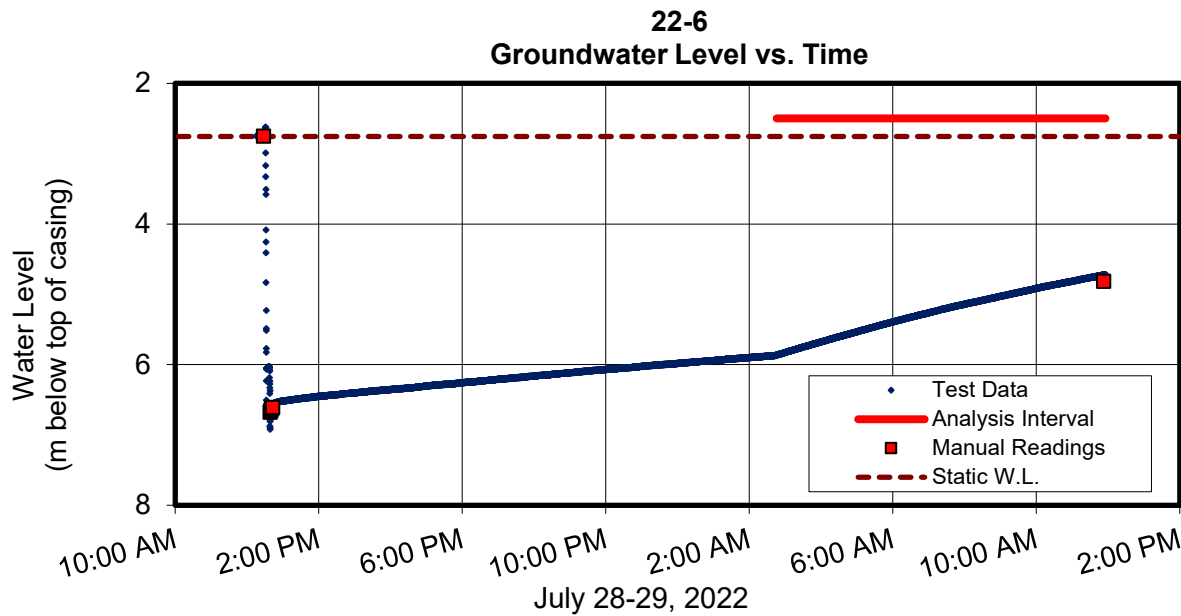
FIGURE E-3

Monitoring Well 22-6

Sand Pack Interval (below ground surface)

5.8 m - 7.6 m

Time Lag (T_0) = 1170 min

Sand Pack Length (L) = 1.8 m

known volume of water followed by recording the time taken for the water level to return to static conditions (i.e., rising head test). Data were analyzed using the Hvorslev (1951) solution. Testing provided an estimate of the horizontal hydraulic conductivity of the overburden material within the screened intervals for the monitoring wells.
