Phase One Environmental Site Assessment

Mayfield Golf Course Redevelopment 12552 and 12580 Torbram Road Caledon, Ontario

> September 15, 2022 Project: 101987.001(1)

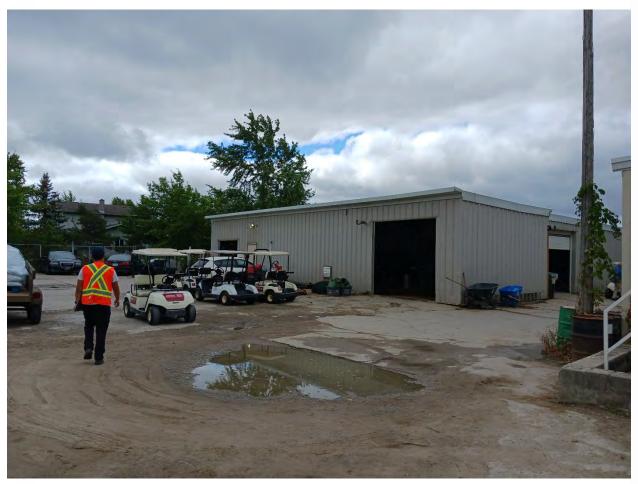
Figure No: H6

Photo H6 (South): View of maintenance yard. Golf carts can be seen being repaired

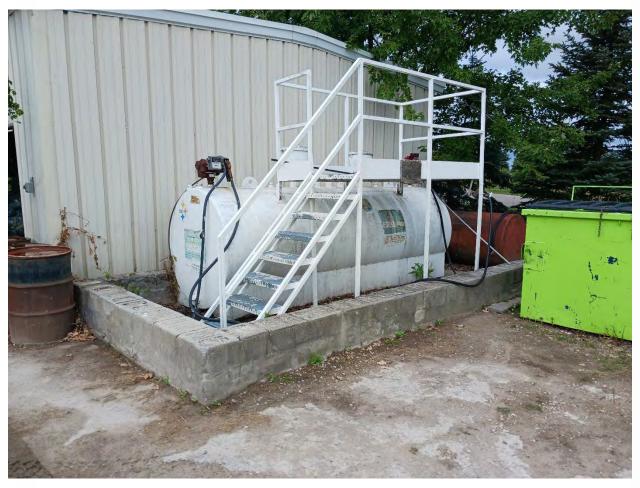
Figure No: H7

Photo H7 (South): 2000L AST compartmentalized to hold both gasoline and diesel in maintenance yard. Second smaller AST behind 2000L tank is no longer in use.

- Drums of used cooking oil are stored exterior to the eastern corner of the storage building. No staining was observed around the drums.
- There is a refuelling area just north of the storage building. An active 2000L AST is in
 this fuel depot and is compartmentalized to contain gasoline and diesel, with a separate
 pump for each. There is a second, smaller AST behind it that is no longer in use. Both
 ASTs are in a concrete containment area. No staining was observed in the area.

A 2000L fuel AST is located east of the storage building. This tank is compartmentalized into two sections: one containing gasoline and the other containing diesel. There is a second, smaller AST located adjacent to the 2000L AST which is no longer in use. Both ASTs are in a concrete containment area. No staining was observed in the area. There are also two 500-gallon propane ASTs on-Site, one servicing the workshop and the other servicing the clubhouse.

During the Site reconnaissance two fuel storage ASTs were observed in the maintenance yard, just north of the storage building. The smaller AST was no longer in use, while the larger 2000L AST was actively used to refuel golf carts and equipment. It is compartmentalized to contain both gasoline and diesel. Associated COPCs are petroleum hydrocarbons (PHCs) and benzene, toluene, ethylbenzene and xylene (BTEX). This APEC is present east of the storage building.

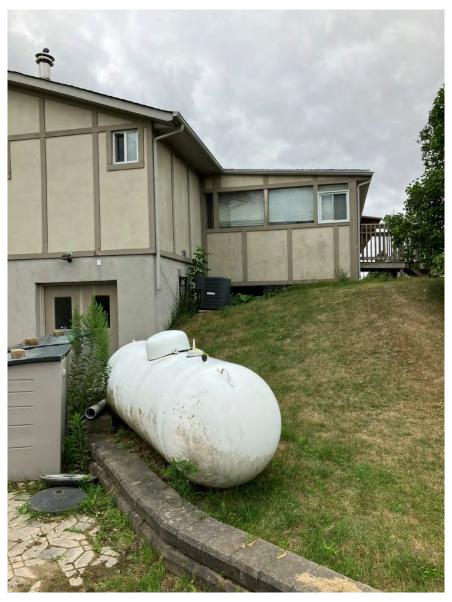
Project No: Figure No: H8

Photo H8 (East): 500-gallon propane AST at clubhouse

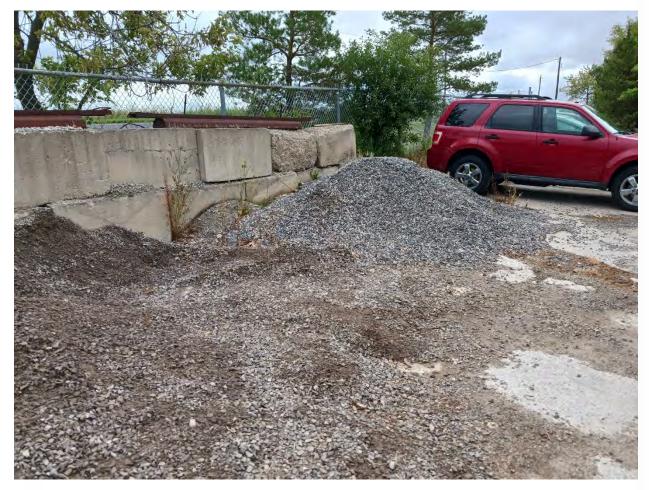
Project No: Н9

Photo H9 (North): Gravel stockpile

- Stockpile of fill was observed in the eastern corner of the maintenance yard consisting of sand and gravel used for golf cart trails and sand traps. Adjacent to these fill stockpiles were dumpsters for domestic garbage.

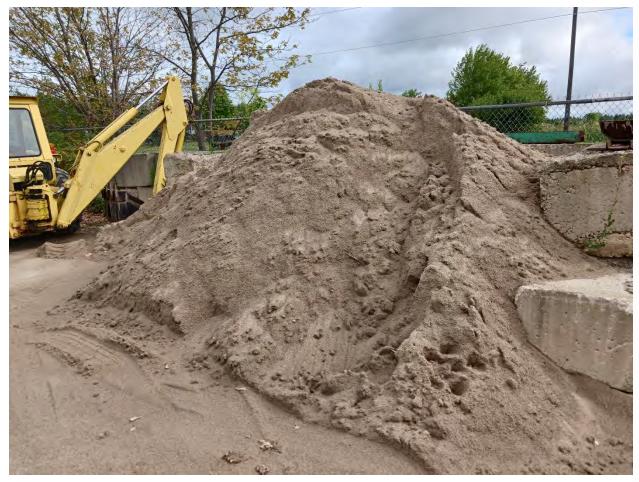
Figure No: H10

Photo H10 (North): Sand Stockpile

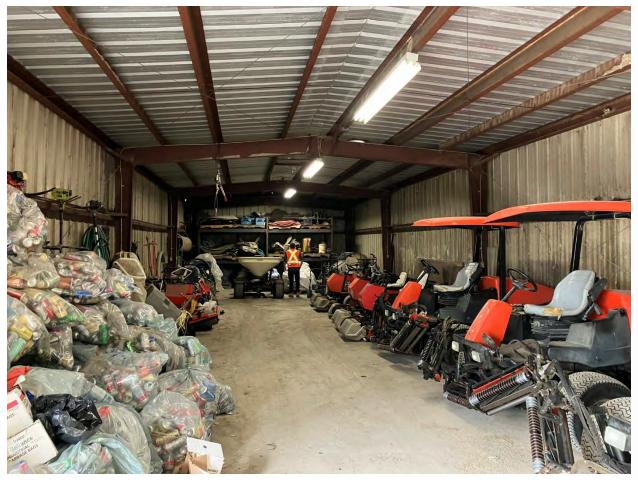
Figure No: H11

Photo H11 (Inside the storage building): Storage building used to store landscaping equipment, fertilizer, garbage

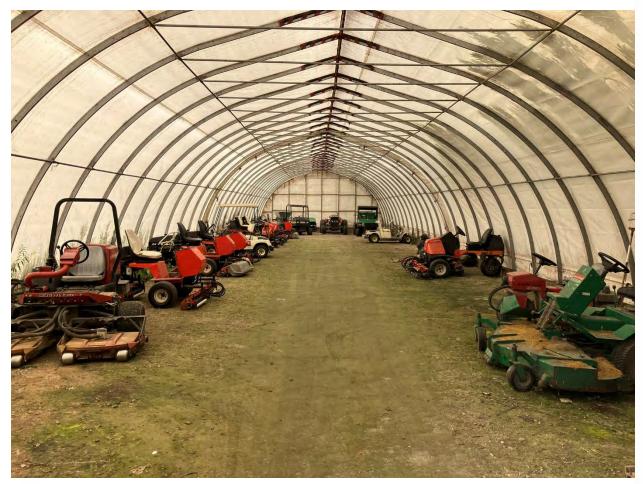
Figure No: H12

Photo H12 (Inside the vehicle storage shed): Carport structure used to store landscaping equipment

- The storage shed contained various lawn tractors and golf carts that were not in use. Some small blue stains were observed on the ground inside the shed. The Site contact stated organic dye is occasionally used to colour the golf course green. The dye is applied using the lawn tractors which is why there are some stains in the vehicle storage shed.

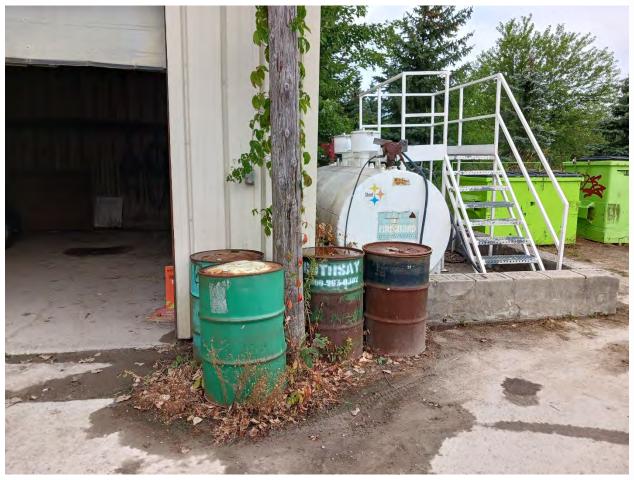
Photo H13 (North): Used kitchen oil stored in drums next to gasoline AST

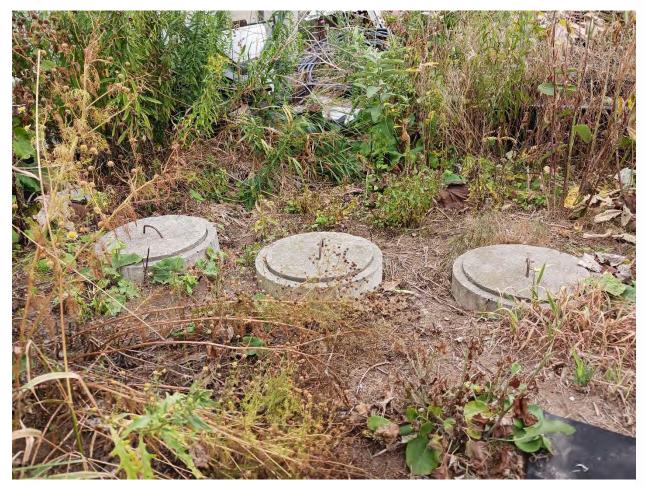
Photo H14 (West exterior of maintenance yard): Oil-water separator

- o Fertilizer
 - Lawn tractors
 - o PVC piping
 - Soil surfactant
- The workshop had a breakroom for employees, along with a mudroom used to hose down dirty garments (e.g., boots, coveralls). Behind the workshop was the oil/water separator and 500 gallon propane tank. Activities observed in the workshop were as follows:

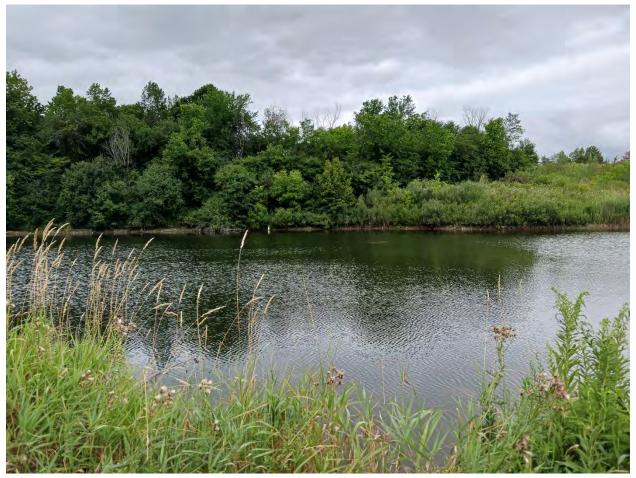
Photo H15 (Southern portion of the site: Irrigation pond

A natural stream flows through the Site with three irrigation ponds and other ponded areas throughout the golf course. No areas of natural significance were observed within the study area.

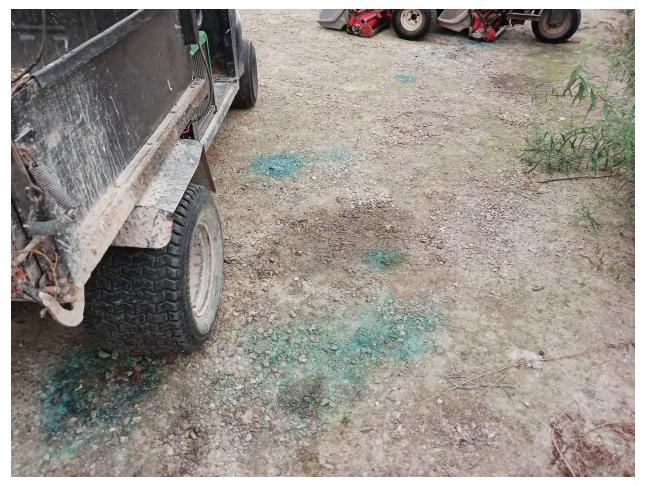
Photo H17 (Interior of vehicle storage shed): Some small dye stains observed on ground

No stressed vegetation was observed during the Site reconnaissance. Small dye stains were observed on the ground inside the vehicle storage shed and appeared to be surficial. The Site contact stated organic dye is occasionally used to colour the golf course green.
