**Phase Two Environmental Site Assessment
Mayfield Golf Course Redevelopment –
South Lands
Caledon, Ontario**

GEMTEC Project: 101987.001

April 22, 2024
GEMTEC Project: 101987.001

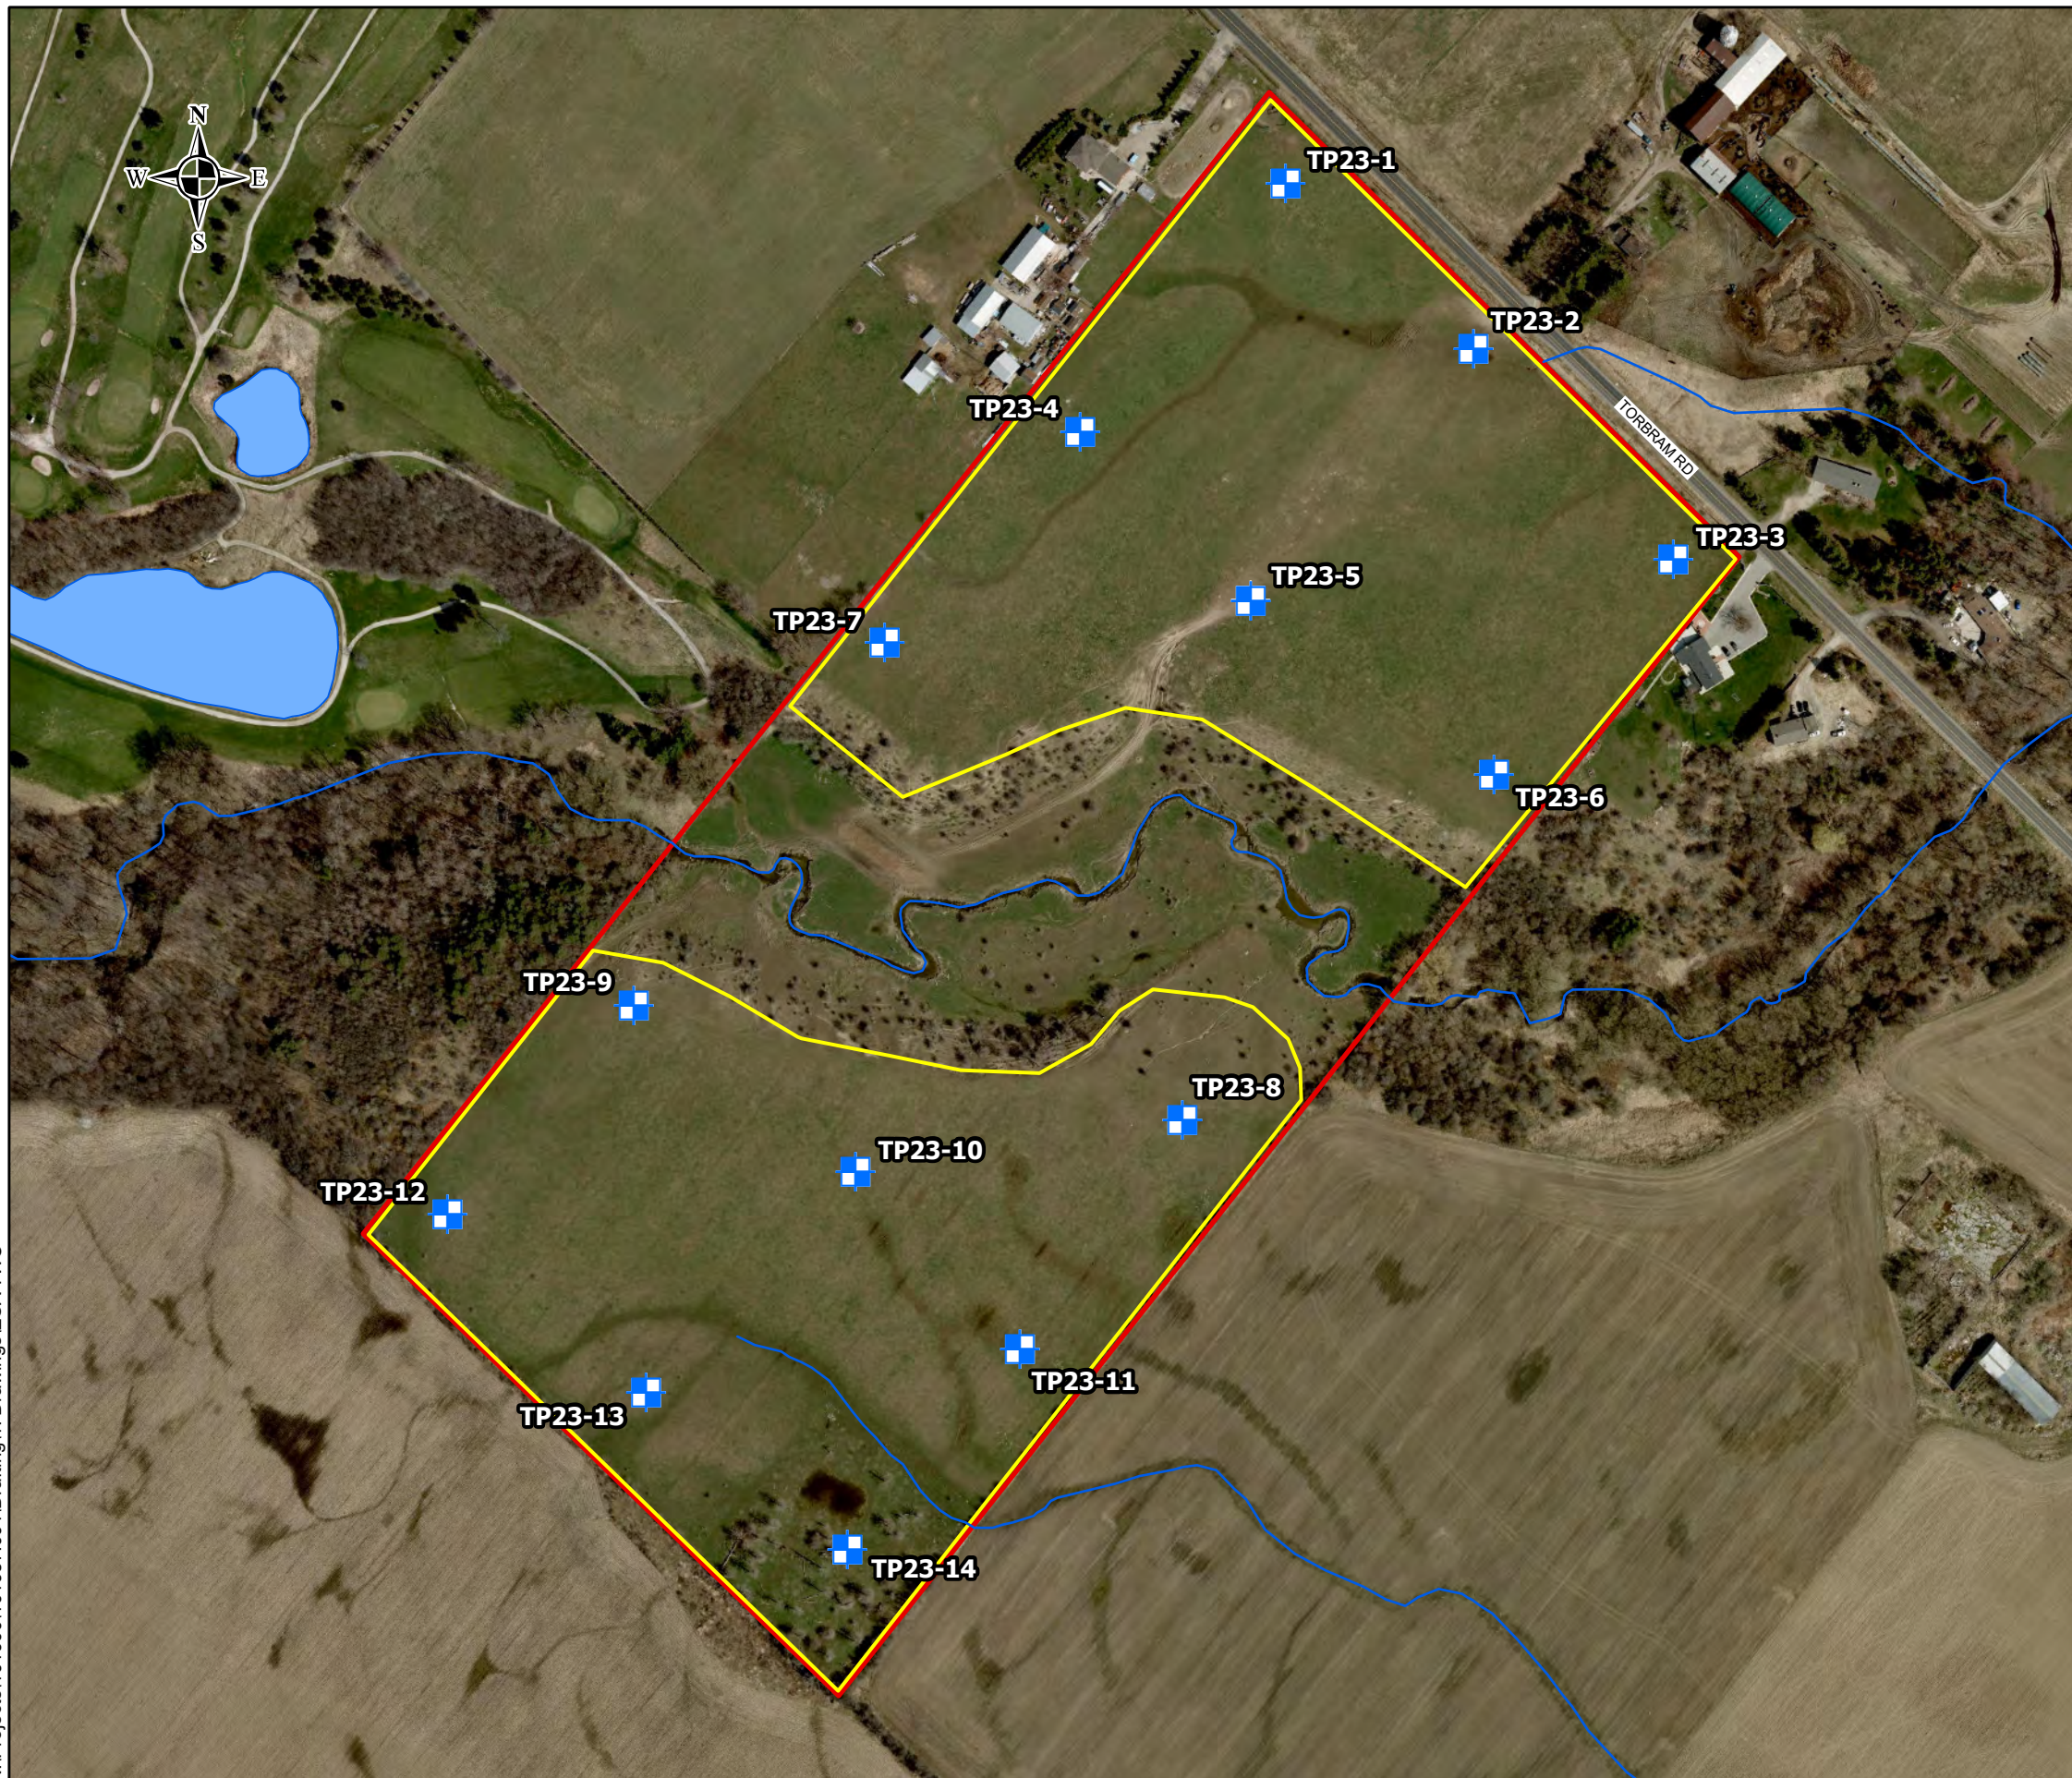
This APEC was investigated as part of this Phase Two ESA via the advancement of fourteen test pits (TP23-1 to TP23-14). The test pits were located in the areas of the Site that are currently and were historically used for agricultural purposes. The test pits were advanced to a depth of 0.15 m bgs. During sampling, there was no evidence of staining or odour. A total of sixteen surface soil samples (fourteen plus two duplicates) were collected from the test pits and were submitted for analysis of metals, including hydride-forming metals, OCPs and pH. Based on a comparison to the applicable standards, no exceedances were identified.

- Test Pit
- WaterBody
- Watercourse
- APEC 1
- SUBJECT SITE

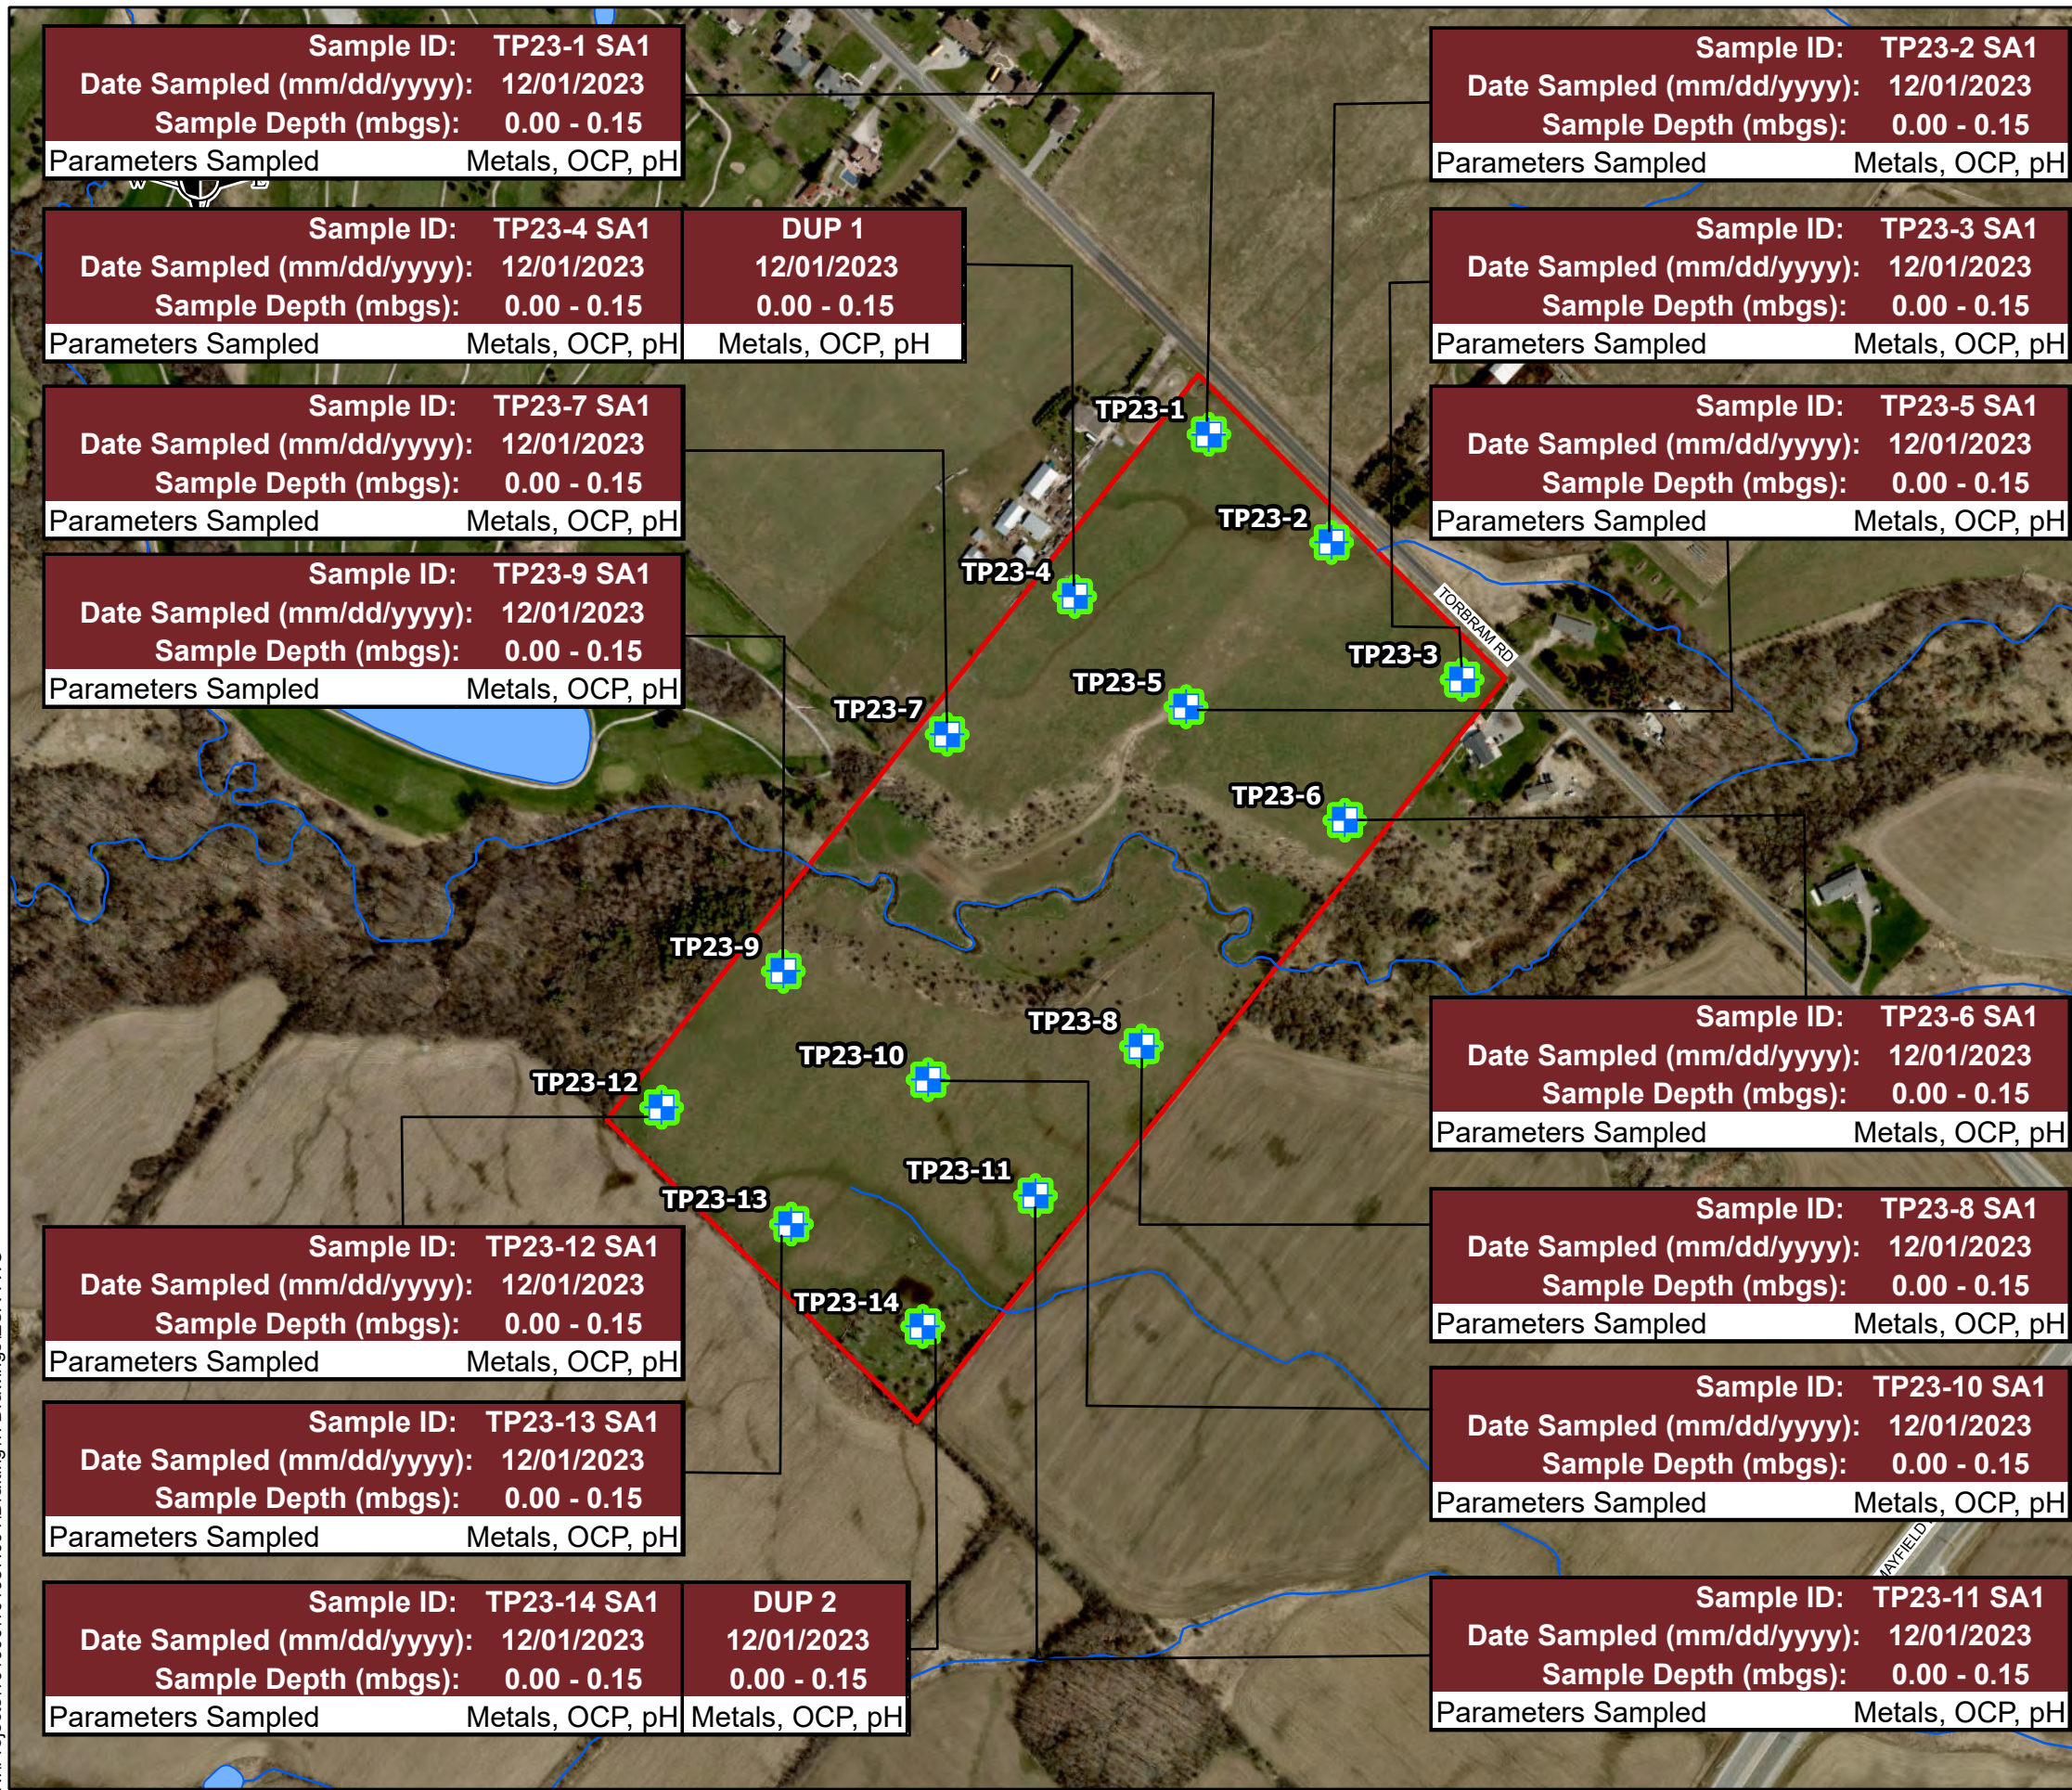
- Test Pit Meets Table 1 Standards
- WaterBody
- Watercourse
- SUBJECT SITE

- Samples were compared to the Table 1 Full Depth Background Site Condition Standards (SCS) for Agricultural or Other Property Use.
- Metals - metals parameters as per O.Reg. 153/04 including hydride forming metals (antimony, arsenic, selenium)
- OCP – Organochlorine Pesticides

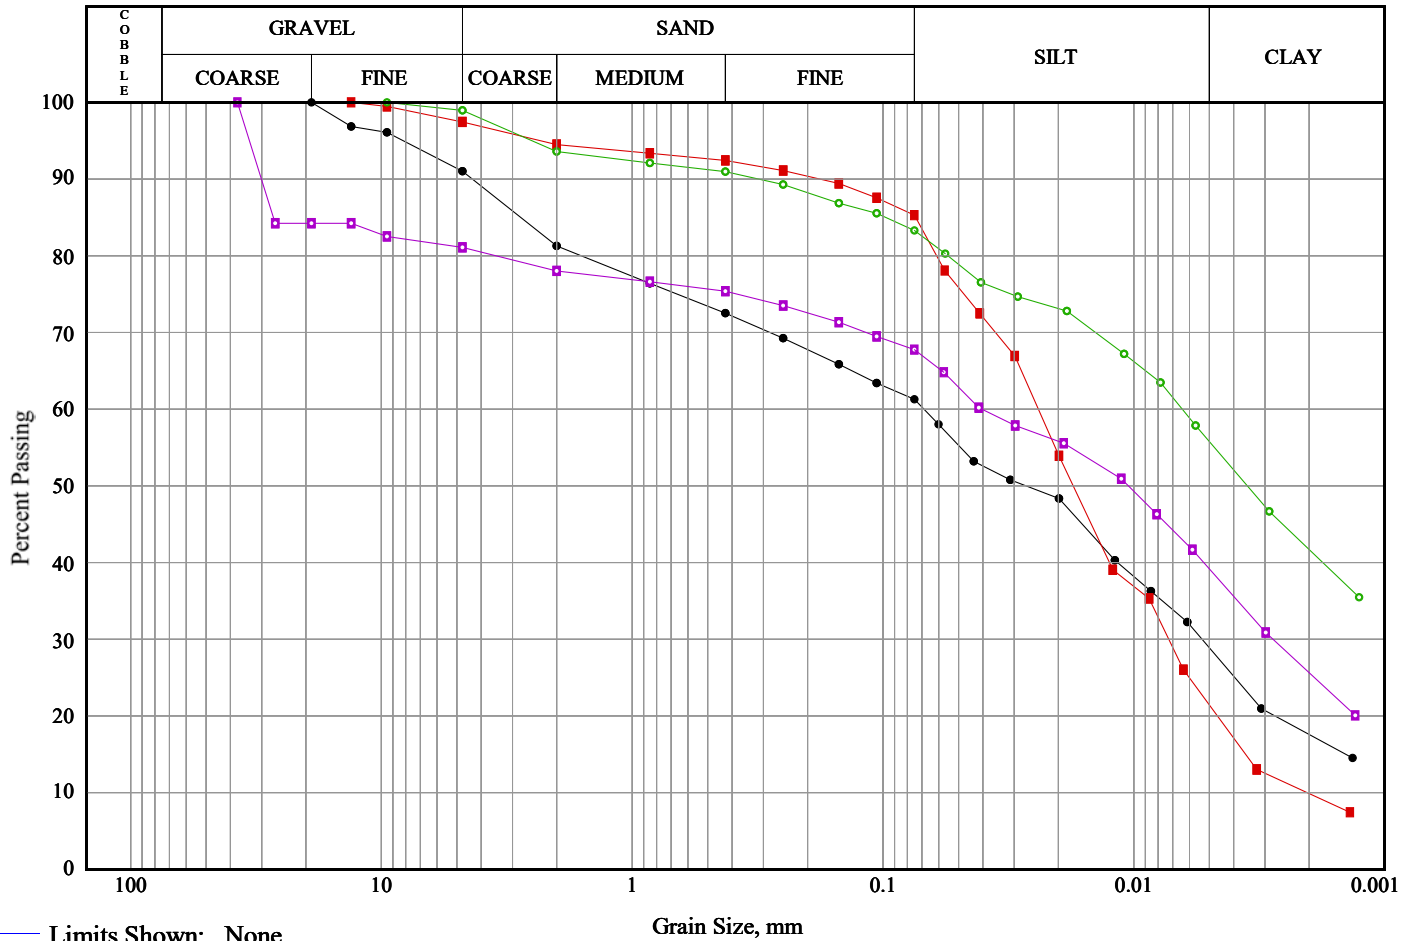
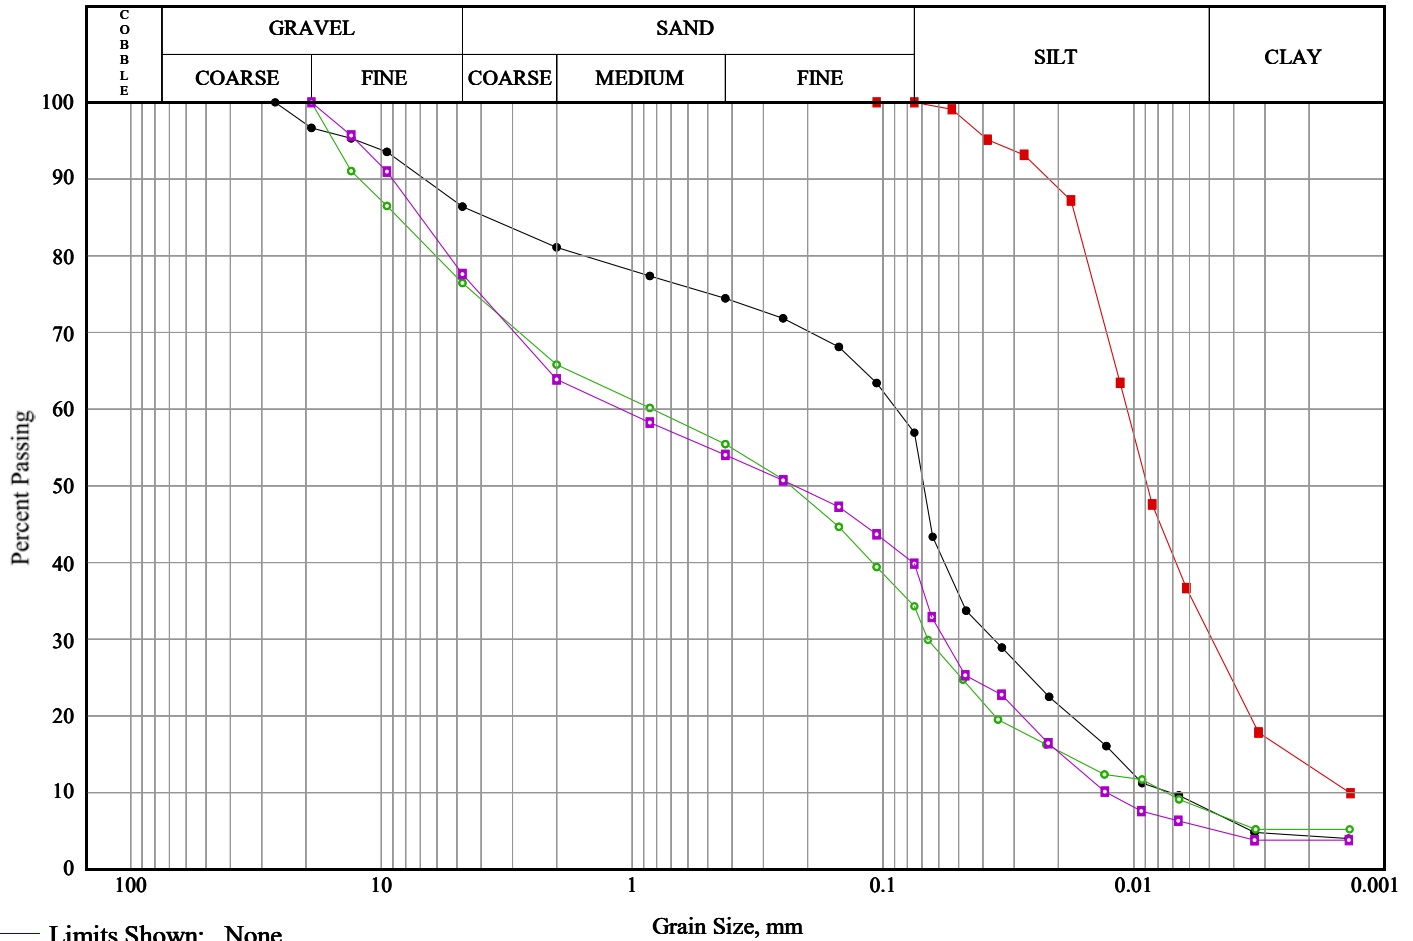
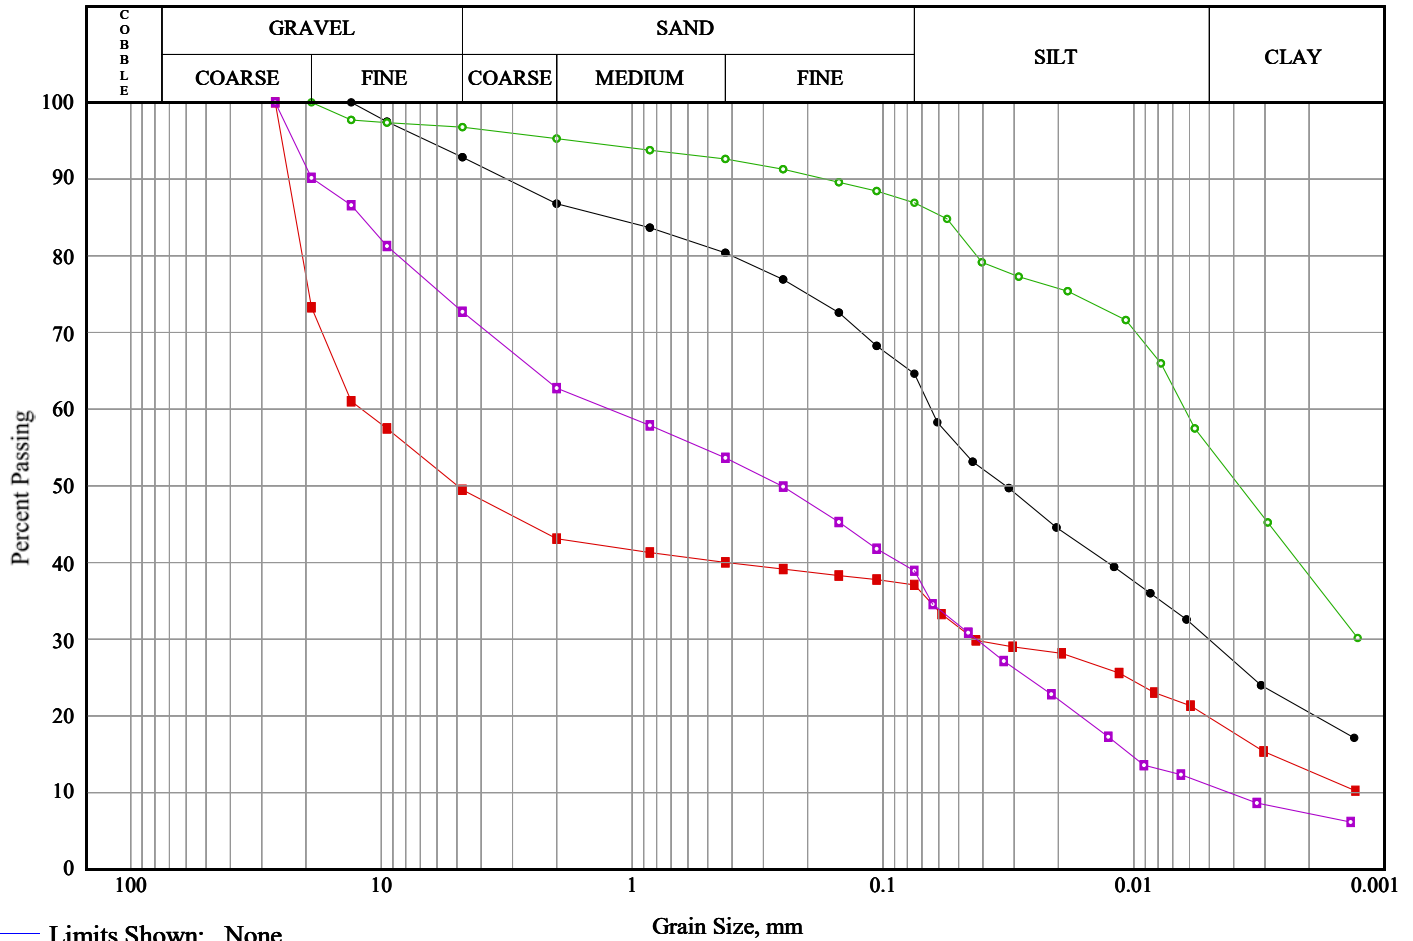
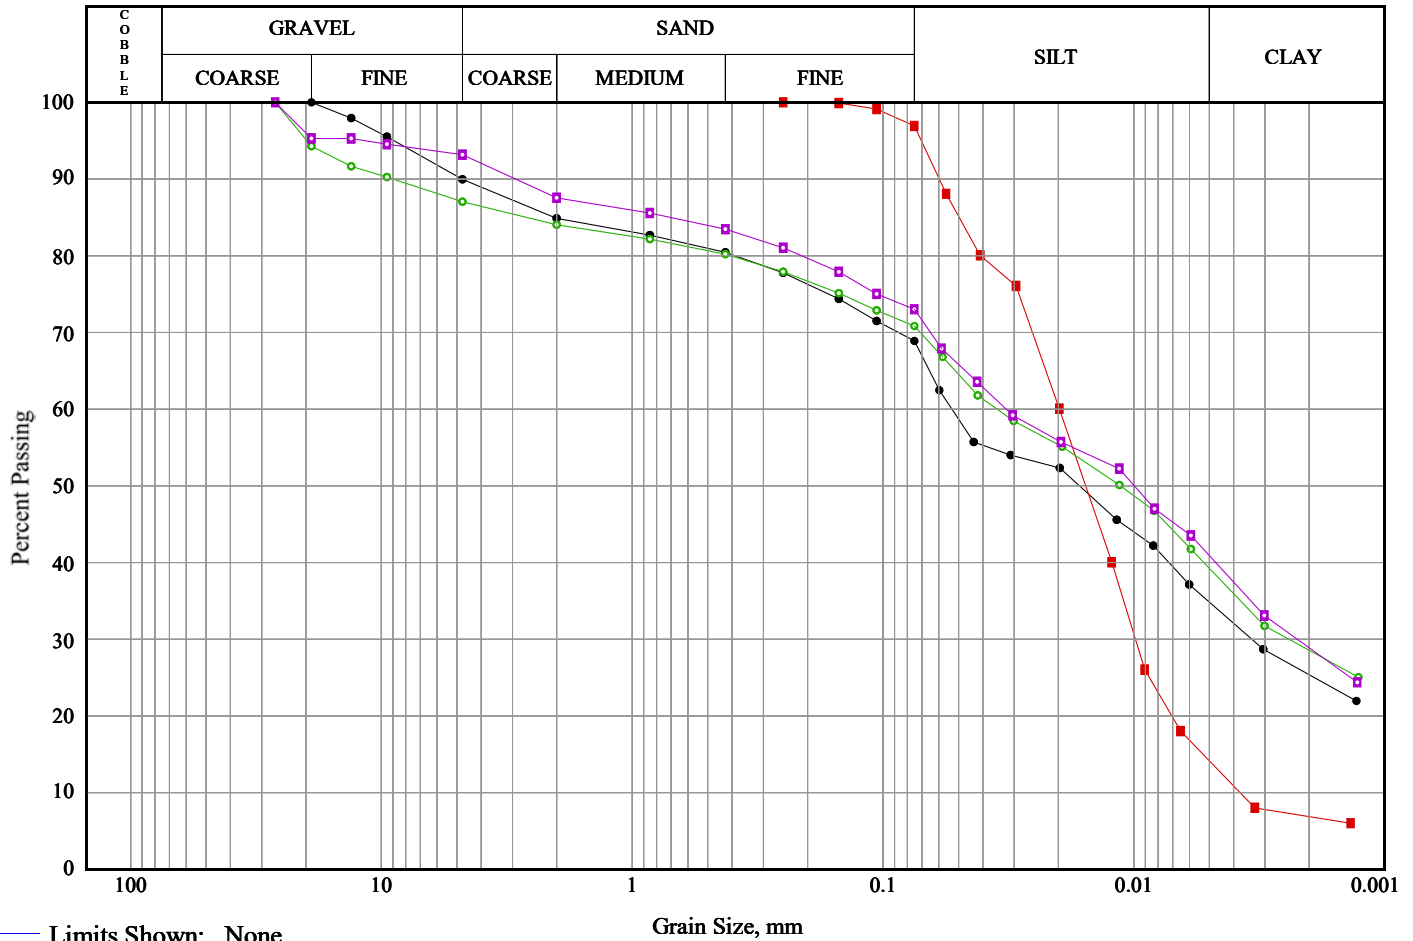
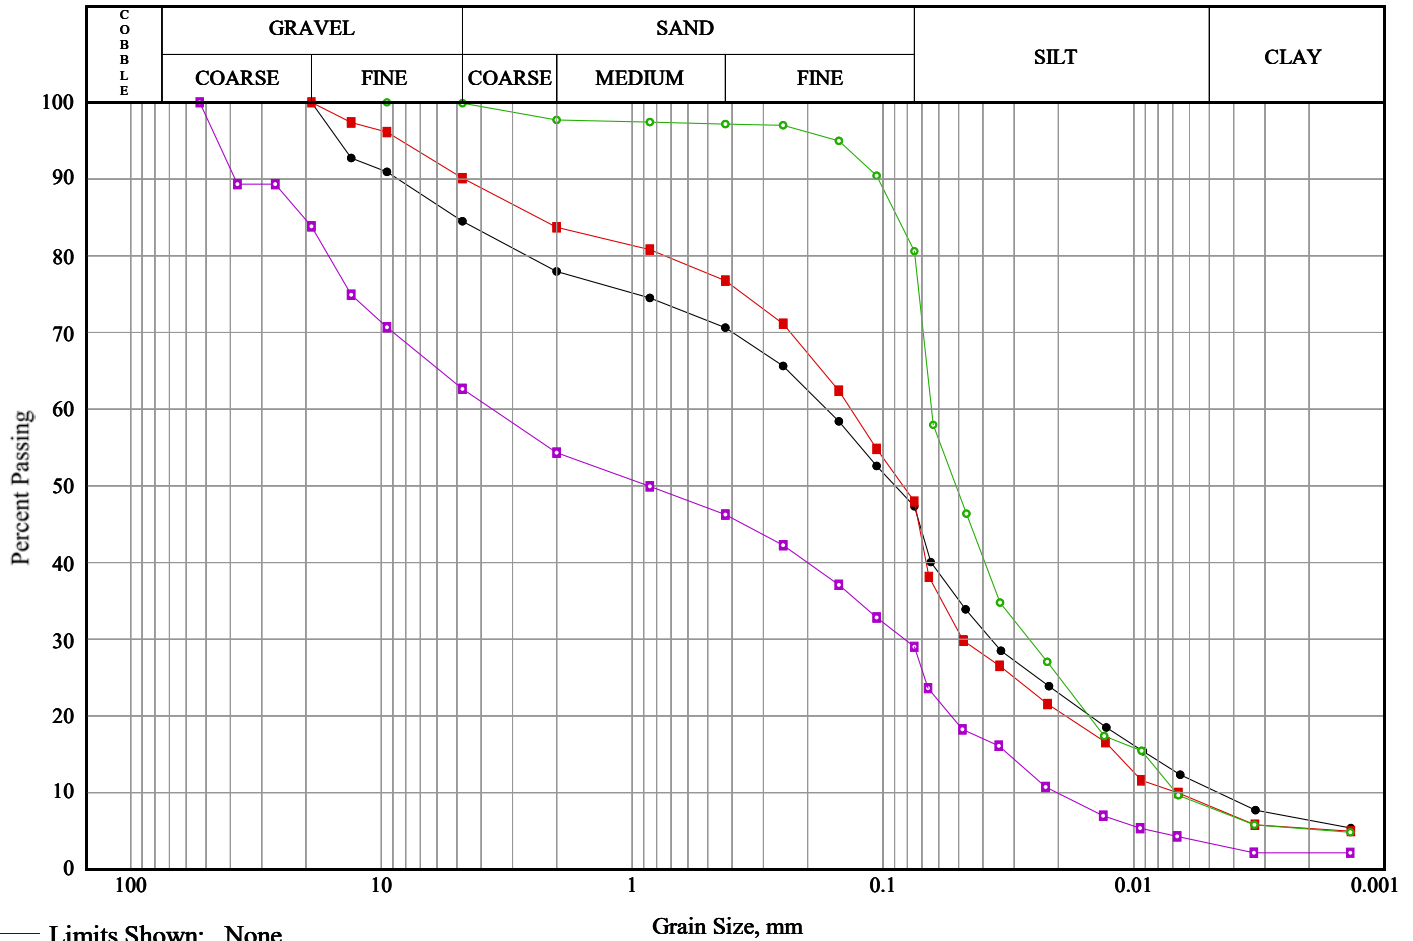
Based on soil conditions encountered in the test pits and a grain size analysis of soil collected from TP23-6 SA1, the soil is considered fine to medium textured. The results for this analysis are provided on the Certificate of Analysis in Appendix D. Additionally, grain size analyses carried out as part of the 2023 Geotechnical and Hydrogeological Report indicated soil at the site to be fine to medium textured. A copy of the grain size curves from this report are provided in Appendix C.

| Line Symbol | Sample | Borehole/ Test Pit | Sample Number | Depth | % Cob.+ Gravel | % Sand | % Silt | % Clay |
| —●— | (CL-ML) Sandy SILTY CLAY to CLAYEY SILT TILL | BH23-02 | SA-06 | 4.6-5.0 | 9.0 | 29.7 | 32.4 | 28.9 |
