Proposed Warehouse Development

Hydrogeological Assessment

12892 and 12668 Dixie Road, Caledon, Ontario

MTE File No.: 48043-300

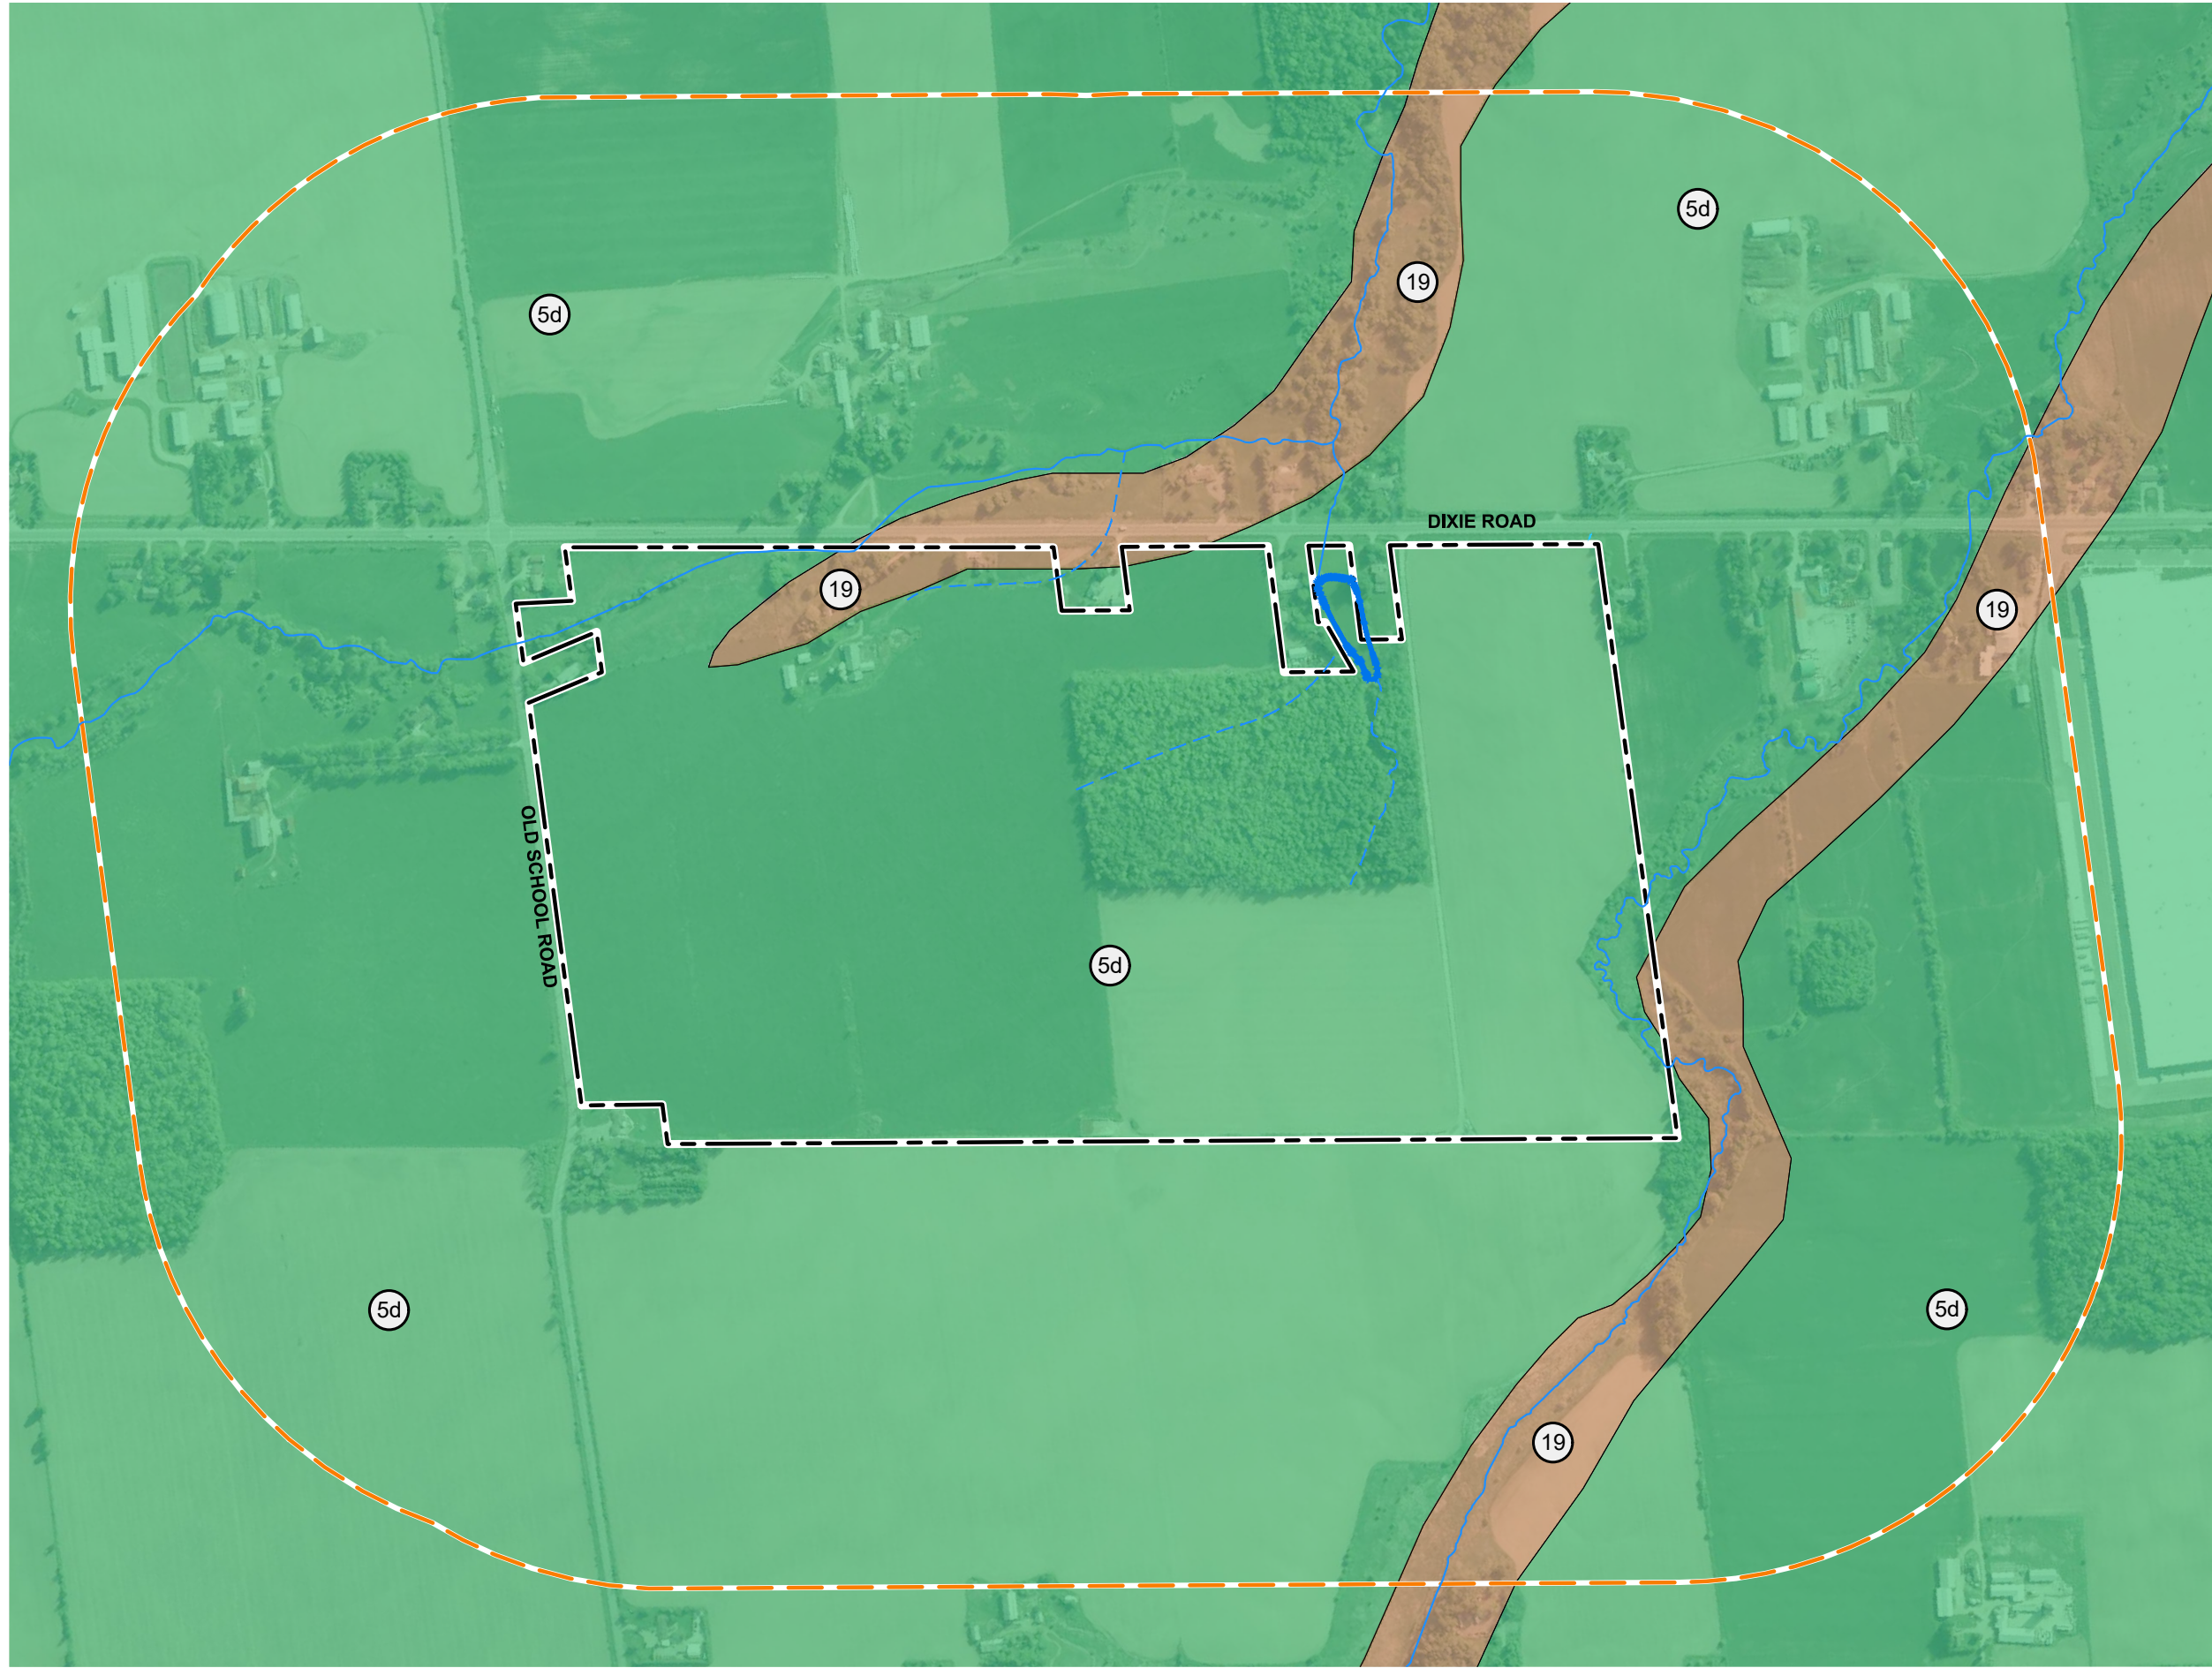
Drawn	DCH	Scale	1:7,500	2
Checked		Project No.	48043-300	
Date	2024-03-07	Rev No.	0

TITLE
QUATERNARY GEOLOGY

The Quaternary deposits in the region of the Site are mapped as a predominantly clay to silt textured till derived from glaciolacustrine deposits (Ontario Geological Survey, 2003). Along the northeastern boundary of the Site, modern alluvial deposits consisting of clay, silt, sand and gravel may also be found (Ontario Geological Survey, 2003). The Quaternary geology in the vicinity of the Site is shown on **Figure 2**.

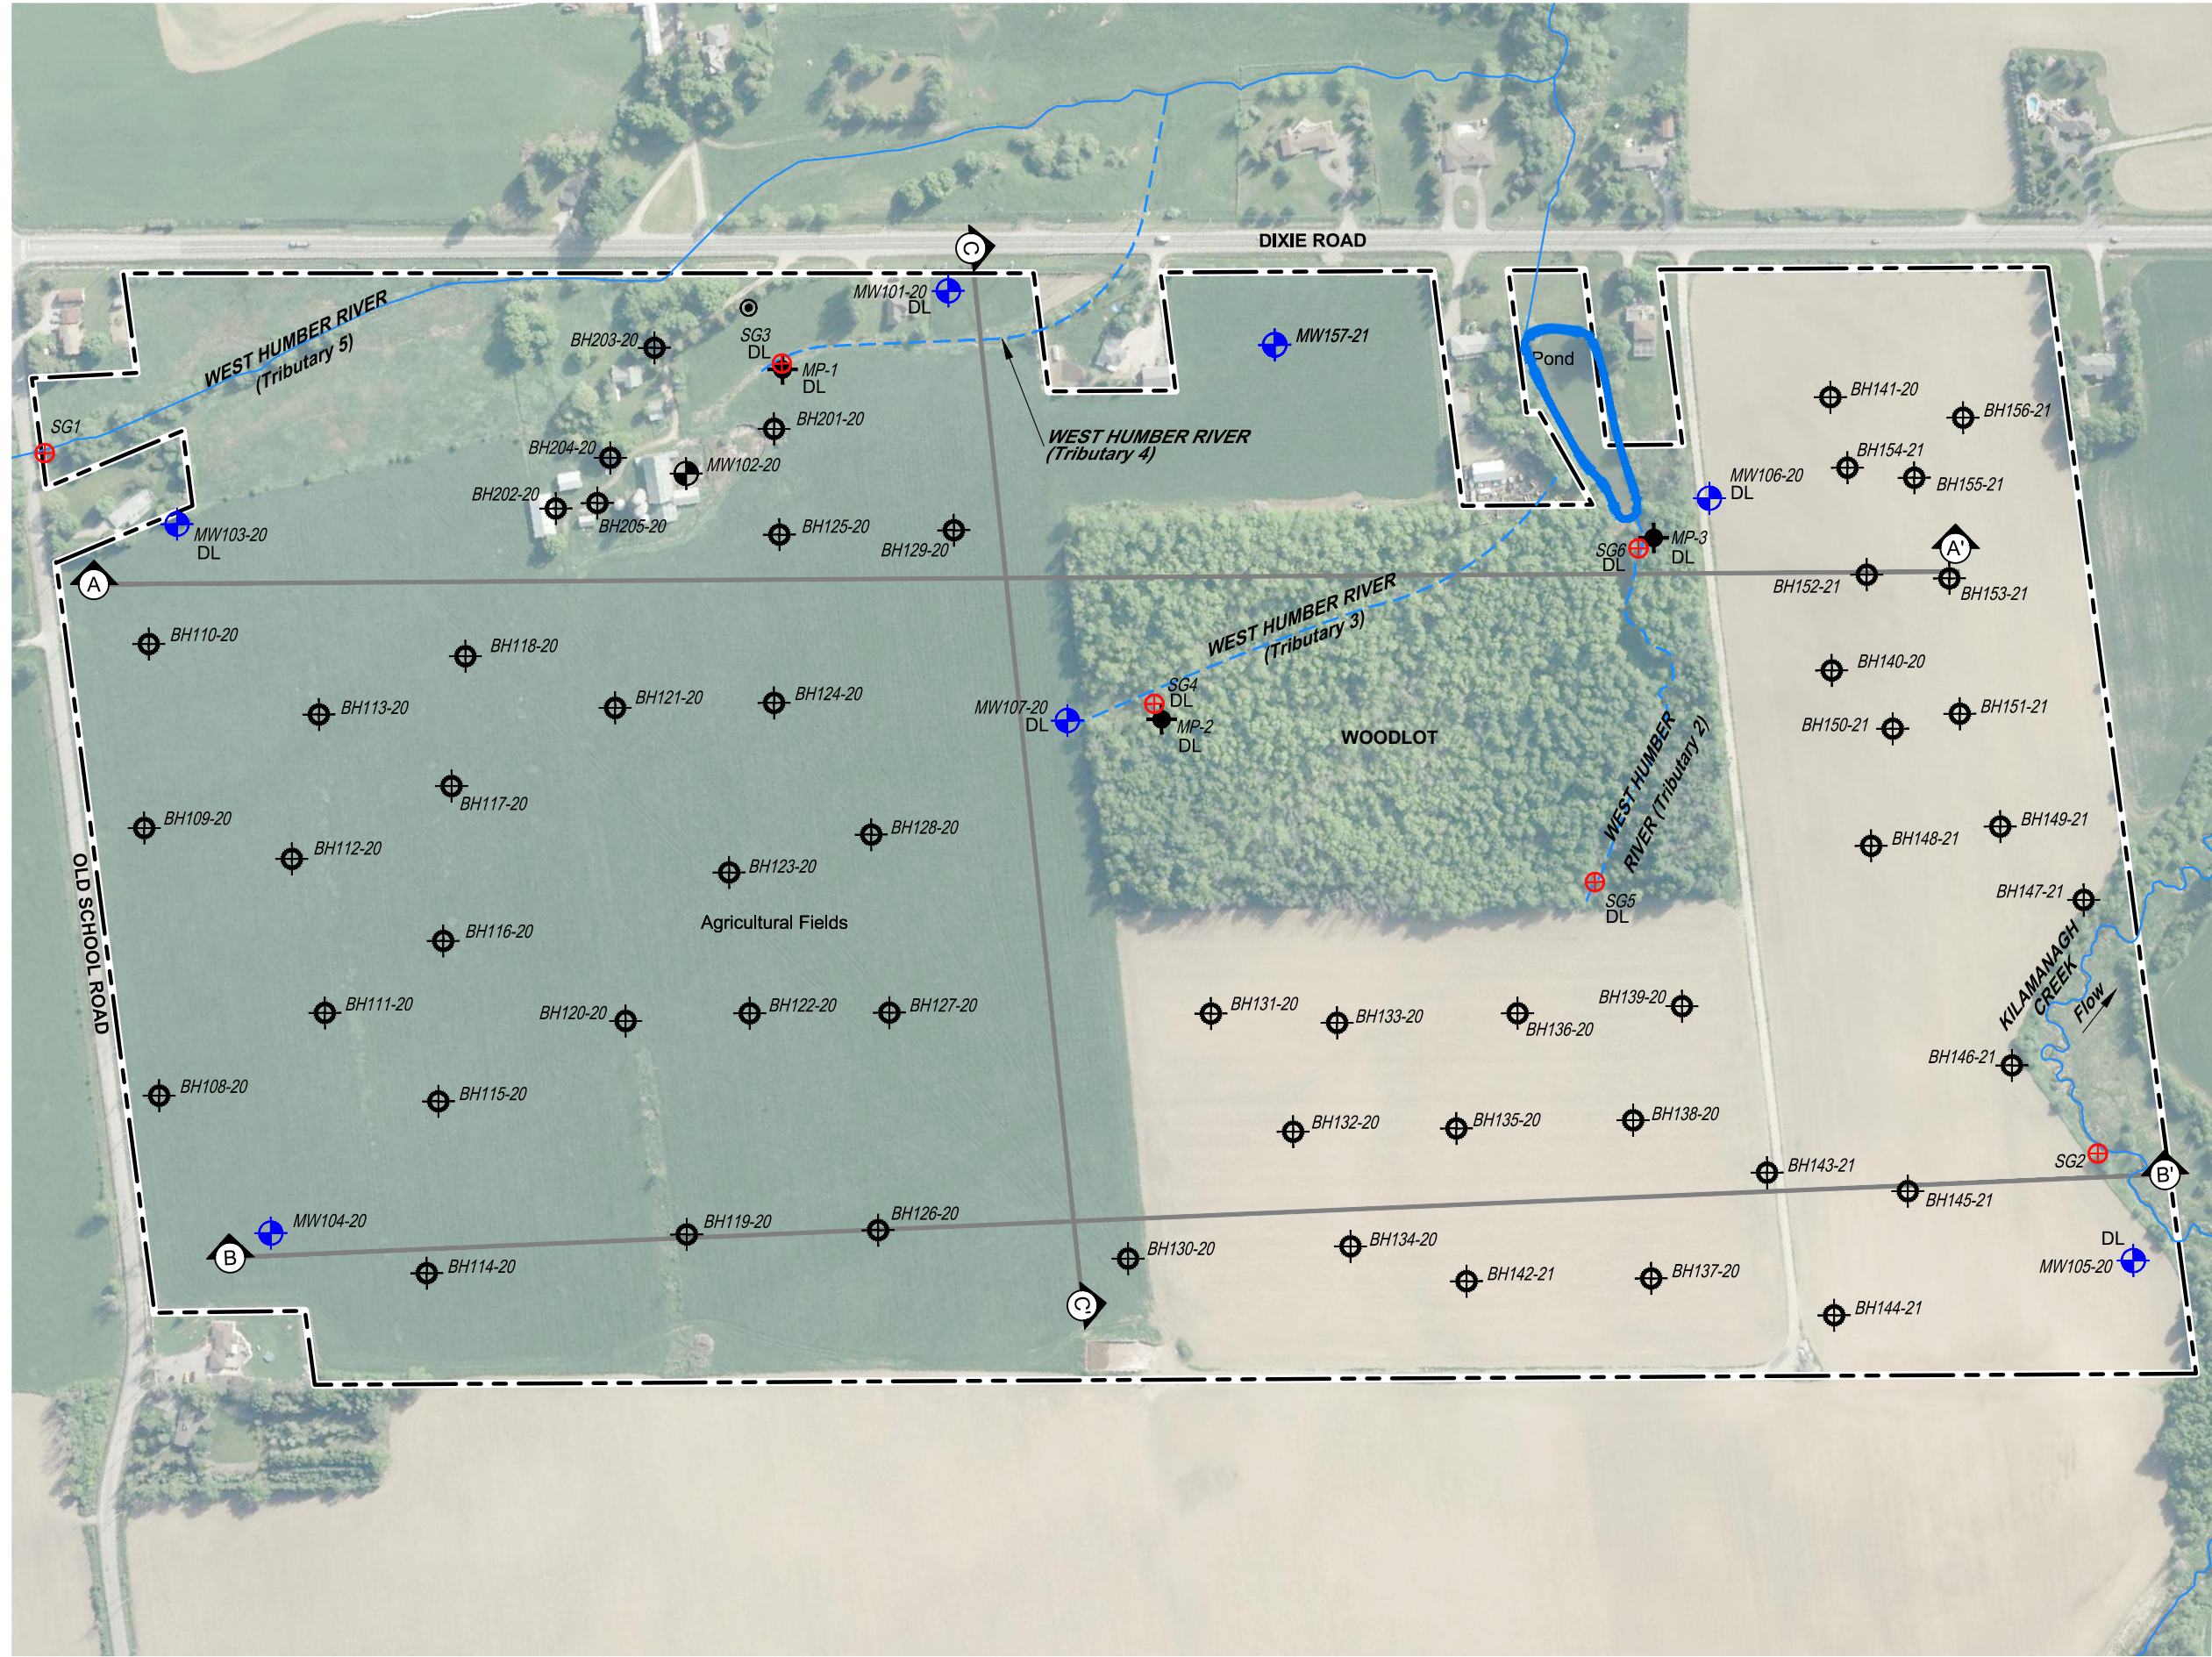
Drawn	DCH	Scale	1:4,000	Figure 4
Checked		Project No.	48043-300	
Date	2024-03-07	Rev No.	0

TITLE
BOREHOLE LOCATION PLAN

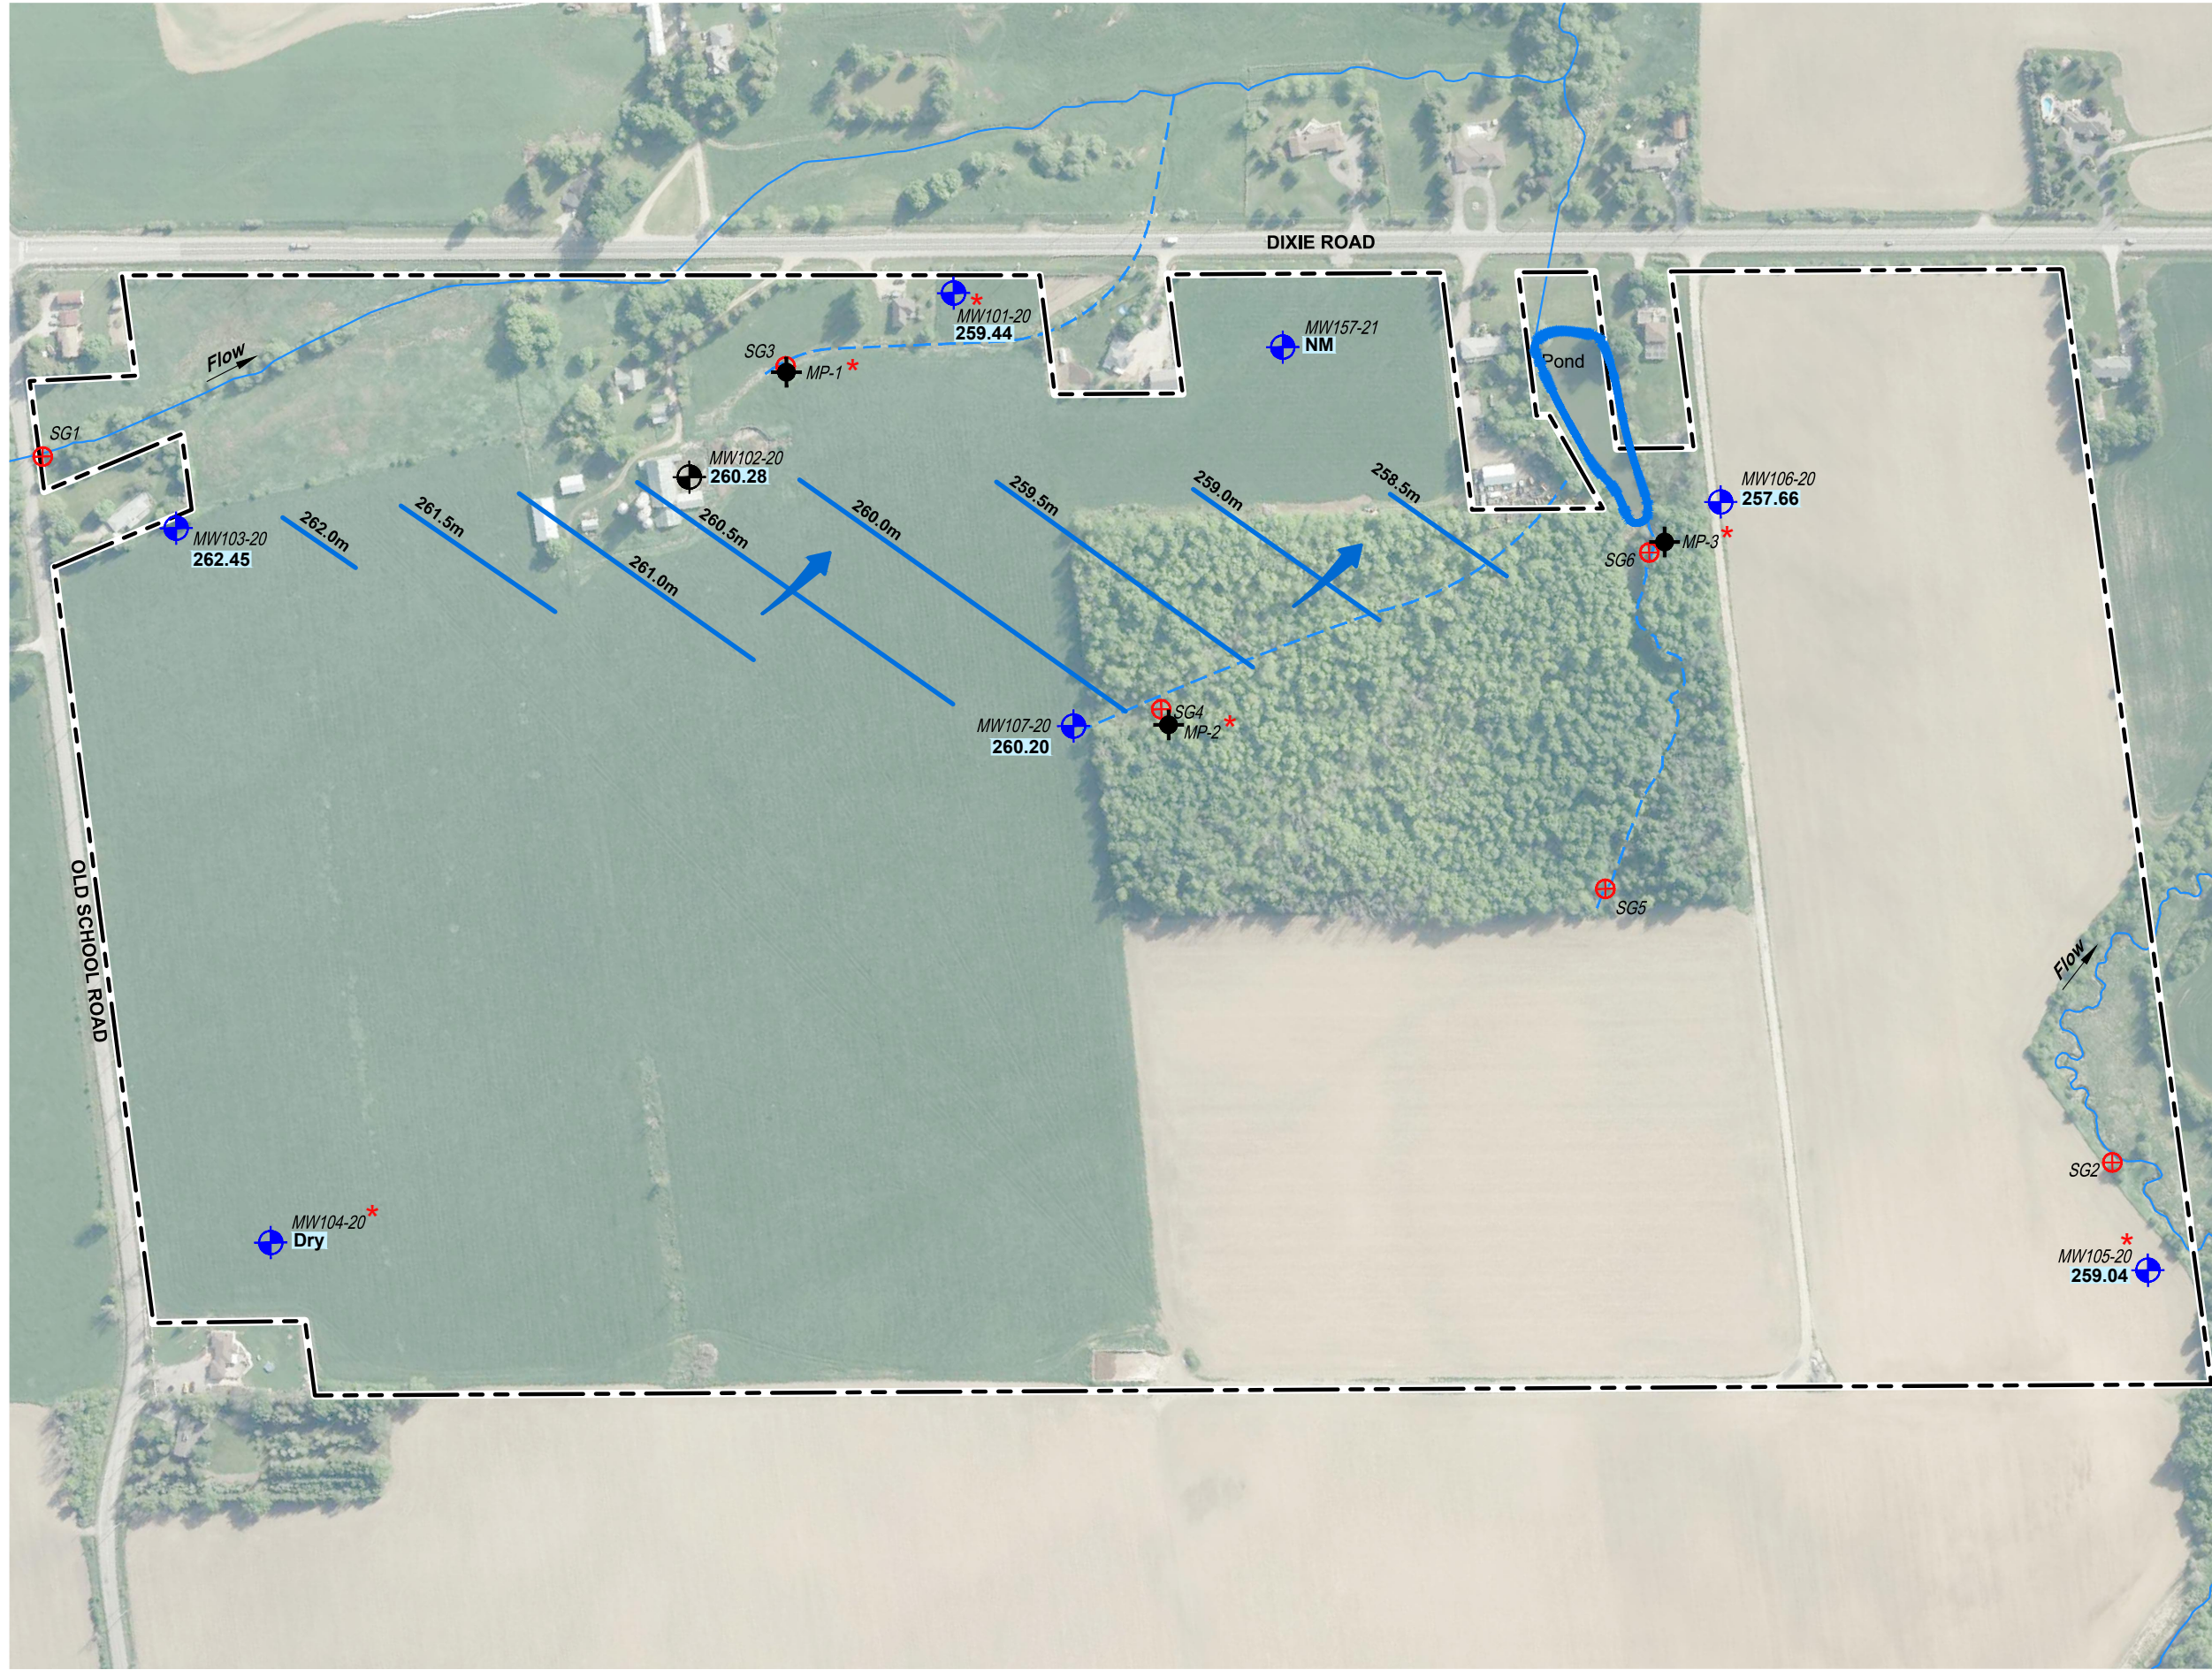
PROJECT		HYDROGEOLOGICAL ASSESSMENT	
12668 & 12892 DIXIE ROAD, CALEDON, ONTARIO			
TITLE		GROUNDWATER FLOW IN CONFINED SANDS (December 2020)	
Drawn	DCH	Scale	1:4,000
Checked		Project No.	48043-300
Date	2024-03-07	Rev No.	0
			8A

Figures 8a, 8b, and 8c show the inferred potentiometric surfaces and inferred groundwater flow directions in the confined granular deposits (sand unit) for December 2020, September 2021 and March 2023 (respectively). The results indicate that the groundwater flow direction is generally towards the east, with observed gradients (i.e., slope) ranging from 0.002 to 0.008 m/m (March 2023) over the Site.

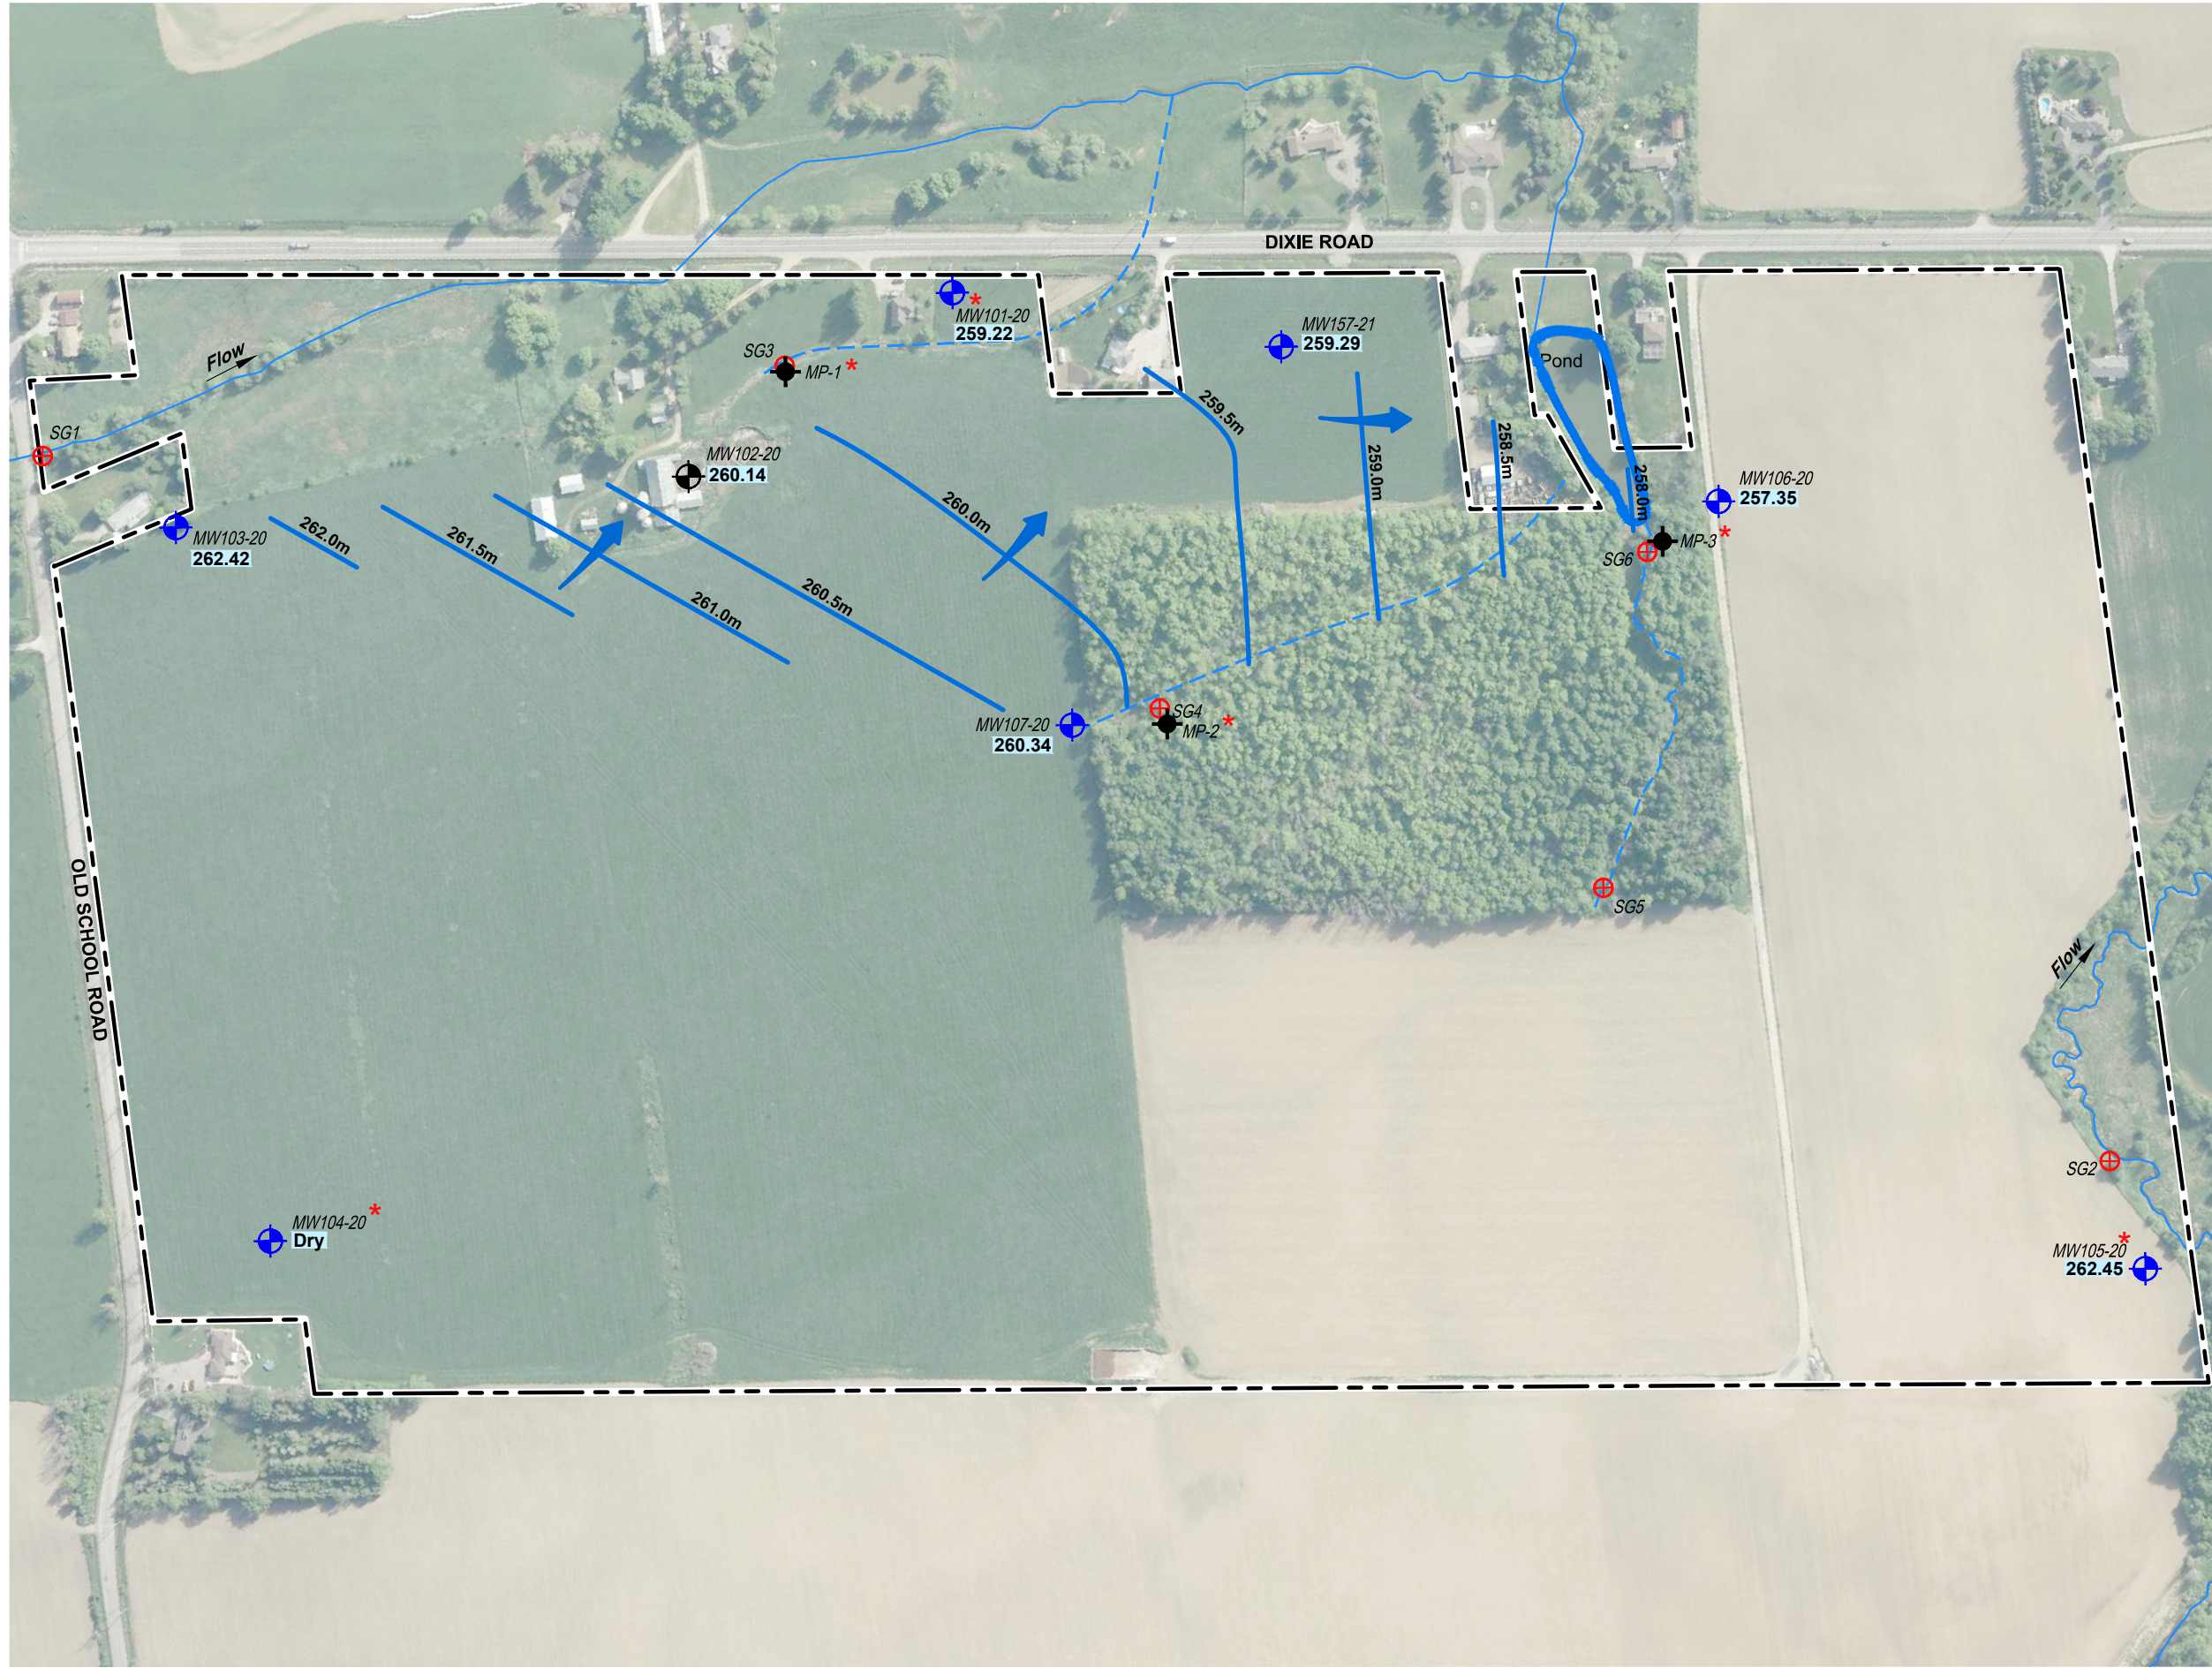
Drawn	DCH	Scale	1:4,000	8B
Checked		Project No.	48043-300	
Date	2024-03-07	Rev No.	0

TITLE
GROUNDWATER FLOW IN CONFINED SANDS (September 2021)
