# Caledon Station

## Community-Wide Comprehensive Environmental Impact Study and Management Plan

### Draft Plans of Subdivision

**Beacon Environmental Limited**

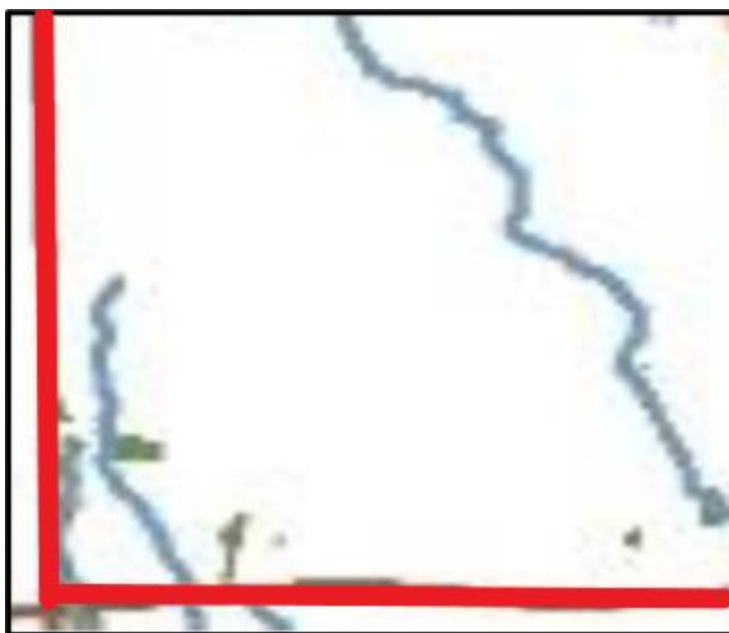
**Image 1. Town of Caledon CA NHS mapping of the Caledon Station Secondary Plan area (CVC 2019) with overlay of Secondary Plan boundaries in red**

These potential enhancement areas, which included areas of agriculture, open space and successional land cover, were identified in the report as opportunities to maintain and enhance the functionality and connectedness of the CA NHS. They also included areas of urban land use that provided a degree of ecological function due to their placement in the system (e.g., infiltration, habitat, linkage functions on lake shorelines or in valleylands). **Image 1** illustrates features mapped as watercourses and areas of existing natural cover (green) in the Town of Caledon CA NHS mapping (Figure A3). The report did not identify any potential enhancement areas within the Secondary Plan area.

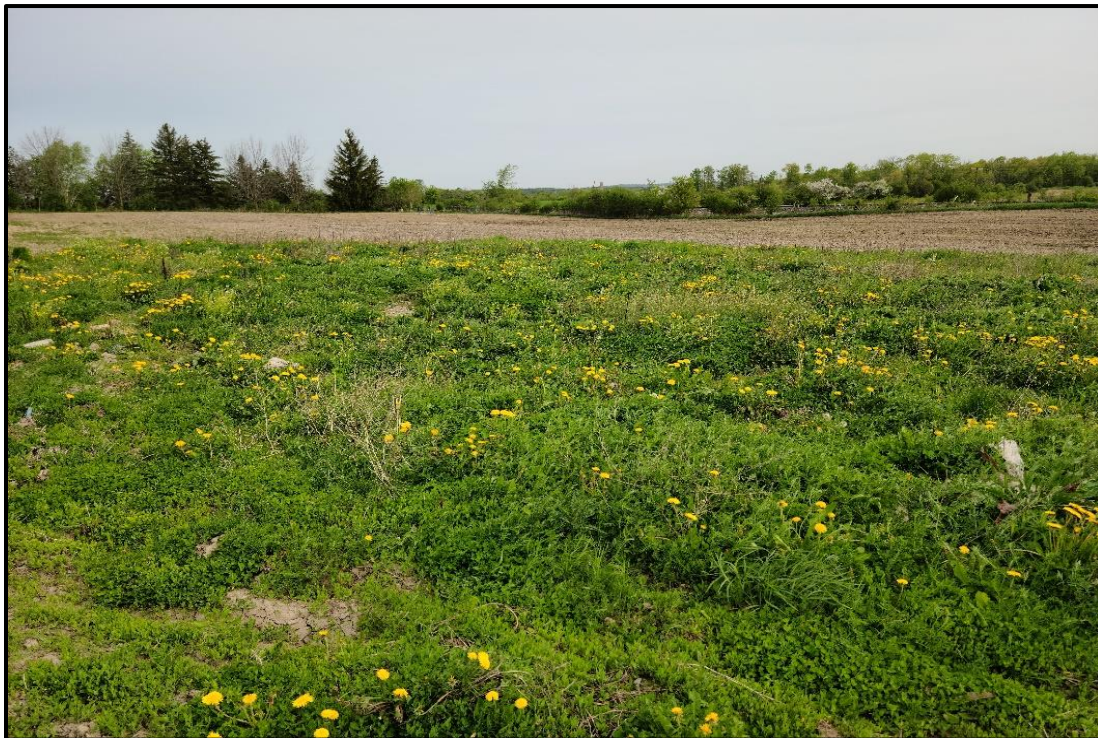
**Photograph 2. Potential Snake Habitat at an Old Foundation – Argo Humber Station (May 16, 2023)**

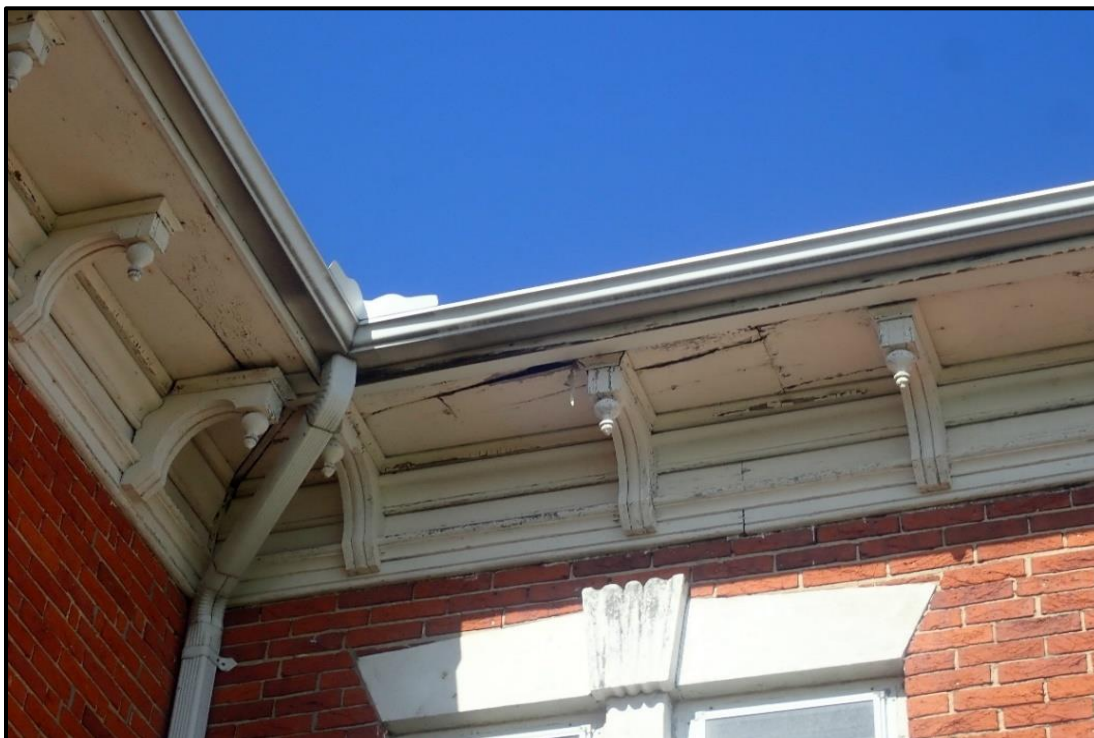
**Photograph 3. Potential Bat Maternity Roosting Habitat: Cracks in the Soffit of the Residential Home (April 7, 2021)**

In April of 2021, visual surveys were undertaken by Beacon to determine if buildings proposed for relocation or demolition provided potential maternity roosting habitat for endangered bat species. Based on a review of each individual building, it was determined that three buildings could potentially provide habitat for bats. Specifically, there were three areas on the existing farmhouse where bats could access the attic for roosting or hibernation. Similarly, the large barn (northeast of the residential house) and the small shed (northwest of the house) also had entry points which could accommodate roosting bats. Refer to **Photograph 3** below for an example of potential bat maternity roosting habitat within the residential house.

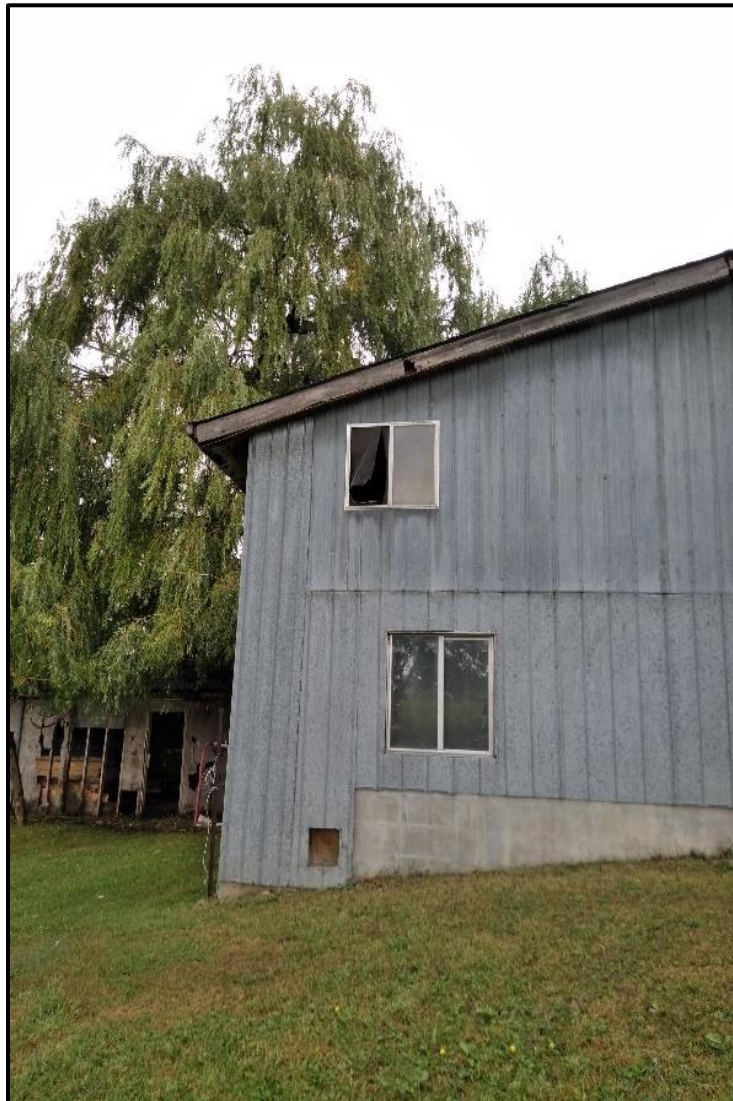
**Photograph 4. Potential Bat Maternity Roosting Habitat: Multiple Gaps in Roof (September 12, 2023)**

On September 12, 2023, visual surveys were undertaken by Beacon to determine if buildings proposed for relocation or demolition provided potential maternity roosting habitat for endangered bat species. Based on a review of each individual building, it was determined that six (6) could potentially provide habitat for bats. Specifically, areas were identified on existing houses where bats could access the attic for roosting or hibernation. Similarly, several shed structures also had entry points which could accommodate roosting bats. Refer to **Photograph 4** below for an example of potential bat maternity roosting habitat on the Humberking West lands.

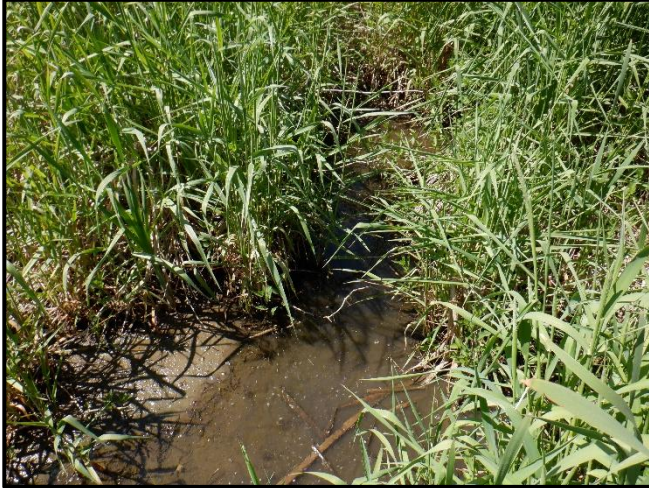
**Photograph 1.**

**Reach WHT6-A (June 8, 2020)**

Facing west (upstream). Feature flowing at time of assessment. Wetland riparian vegetation.

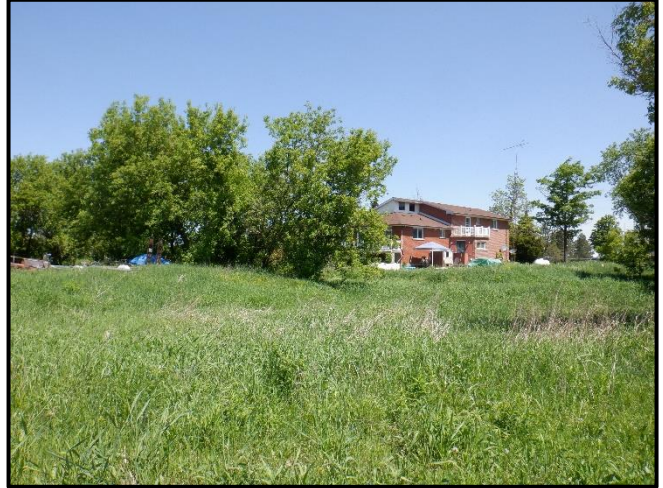
**Photograph 2.**

**Reach WHT6-B (June 8, 2020)**

Facing north east (downstream). Feature was dry at the time of assessment. Wetland riparian vegetation.

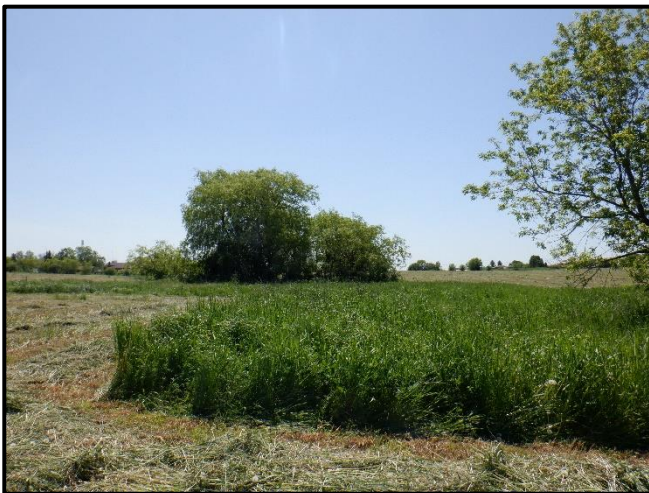
**Photograph 3.**

**Reach WHT6-C (June 8, 2020)**

Facing east (upstream). Feature was dry at the time of assessment. Wetland riparian vegetation.

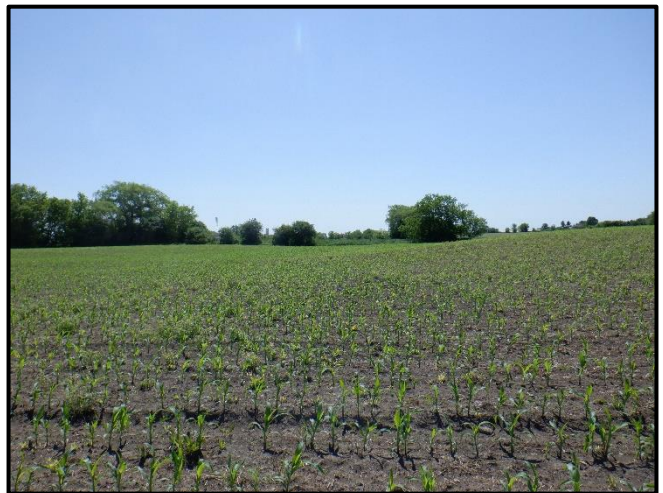
**Photograph 4.**

**Reach WHT6-D (June 8, 2020)**

Facing east (downstream). Feature was dry at the time of assessment. Agricultural riparian vegetation.

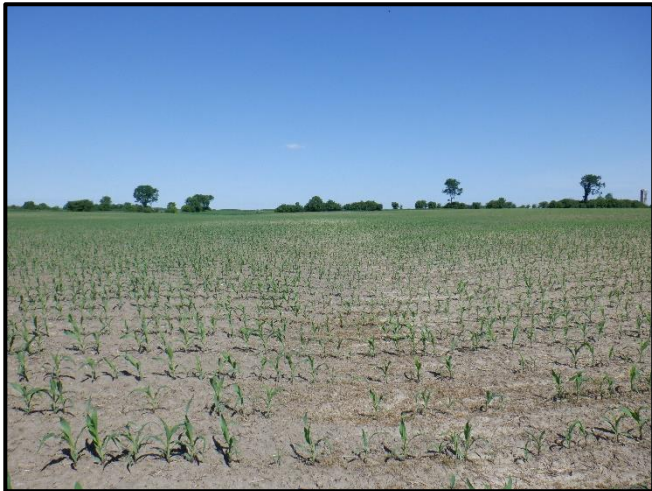
**Photograph 5.**  
**Reach WHT6-E (June 8, 2020)**  
Facing west (upstream). Feature was dry at the time of assessment. Agricultural riparian vegetation.

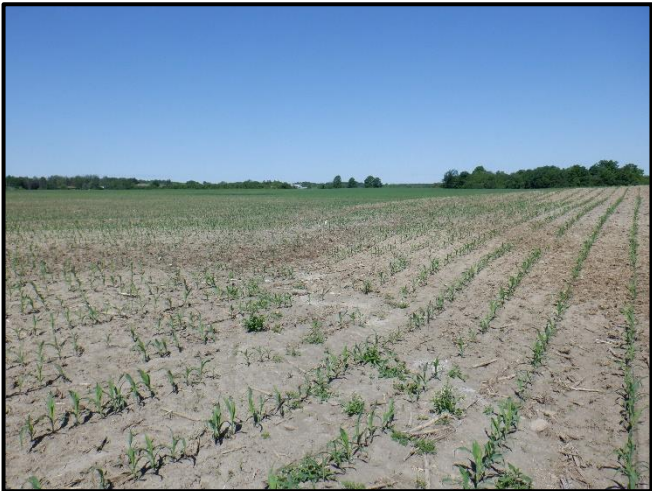
**Photograph 6.**  
**Reach WHT6-F (June 8, 2020)**  
Facing north west (upstream). Feature was dry at the time of assessment. Agricultural riparian vegetation.

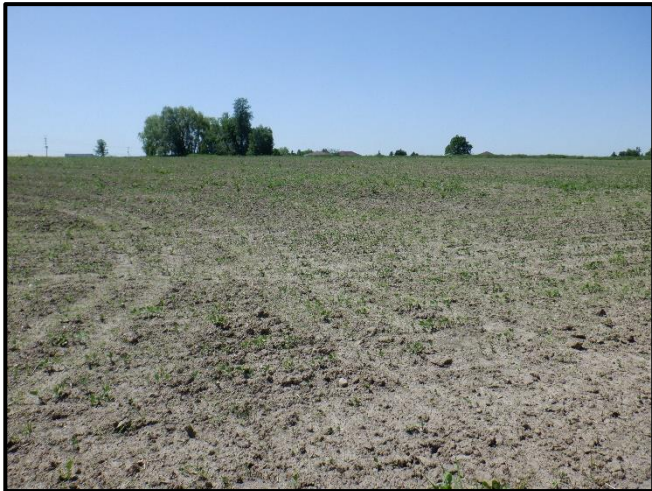
**Photograph 7.**  
**Reach WHT6-G (June 8, 2020)**  
Facing south west (upstream). Feature was dry at the time of assessment. Agricultural riparian vegetation.

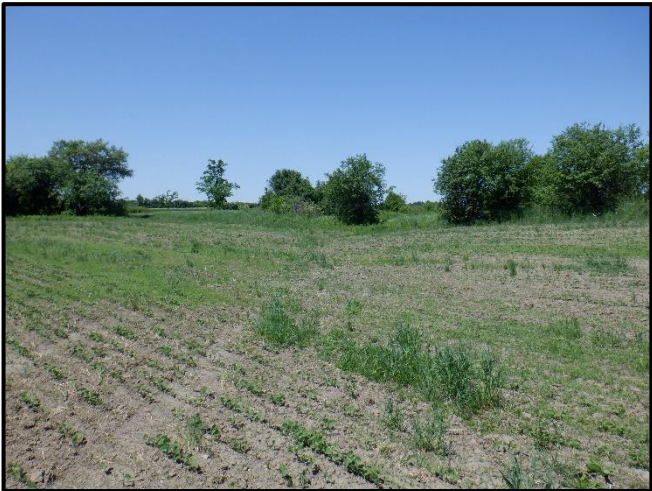
**Photograph 8.**  
**Reach WHT6-H (June 8, 2020)**  
Facing north west (upstream). Feature was dry at the time of assessment. Agricultural riparian vegetation.

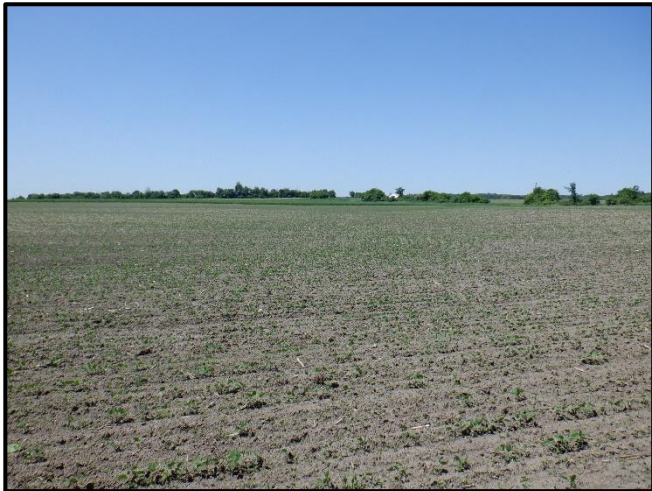
**Photograph 9.**  
**Reach WHT6-I (June 8, 2020)**  
Facing west (upstream). Feature was dry at the time of assessment. Agricultural riparian vegetation.

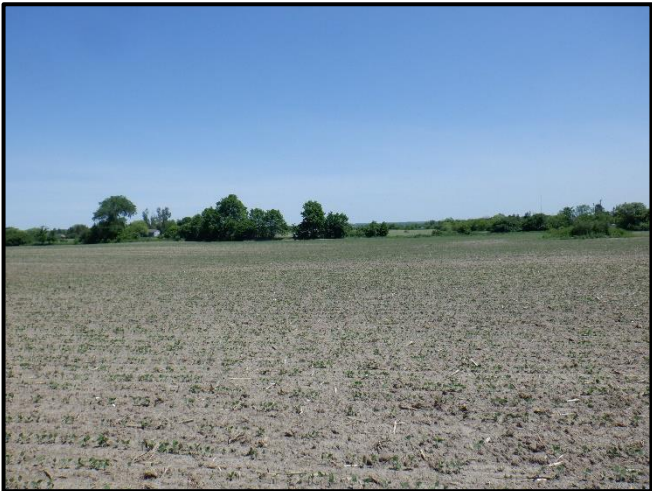
**Photograph 10.**  
**Reach WHT-J (June 8, 2020)**  
Facing north east (upstream). Feature was dry at the time of assessment. Agricultural riparian vegetation.

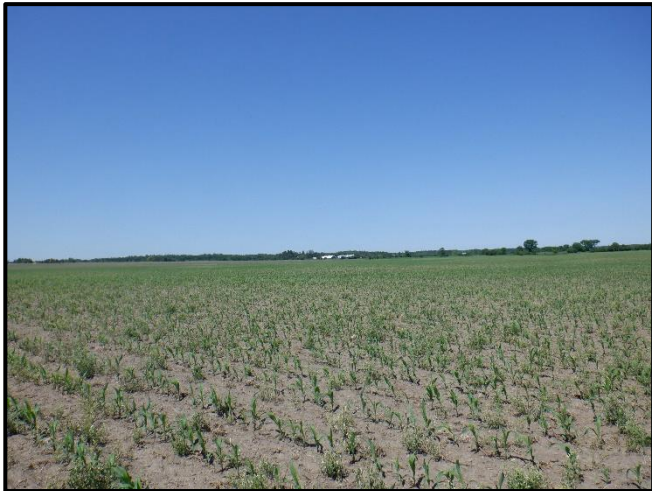
**Photograph 11.**  
**Reach WHT6-K (June 8, 2020)**  
Facing south west (upstream). Feature was dry at the time of assessment. Agricultural riparian vegetation.

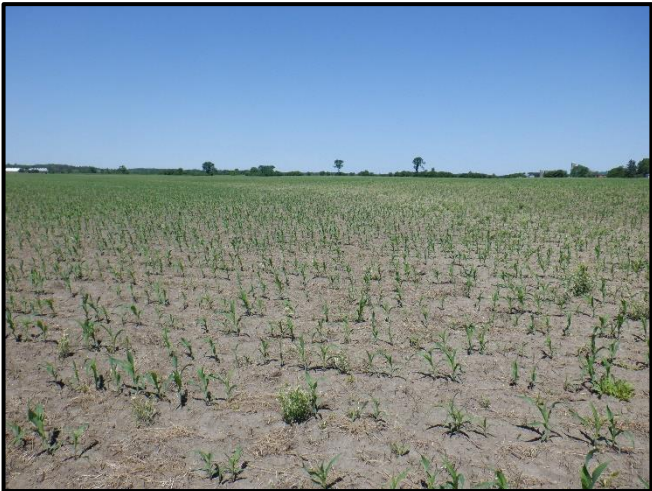
**Photograph 12.**  
**Reach WHT6-L (June 8, 2020)**  
Facing north west (upstream). Feature was dry at the time of assessment. Agricultural riparian vegetation.

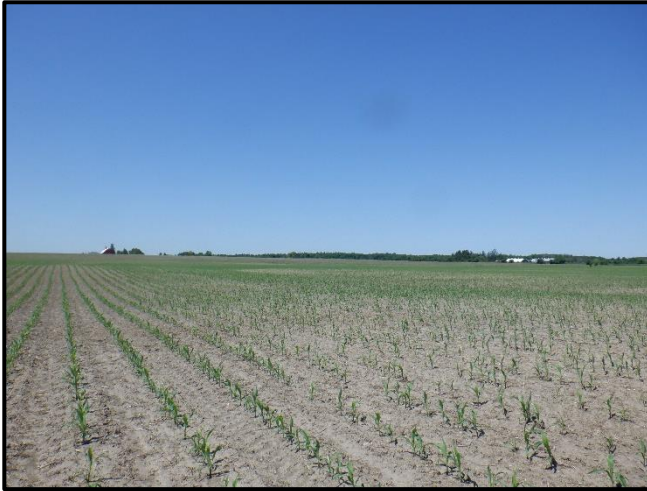
**Photograph 13.**  
**Reach WHT6-M (June 8, 2020)**  
Facing west (upstream). Feature was dry at the time of assessment. Agricultural riparian vegetation.

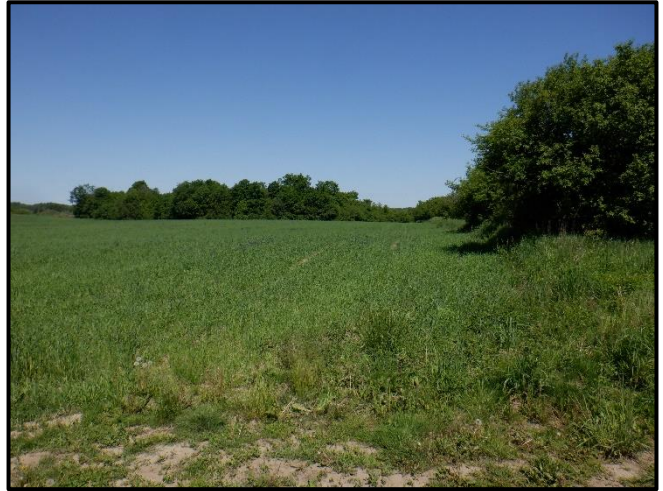
**Photograph 14.**  
**Reach WHT6-N (June 8, 2020)**  
Facing north east (upstream). Feature was dry at the time of assessment. Agricultural riparian vegetation.

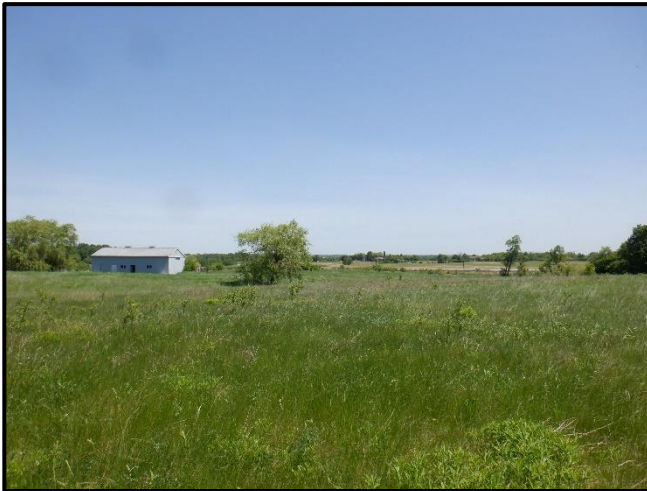
**Photograph 15.**  
**Reach MHT7-C (June 8, 2020)**  
Facing north east (downstream). Feature was dry at the time of assessment. Meadow riparian vegetation.

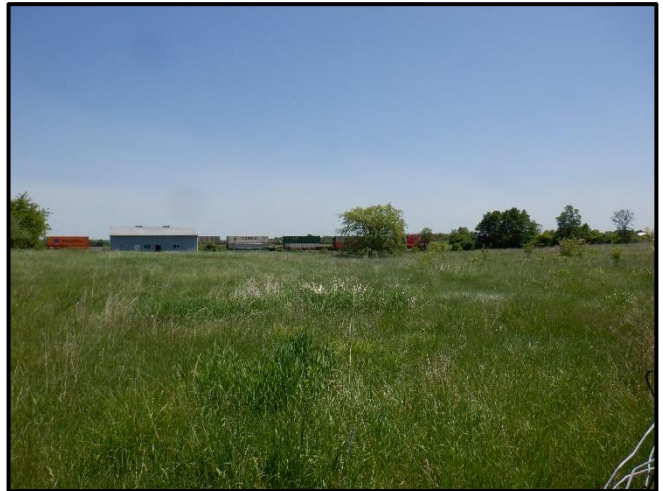
**Photograph 16.**  
**Reach MHT7-D (June 8, 2020)**  
Facing east (downstream). Feature was dry at the time of assessment. Meadow riparian vegetation.

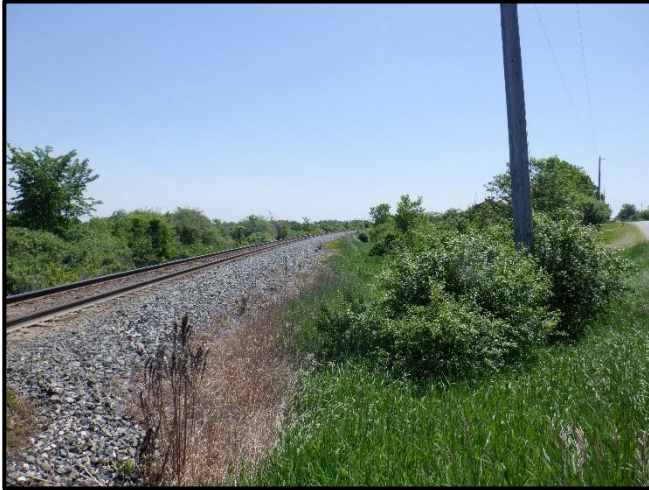
**Photograph 17.**  
**Reach MHT8-A (June 8, 2020)**  
Facing north east (downstream). Feature was dry at the time of assessment. Meadow riparian vegetation.

Within the CEISMP Study Area, all assessed HDF reaches east of Humber Station Road (draining to the main Humber River) were classified as mitigation. These features were characterized as providing surface drainage to downstream fish habitat, with meadow vegetation within riparian communities. While amphibian calls were documented for Reach MHT8-A, this feature was characterized as a heavily modified (channelized) ditch along the rail line embankment. As the vegetation community was classified as Anthropogenic (no wetland present), terrestrial habitat for this reach was classified as 'Valued' (i.e., potential steppingstone habitat), refer to **Appendix B (Photograph 17)**.

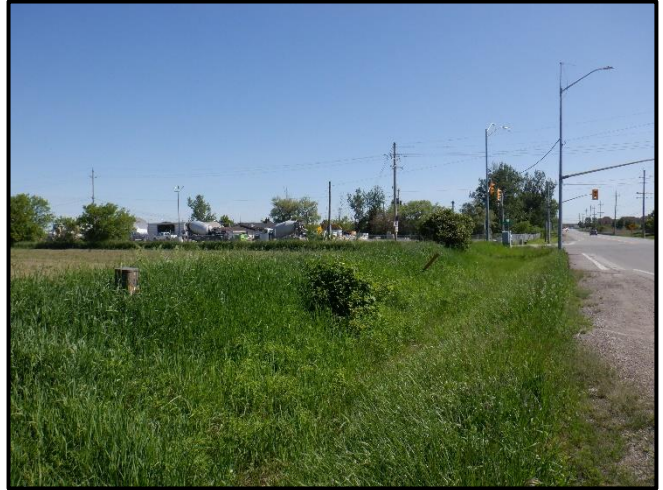
**Photograph 18.**  
**Reach WHT5-A (June 8, 2020)**  
Facing south west (upstream). Feature was dry at the time of assessment. Meadow riparian vegetation.

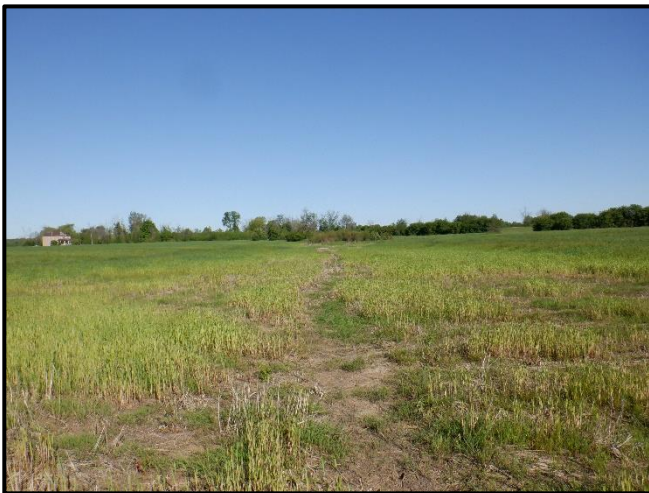
**Photograph 19.**  
**Reach WHT2-A (June 8, 2020)**  
Facing north west (upstream). Feature was dry at the time of assessment. Meadow marsh riparian vegetation.

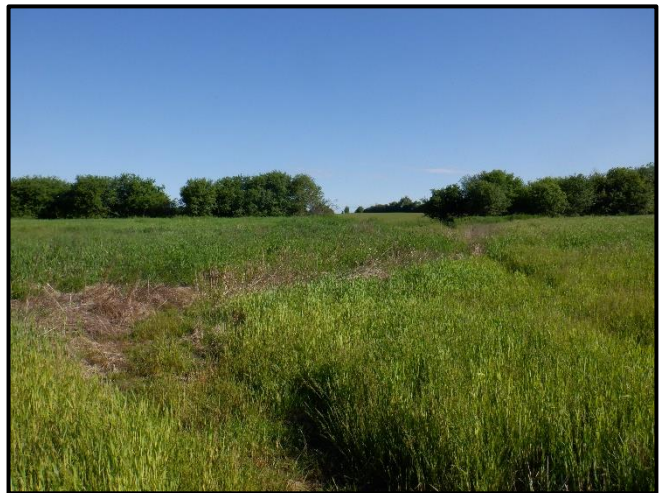
**Photograph 20.**  
**Reach WHT2-B (June 8, 2020)**  
Facing north west (upstream). Feature was dry at the time of assessment. Meadow marsh riparian vegetation.

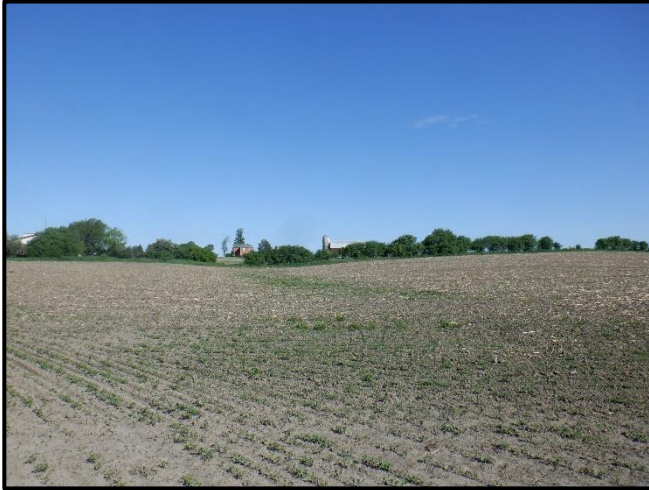
**Photograph 21.**  
**Reach WHT2-C (June 8, 2020)**  
Facing north west (upstream). Feature was dry at the time of assessment. Agricultural riparian vegetation.

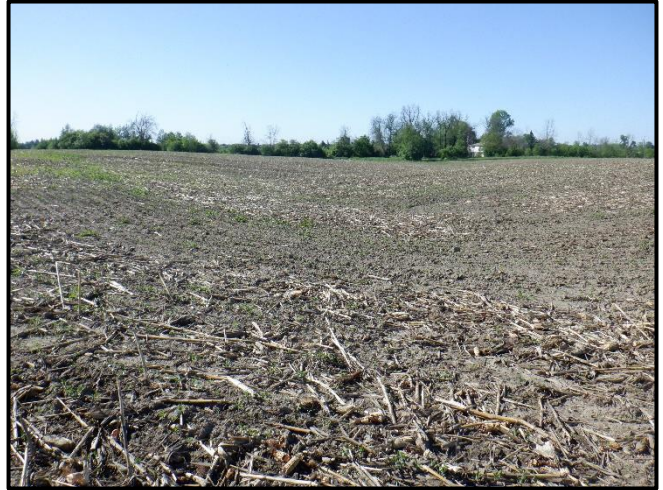
**Photograph 22.**  
**Reach WHT2-E (June 8, 2020)**  
Facing south west (upstream). Feature was dry at the time of assessment. Agricultural riparian vegetation

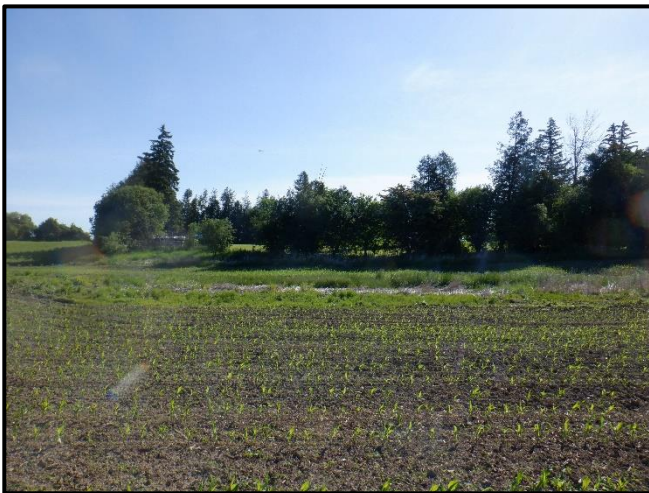
**Photograph 23.**  
**Reach WHT2-G (June 8, 2020)**  
Facing north (upstream). Feature was dry at the time of assessment. Agricultural riparian vegetation.

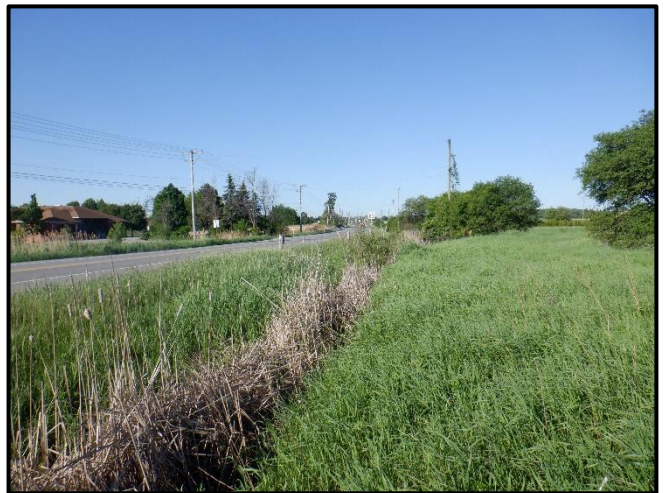
**Photograph 24.**  
**Reach WHT3-A (June 8, 2020)**  
Facing north east (downstream). Feature was dry at the time of assessment. Wetland riparian vegetation.

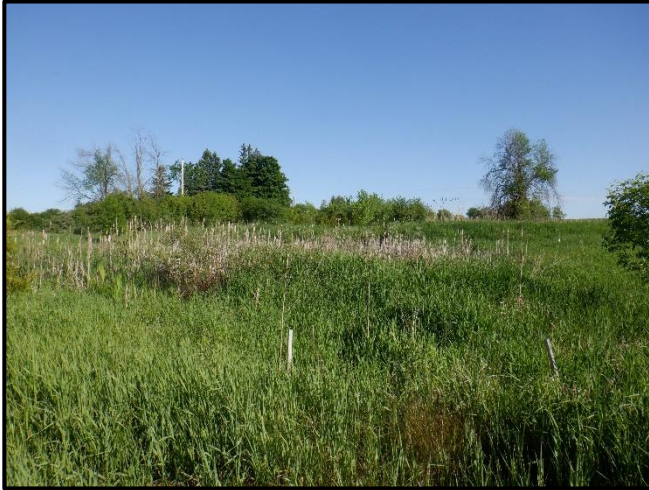
**Photograph 25.**  
**Reach WHT3-B (June 8, 2020)**  
Facing north west (upstream). Feature was dry at the time of assessment. Wetland riparian vegetation.

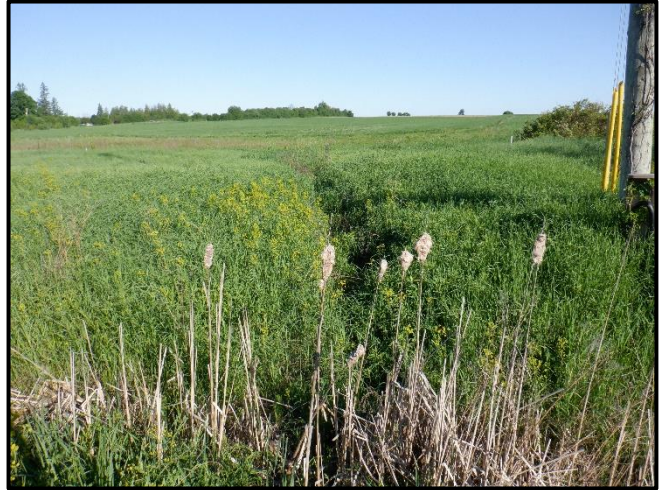
**Photograph 26.**  
**Reach WHT3-C June 8, 2020**  
Facing north west (upstream). Feature was dry at the time of assessment. Meadow riparian vegetation.

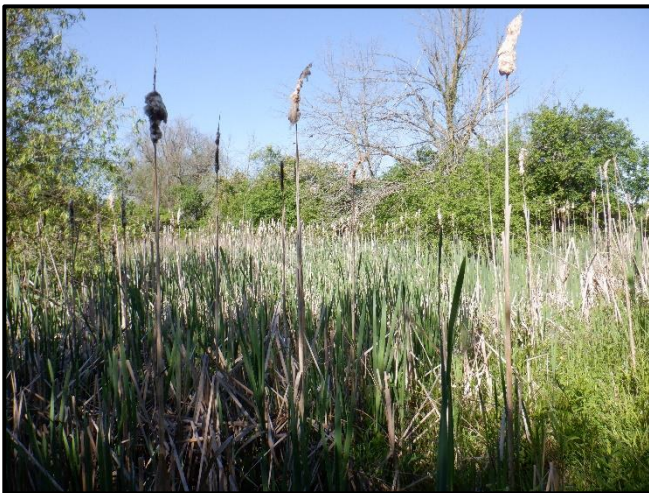
**Photograph 27.**  
**Reach WHT1-A (June 8, 2020)**  
Facing north west (upstream). Feature was flowing at the time of assessment. Wetland riparian vegetation.

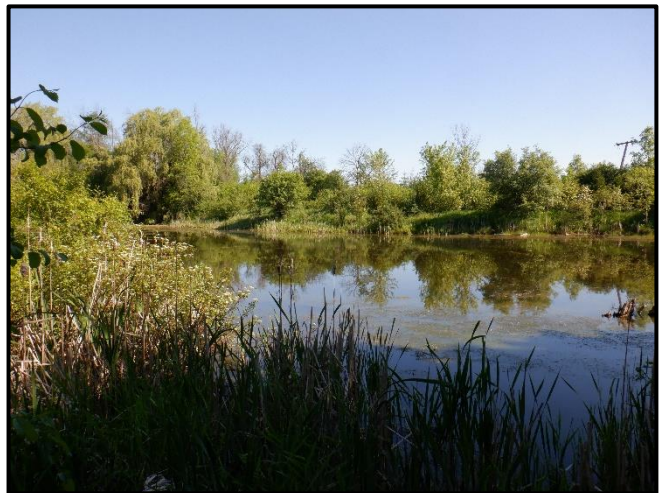
**Photograph 28.**  
**Reach WHT1-B (June 8, 2020)**  
Facing north east (upstream). Feature was flowing at the time of assessment. Wetland riparian vegetation.

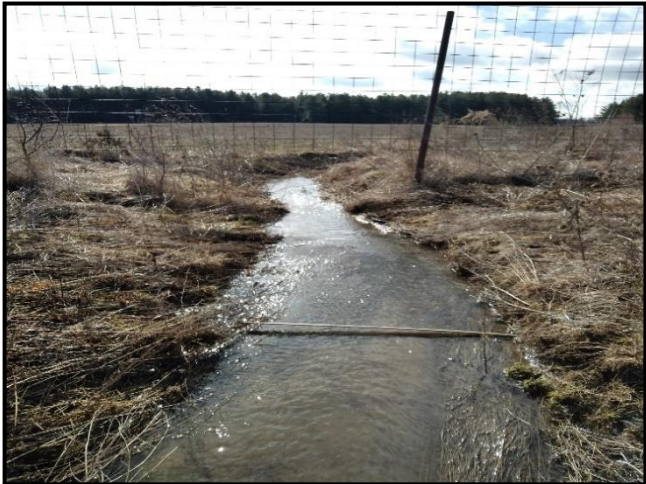
**Photograph 29.**  
**Reach WHT3-A1 (March 27, 2024)**  
Facing southeast (downstream). Feature was flowing during the time of assessment. Meadow riparian vegetation.

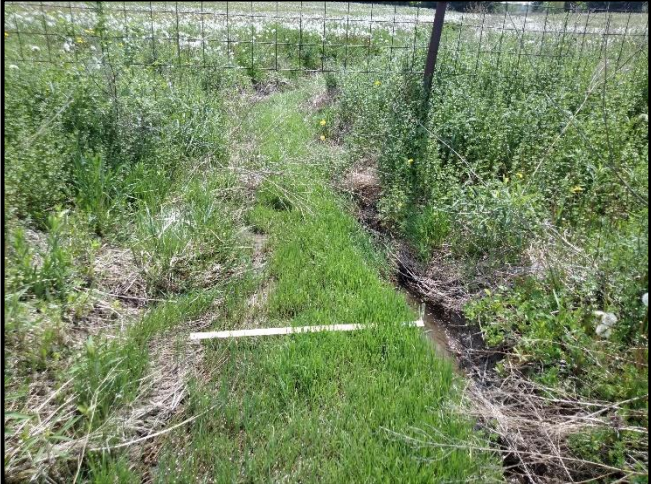
**Photograph 30.**  
**Reach WHT3-A1 (May 16, 2024)**  
Facing southeast (downstream). Feature was flowing during the time of assessment. Meadow riparian vegetation.

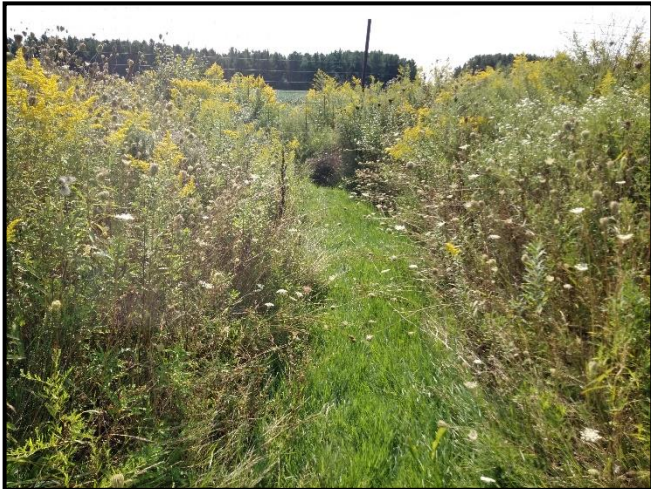
**Photograph 31.**  
**Reach WHT3-A1 (September 4, 2024)**  
Facing southeast (downstream). Feature was dry at the time of assessment. Wetland riparian vegetation.

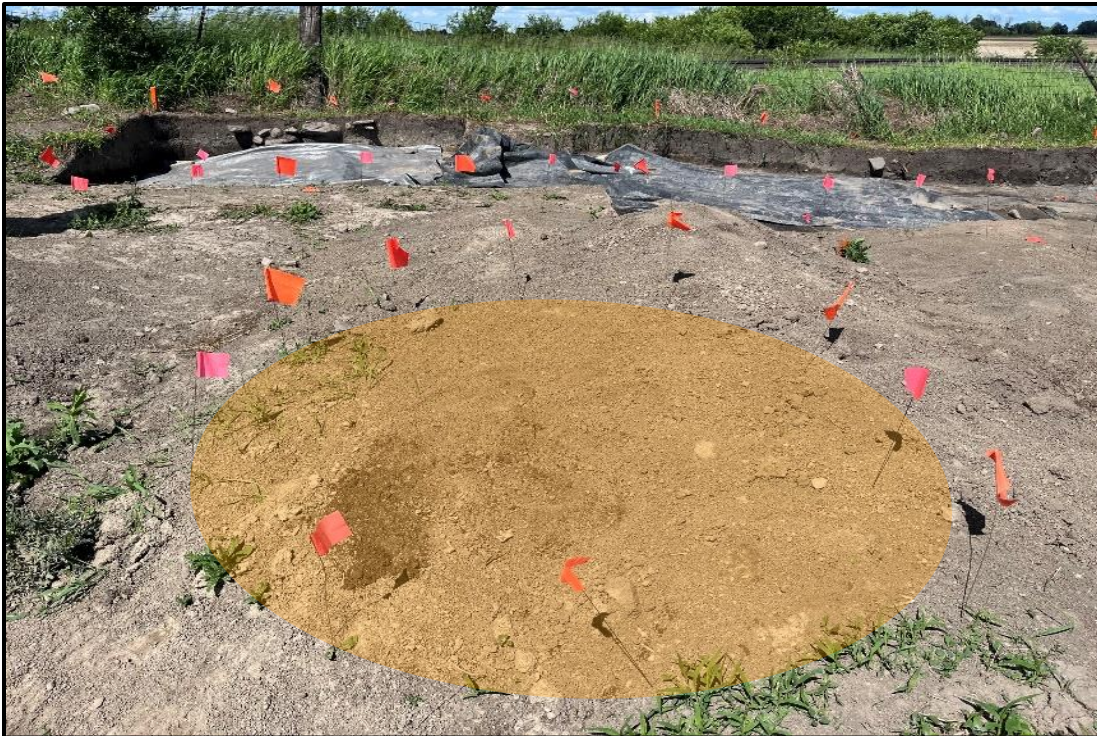
**Photograph 1. Flagged snapping turtle Nest Area – approximate limits (June 6, 2024)**

On June 5, 2024, ASI confirmed that the turtle had nested within the archaeological excavation area. The nest was flagged and provided a buffer to ensure that this area was not disturbed. The Owner then contacted Beacon to advise of the presence of the nest and to request that a site visit be conducted to document site conditions and provide mitigation recommendations to protect the nest. This information was shared with the HDI Archaeology Logistics Coordinator (email correspondence) on June 5, 2024.

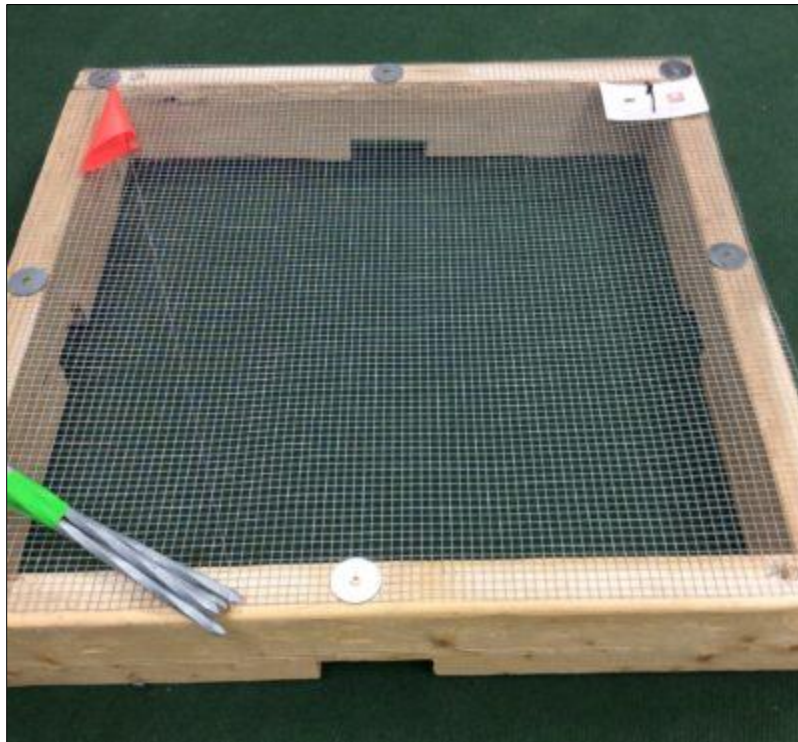
**Photograph 2. Example of a Turtle Nest Protector Structure (<https://ontarioturtle.ca/get-involved/turtle-nests-and-nest-protection/>)**

Beacon staff undertook a site visit on June 6, 2024. At this time, recommendations were provided to ASI and the Owner to stop work in the area and install a nest protector structure (**Photograph 2**) or equivalent to protect the nest (<https://ontarioturtle.ca/get-involved/turtle-nests-and-nest-protection/>). The Owner was able to install the turtle nest protector structure on June 18, 2024. These recommendations were shared with the HDI in a memo prepared by Beacon dated June 25, 2024.

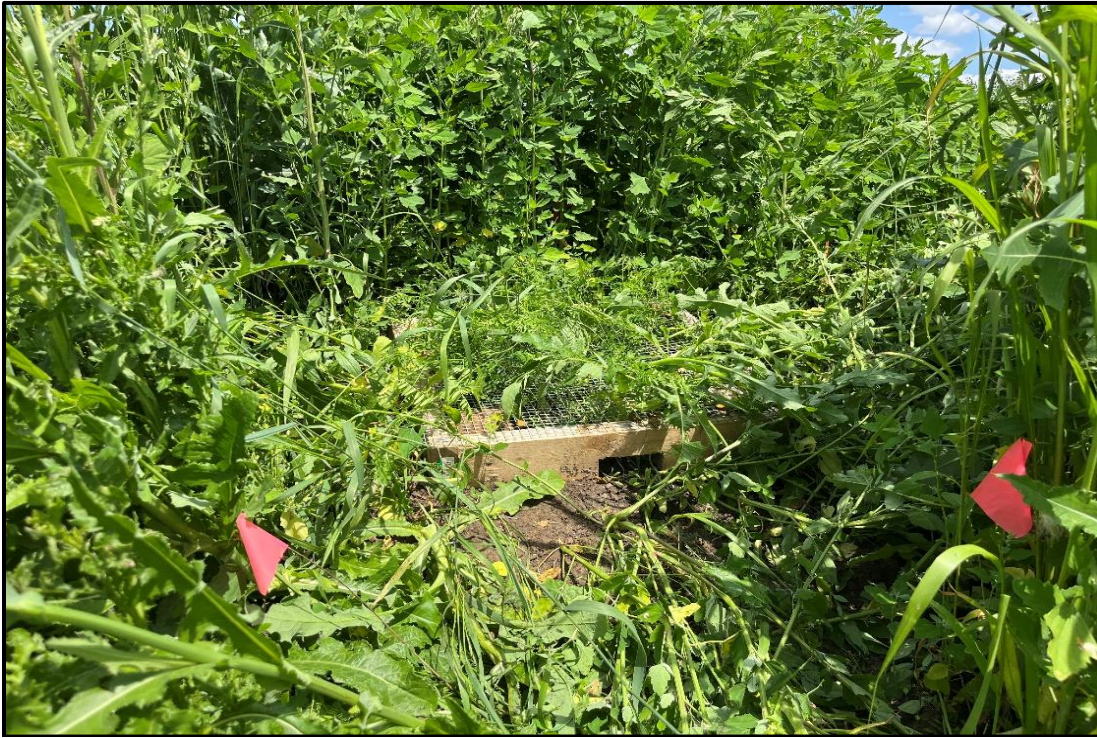
**Photograph 3. Snapping turtle nest protector structure (July 19, 2024).**

- July 19, 2024 (**Photograph 3**);
- August 23, 2024 (**Photograph 4**); and
- September 10, 2024 (**Photograph 5**).

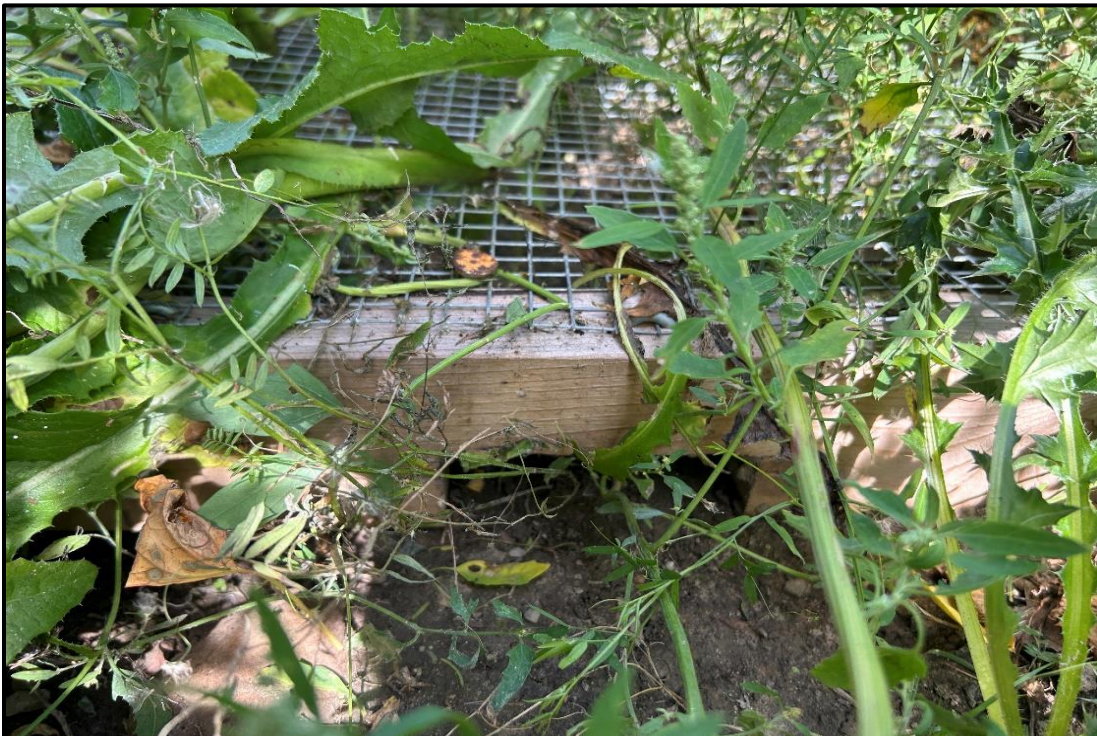
**Photograph 4. Snapping turtle nest protector structure (August 23, 2024).**

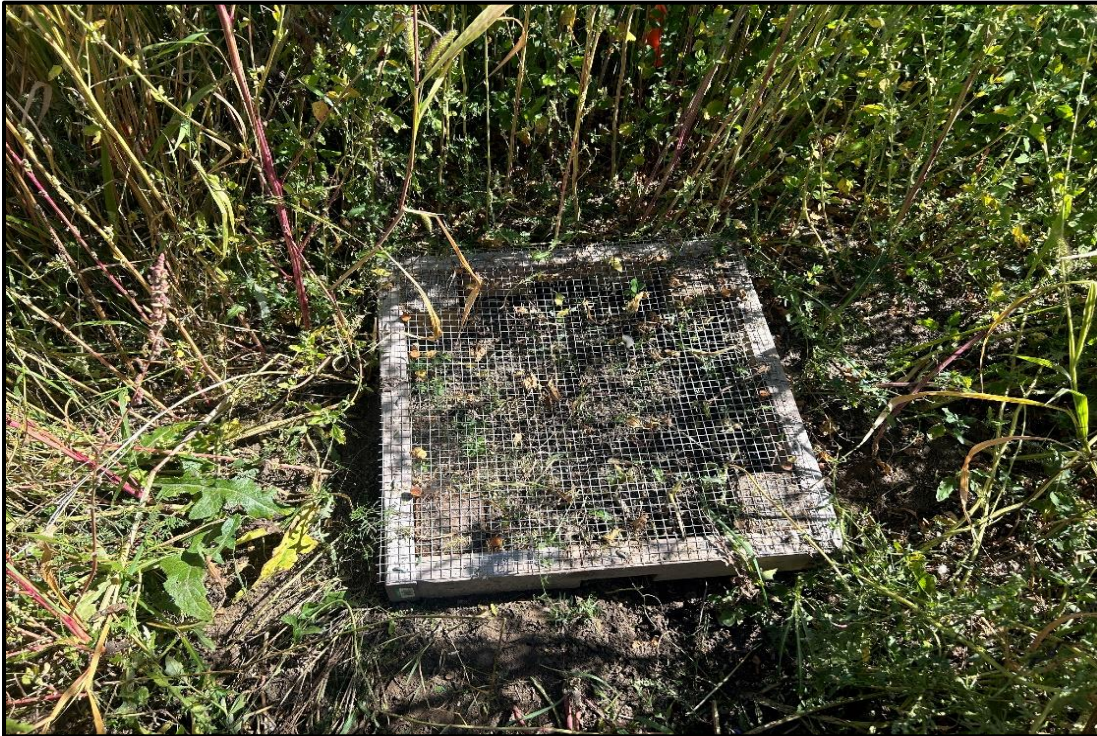
**Photograph 5. Snapping turtle nest protector structure (September 10, 2024).**

During each site visit, staff confirmed that the exit from the nest protector was clear of vegetation or other obstructions to allow the hatchlings to leave the nest protector. Flagging remained in place around the nest protector structure. No evidence of emergence was observed during any of the three site visits. As a result, monitoring will continue until the end of October or until it can be confirmed that the hatchlings have departed the nest.

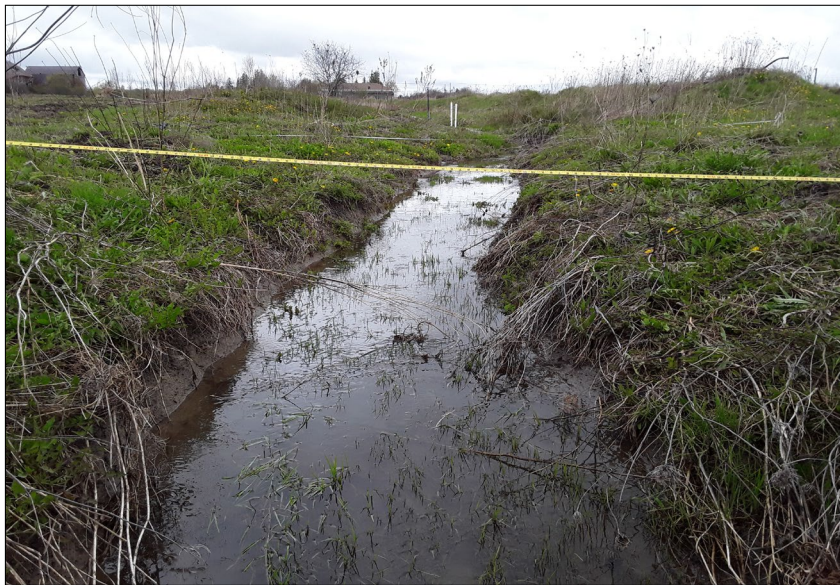
**Photo 1.** Representative photo of WHT3 Reach A1 detailed field site.

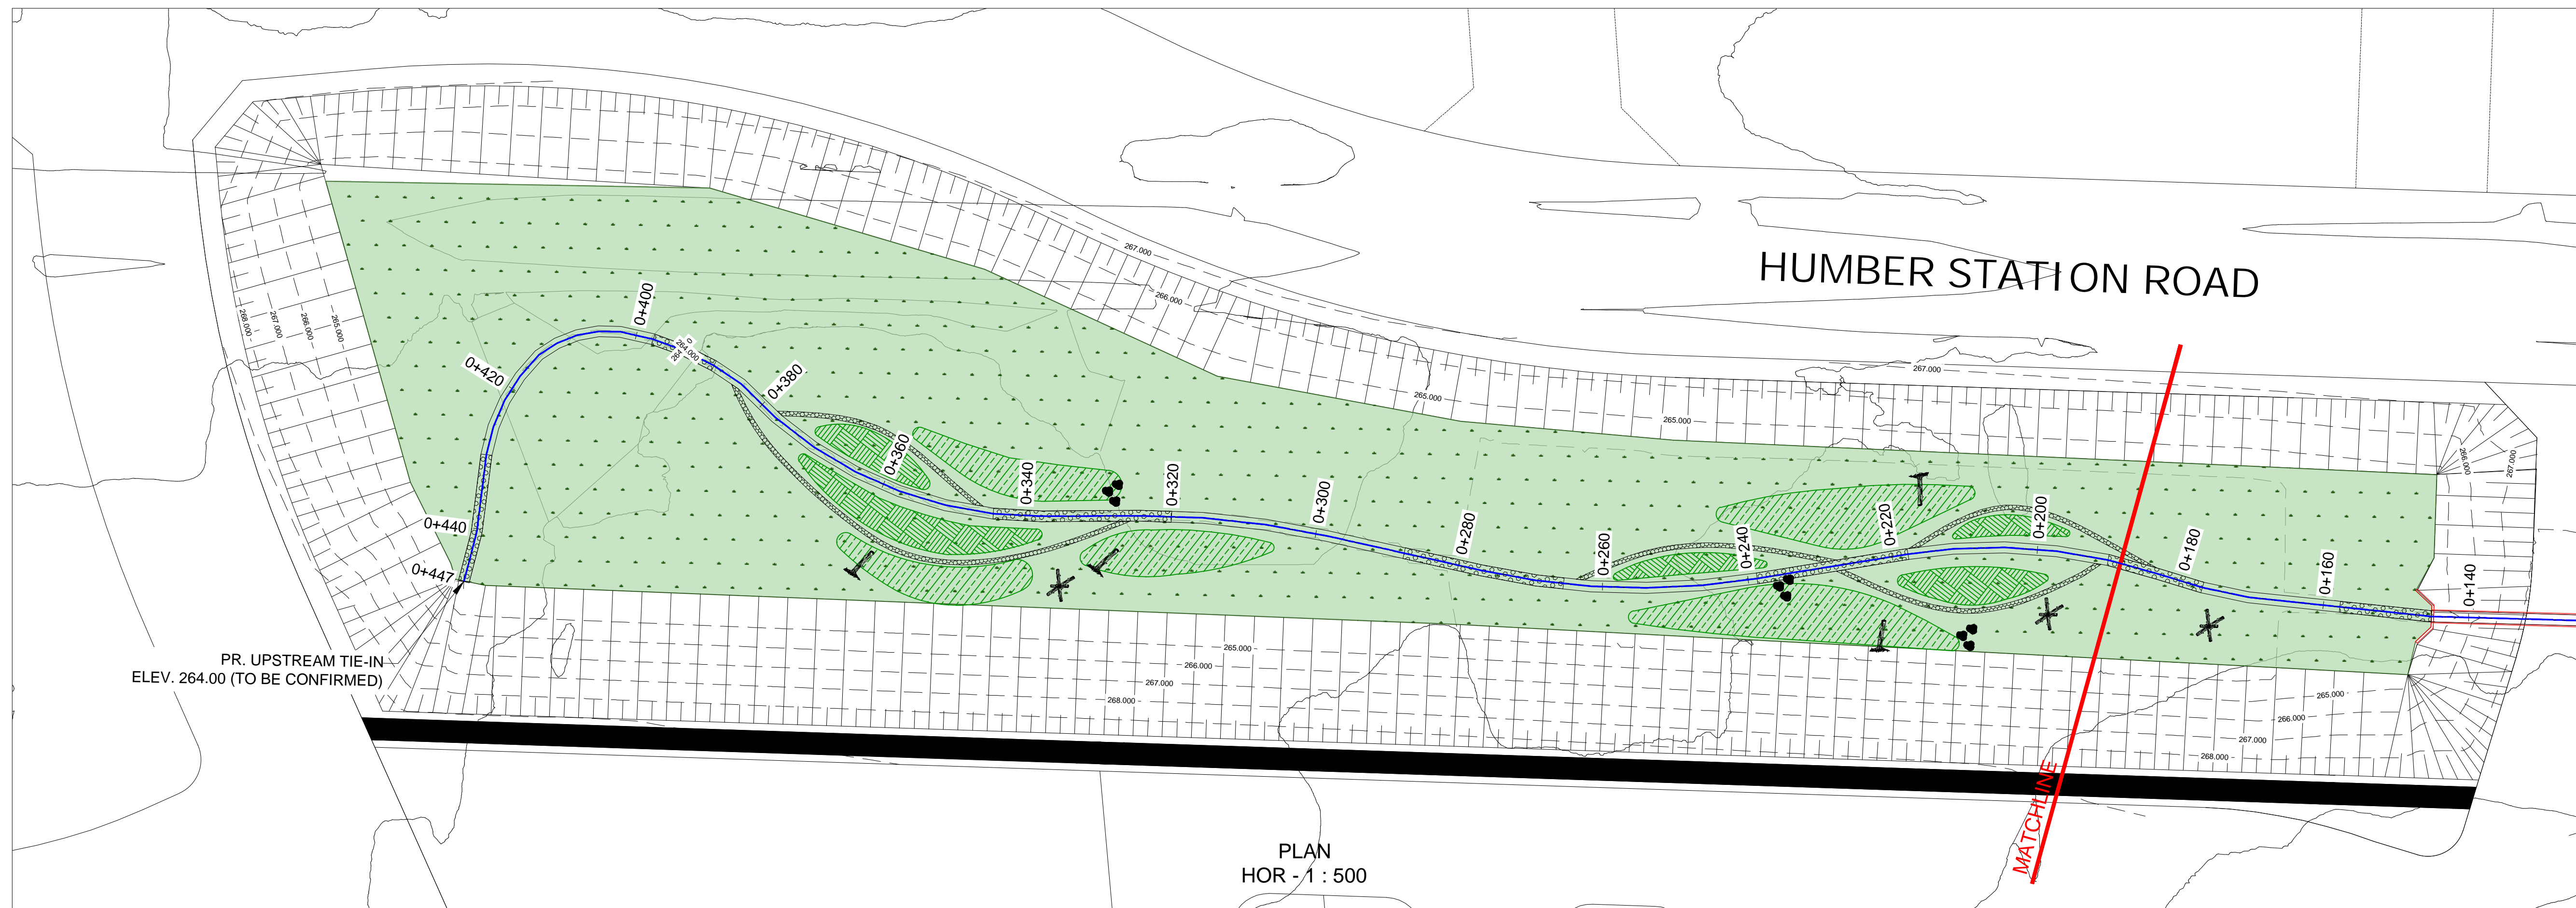
- PR. CONTOURS
- PR. CHANNEL CENTRELINE AND BANKS
- PR. RIVERSTONE MIX (REFER TO DETAILS ON D-1)
- PR. SECONDARY OVERFLOW CHANNELS
- PR. WETLAND (REFER TO DETAILS ON D-1)
- PR. HUMMOCK FEATURES
- PR. VERNAL POOLS
- PR. BOULDER CLUSTERS
- ✂ PR. BASKING LOGS
- ✂ PR. WOOD DEBRIS HABITAT FEATURES
