Humber Station – Comprehensive Environmental Impact Study and Management Plan

Phase 1 – Characterization/Existing Conditions and Baseline Inventory

Town of Caledon, Ontario

October 2023
Project 1901485

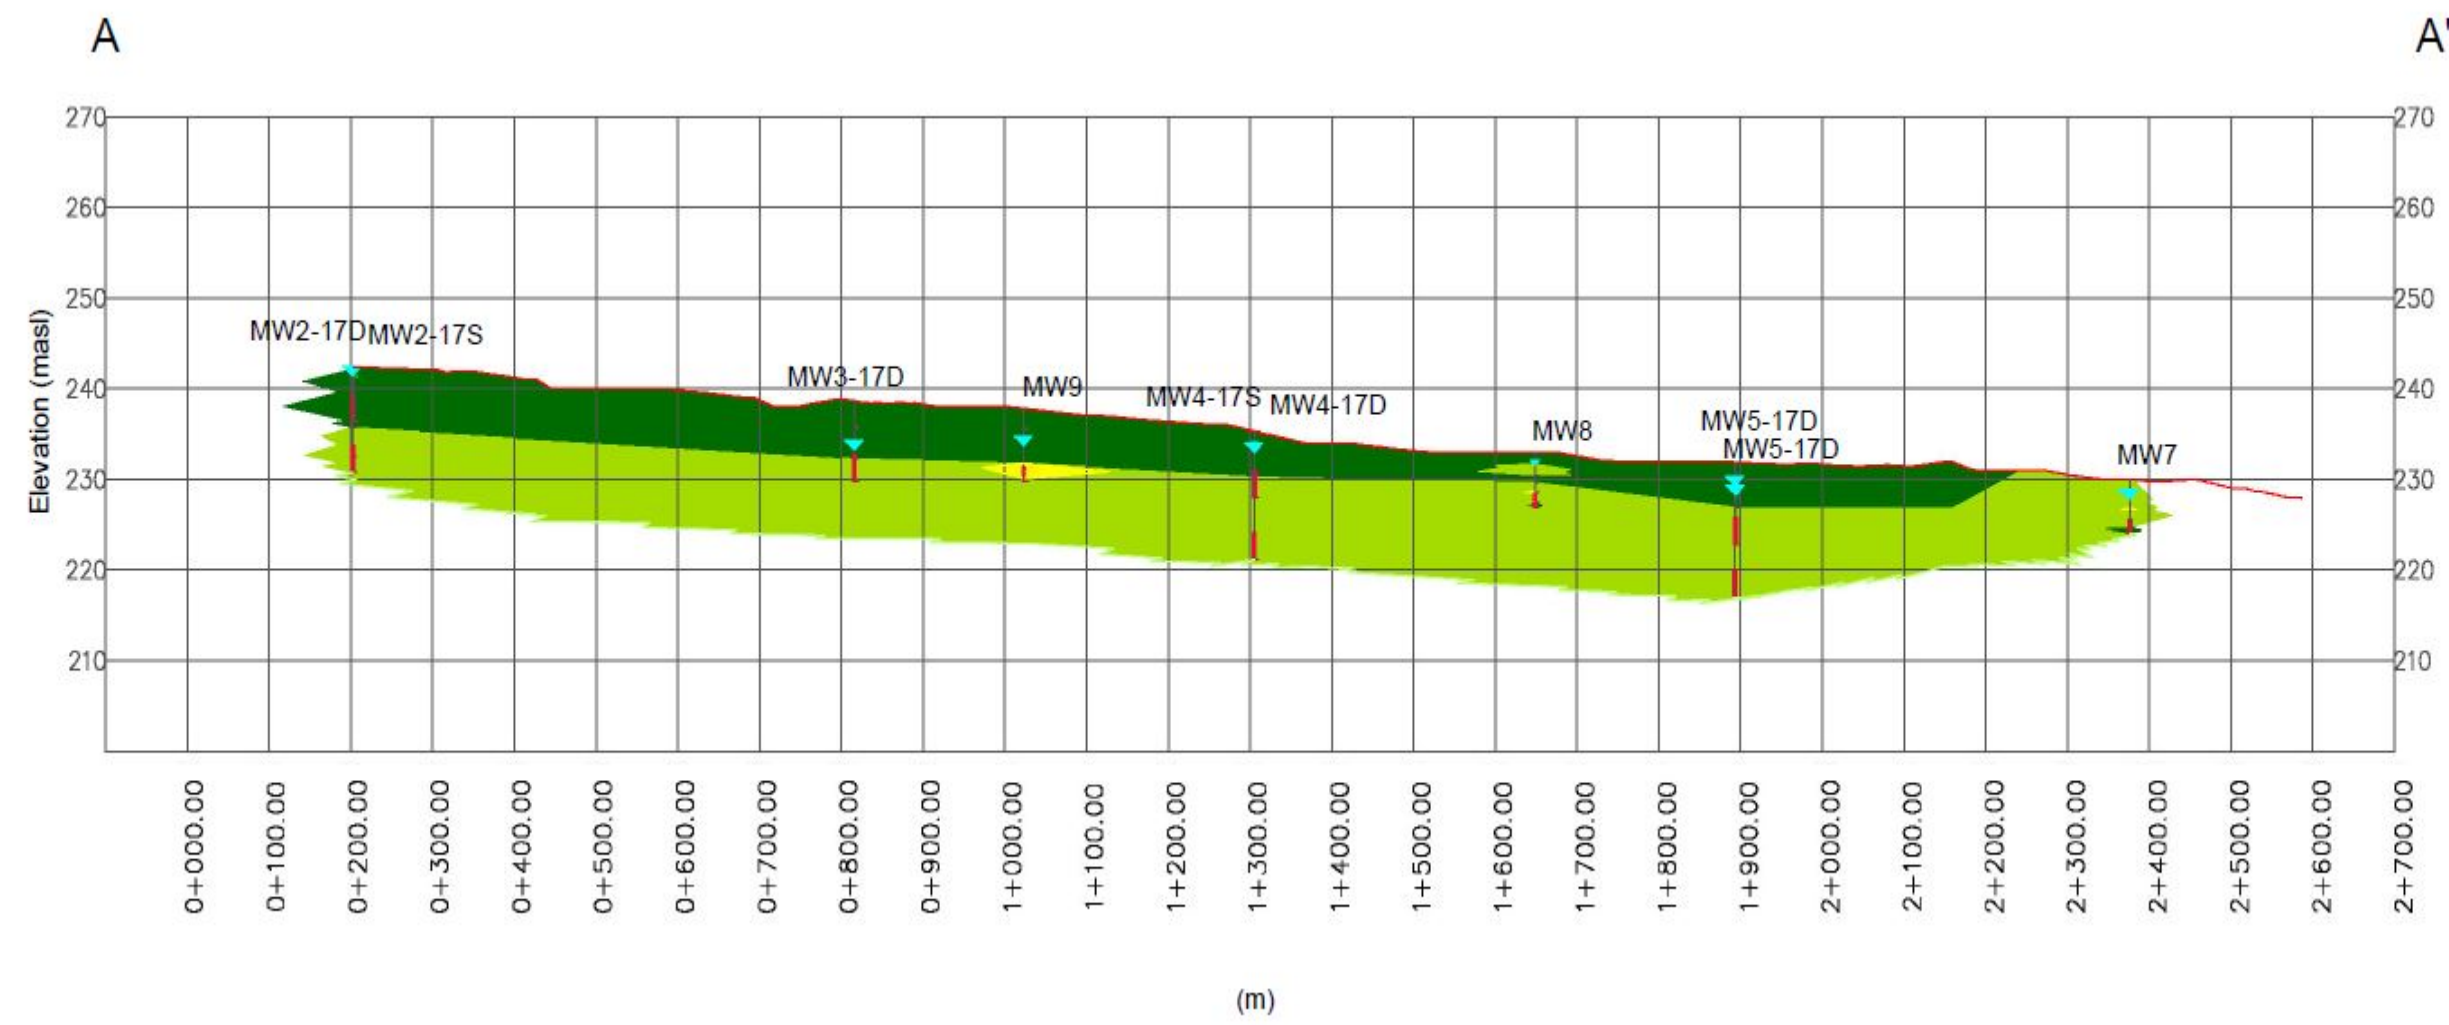
Figure A2-5
Local Cross-Section

- ### Legend
- Silty Clay Till (Halton Till)
 - Silt Till (Newmarket Till)
 - Sand
 - Monitoring Well Screen
 - Measured Water Level

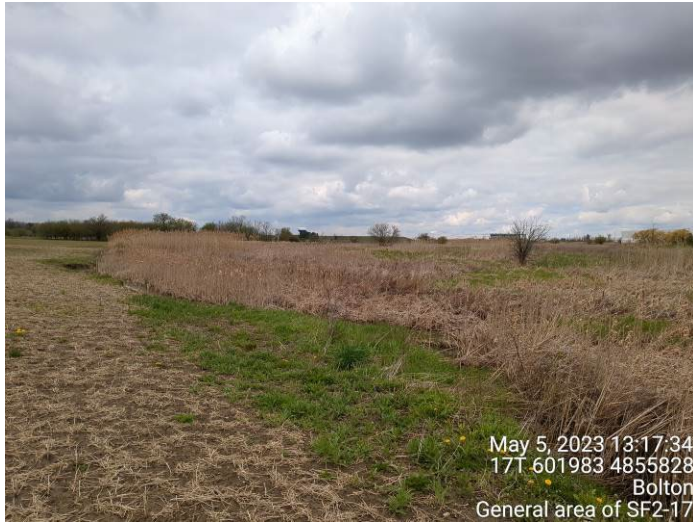
Photo 5: Streamflow station SF2-17 was unable to be located due to dense population of cattails. A view of the general area where SF2-17 was installed taken on May 5, 2023, is shown above. It should be noted that access to this area was not available on December 2022 site visit.

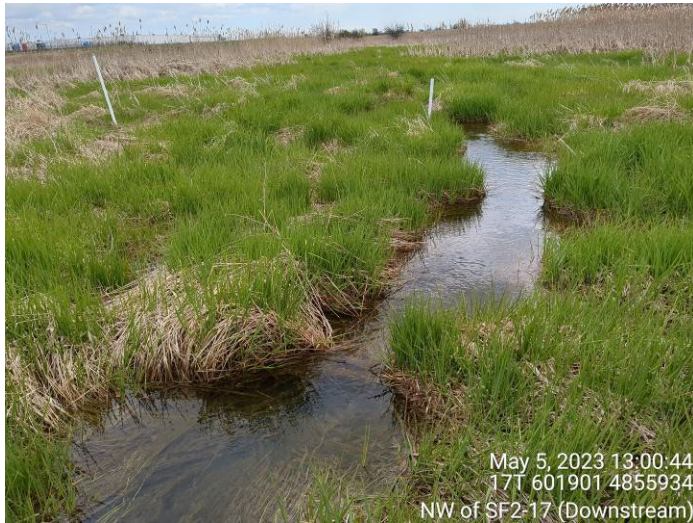
Photo 7: A view of the drainage feature, facing downstream, in the general area of SF2-17. Flow was observed to be intermediate to fast at this area. It should be noted that access to this area was not available on the December 2022 site visit.

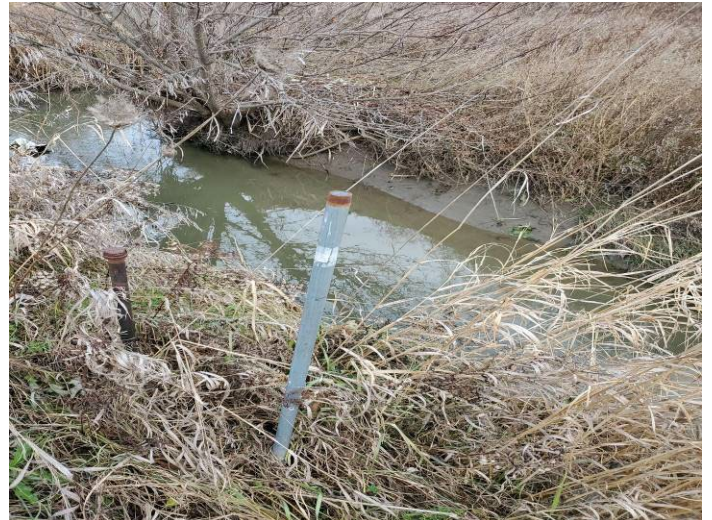
Photo 16: A view of the piezometers at SF6-17 taken on December 9, 2022. A missing cap was observed on one of them, but remaining conditions were noted to be in good condition.

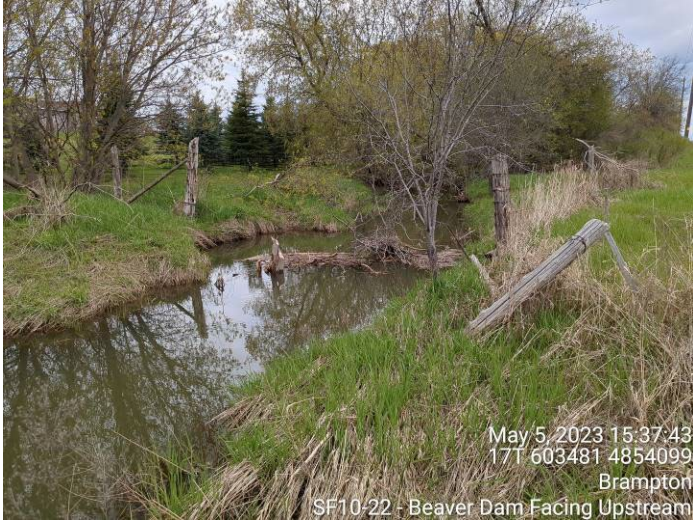
Photo 32: A view of the streamflow station at SF10-22, facing upstream, taken on May 5, 2023 for additional observations. A beaver dam was observed. Moderate flow was observed.
