Humber Station – Comprehensive Environmental Impact Study and Management Plan

Phase 1 – Characterization/Existing Conditions and Baseline Inventory

Town of Caledon, Ontario

October 2023
Project 1901485

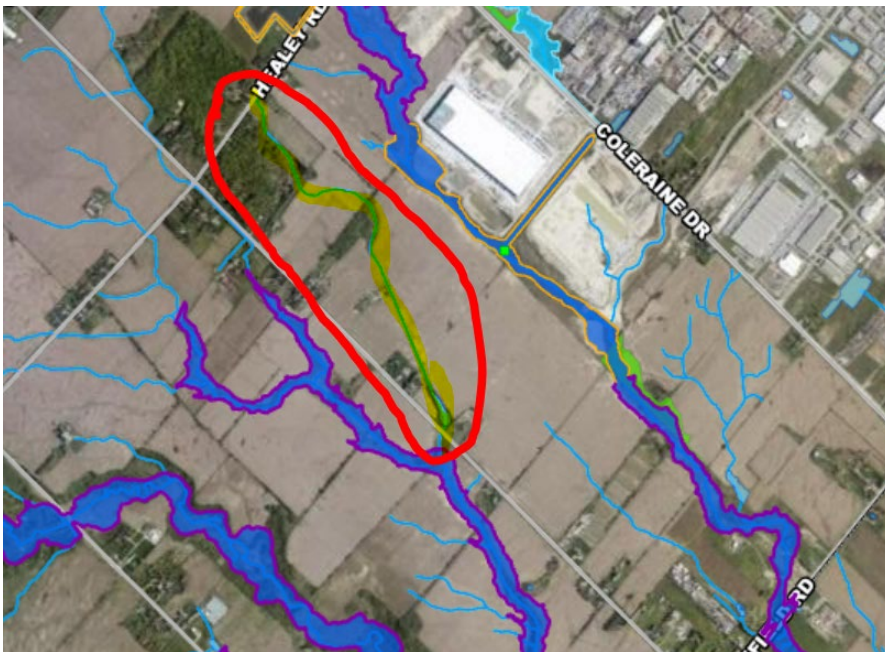
As Discussed, I am preparing the floodplain mapping sheet "hum_145" in CAD format, corresponding engineered HEC-RAS model and the regional peak flow data to be used in developing the HEC-RASA model for the watercourse circled in RED below.

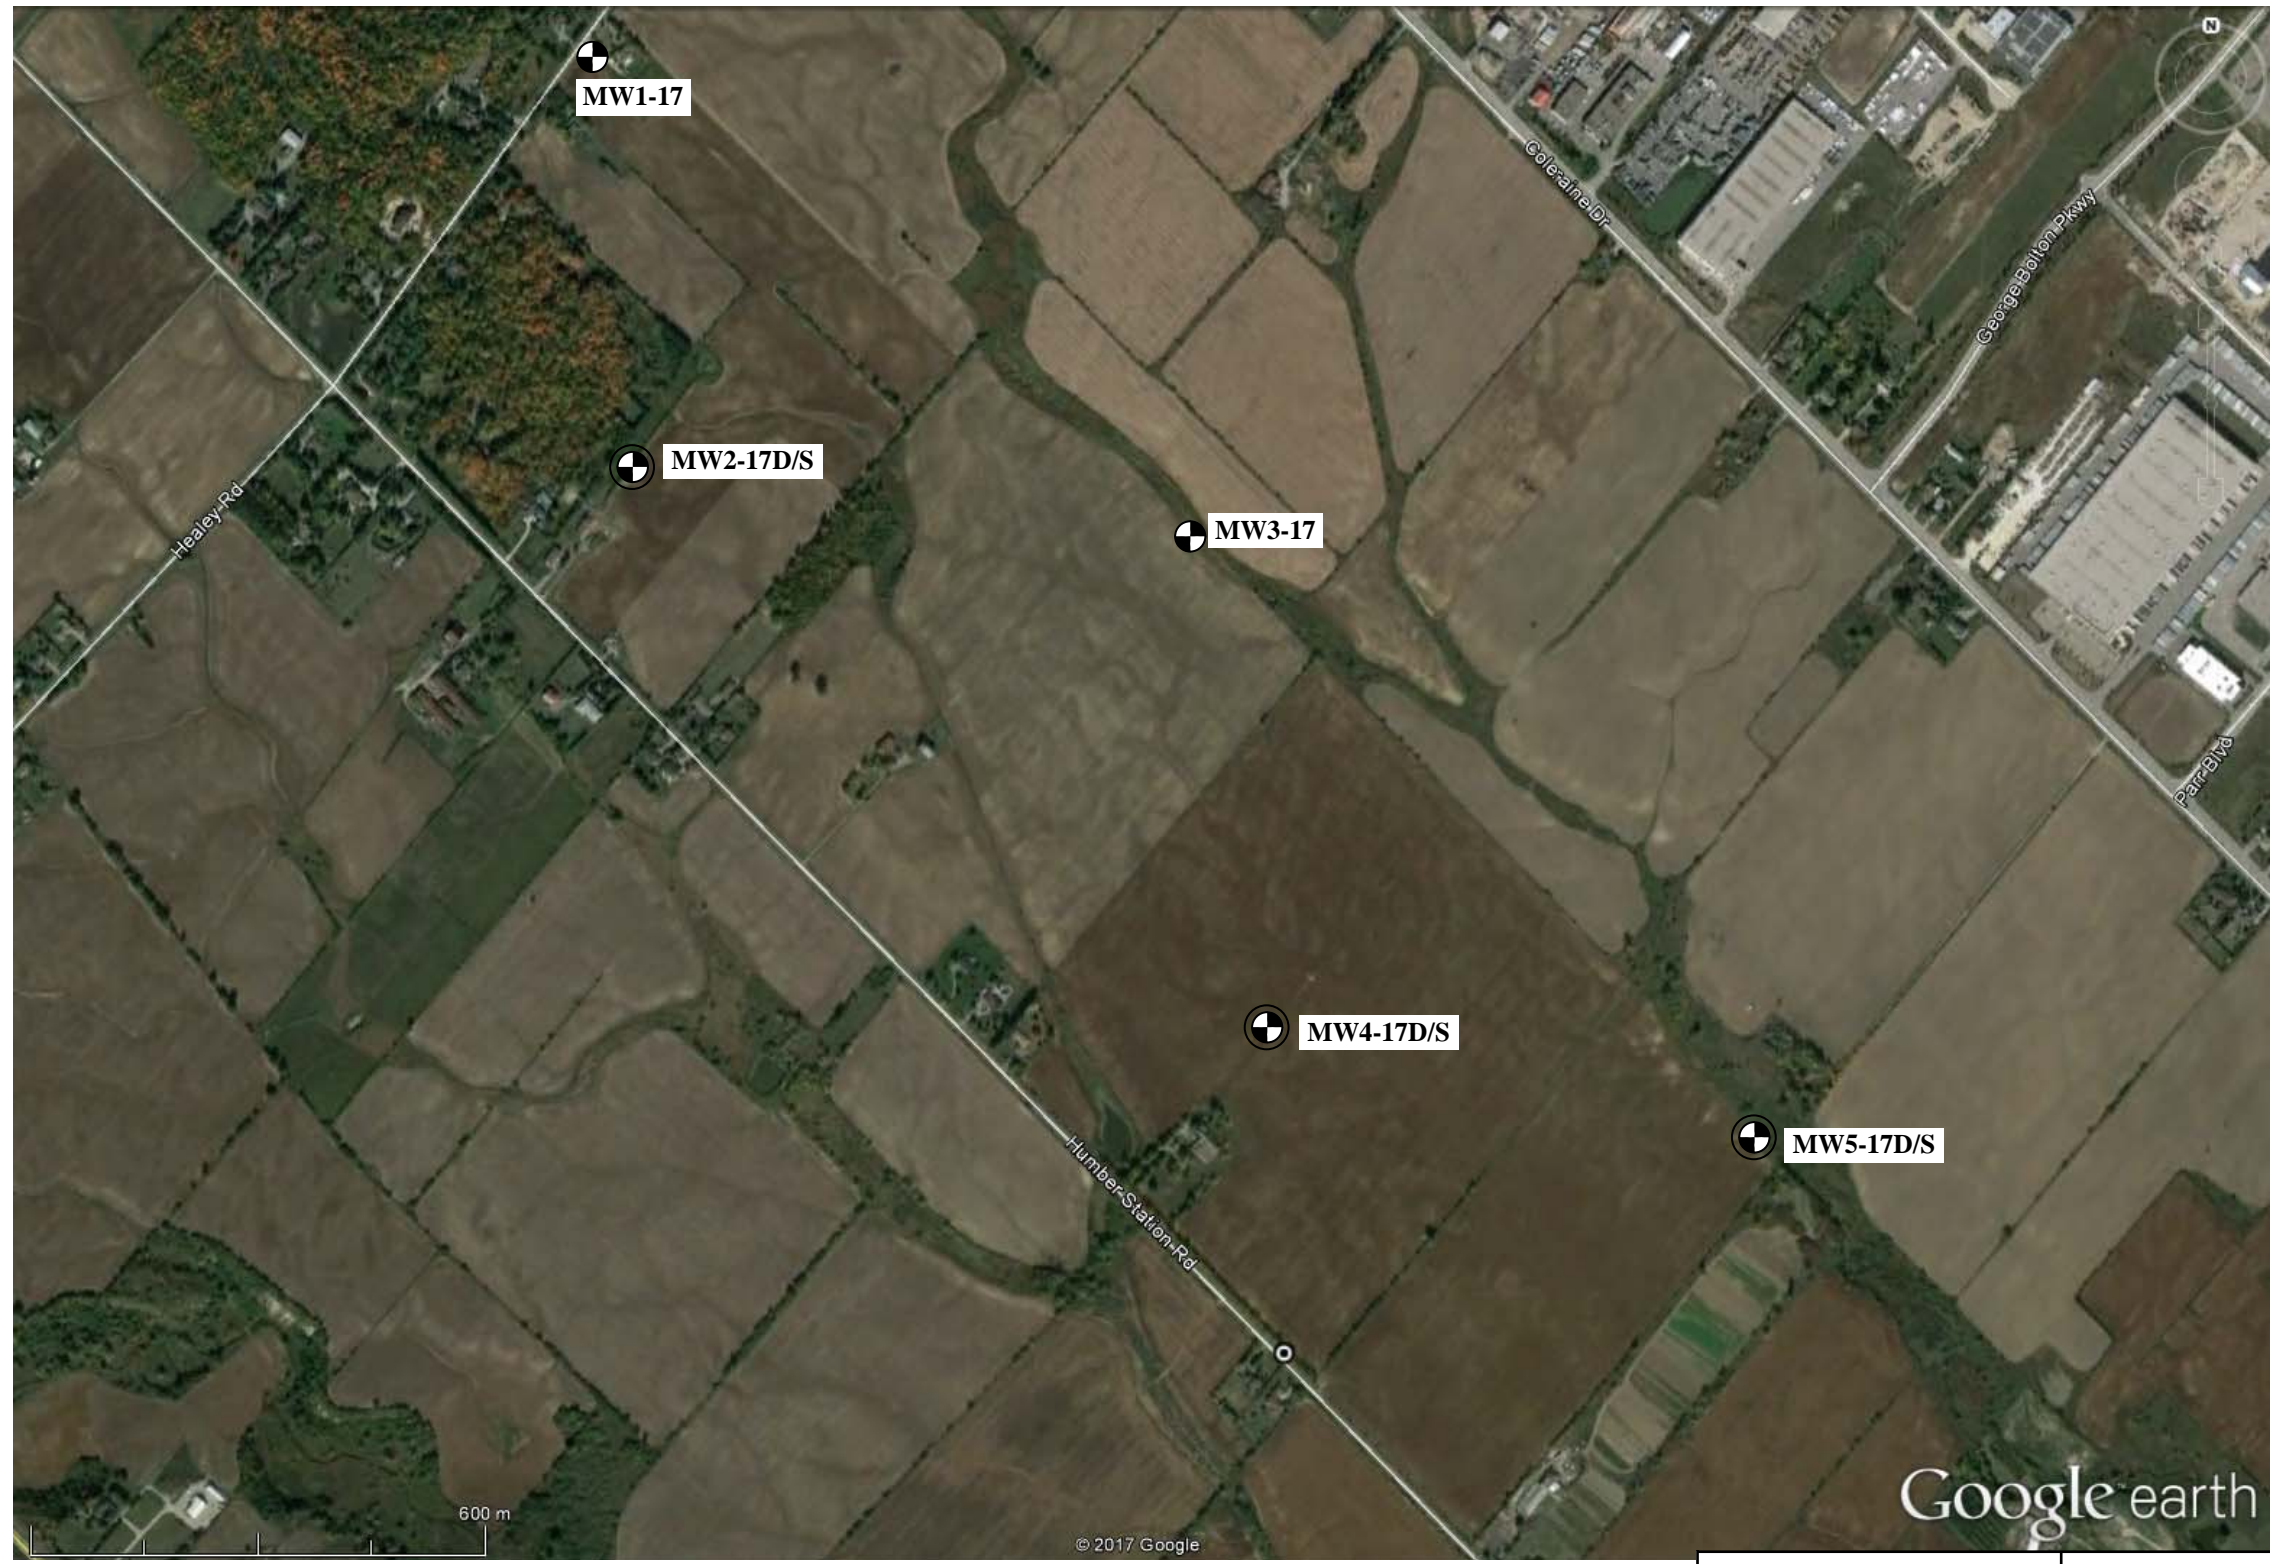
Figure: 12

Classification of Sample [& Group Symbol]: SILT, some clay, a trace of fine sand

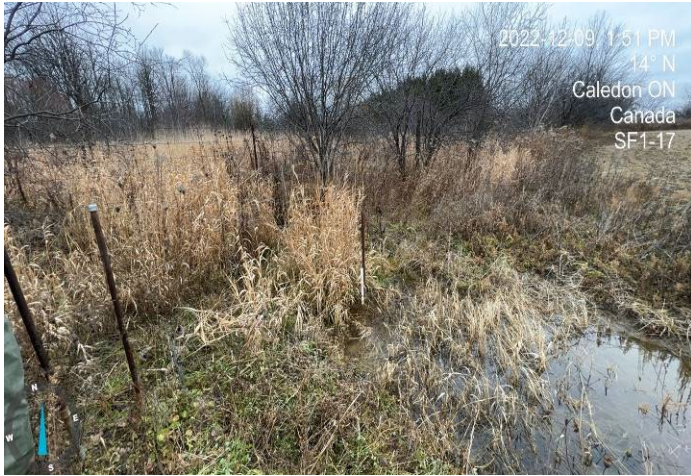
Photo 1: A view of streamflow station SF1-17 taken on December 9, 2022. Piezometers and staff gauge were observed in good condition.

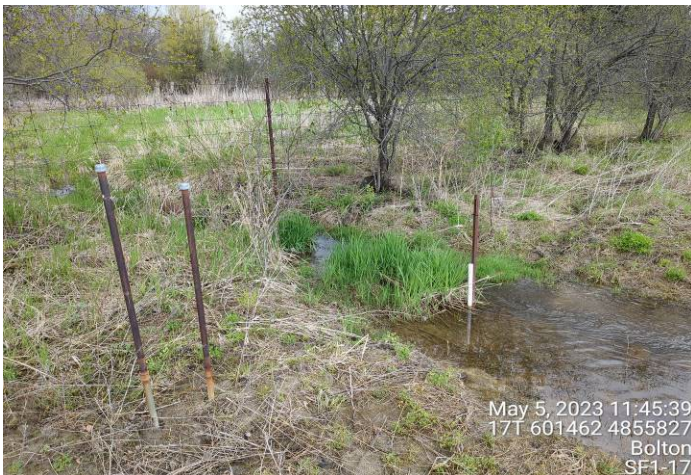
Photo 2: Another view of streamflow station SF1-17 taken on December 9, 2022.

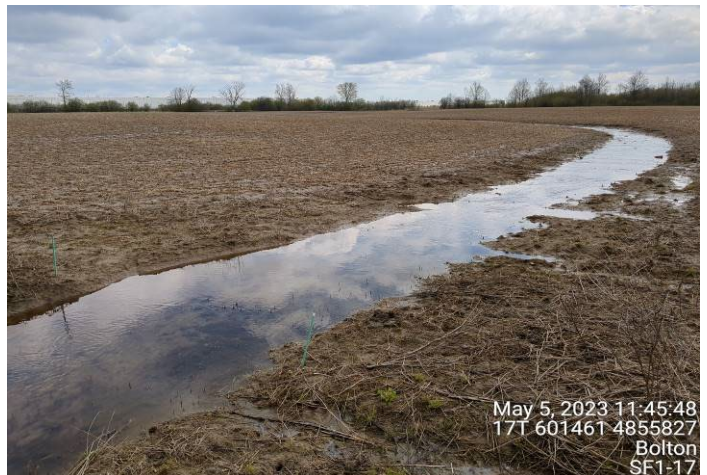
Photo 4: A view of streamflow station SF1-17, facing downstream, taken on May 5, 2023. Stream flow observed was observed to be slow to intermediate at this area.

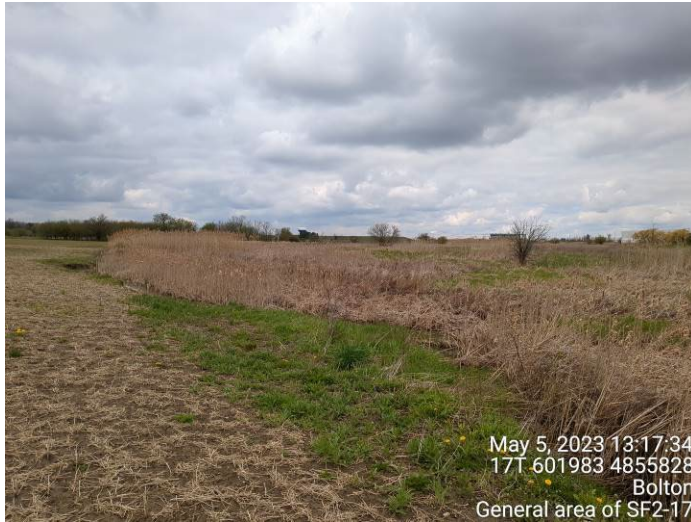
Photo 5: Streamflow station SF2-17 was unable to be located due to dense population of cattails. A view of the general area where SF2-17 was installed taken on May 5, 2023, is shown above. It should be noted that access to this area was not available on December 2022 site visit.

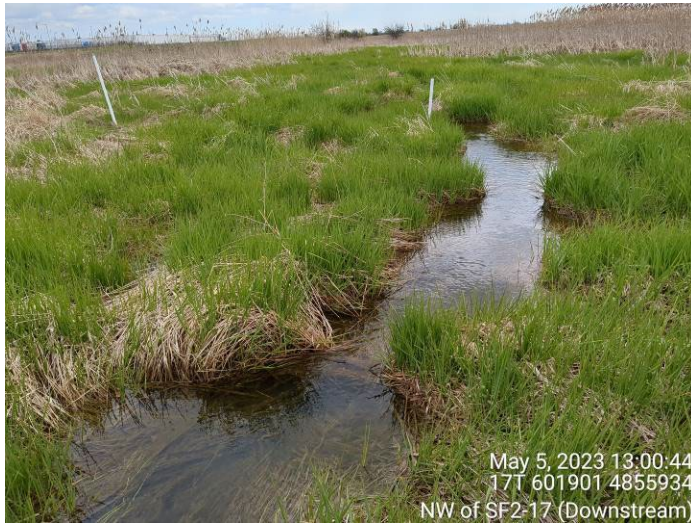
Photo 7: A view of the drainage feature, facing downstream, in the general area of SF2-17. Flow was observed to be intermediate to fast at this area. It should be noted that access to this area was not available on the December 2022 site visit.

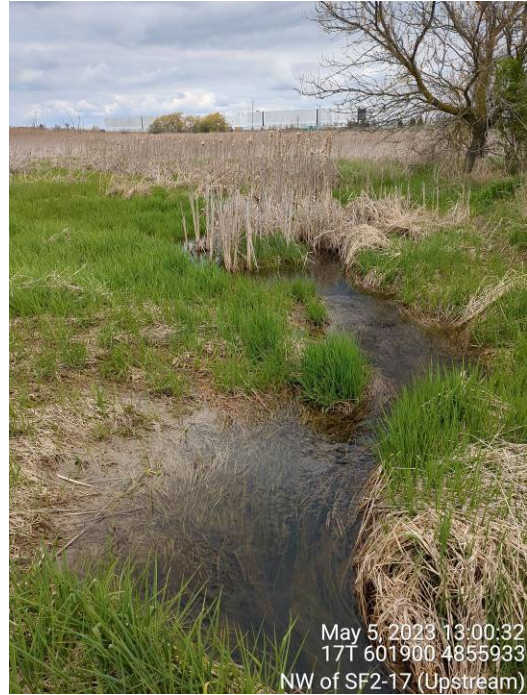
Photo 6: A view of the drainage feature, facing upstream, in the general area of SF2-17. Flow was observed to be intermediate to fast at this area. It should be noted that access to this area was not available on the December 2022 site visit.

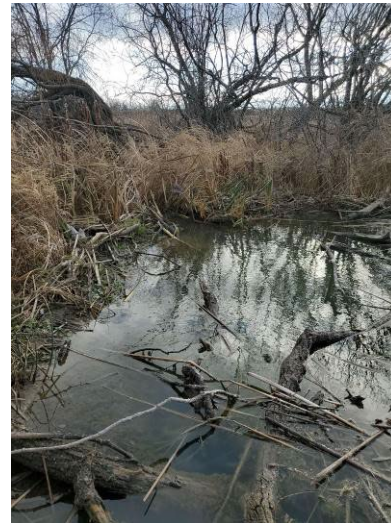
Photo 8: A general view of streamflow station SF3-17 taken on December 9, 2022. Evidence of a beaver dam was observed in the area. The streamflow station was not located and likely destroyed, as result of the beaver dam.

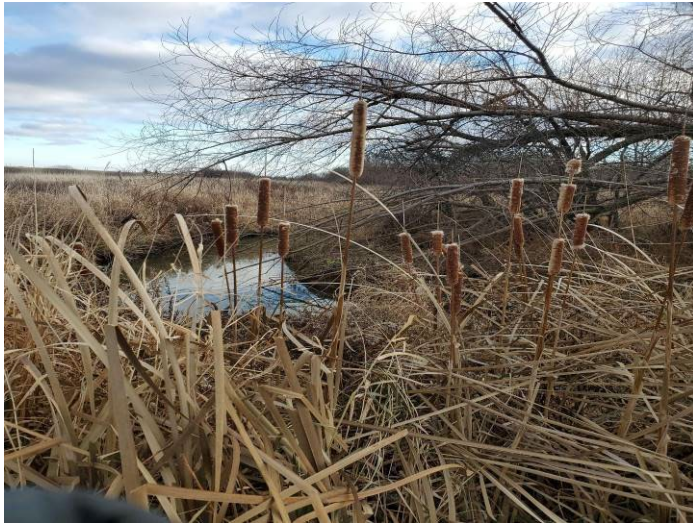
Photo 9: Another general view of streamflow station SF3-17 taken on December 9, 2022. Water levels were observed noticeably higher (~3ft) upstream the dam then downstream.

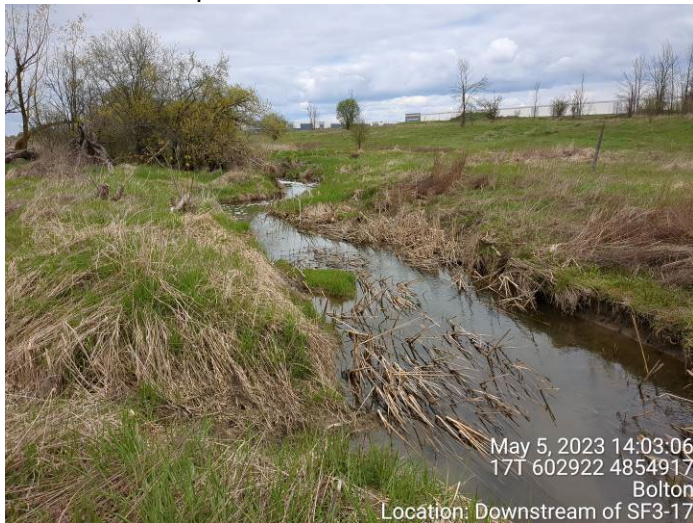
Photo 11: A view of SF3-17, facing upstream, taken on May 5, 2023. The beaver dam was observed further upstream behind the tree. Stream flow was observed slow.

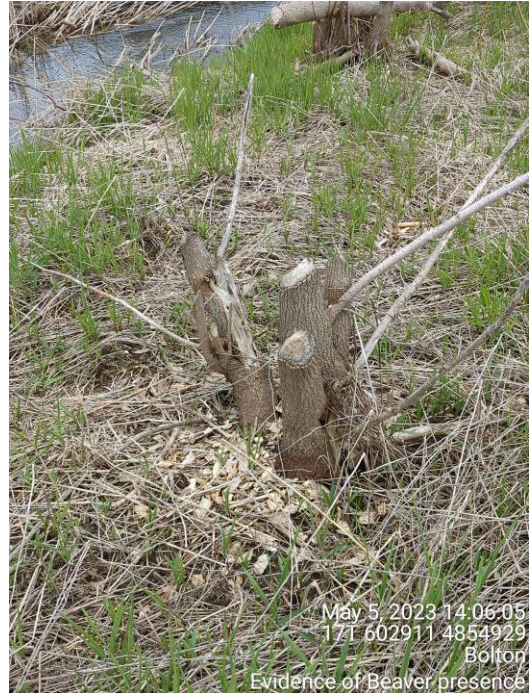
Photo 10: Evidence supporting beaver presence in the area of SF3-17 taken on May 5, 2023. Wood chips and sharp cuts on the tree stump can be observed.

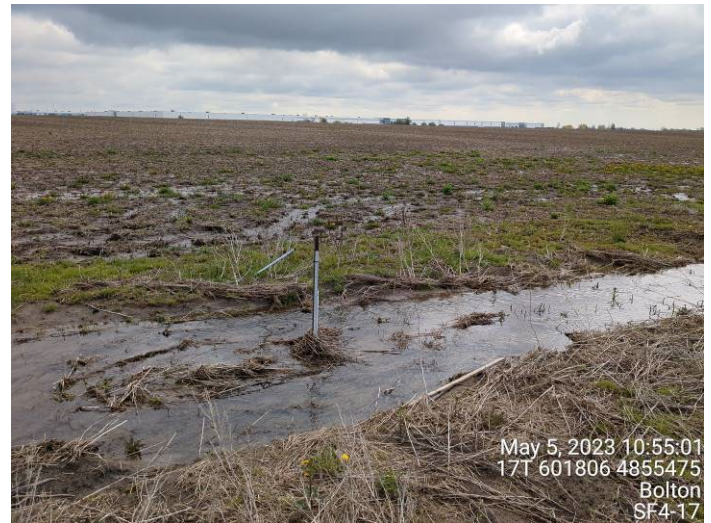
Photo 12: A view of SF4-17 taken on May 5, 2023. A damaged piezometer nest is observed behind the staff gauge. Stream flow was observed slow to intermediate at this area. It should be noted that access to this area was not available on December 2022 site visit.

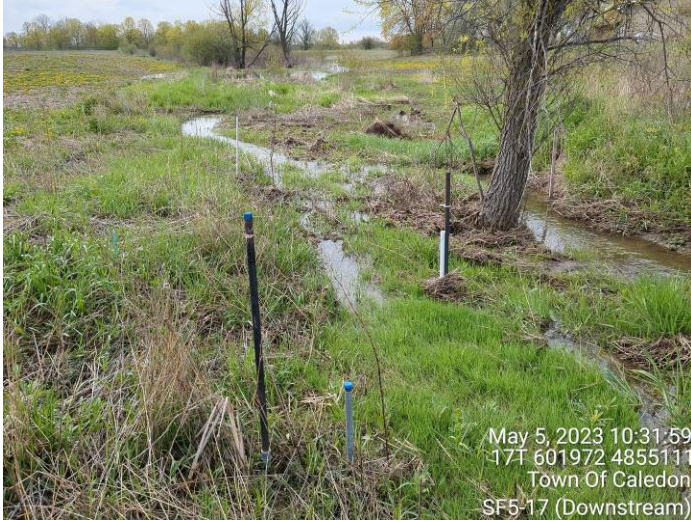
Photo 13: A view of streamflow station SF5-17, facing downstream, taken on May 5, 2023. Piezometers and staff gauge were observed in good condition. Stream flow was observed to be fast in the area.

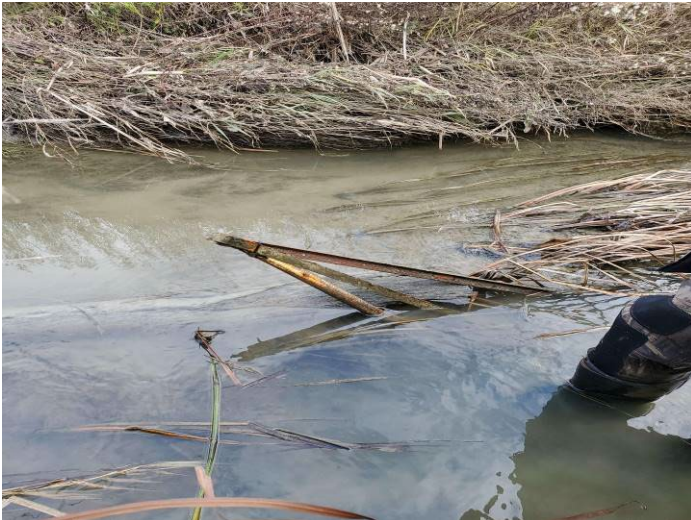
Photo 14: A view of streamflow station SF5-17, facing upstream, taken on May 5, 2023. Stream flow was observed to be fast in the area.

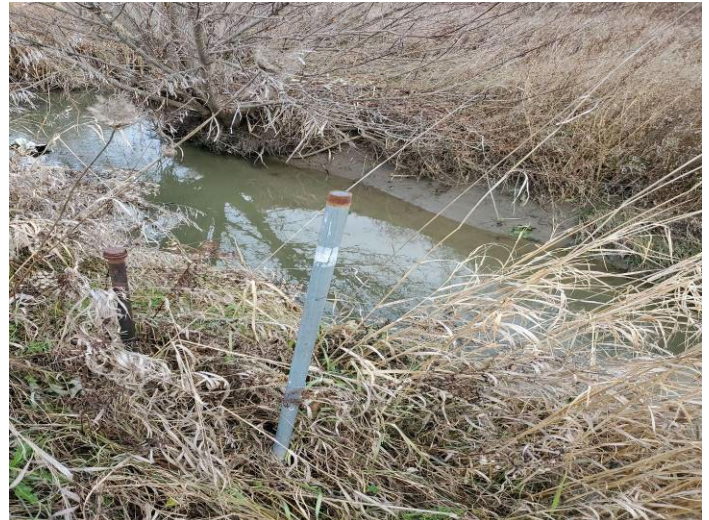
Photo 16: A view of the piezometers at SF6-17 taken on December 9, 2022. A missing cap was observed on one of them, but remaining conditions were noted to be in good condition.

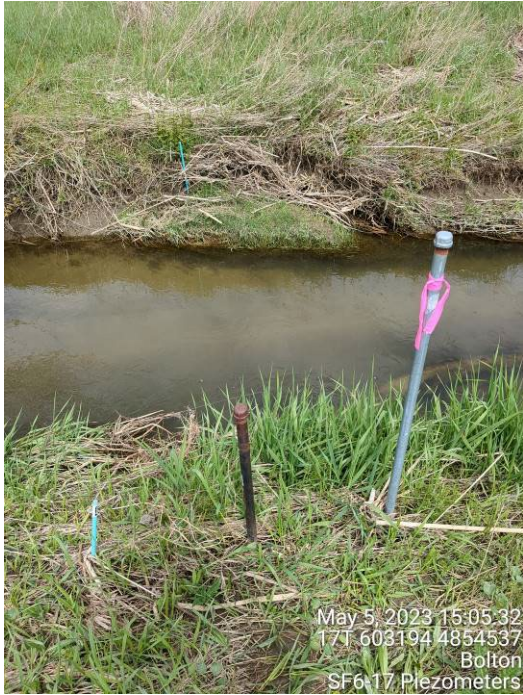
Photo 17: A view of the piezometers at streamflow station SF6-17 taken on May 5, 2023. A replacement cap was provided. Piezometer conditions were noted to be in good condition.

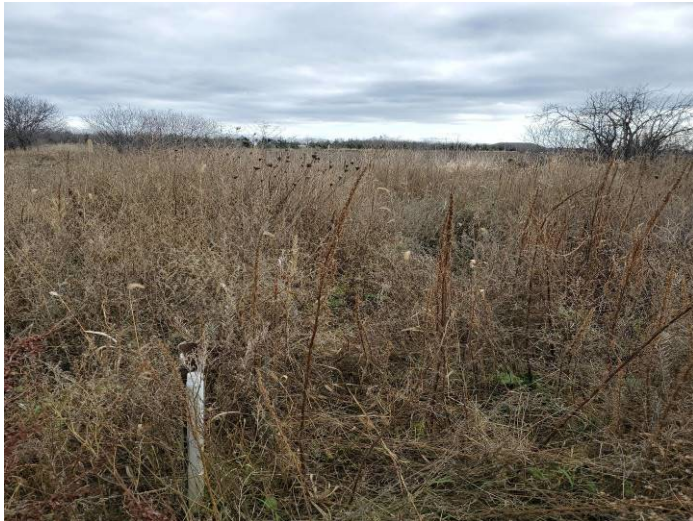
Photo 19: A view of the staff gauge at streamflow station SF7-17 taken on December 9, 2022. A piezometer nest was not located in the area.

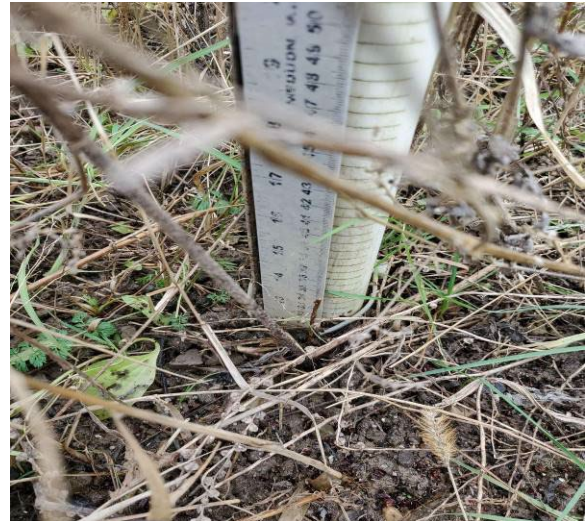
Photo 19: A closer view of the staff gauge at streamflow station SF7-17 taken on December 9, 2022. Very low water levels were observed.

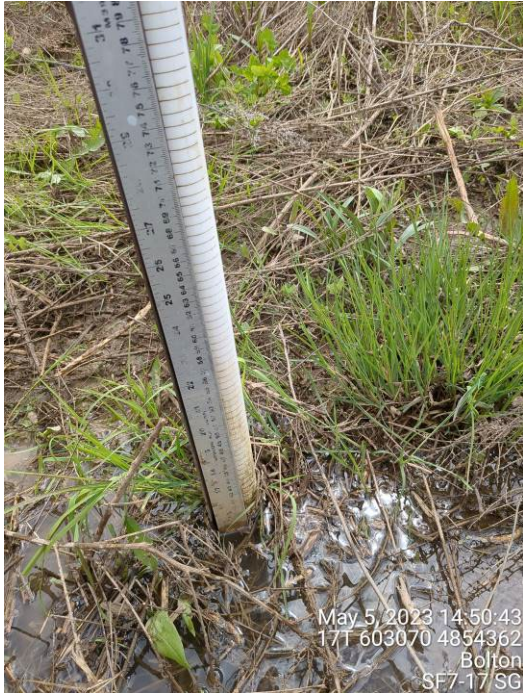
Photo 20: A closer view of the staff gauge at streamflow station SF7-17 taken on May 5, 2023. Higher water levels compared to December's visit were observed.

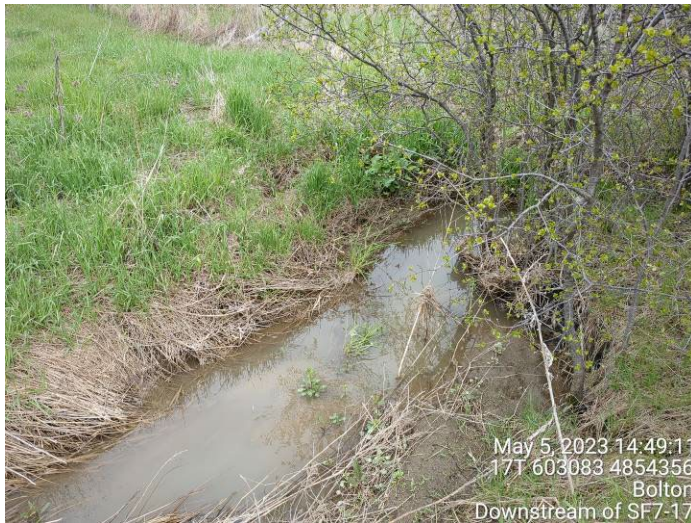
Photo 21: A view of the staff gauge at streamflow station SF7-17, facing upstream, taken on May 5, 2023.

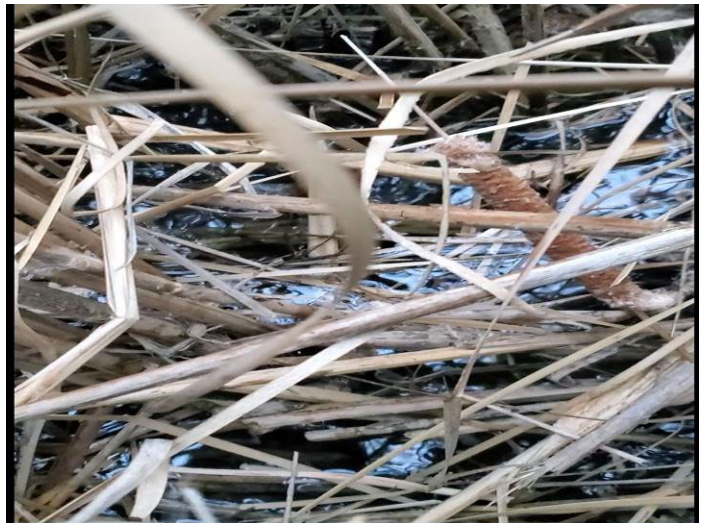
Photo 23: A close up view of the streamflow station at a new location, SF8-22, taken on December 9, 2022 for additional observations. Streamflow was observed to be slow at this area. No piezometers or staff gauge were installed.

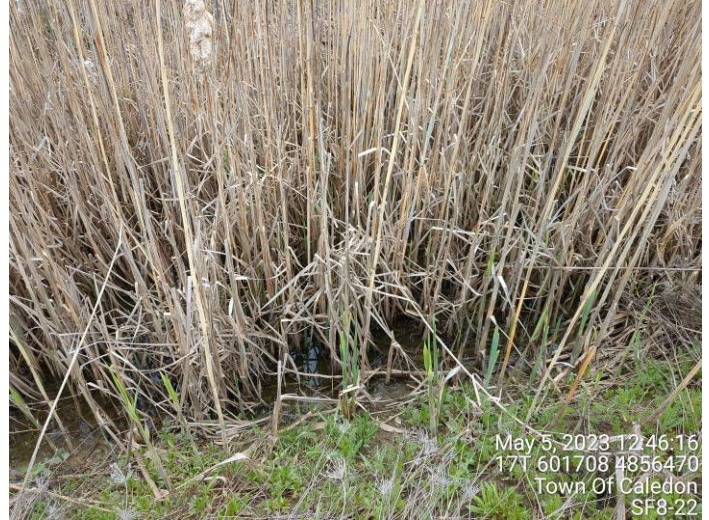
Photo 25: A view of the streamflow station at a new location, SF8-22, taken on May 5, 2023 for additional observations. Shallow water levels (~3cm) were observed at the edge and streamflow was observed to be slow at this area.

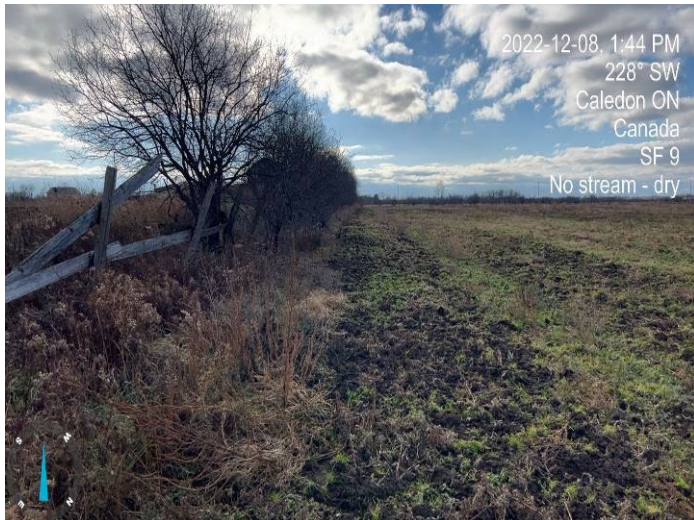
Photo 26: A view of the streamflow station at a new location, SF9-22, taken on December 9, 2022 for additional observations. No stream or a defined drainage feature were observed at this area. No piezometers or staff gauge were installed.

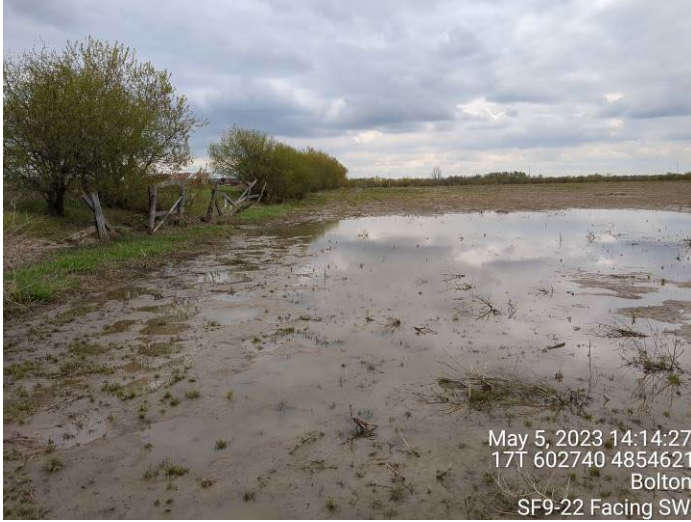
Photo 27: Another view of the area around streamflow station SF9-22 taken on December 9, 2022.

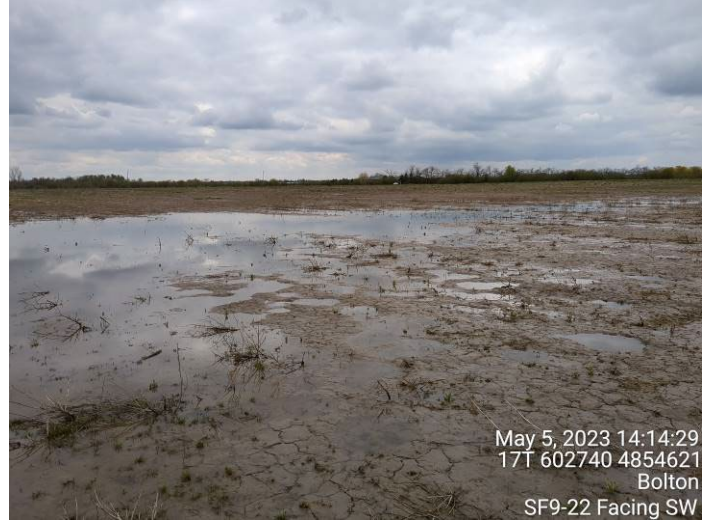
Photo 28: A view of the streamflow station at SF9-22, facing southwest, taken on May 5, 2023 for additional observations. No stream or a defined drainage feature were observed at this area but ponding with very slow flow towards the fence area was observed.

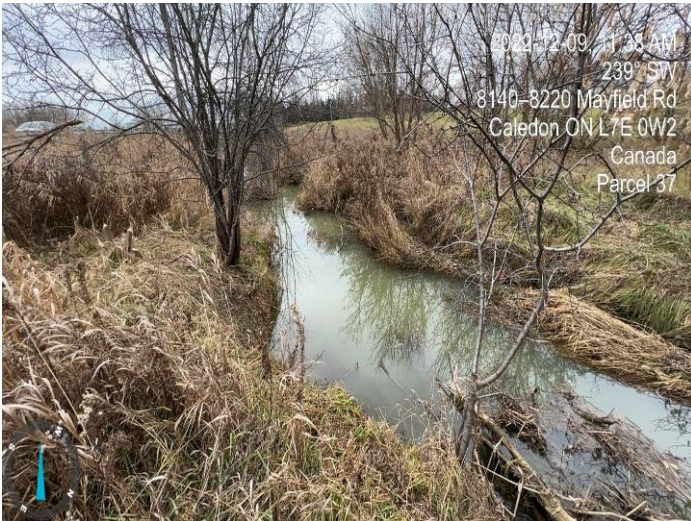
Photo 29: An extended view of the area around streamflow station SF9-22, facing southwest, taken on May 5, 2023.

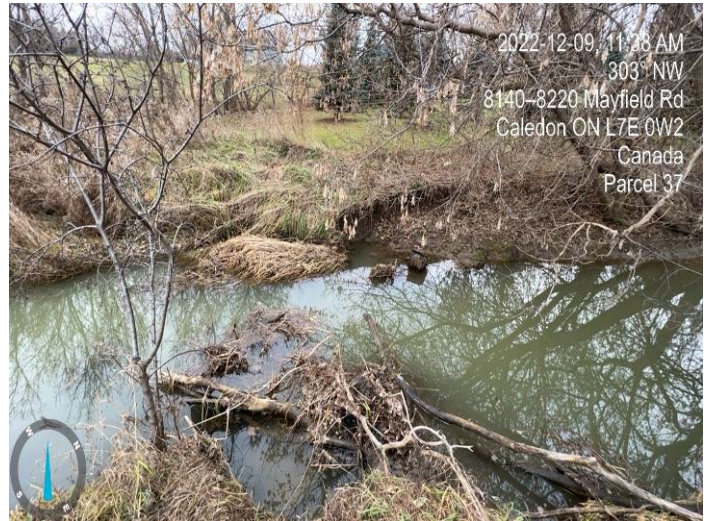
Photo 31: Another view of the streamflow station at SF10-22, taken on December 9, 2022. A beaver dam was observed. No piezometers or staff gauge were installed.

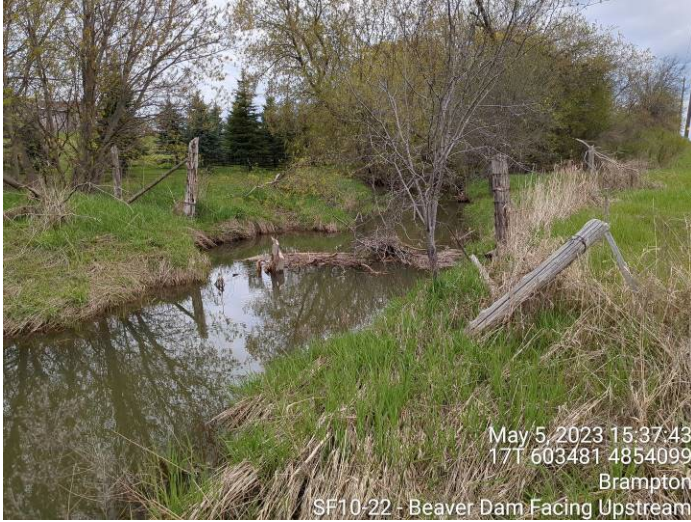
Photo 32: A view of the streamflow station at SF10-22, facing upstream, taken on May 5, 2023 for additional observations. A beaver dam was observed. Moderate flow was observed.

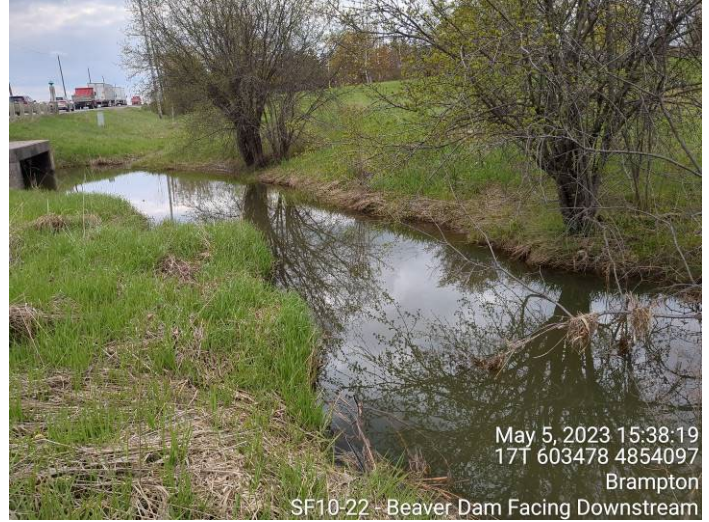
Photo 33: An extended view of the area around streamflow station SF10-22, facing upstream, taken on May 5, 2023. The stream converges with another drainage feature, located southwest, at the culvert observed.

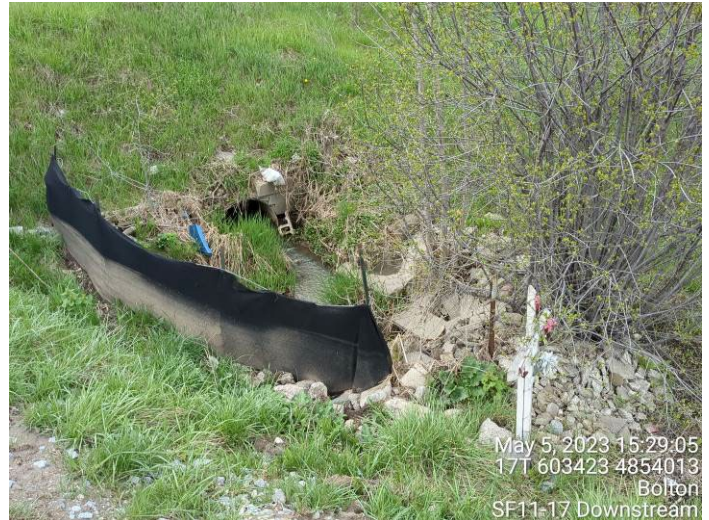
Photo 35: A view of the streamflow station SF11-22 located downstream, taken on May 5, 2023. The flow continues further down and converges with a stream, where SF10-22 was observed, into a larger-sized culvert.

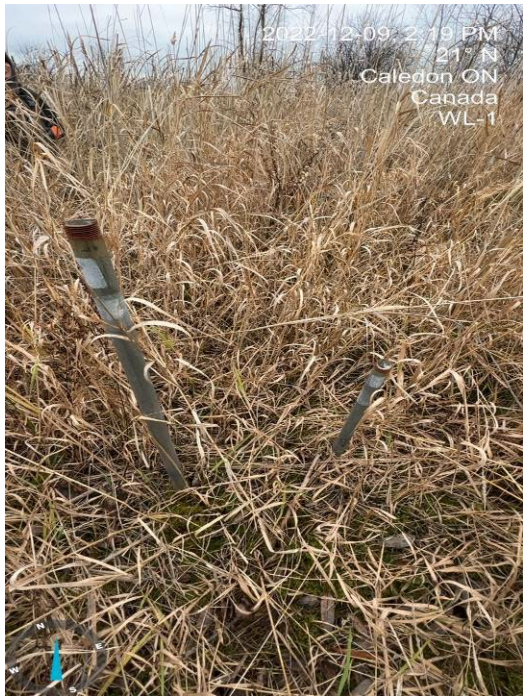
Photo 37: A view of the wetland station at WL1-17 taken on December 9, 2022. Piezometers were observed in fair condition.

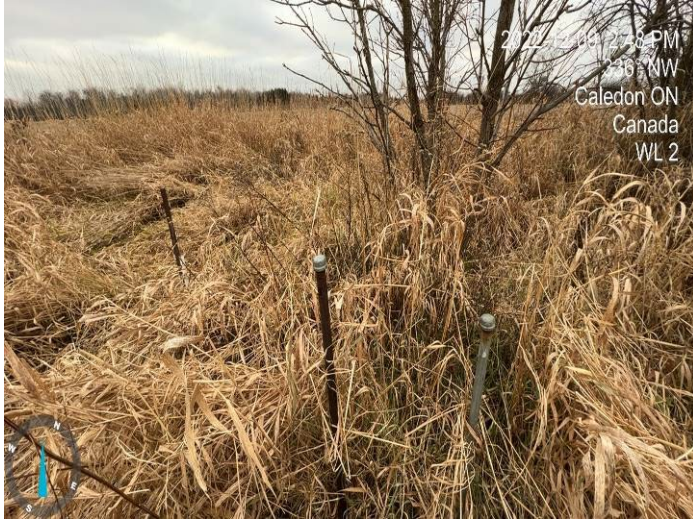
Photo 39: A view of the wetland station at WL2-17 taken on December 9, 2022. Piezometers were observed in fair condition. Staff gauge is observed behind the piezometers.

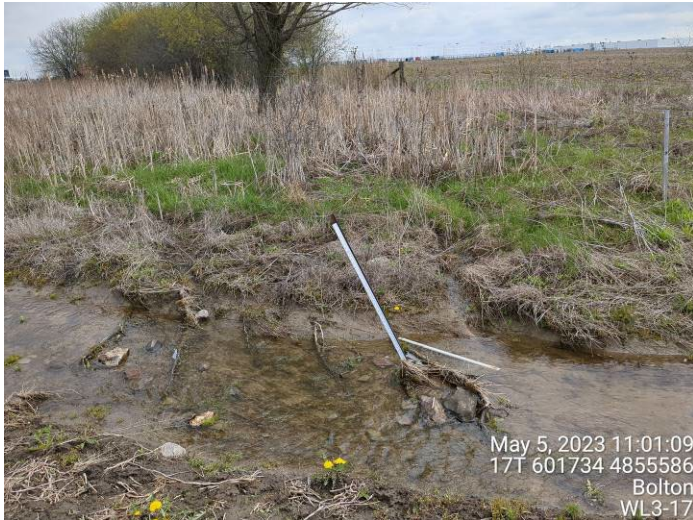
Photo 41: A view of the wetland station at WL3-17 taken on May 5, 2023. No piezometers were observed in the vicinity. Staff gauge is observed to be in poor condition. Stream flow was observed from slow to intermediate.

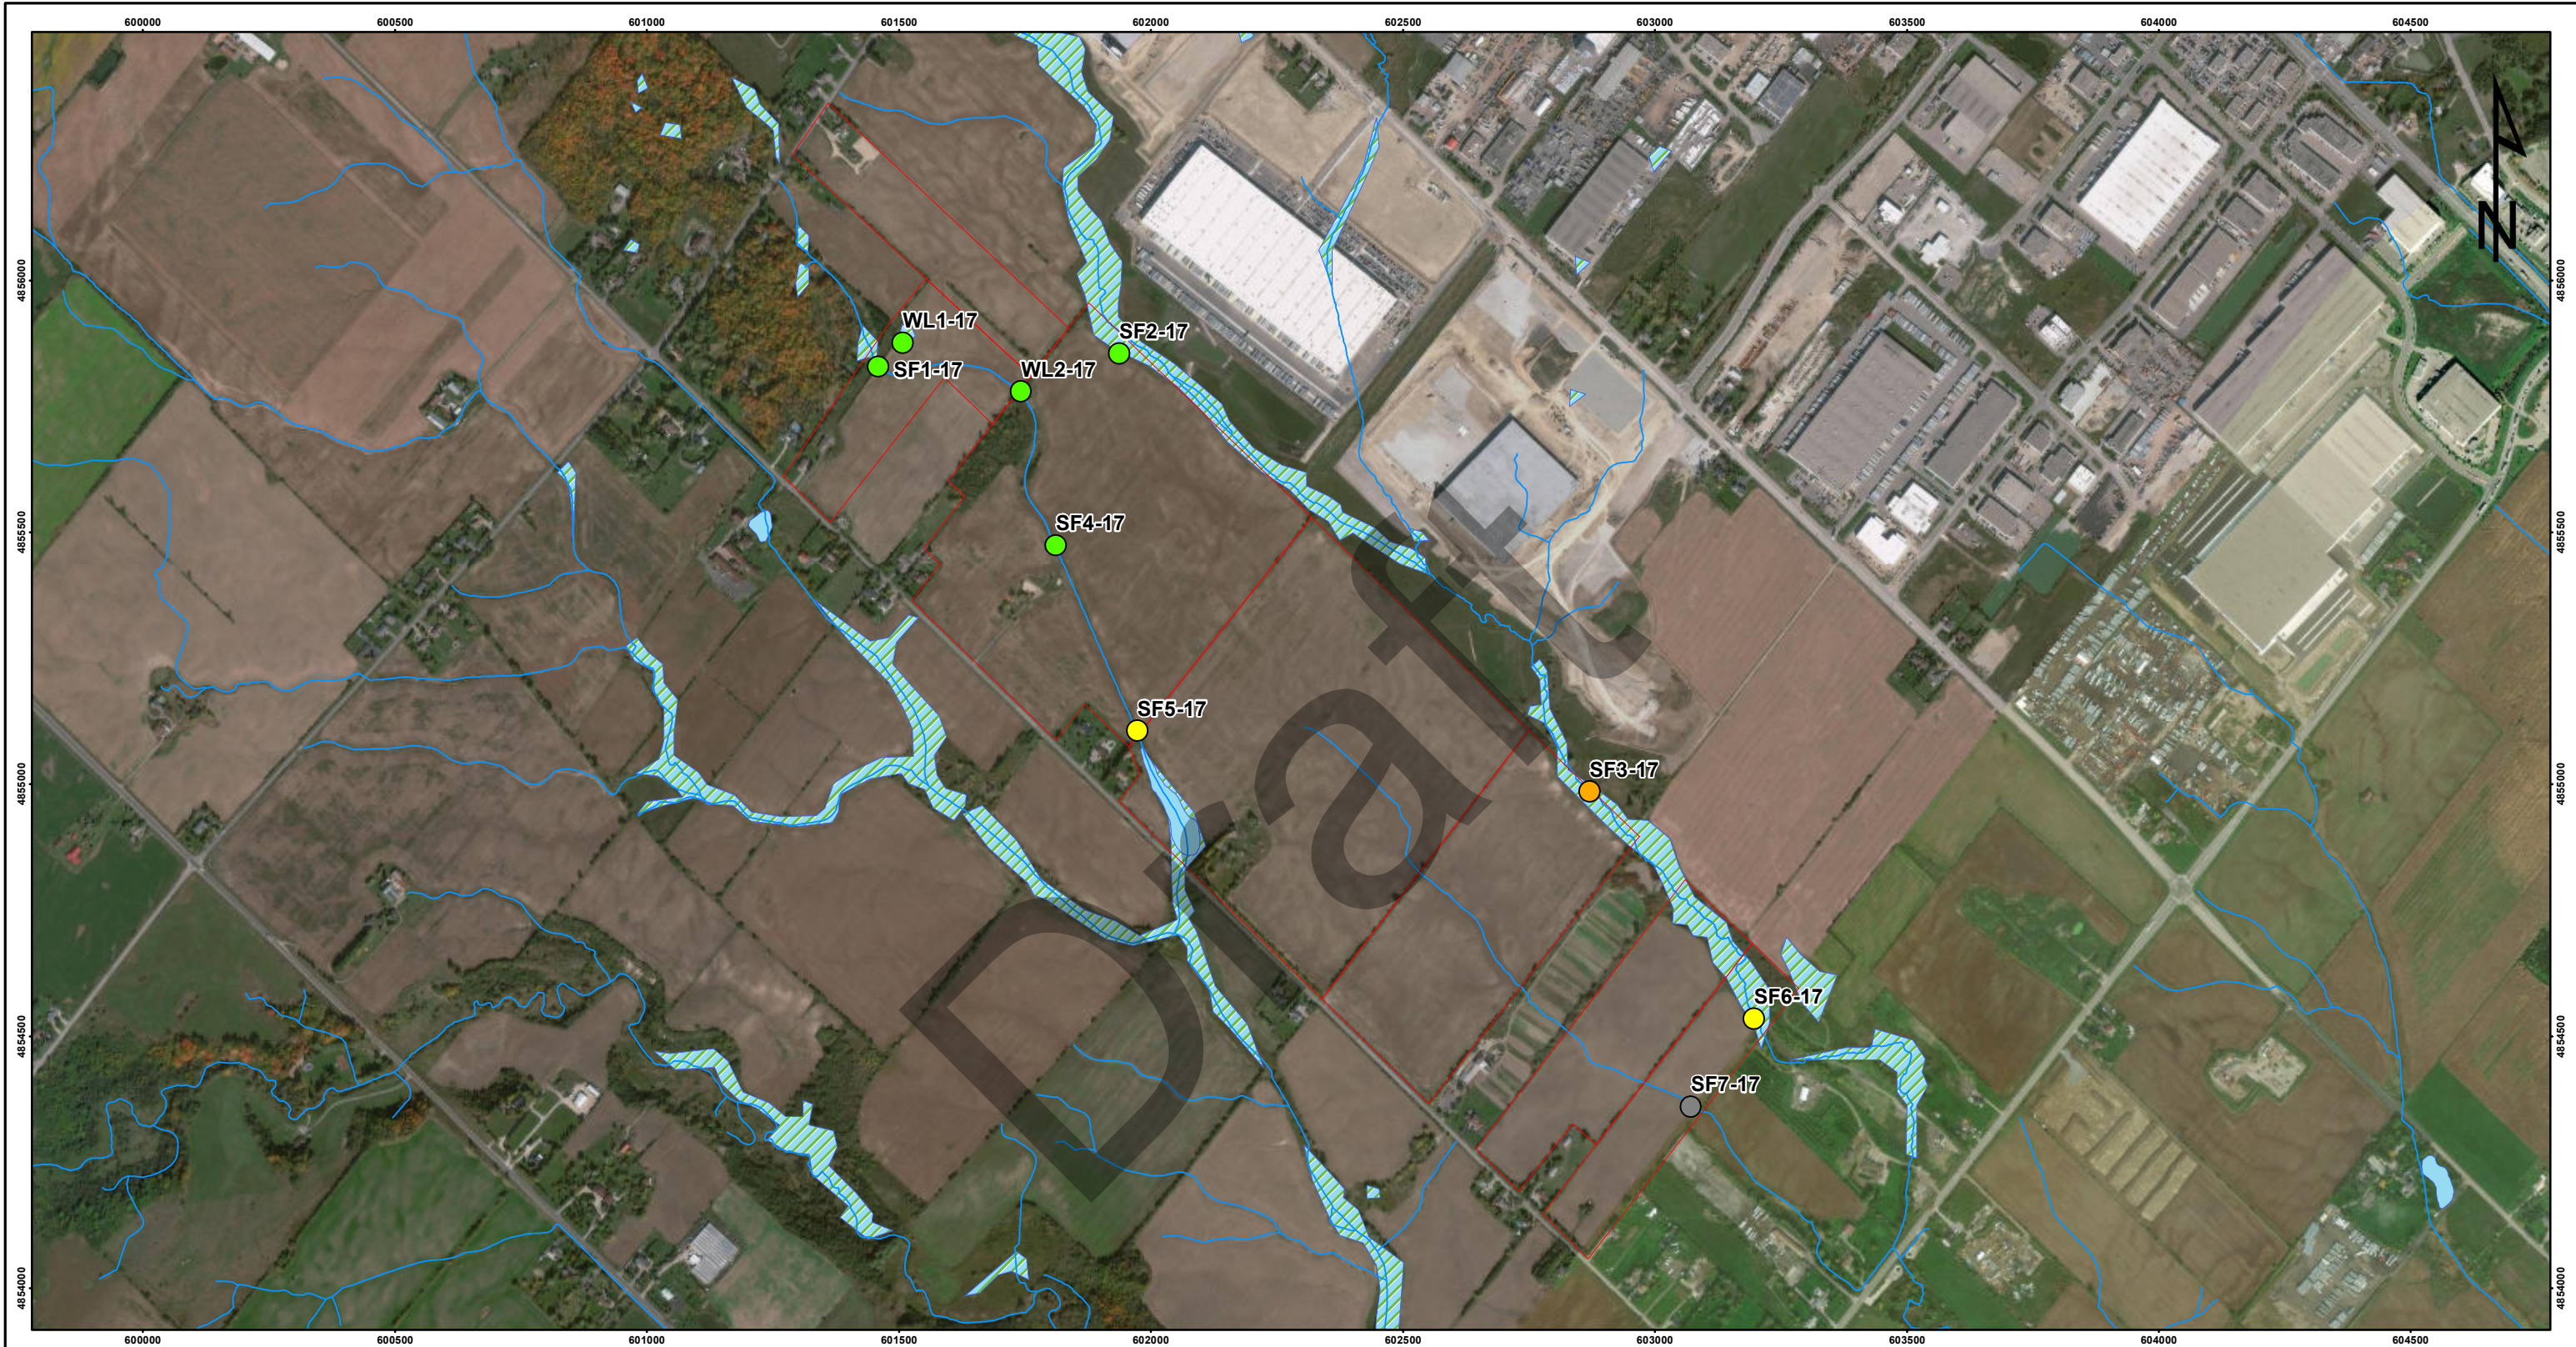
FIGURE 12

A surface water monitoring network was set up across the Site by IBI Group to assess interactions between the groundwater system and the on-site tributaries of the Humber River. IBI Group installed nine (9) surface water monitoring stations at the Site in July 2017. These included seven (7) stream flow stations (SF1, SF2, SF3-17, SF4-17, SF5-17, SF6-17, and SF7-17) installed along tributaries of the Humber River, and two (2) wetland monitoring stations (WL1-17, WL2-17) at two (2) locations at the Site. The locations of the surface water monitoring stations are illustrated on **Figure 12**.
