Humber Station – Comprehensive Environmental Impact Study and Management Plan

Phase 1 – Characterization/Existing Conditions and Baseline Inventory

Town of Caledon, Ontario

July 2024
Project 1901485

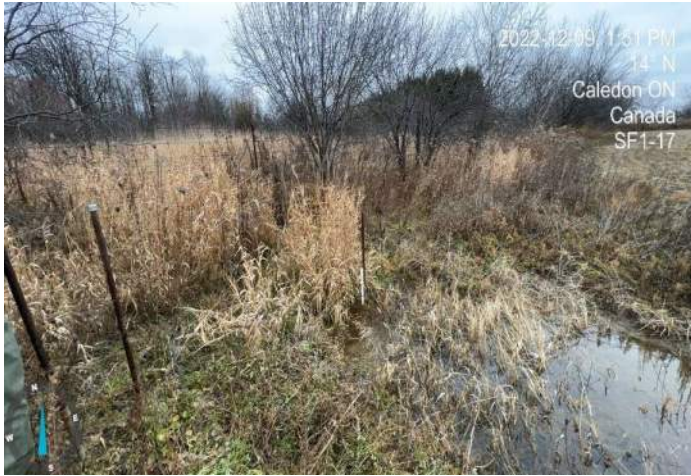
Photo 1: A view of streamflow station SF1-17 taken on December 9, 2022. Piezometers and staff gauge were observed in good condition.

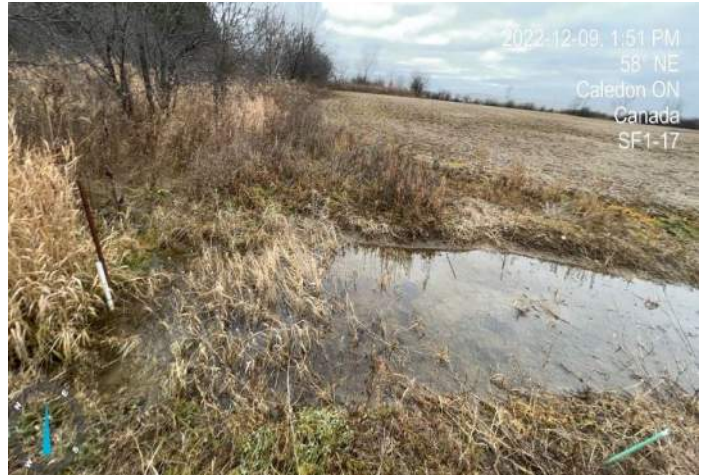
Photo 2: Another view of streamflow station SF1-17 taken on December 9, 2022.

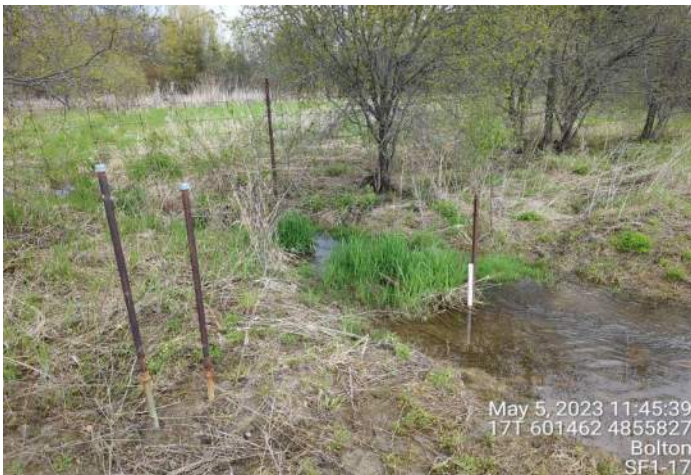
Photo 3: A view of streamflow station SF1-17 taken on May 5, 2023. Piezometers and staff gauge were observed in good condition.

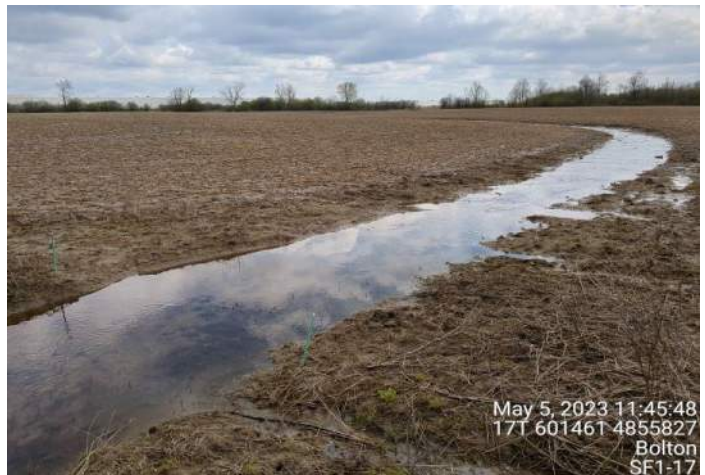
Photo 4: A view of streamflow station SF1-17, facing downstream, taken on May 5, 2023. Stream flow observed was observed to be slow to intermediate at this area.

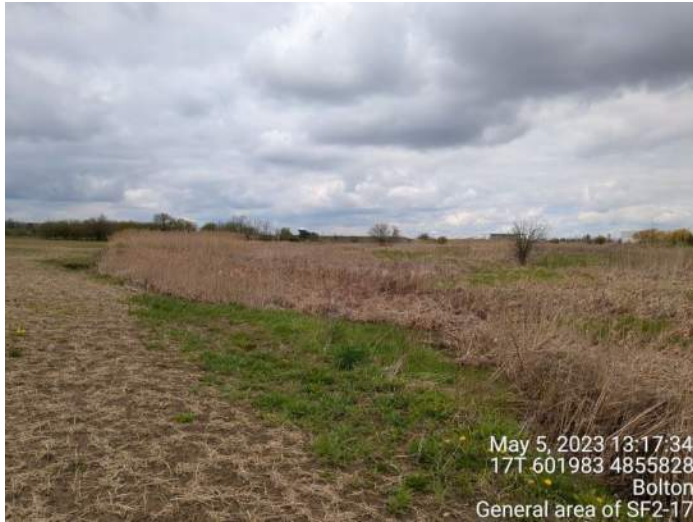
Photo 5: Streamflow station SF2-17 was unable to be located due to dense population of cattails. A view of the general area where SF2-17 was installed taken on May 5, 2023, is shown above. It should be noted that access to this area was not available on December 2022 site visit.

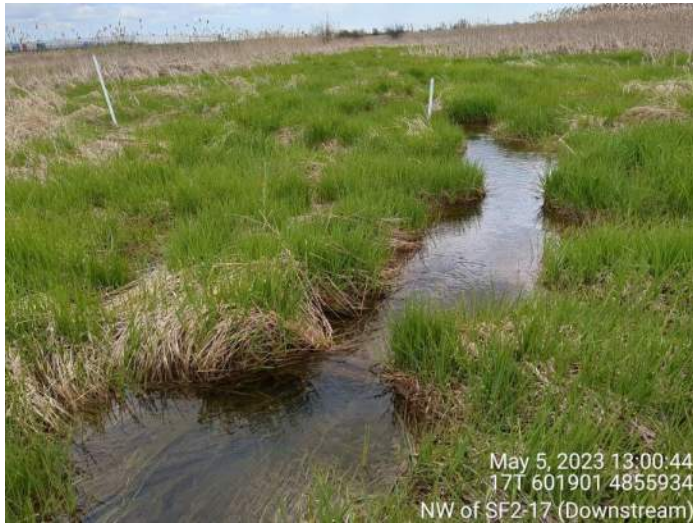
Photo 7: A view of the drainage feature, facing downstream, in the general area of SF2-17. Flow was observed to be intermediate to fast at this area. It should be noted that access to this area was not available on the December 2022 site visit.

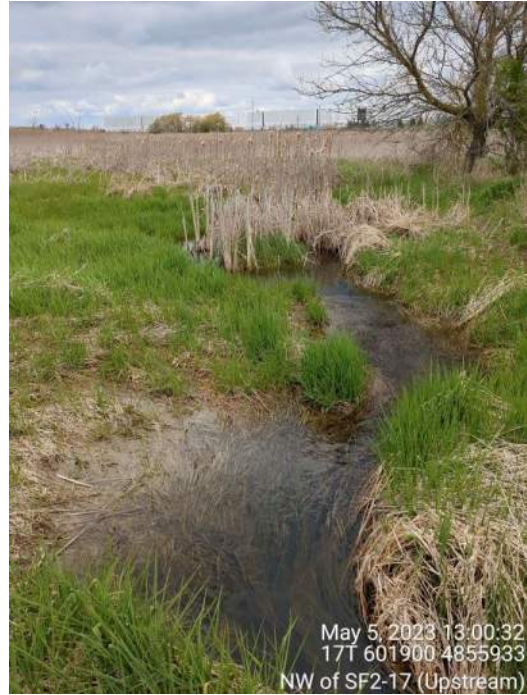
Photo 6: A view of the drainage feature, facing upstream, in the general area of SF2-17. Flow was observed to be intermediate to fast at this area. It should be noted that access to this area was not available on the December 2022 site visit.

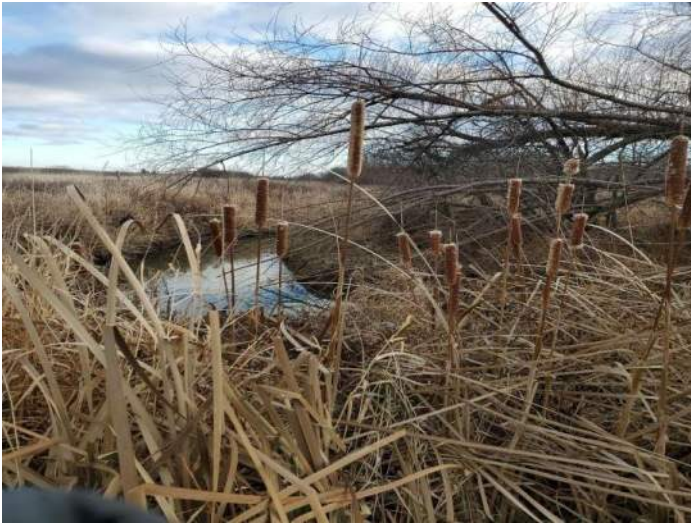
Photo 9: Another general view of streamflow station SF3-17 taken on December 9, 2022. Water levels were observed noticeably higher (~3ft) upstream the dam then downstream.

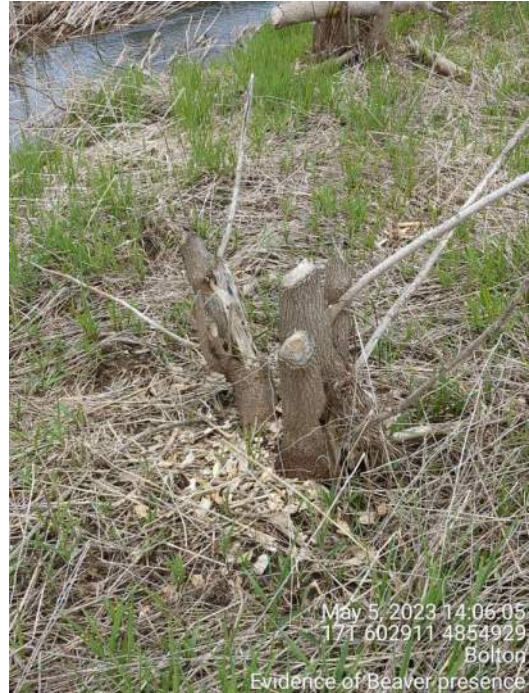
Photo 10: Evidence supporting beaver presence in the area of SF3-17 taken on May 5, 2023. Wood chips and sharp cuts on the tree stump can be observed.

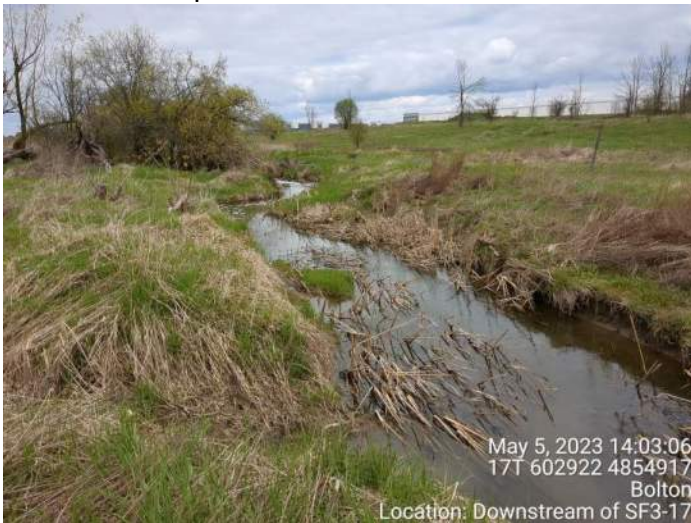
Photo 11: A view of SF3-17, facing upstream, taken on May 5, 2023. The beaver dam was observed further upstream behind the tree. Stream flow was observed slow.

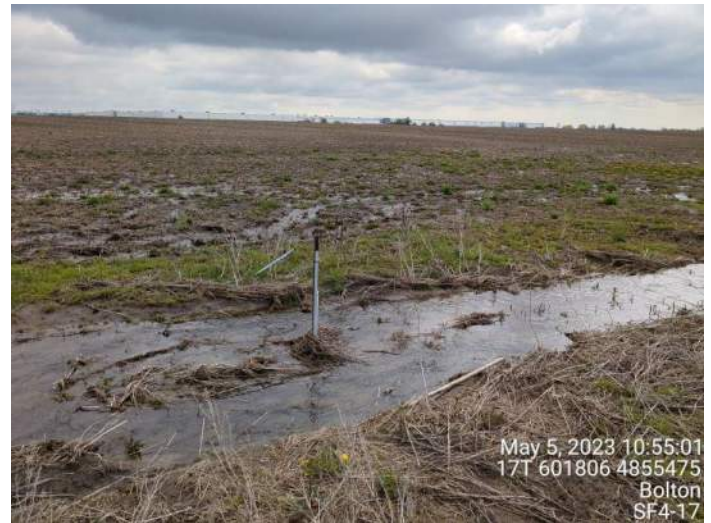
Photo 12: A view of SF4-17 taken on May 5, 2023. A damaged piezometer nest is observed behind the staff gauge. Stream flow was observed slow to intermediate at this area. It should be noted that access to this area was not available on December 2022 site visit.

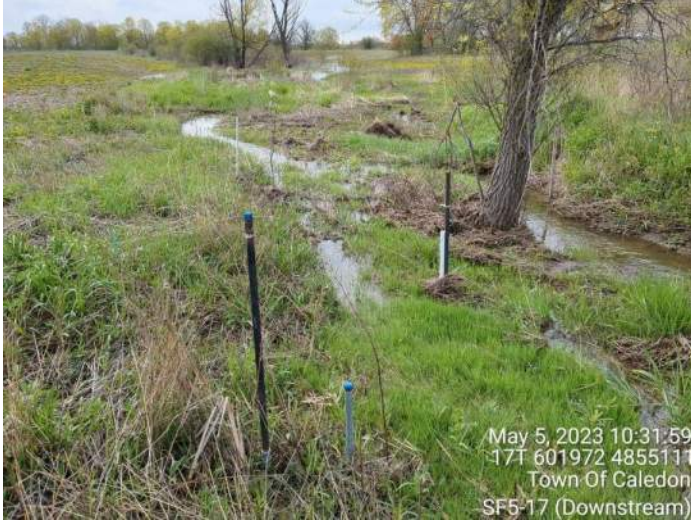
Photo 13: A view of streamflow station SF5-17, facing downstream, taken on May 5, 2023. Piezometers and staff gauge were observed in good condition. Stream flow was observed to be fast in the area.

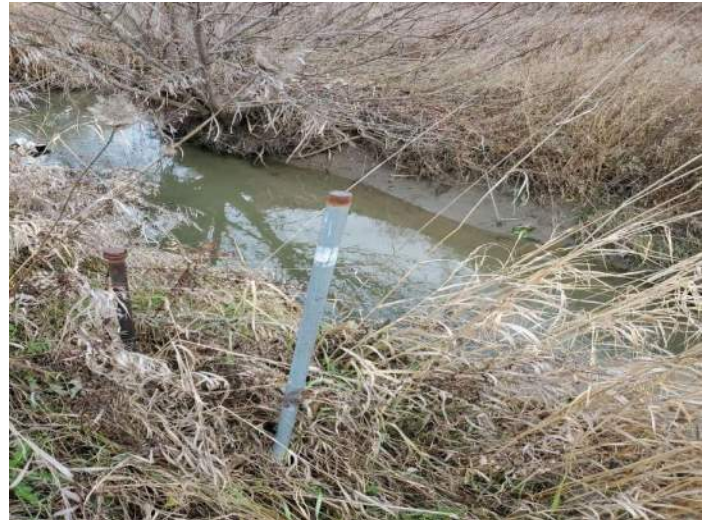
Photo 16: A view of the piezometers at SF6-17 taken on December 9, 2022. A missing cap was observed on one of them, but remaining conditions were noted to be in good condition.

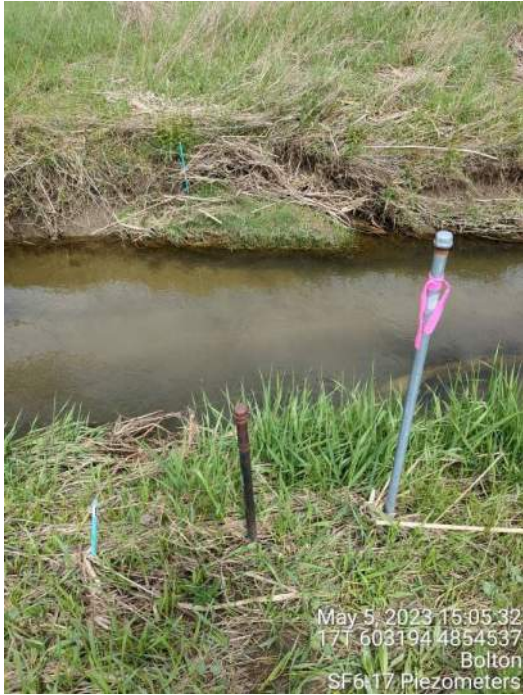
Photo 17: A view of the piezometers at streamflow station SF6-17 taken on May 5, 2023. A replacement cap was provided. Piezometer conditions were noted to be in good condition.

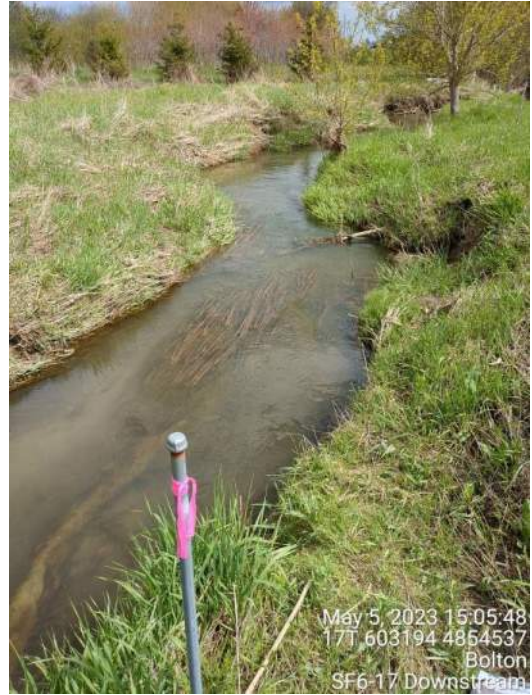
Photo 18: Another view of SF6-17, facing downstream, taken on May 5, 2023. The staff gauge was not located at the time and stream flow was observed to be fast in the area.

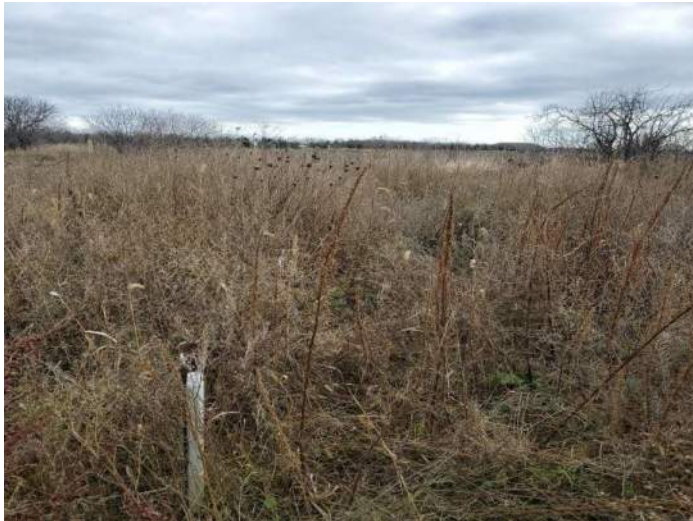
Photo 19: A view of the staff gauge at streamflow station SF7-17 taken on December 9, 2022. A piezometer nest was not located in the area.

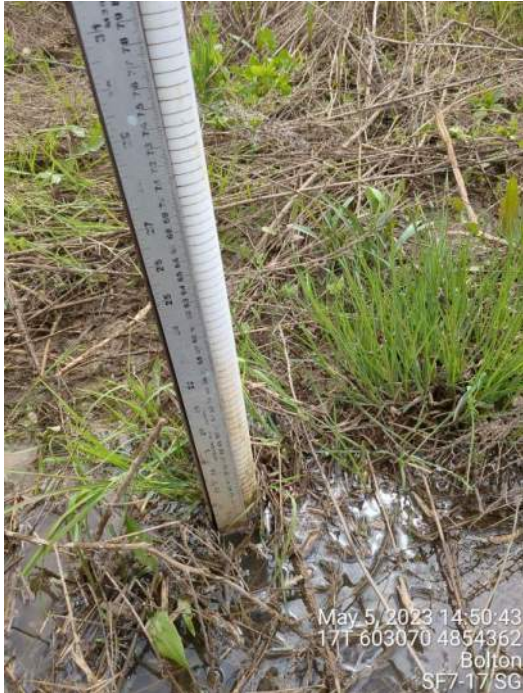
Photo 20: A closer view of the staff gauge at streamflow station SF7-17 taken on May 5, 2023. Higher water levels compared to December's visit were observed.

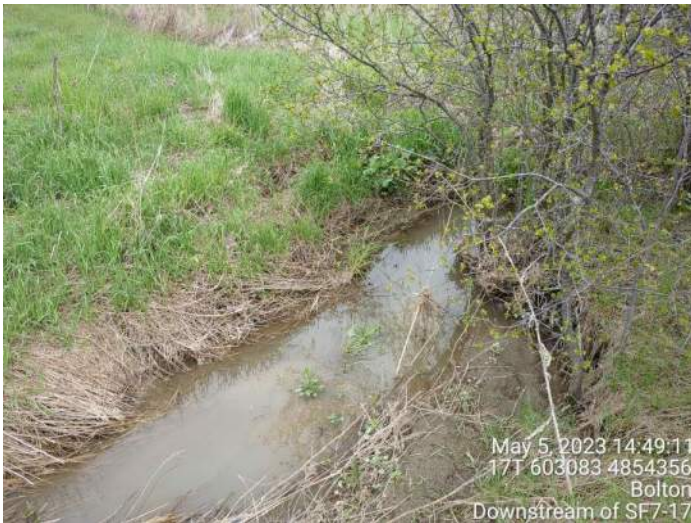
Photo 22: A view downstream of station SF7-17 taken on May 5, 2023. Stream flow was observed slow to moderate.

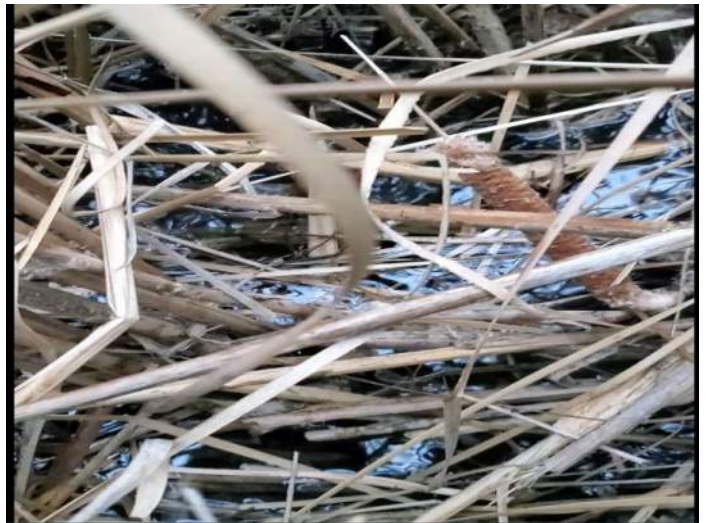
Photo 23: A close up view of the streamflow station at a new location, SF8-22, taken on December 9, 2022 for additional observations. Streamflow was observed to be slow at this area. No piezometers or staff gauge were installed.

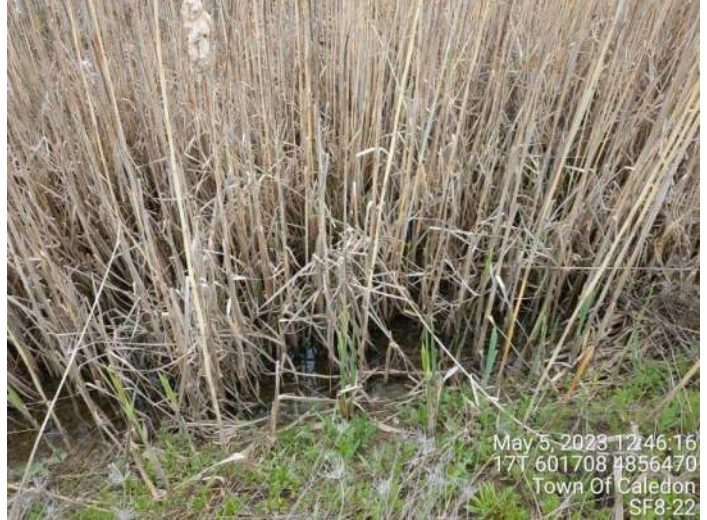
Photo 25: A view of the streamflow station at a new location, SF8-22, taken on May 5, 2023 for additional observations. Shallow water levels (~3cm) were observed at the edge and streamflow was observed to be slow at this area.

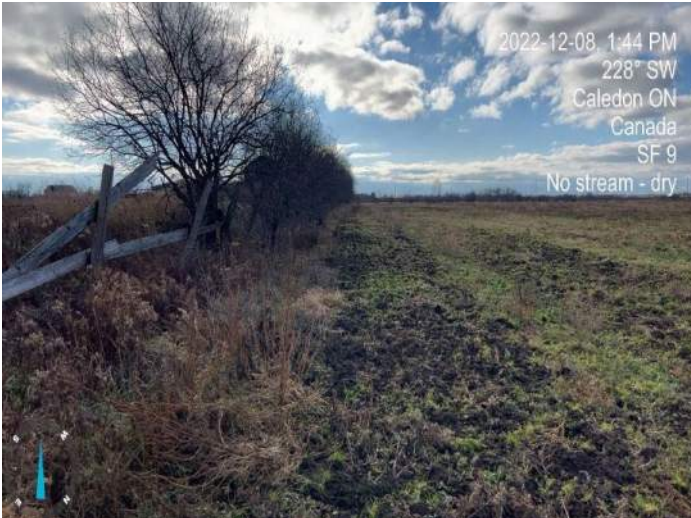
Photo 26: A view of the streamflow station at a new location, SF9-22, taken on December 9, 2022 for additional observations. No stream or a defined drainage feature were observed at this area. No piezometers or staff gauge were installed.

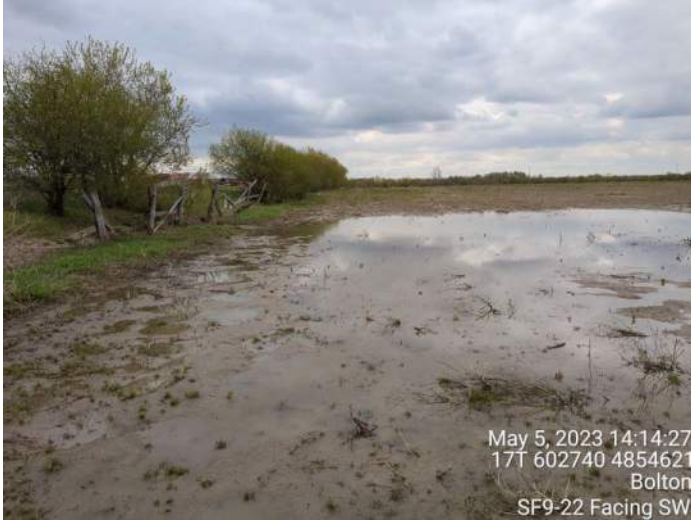
Photo 28: A view of the streamflow station at SF9-22, facing southwest, taken on May 5, 2023 for additional observations. No stream or a defined drainage feature were observed at this area but ponding with very slow flow towards the fence area was observed.

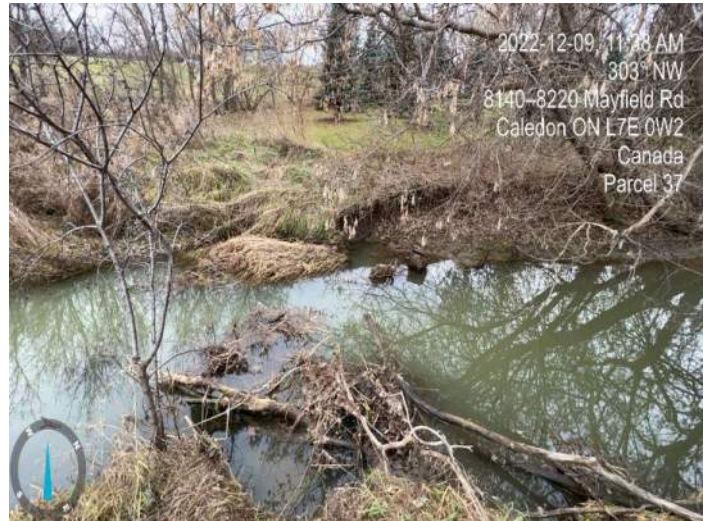
Photo 31: Another view of the streamflow station at SF10-22, taken on December 9, 2022. A beaver dam was observed. No piezometers or staff gauge were installed.

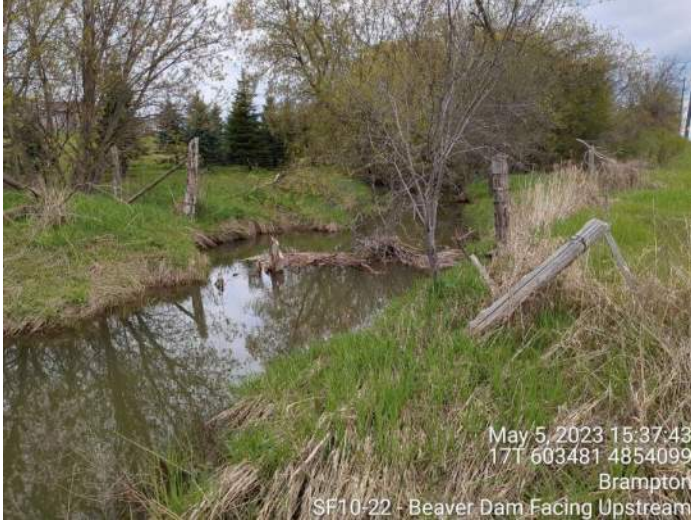
Photo 32: A view of the streamflow station at SF10-22, facing upstream, taken on May 5, 2023 for additional observations. A beaver dam was observed. Moderate flow was observed.

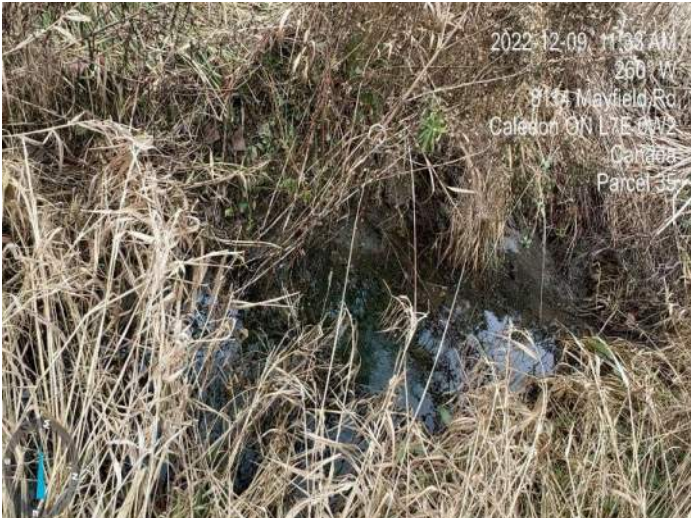
Photo 34: A view of the streamflow station at a new location, SF11-22, taken on December 9, 2022 for additional observations. Flow was observed in the narrow channel

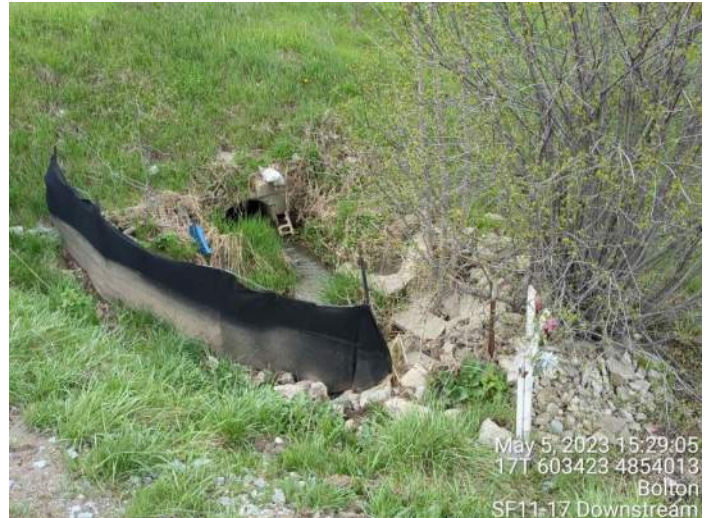
Photo 35: A view of the streamflow station SF11-22 located downstream, taken on May 5, 2023. The flow continues further down and converges with a stream, where SF10-22 was observed, into a larger-sized culvert.

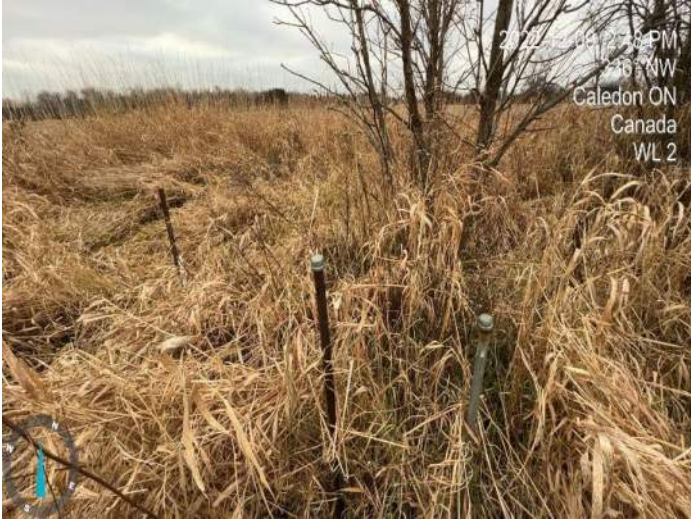
Photo 39: A view of the wetland station at WL2-17 taken on December 9, 2022. Piezometers were observed in fair condition. Staff gauge is observed behind the piezometers.

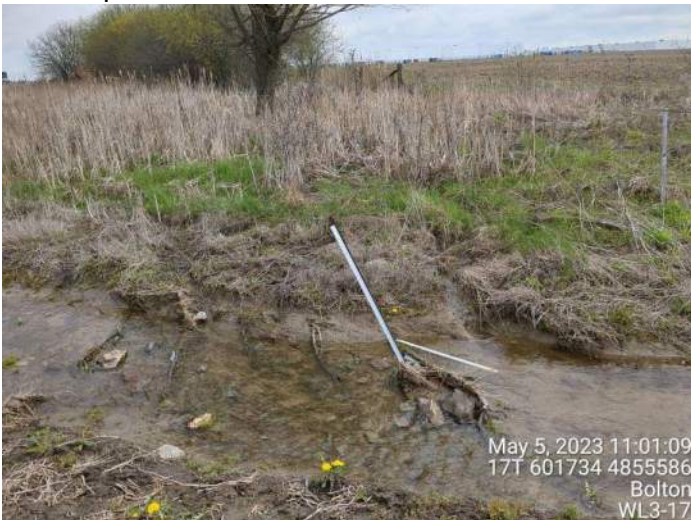
Photo 41: A view of the wetland station at WL3-17 taken on May 5, 2023. No piezometers were observed in the vicinity. Staff gauge is observed to be in poor condition. Stream flow was observed from slow to intermediate.
