**PHASE ONE ENVIRONMENTAL SITE ASSESSMENT  
12097 KENNEDY ROAD  
CALEDON, ONTARIO**

Project: 943-1101  
October 5, 2011

Phase One Environmental Site Assessment  
12097 Kennedy Road  
Caledon, Ontario

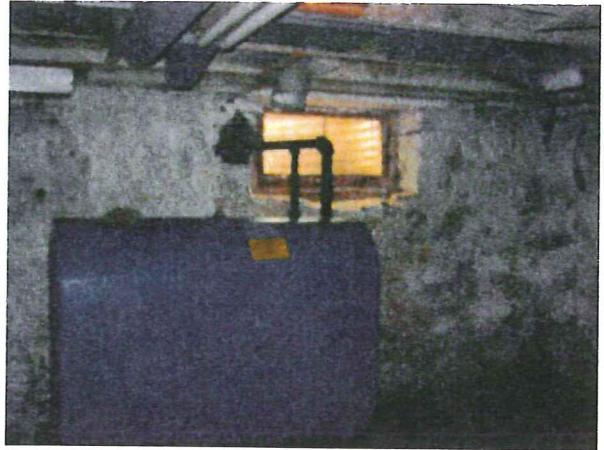
2. View of the fuel oil AST located in the basement facing north.

A vent and fill pipe was observed on the west exterior wall of the residential dwelling. The vent and fill pipes lead to a fuel oil AST in the basement. An additional fuel oil AST is located on the south side of the shed. Three (3) ASTs (500gallon and 1000 gallon diesel and a 500 gallon dyed diesel tank) were observed on the east side of the shed. No vent or fill pipes indicative of an underground storage tank were observed on the phase one property. An environmental impact as a result of onsite fuelling is unknown.

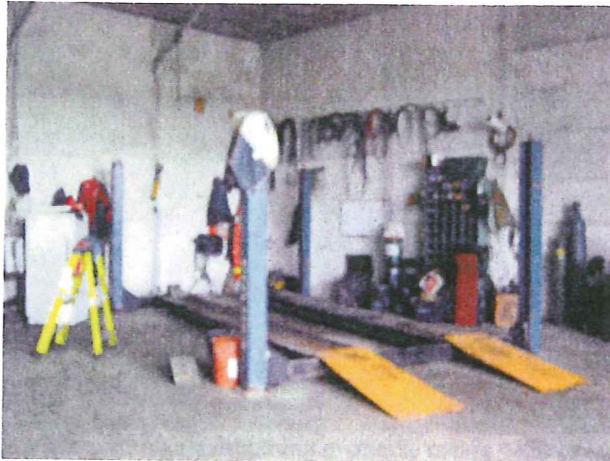
3. Interior view of the hoist in the most eastern shed facing northwest.

as indicted by Mr. Keyes. Various tools and equipment including welding tools, gas cylinders and a hoist were observed in the portion utilized for repairs. There is a dirt floor in the portion utilized for storage of equipment. A fuel oil AST was observed on the south wall of the shed; however, Mr. Keyes indicated that the AST is no longer used and that the propane tank located to the west of the shed is currently used for heating purposes. A drain was observed at the east end of the shed. Mr. Keyes indicated that the drain is connected to the catch basin located between the two sheds. This catch basin drains to an unknown area of the phase one property into the farm fields. An additional three(3) ASTs (500 gallon and 1000 gallon diesel and a 500 gallon dyed diesel tank) were observed on the east side of the shed. Mr. Keyes indicated that the ASTs were used for fuelling trucks and farm equipment. No secondary containment was observed around the ASTs. No surficial soil staining was observed in the vicinity of the ASTs.

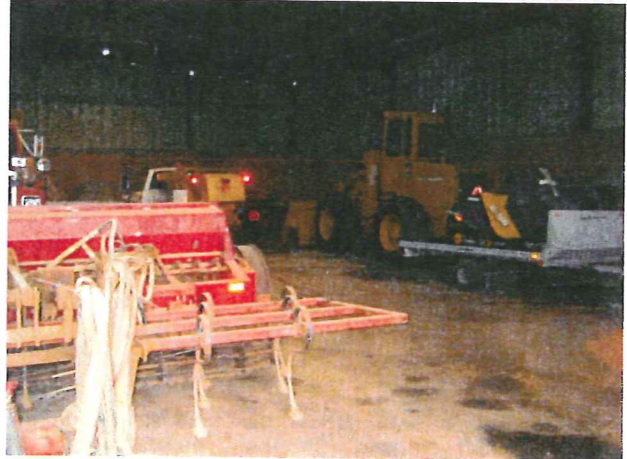
4. View of the second shed (facing north).

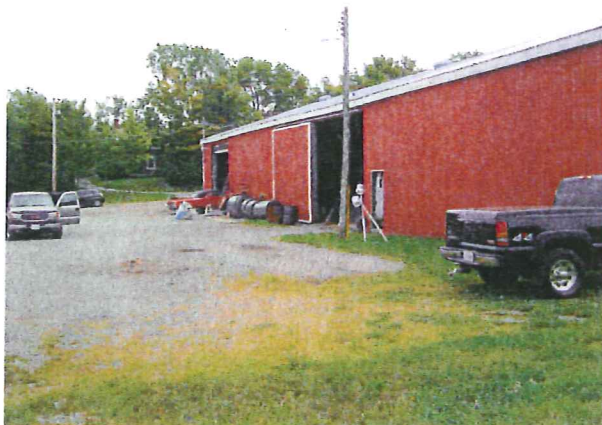
5. View of the diesel ASTs located on the phase one property (facing south).

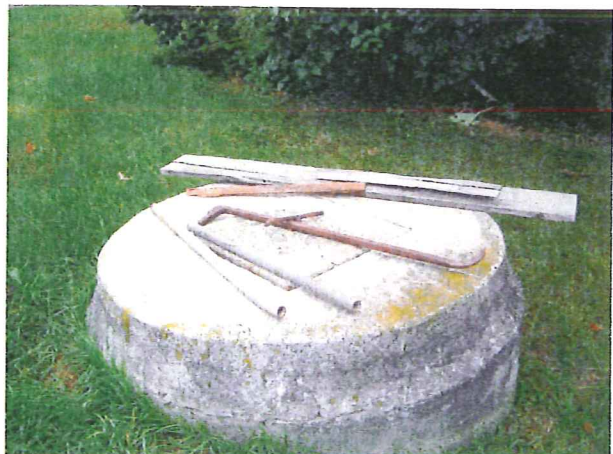
6. View of the water well on the phase one property (facing northwest).

The water well identified on the property will require decommissioning in accordance with Ontario Regulation 903 when no longer required. A septic tank/septic system should also be decommissioned in accordance with applicable regulatory requirements.

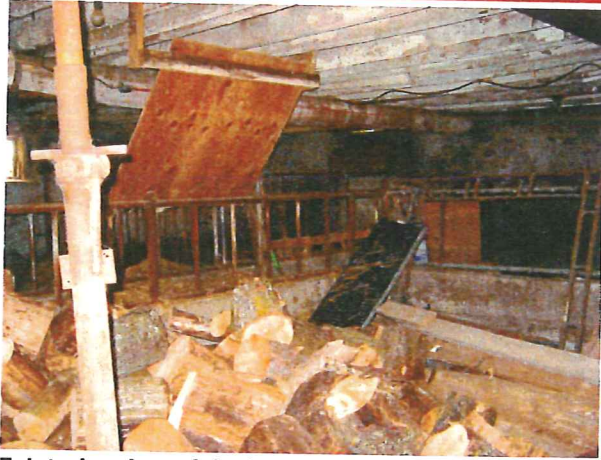
7. Interior view of the barn facing northwest.

The storage shed located further east is currently used for the storage of equipment and is also where the chicken coop is currently kept. The barn located north of the sheds is a slab on grade wood frame construction. Storage of a large quantity of Styrofoam was observed within the barn. Throughout the phase one property construction materials consisting of concrete pipes and metal were observed.
