Mayfield Tullamore Local Subwatershed Study

Phase 1 – Subwatershed Characterization and Integration
Report
Town of Caledon, Peel Region, Ontario

August 2024
Project 2400278

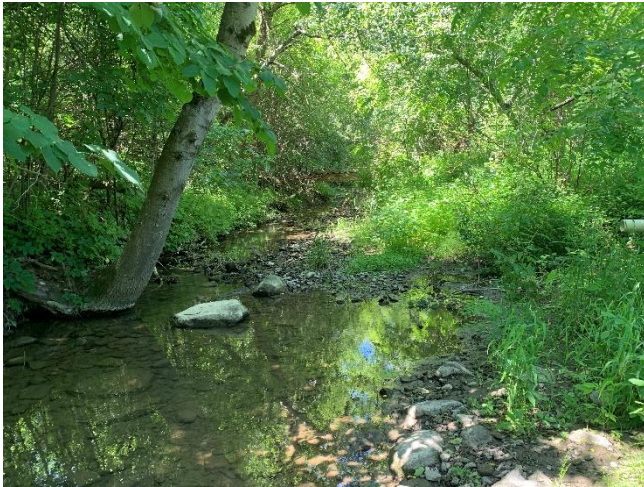
Photograph 1.
Representative View of the North Parcel Reach (WHT-1) of the West Humber River Tributary.

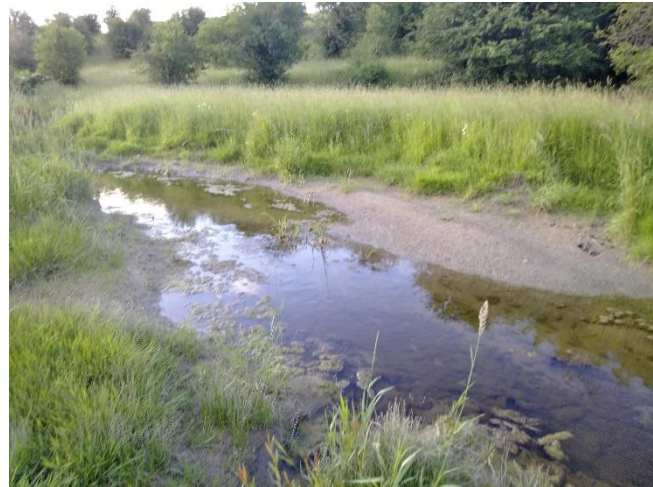
Photograph 2.
Representative View of the South Parcel Reach (WHT-1A) of the West Humber River Tributary.

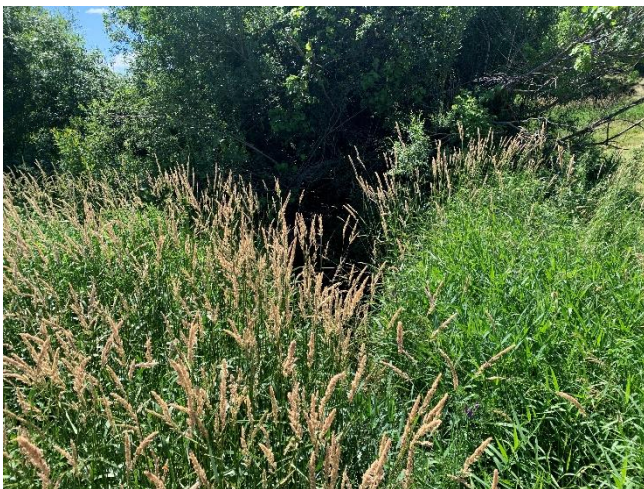
Photograph 3.
Representative View of the Downstream Reach (WHT-2) of the North-South Tributary.

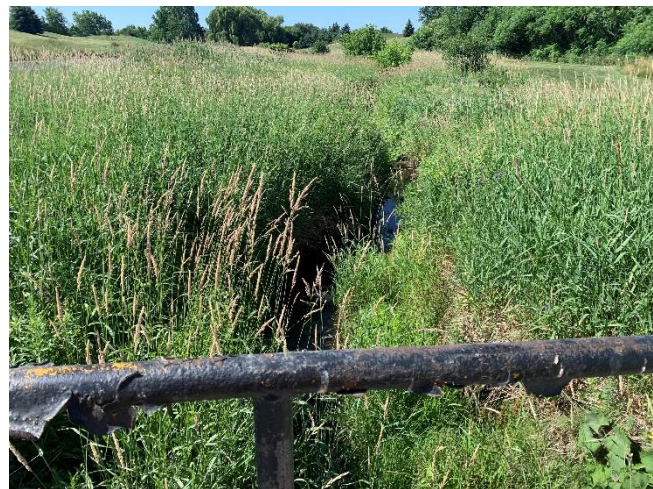
Photograph 4.
Representative View of the Upstream Reach (WHT-3) of the North-South Tributary.

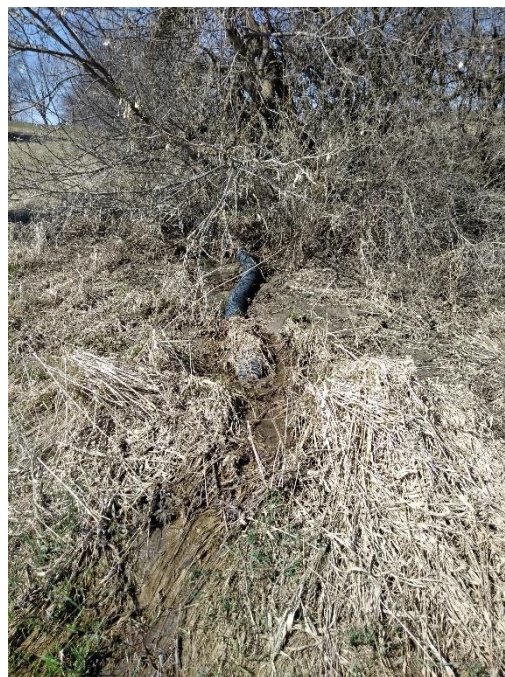
Photograph 11.
HDF 3B – Upstream View of Tile Drain Outfall (April 12, 2023).

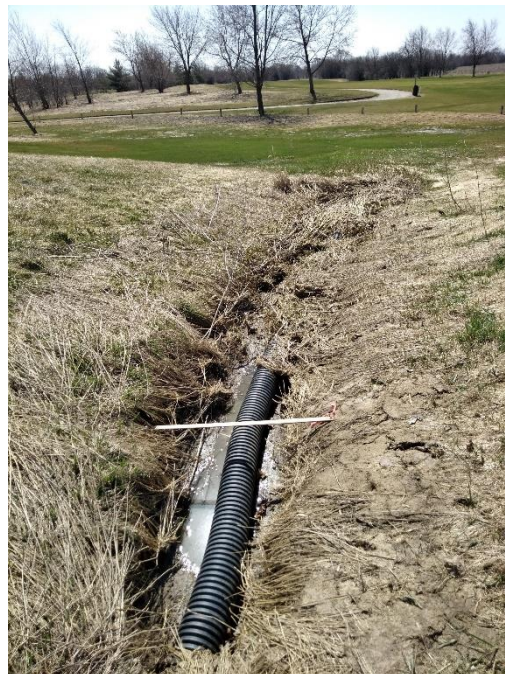
Photograph 13.
HDF 4A – Downstream View of Tile Drain (April 12, 2023).
