TRIPLE CROWN LINE DEVELOPMENTS INC.

# Agricultural Opinion Report

15505 Airport Road, Town of Caledon, Ontario

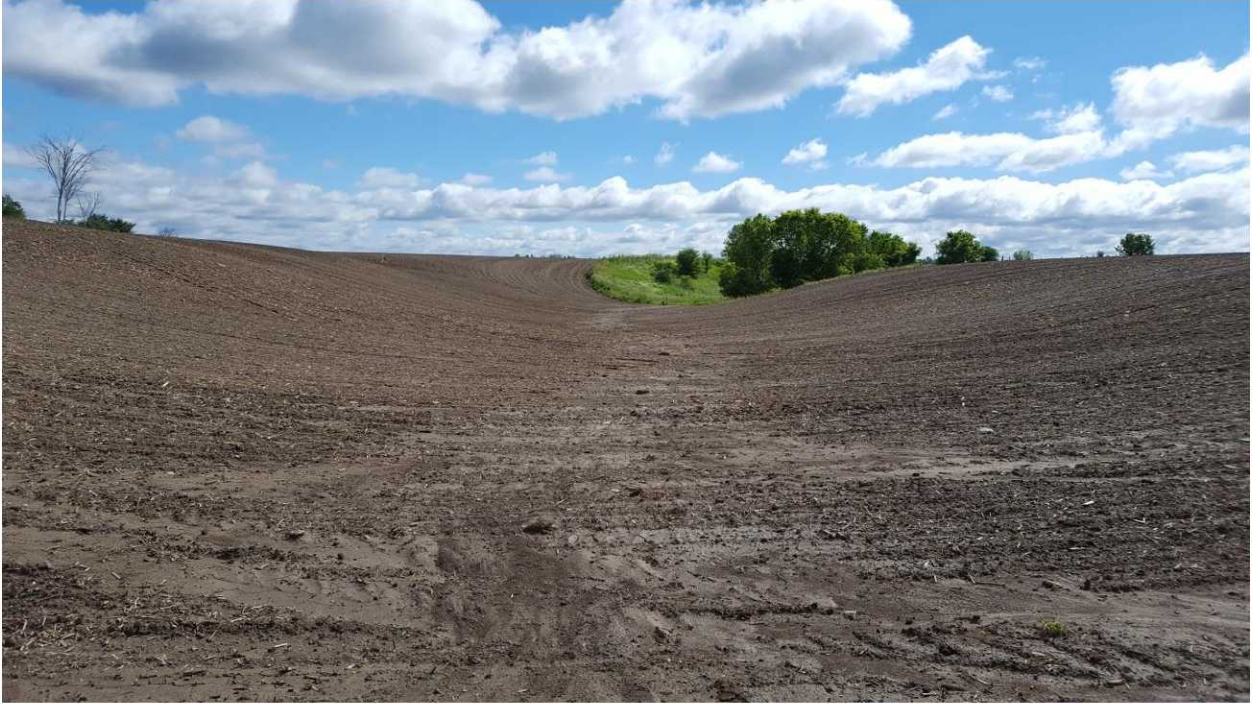
A distinctive depression approximately 4 m to 5 m in depth and 40 m wide is located in the northern third of the Field and represents approximately 1 ha (**Figure 1 and Photo 1**). To the east of this feature is a narrow grassy valley (**Photo 2**) that eventually drains east into Innis Lake. In contrast, the southern portion of the Field is comparatively flat with a gentle slope towards the depression (**Photo 3**).

Photo 1 – View of valley system within northwest field looking east.

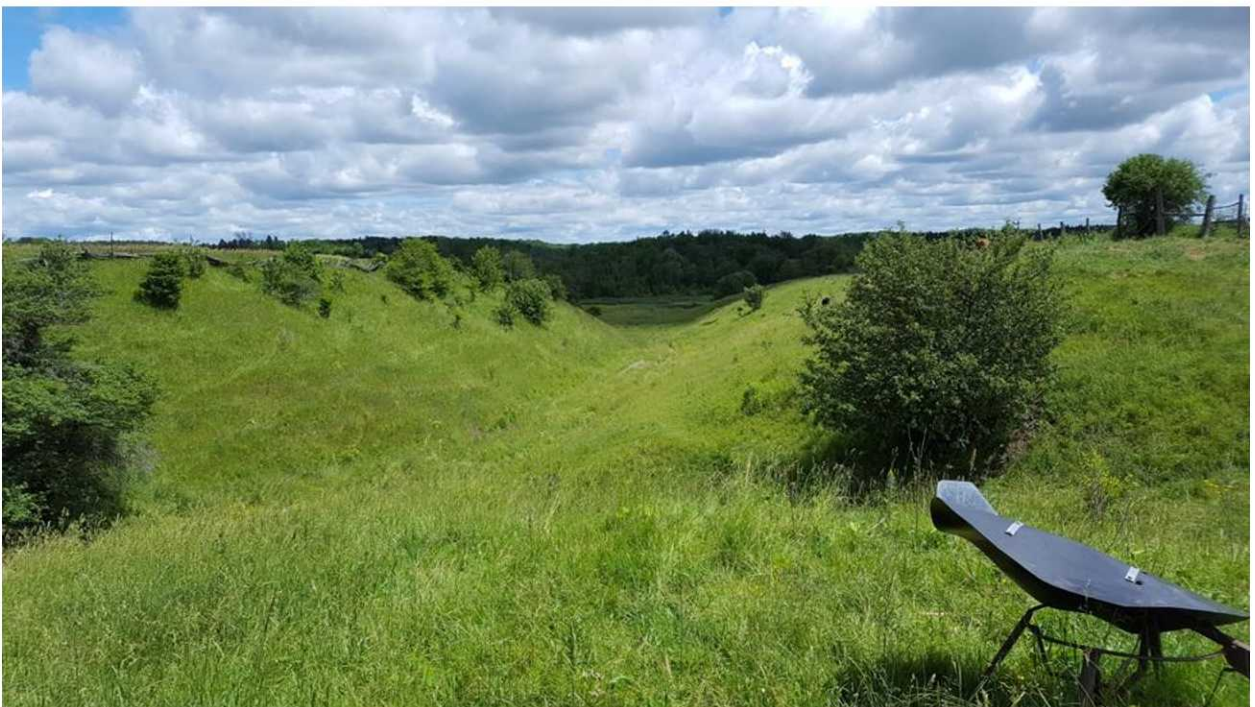
Photo 2 – View of steep grassy slopes that drain eastward towards Innis Lake

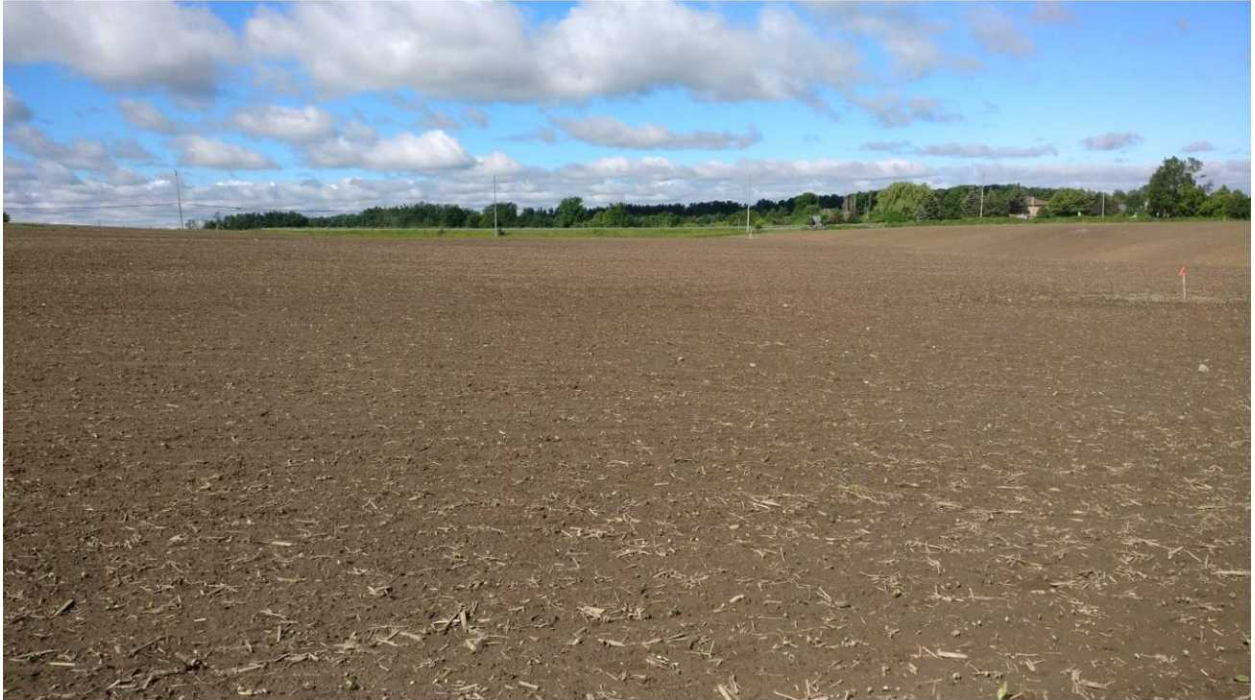
**Photo 3 – Southern portion of the field planted with soy bean, looking west; Note the relatively flat topography and the depression in the background.**

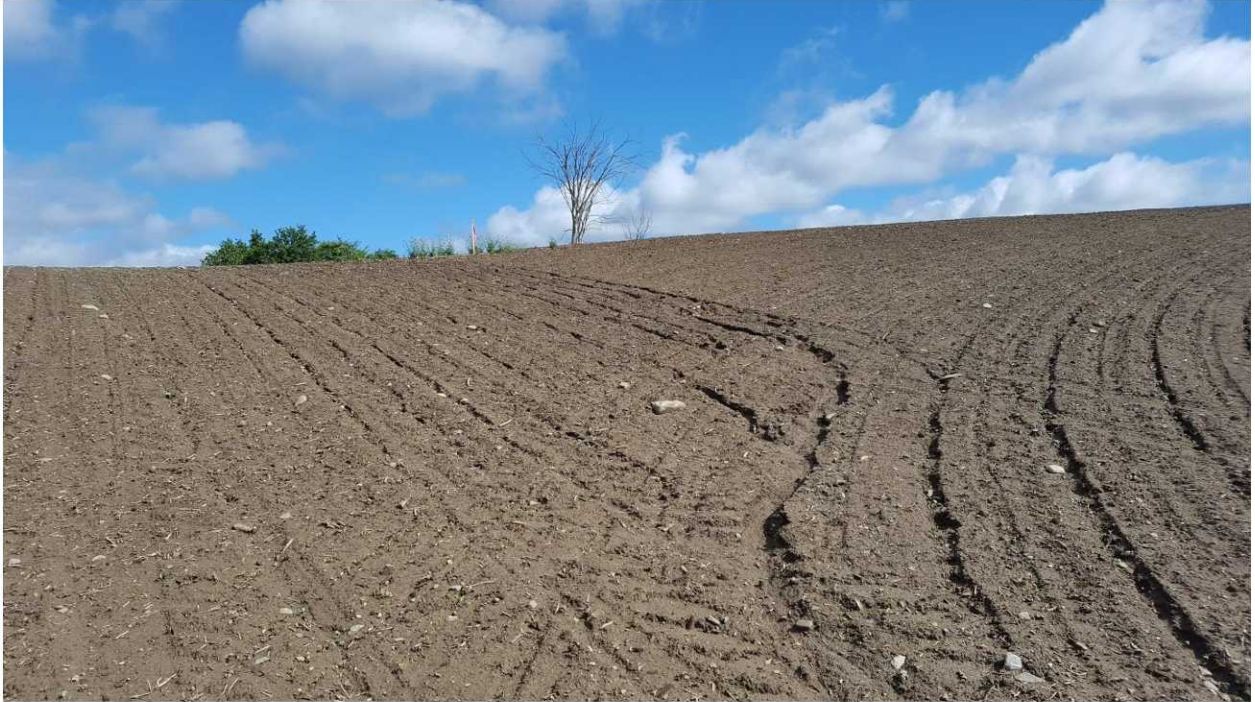
A review of **Figure 1** shows that there are numerous areas along the north and south valley wall where erosion of the slope has been sufficient to move the topsoil into the valley bottom causing limited topsoil cover to remain. It is likely that this trend will continue, and subsoil will become exposed if common field crops continue to be grown in this valley feature. Inspection of the side slopes also found signs of sheet, rill and gully erosion where soybean had been planted along with migration of topsoil (**Photo 4**).

**Photo 4 – View of north slopes with northwest field. Soybean has been planted, but rill erosion is occurring along the planted rows that flow downslope into the valley.**

The limitation of topography is an issue within at least the northern portion of the field as the presence of steep slopes, as well as visible signs of erosion, has been encountered. Cultivation of these slopes by farm equipment on these slopes does occur, but extreme caution is required to avoid tractor roll-over. However, continued erosion will occur on an annual basis unless a permanent cover crop or grassed water ways are installed throughout this area.

The slopes within the northern portion of the Field are steep and are contiguous with steeper slopes downstream that remain vegetated. To reduce the soil erosion in this area, it is recommended that agricultural operations cease and the area should be permanently vegetated. Alternatively, this area could be modified to accommodate a storm management pond for the planned development to the north. The construction of a berm and outlet for overflows could be directed to the east for long term treatment.

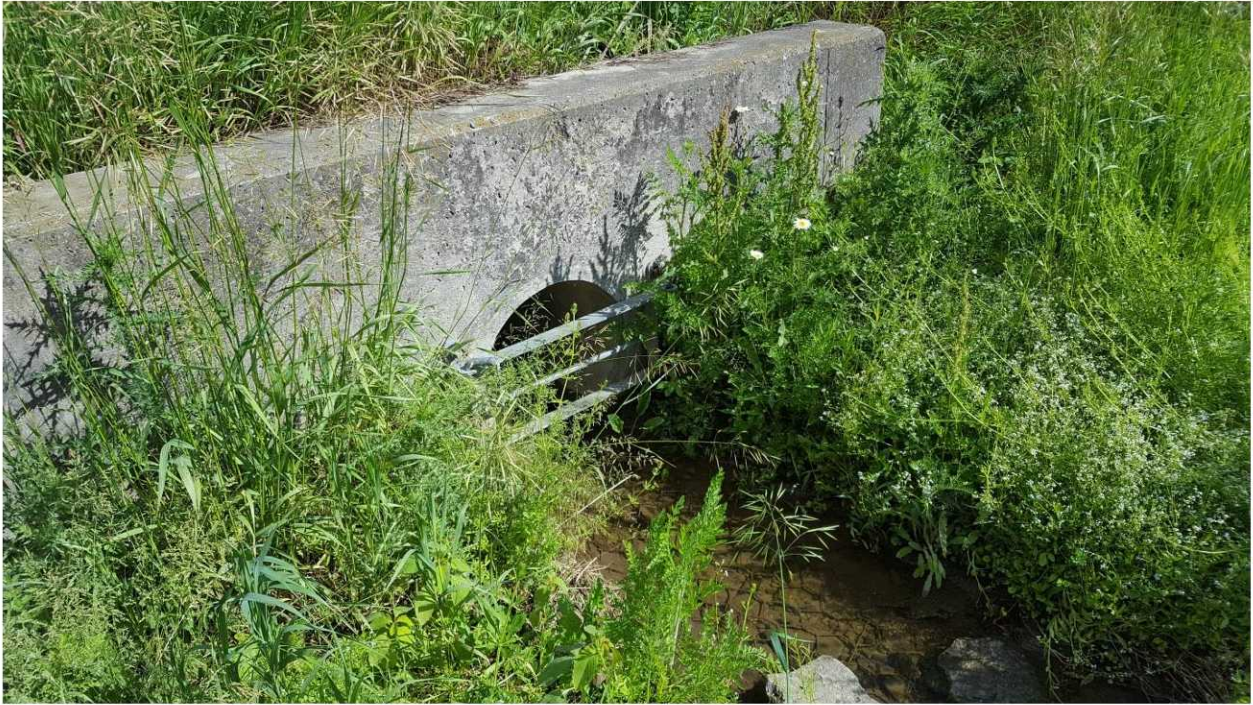
Upon further field review, it was discovered that disruption of soils in the northern portion of the northwest field had occurred due to the installation of a 66 cm diameter concrete culvert to drain flows from the west of Airport Road towards Innis Lake located to the east (**Photo 5**). In this regard, chunks of concrete, bedrock and brick had been found within the headlands of the northwest field, along with thinner soils compared to those compared to the south. In addition, deposition of soils and crop debris

**Photo 5 – Outlet of 66 cm diameter culvert near east end of northwest field.**

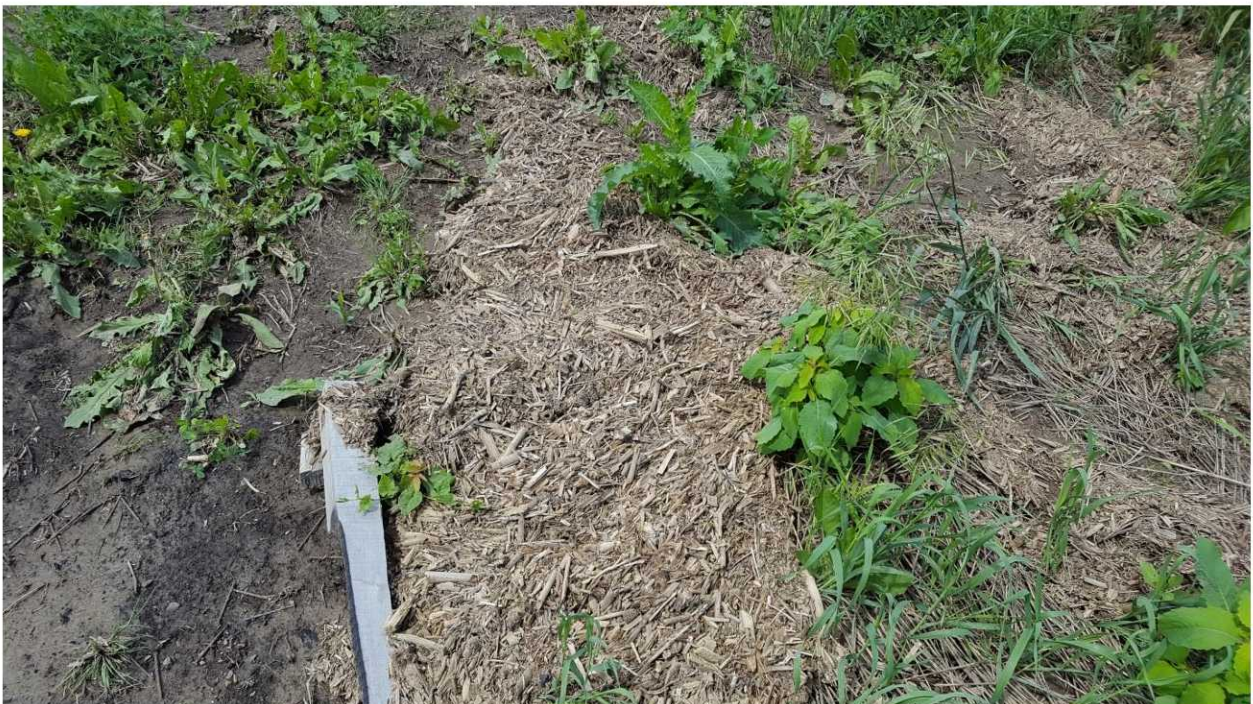
from flooding events within the valley this spring had been found near the outlet of the culvert (**Photo 6**).

**Photo 6 – View of sediment and corn stalk residue that has washed off the northwest field into adjacent valley lands. This accumulation of soil was at least 15 cm deep in some areas.**
