# Geomorphic Assessment for Part of Lots 19, 20 and 21 Concession 5, Town of Caledon, Region of Peel

**Mayfield Golf Course Inc. and  
Tullamore Industrial GP Limited**

**Beacon Environmental Limited**

**222239**

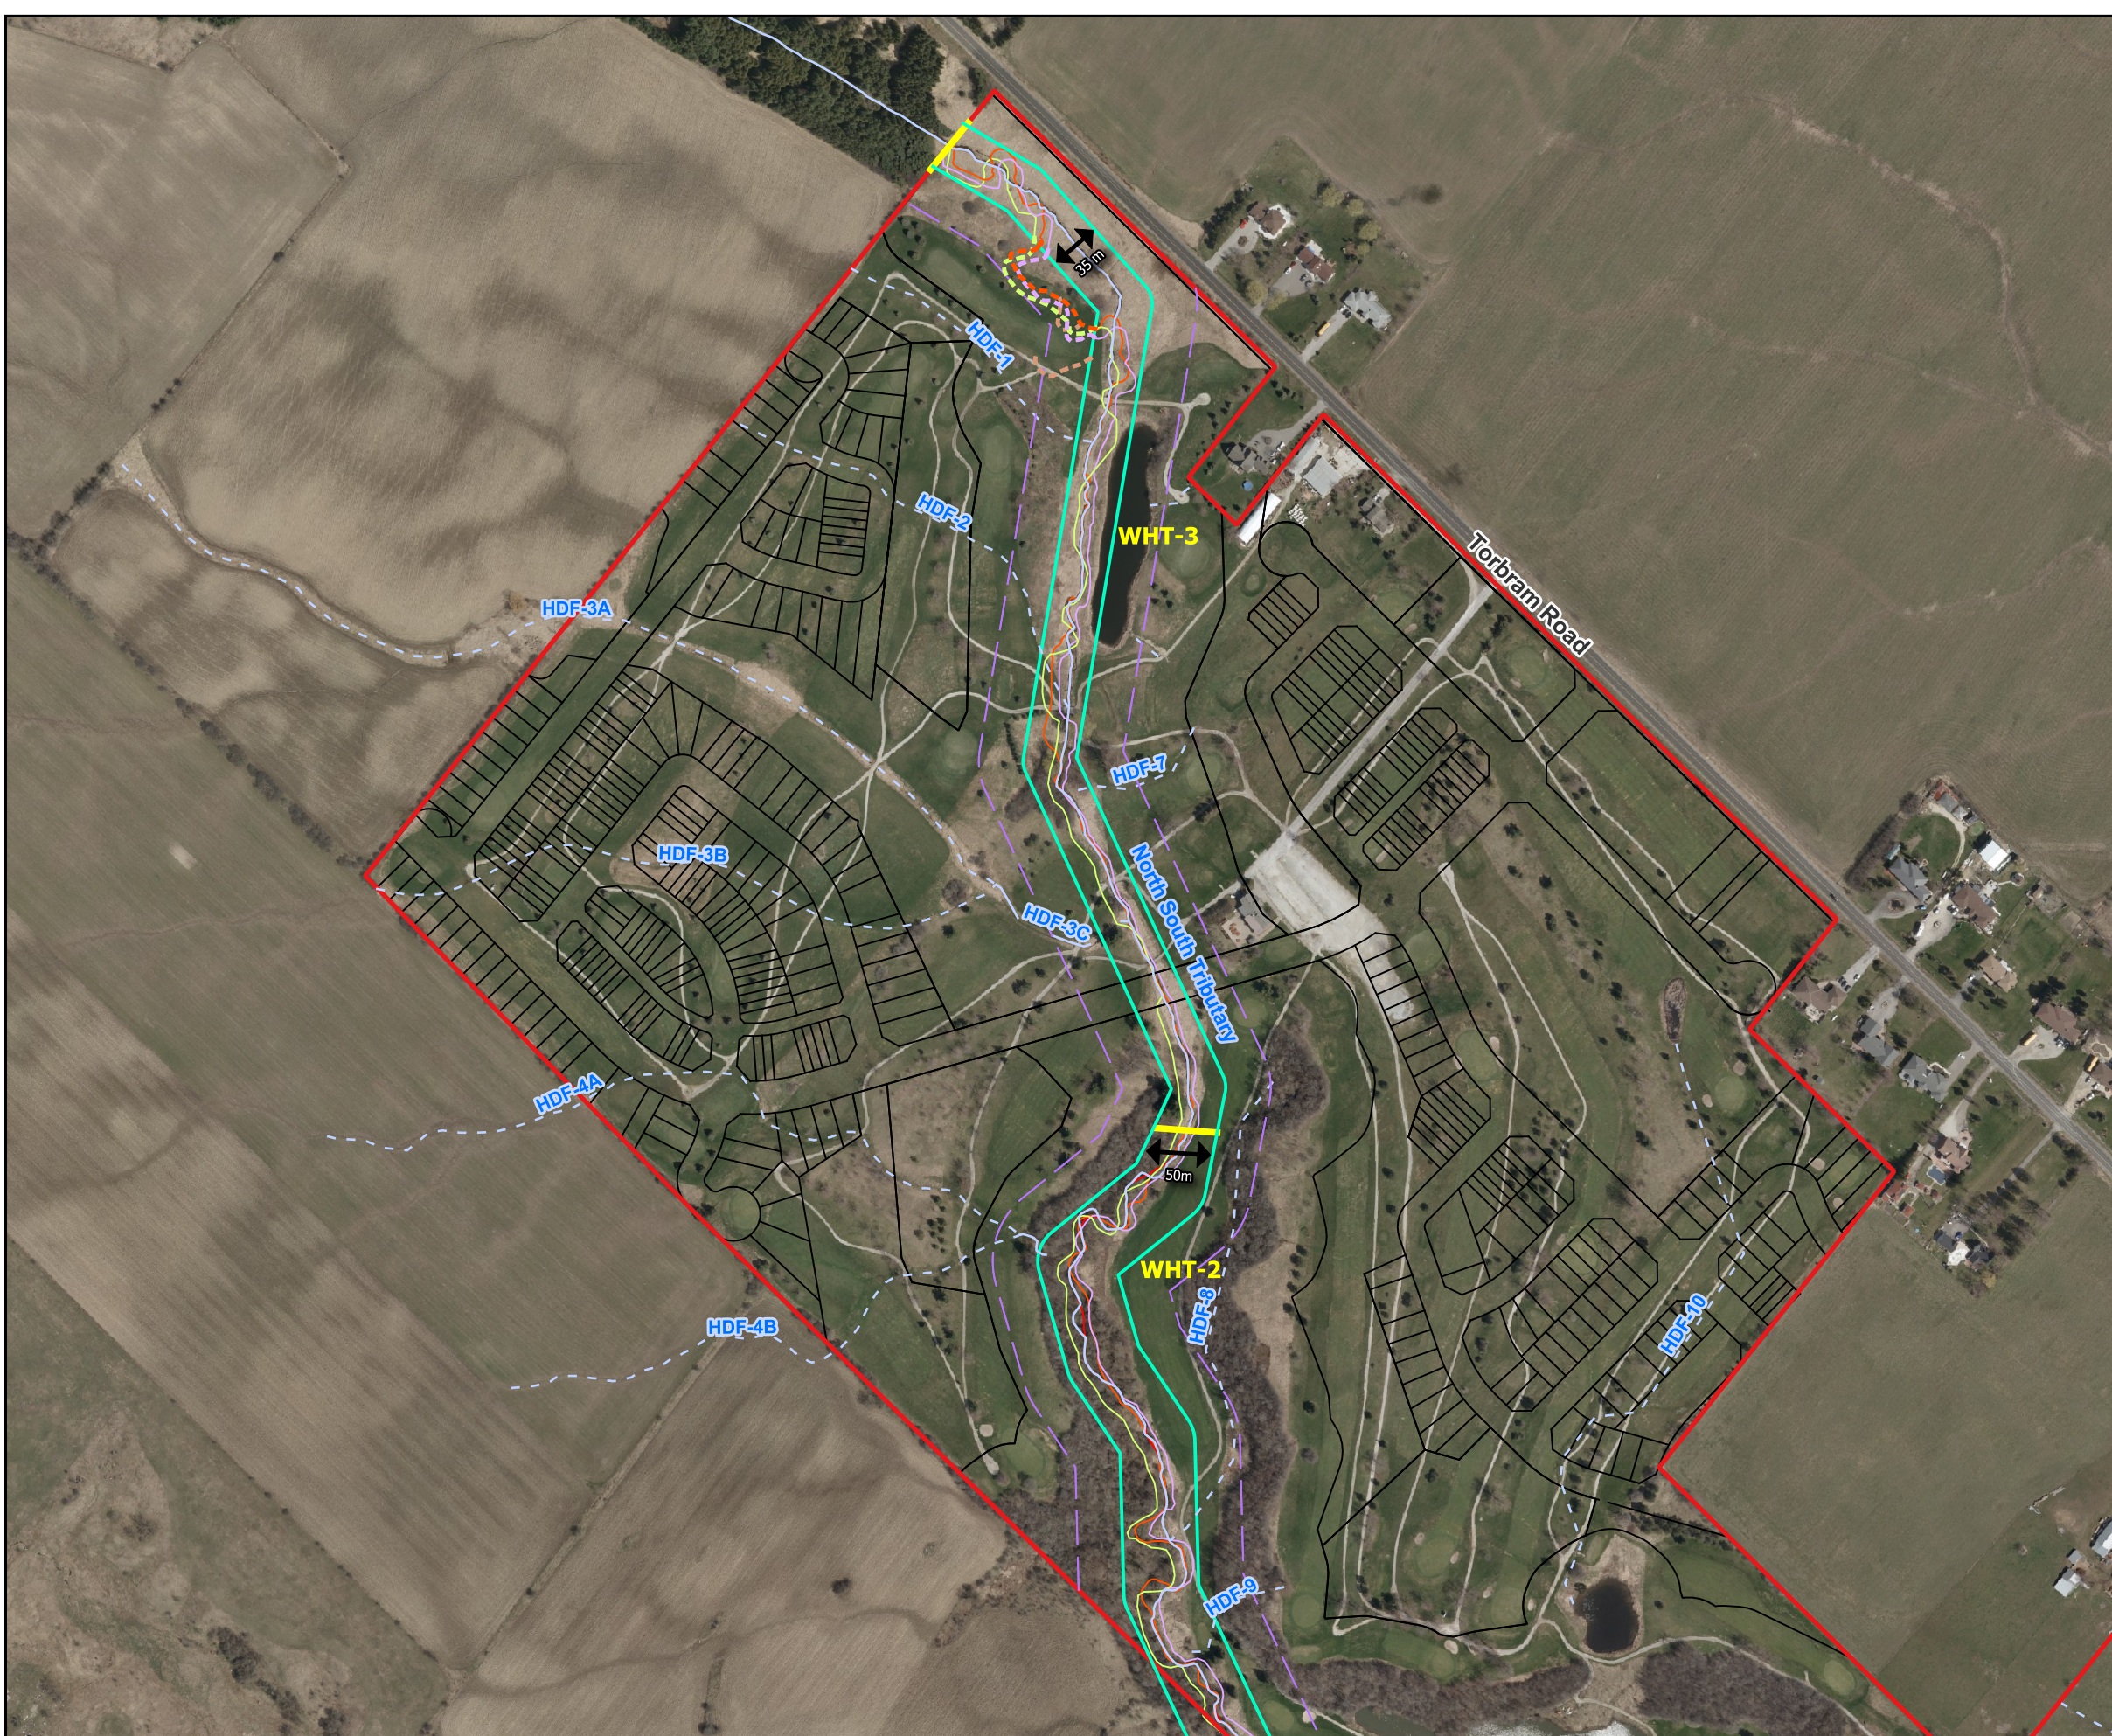
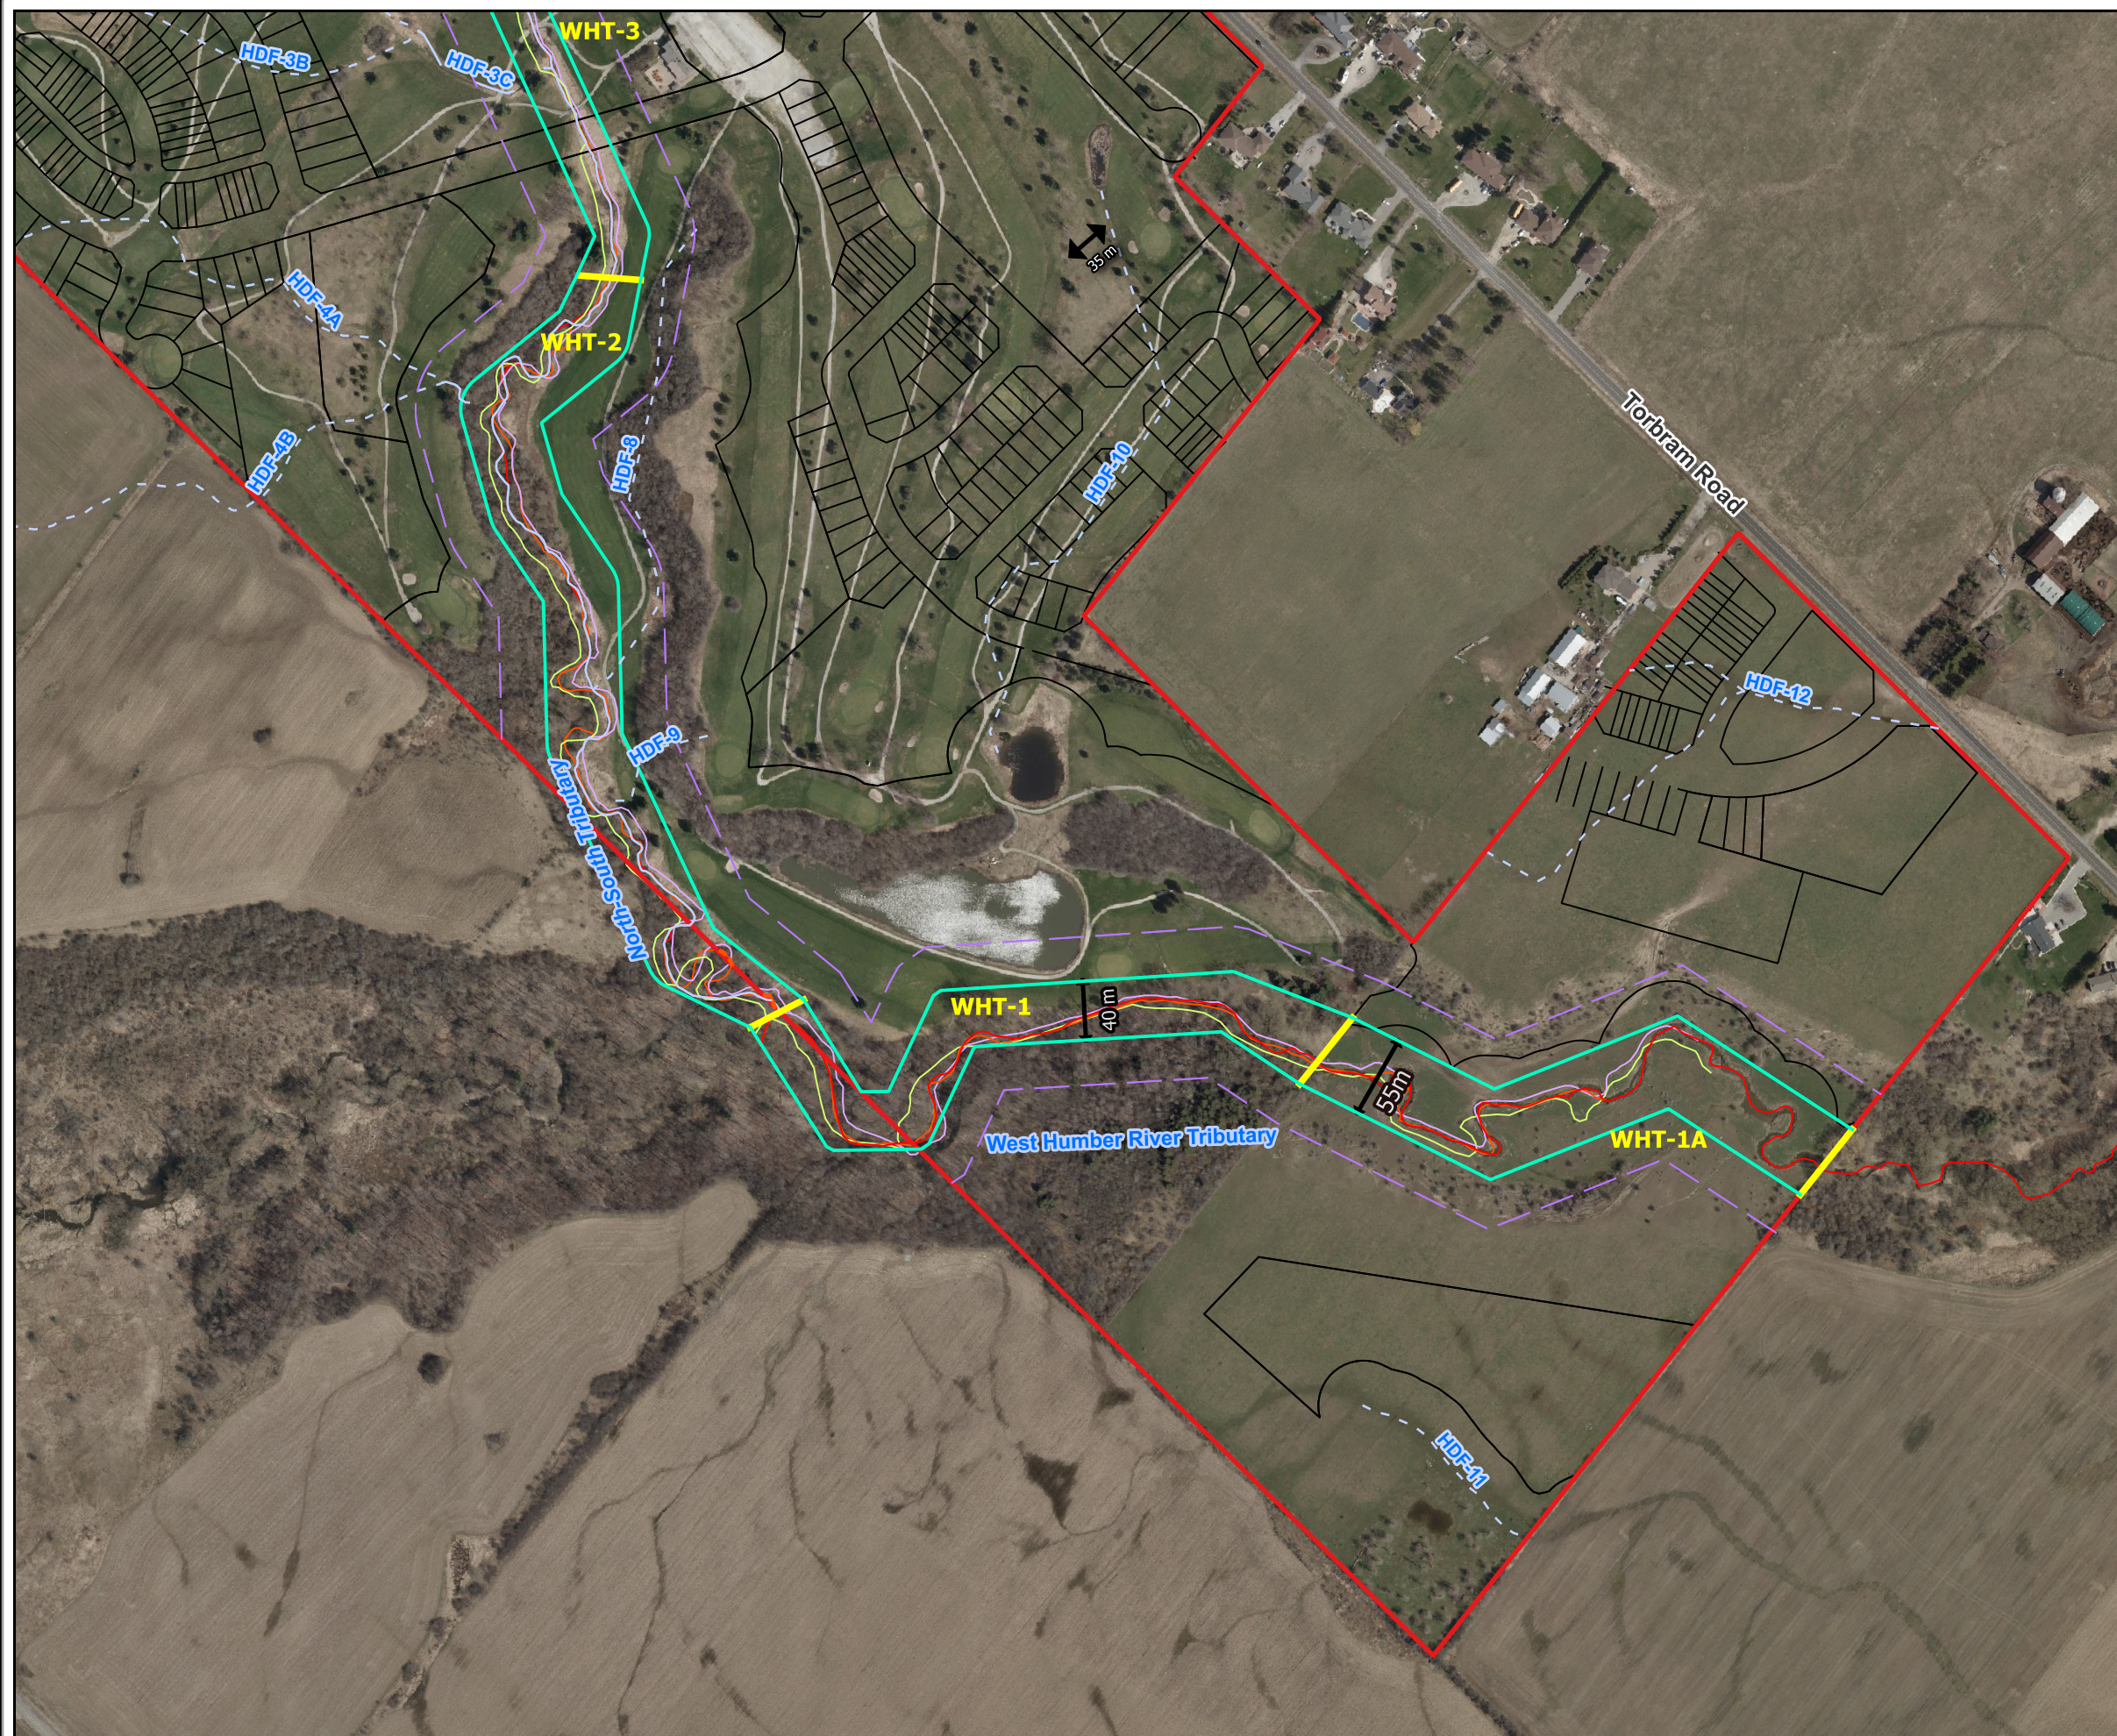
These dimensions were reviewed relative to available topographic mapping and field observations to ensure that they considered valley floor dimensions and were sufficient to capture the active (bankfull) channel, as well as evidence of lateral occupation of the floodplain at the reach scale. **Figures 3A** and **3B** illustrate meander belt limits as delineated for Reaches WHT-1A, WHT-1 WHT-2 and WHT-3.

**Figures 3A** and **3B** identify areas within 30 m of the meander belt as delineated for Reaches WHT-1A, WHT-1 WHT-2 and WHT-3 in relation to the subject lands.

- The following meander belt dimensions were recommended on a reach basis:
  - Reach WHT-1A: 55 m;
  - Reach WHT-1: 40 m;
  - Reach WHT-2: 50 m; and
  - Reach WHT-3: 35 m.

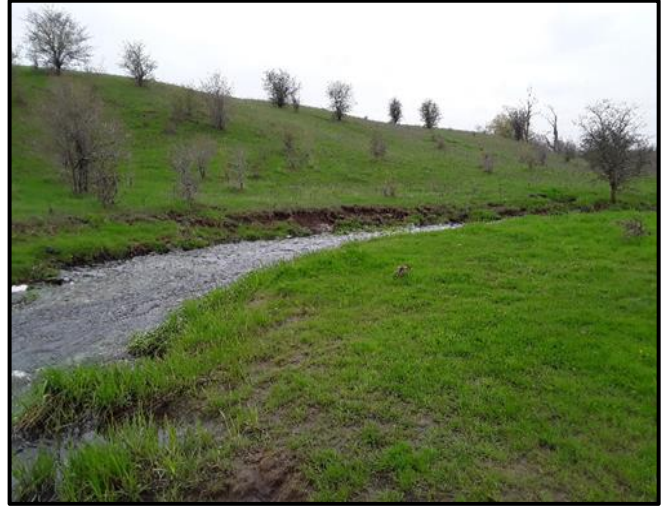
RGA results indicated that Reach WHT-1A was 'in transition', with a score of 0.29. Widening was identified as the dominant mode of adjustment, with evidence of aggradation and planimetric form adjustment also observed. Evidence of widening included leaning/fallen fence posts, occurrence of large woody debris, fracture lines observed along top of bank, basal scour on inside meander bends, on both sides of channel through riffle, and extending greater than 50% of the reach length. Planimetric form adjustment was observed in the form of cut off channels and chute formation. Aggradation was observed through siltation in pools and deposition in the overbank zone. An RSAT score of 24.5 indicated a 'fair' degree of overall ecological health, with channel stability and riparian habitat conditions as the primary limiting factors. The Downs (1995) model reflected the RGA evaluation of this reach through a classification of M – 'lateral migration' based on evidence of bank erosion on outside bend and deposition on inside bends.

**Photograph 1. Location 1.**  
**Reach WHT-1A West Humber River Tributary**  
Upstream view from property limit. Note bank erosion on left bank (photo right) and valley wall contact and outer bank erosion on right bank (photo left).

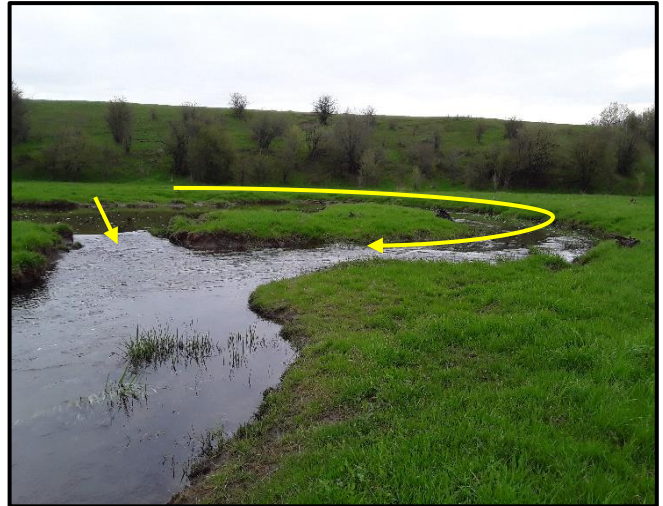
**Photograph 3. Location 3.**  
**Reach WHT-1A West Humber River Tributary**  
Downstream view of meander bend and valley wall contact.

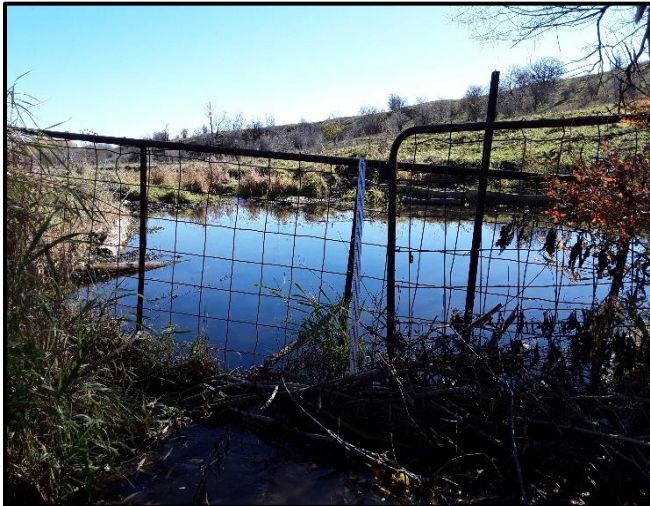
<p><b>Photograph 9. Location 9.</b>  <b>Reach WHT-1 West Humber River</b>  <b>Tributary</b>                  Gate crossing at the downstream reach extent.</p>	<p><b>View: DS</b></p>
<p><b>Date Taken: November 8, 2022</b></p>	
<p><b>Site: 12522 &amp; 12306 Torbram Rd, Caledon ON</b></p>

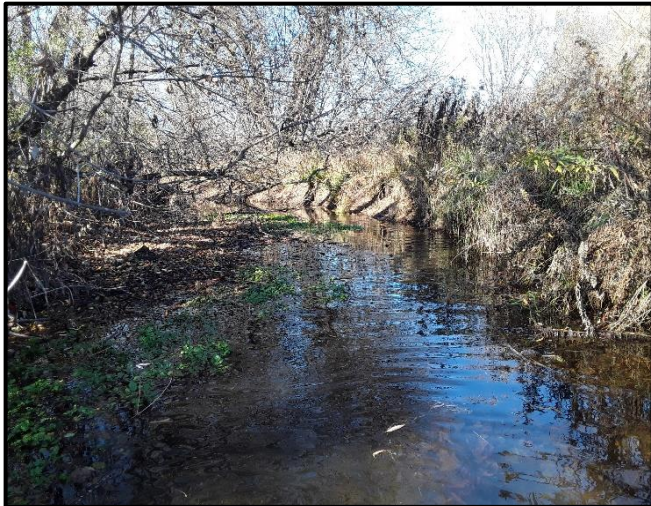
<p><b>Photograph 10. Location 9.</b>  <b>Reach WHT-1 West Humber River</b>  <b>Tributary</b>                  Upstream view of channel from downstream reach break.</p>	<p><b>View: US</b></p>
<p><b>Date Taken: November 8, 2022</b></p>	
<p><b>Site: 12522 &amp; 12306 Torbram Rd, Caledon ON</b></p>

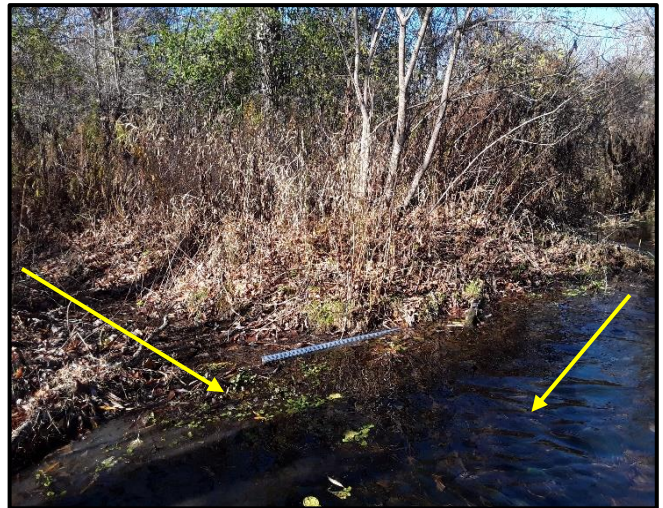
<p><b>Photograph 16. Location 14.</b>  <b>Reach WHT-1 West Humber River</b>  <b>Tributary</b>                  Upstream view of confluence of tributaries at reach extent.</p>	<p><b>View: US</b></p>
<p><b>Date Taken: November 8, 2022</b></p>	
<p><b>Site: 12522 &amp; 12306 Torbram Rd, Caledon ON</b></p>

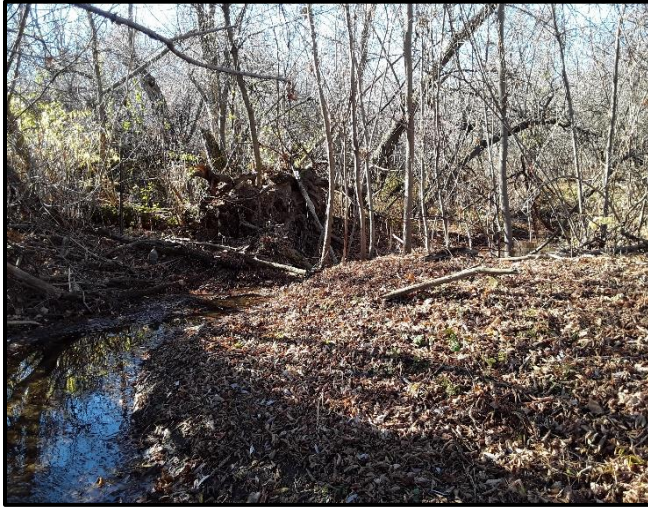
**Photograph 17. Location 15.**  
**Reach WHT-2 North-South Tributary**  
 Downstream view of historical flow path. Standing water present during time of survey.

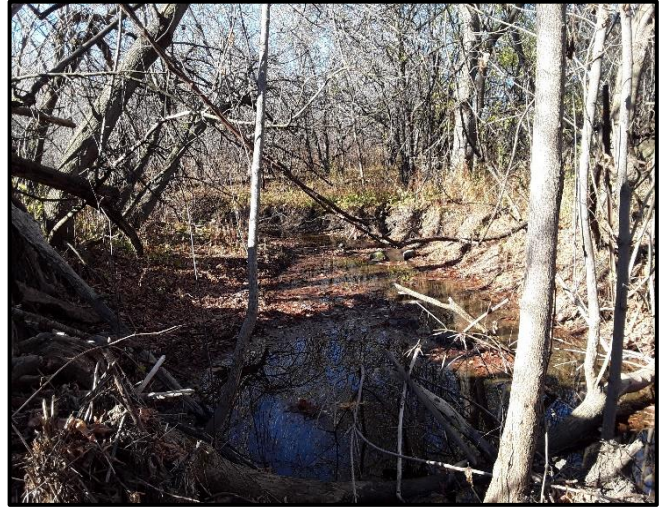
**Photograph 18. Location 16.**  
**Reach WHT-2 North-South Tributary**  
 Downstream view of general channel conditions.

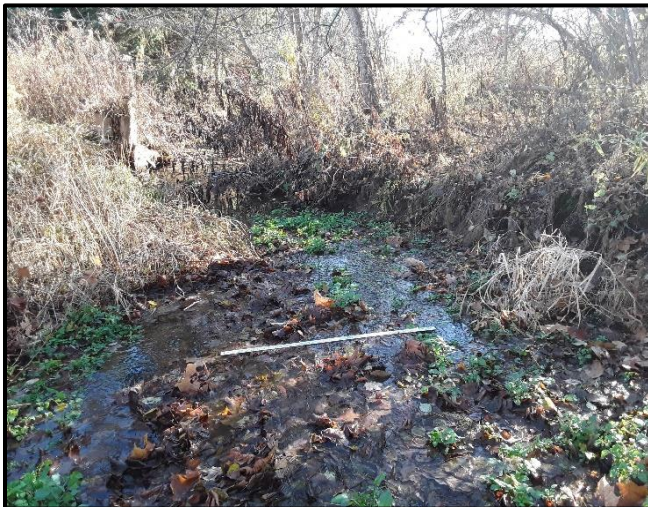
**Photograph 19. Location 17.**  
**Reach WHT-2 North-South Tributary**  
 Downstream view of riffle. Note presence of in-stream vegetation.

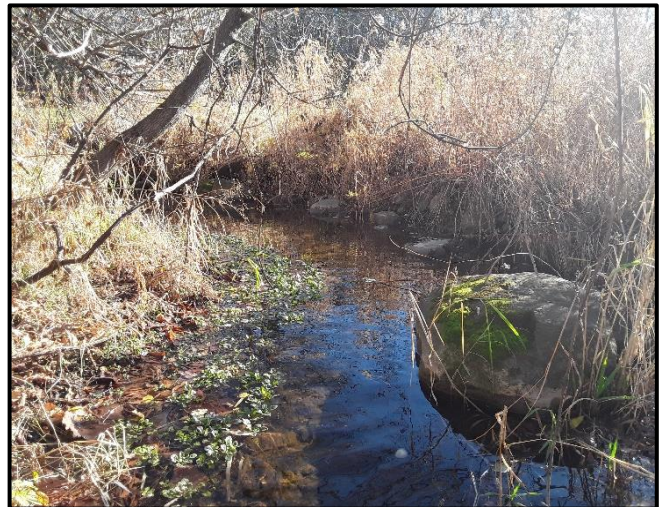
**Photograph 20. Location 18.**  
**Reach WHT-2 North-South Tributary**  
 Upstream view of channel meander bend. Note erratic boulder present instream.

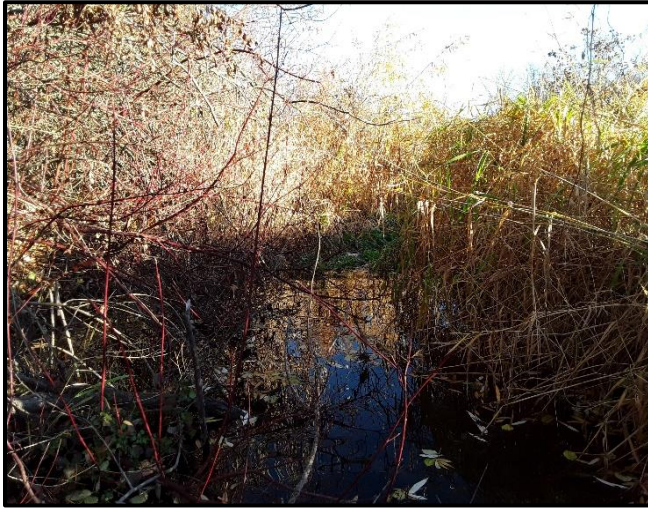
<p><b>Photograph 25. Location 22.</b>  <b>Reach WHT-2 North-South Tributary</b>                  Upstream view of channel conditions at reach break. Note change in riparian vegetation.</p>	<p><b>View: US</b></p>
<p><b>Date Taken: November 8, 2022</b></p>	
<p><b>Site: 12522 &amp; 12306 Torbram Rd, Caledon ON</b></p>

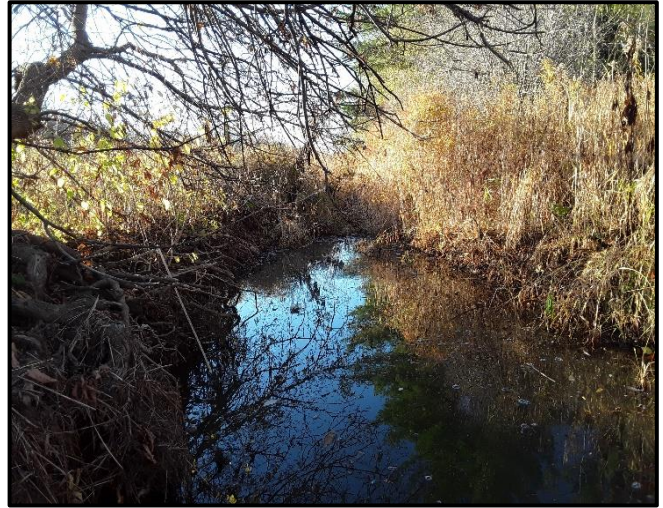
<p><b>Photograph 26. Location 23.</b>  <b>Reach WHT-2 North-South Tributary</b>                  Upstream view of channel conditions at reach break. Note change in riparian vegetation.</p>	<p><b>View: US</b></p>
<p><b>Date Taken: November 8, 2022</b></p>	
<p><b>Site: 12522 &amp; 12306 Torbram Rd, Caledon ON</b></p>

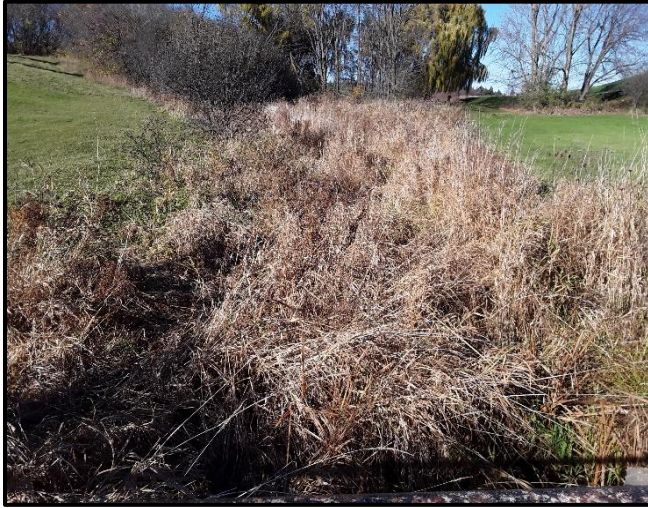
<p><b>Photograph 29. Location 26.</b>  <b>Reach WHT-3 North-South Tributary</b>                  Upstream view of channel conditions from golf cart crossing. Note riparian grasses and vegetation encroachment.</p>	<p><b>View: US</b></p>
<p><b>Date Taken: November 8, 2022</b></p>	
<p><b>Site: 12522 &amp; 12306 Torbram Rd, Caledon ON</b></p>

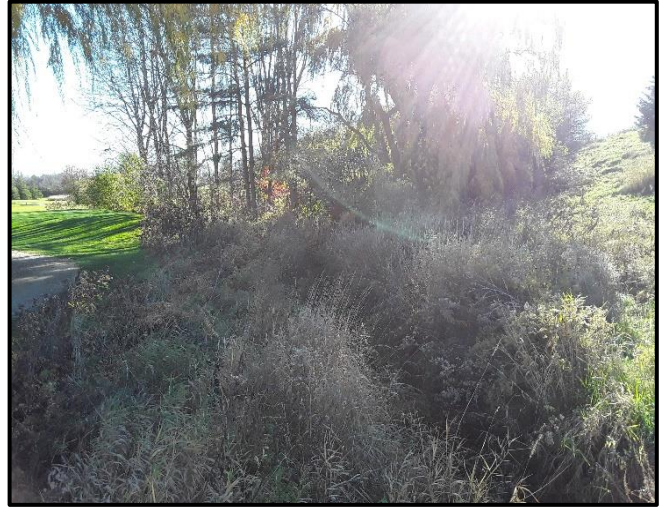
<p><b>Photograph 30. Location 27.</b>  <b>Reach WHT-3 North-South Tributary</b>                  Downstream view of channel from golf cart crossing.</p>	<p><b>View: DS</b></p>
<p><b>Date Taken: November 8, 2022</b></p>	
<p><b>Site: 12522 &amp; 12306 Torbram Rd, Caledon ON</b></p>

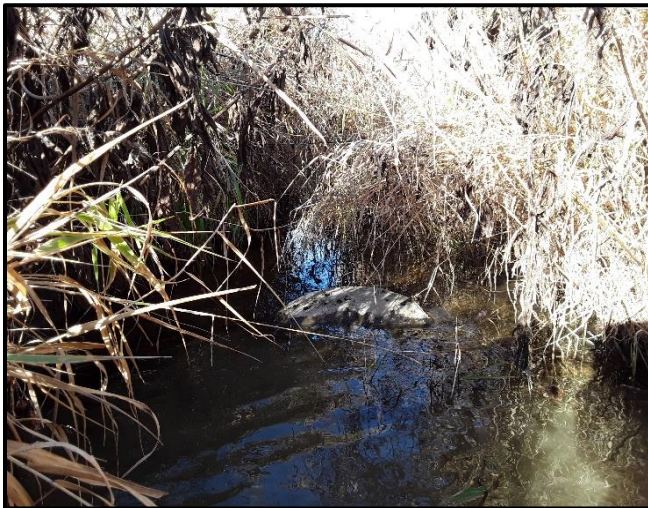
<p><b>Photograph 31. Location 28.</b>  <b>Reach WHT-3 North-South Tributary</b>                  Downstream view of pool feature. Note overhanging grasses and herbaceous species.</p>	<p><b>View: DS</b></p>
<p><b>Date Taken: November 8, 2022</b></p>	
<p><b>Site: 12522 &amp; 12306 Torbram Rd, Caledon ON</b></p>

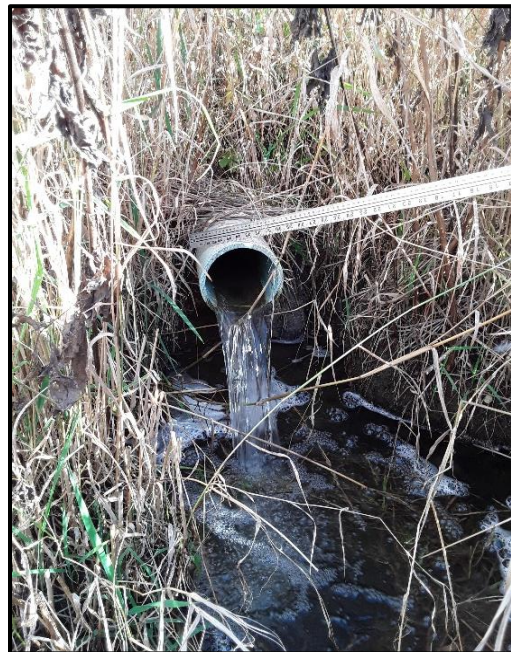
<p><b>Photograph 32. Location 29.</b>  <b>Reach WHT-3 North-South Tributary</b>                  Online pond outlet on channel left bank.</p>	<p><b>View: US</b></p>
<p><b>Date Taken: November 8, 2022</b></p>	
<p><b>Site: 12522 &amp; 12306 Torbram Rd, Caledon ON</b></p>

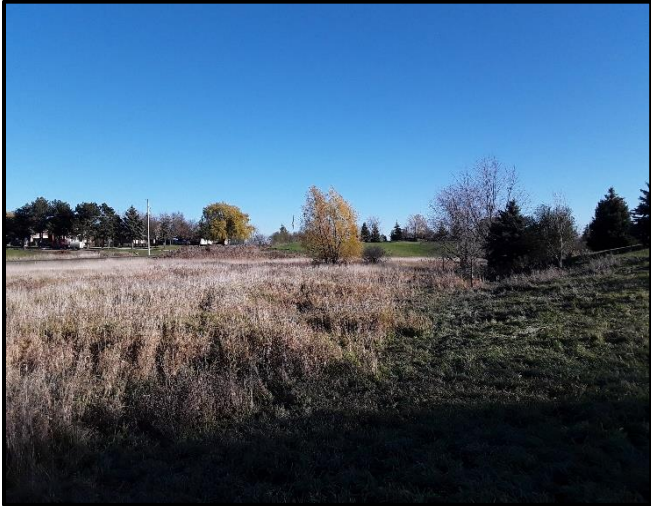
<p><b>Photograph 33. Location 30.</b>  <b>Reach WHT-3 North-South Tributary</b>                  Downstream view of valley corridor. Note riparian grasses and herbaceous species.</p>	<p><b>View: DS</b></p>
<p><b>Date Taken: November 8, 2022</b></p>	
<p><b>Site: 12522 &amp; 12306 Torbram Rd, Caledon ON</b></p>

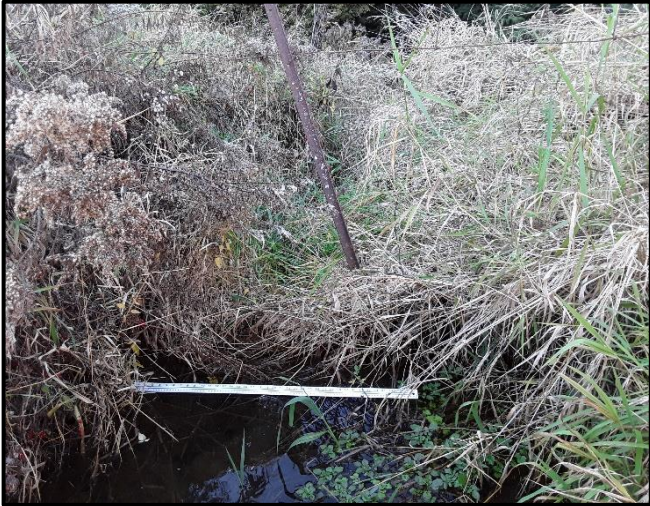
<p><b>Photograph 34. Location 31.</b>  <b>Reach WHT-3 North-South Tributary</b>                  Upstream view of channel conditions at upstream reach extent.</p>	<p><b>View: US</b></p>
<p><b>Date Taken: November 8, 2022</b></p>	
<p><b>Site: 12522 &amp; 12306 Torbram Rd, Caledon ON</b></p>
