Headwater Drainage Feature Assessments

GEO Morphix, June 28, 2024

**Re: Headwater Drainage Feature Assessments
Alloa Secondary Plan Area, Local Subwatershed Study
Town of Caledon, Ontario
GEO Morphix Project No. PN24009**

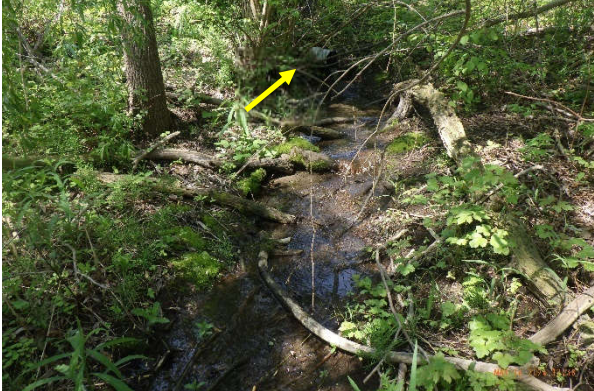
Reach AD1-2D

Location: Mayfield Road, Caledon		Watershed: Etobicoke Creek	
Round 1 Hydrology: Feature not identified/observed	Round 2 Hydrology: Water flowing over ground surface from tile drain	Round 3 Hydrology: To be completed	
Riparian Classification: Feature flowing through a wetland and forest.			
Fish Observed: No	Upstream of HDF: Pond	Downstream of HDF: Alloa Drain tributary (Reach AD1-2)	
Notes: Tile drain feature connecting an adjacent dug pond to the downstream watercourse.			
GEO Morphix Management Recommendation: Conservation Feature status was lowered to Conservation due to the artificial condition associated with the adjacent pond. <i>*Subject to change following round 3 HDFA*</i>

Round 2: Photograph facing upstream of tile drain (yellow arrow).			
Round 3: To be completed

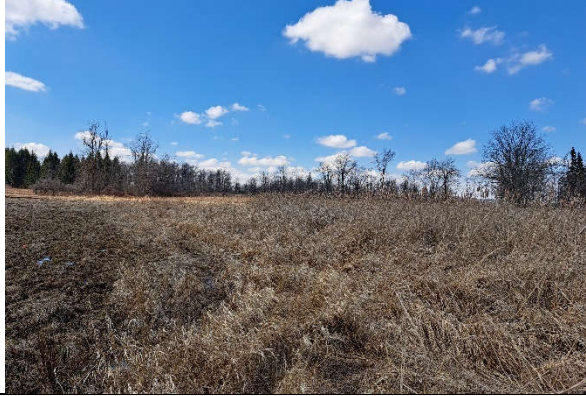
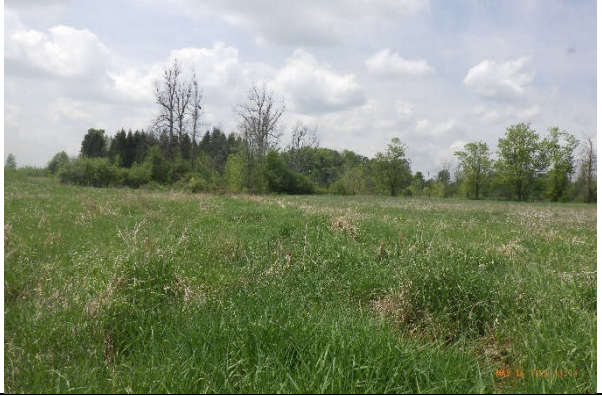
Reach AD1-3

Location: Mayfield Road, Caledon		Watershed: Etobicoke Creek	
Round 1 Hydrology: Standing water	Round 2 Hydrology: Standing water	Round 3 Hydrology: To be completed	
Riparian Classification: The immediate riparian vegetation consists of wetland vegetation with meadow vegetation further from the banks.			
Fish Observed: No	Upstream of HDF: Forest and wetland	Downstream of HDF: Alloa Drain Tributary (Reach AD1-2)	
Notes: Feature lacks definition and flows through a wetland and woodlot (upstream). Approximately half of the feature upstream would be impacted based on the future Highway 413 which would potentially remove the terrestrial linkage to the upstream woodlot. For this reason, the upstream portion of the reach has been lowered to Mitigation (upstream) and Conservation (downstream).			
GEO Morphix Management Recommendation: Mitigation (future Highway 413 upstream footprint) / Conservation (downstream of future Highway 413) <i>*Subject to change following round 3 HDFA*</i>

Round 1: Photograph facing upstream.		Round 2: Photograph facing upstream.	
Round 3: To be completed

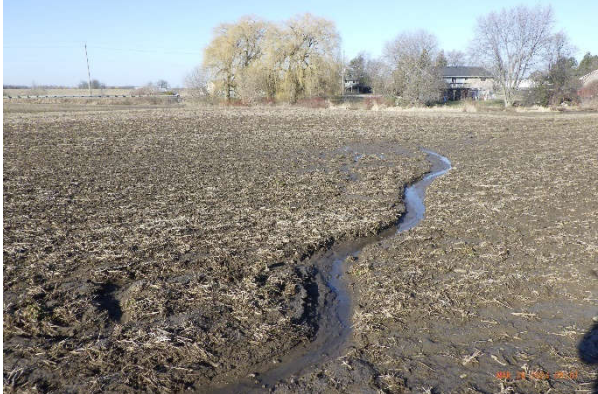
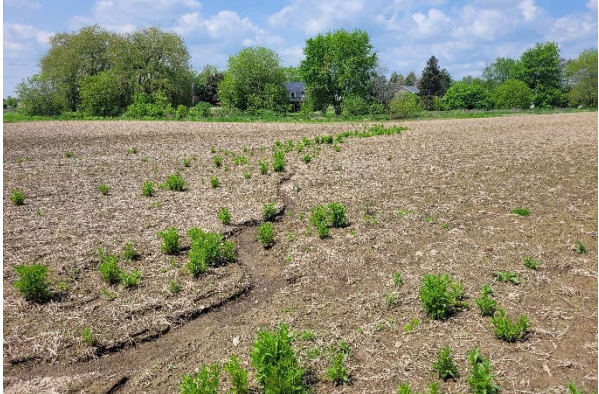
Reach AD3-6

Location: Mayfield Road, Caledon		Watershed: Etobicoke Creek	
Round 1 Hydrology: Flowing water	Round 2 Hydrology: Dry	Round 3 Hydrology: Round 3 site visit will not be completed as the Round 2 site visit was dry.	
Riparian Classification: Through an agricultural field.			
Fish Observed: No	Upstream of HDF: Agricultural field	Downstream of HDF: Alloa Drain	
Notes: Limited feature development identified with a lack of water in Round 2 of the site assessment.			
GEO Morphix Management Recommendation: No Management

Round 1: Photograph facing downstream.		Round 2: Photograph facing downstream.	
Round 3: Round 3 site visit will not be completed as the Round 2 site visit was dry.

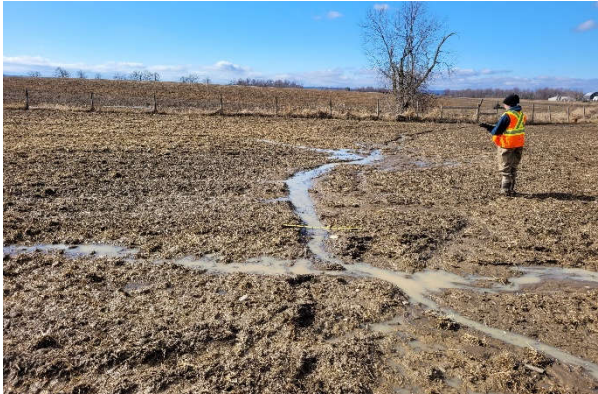
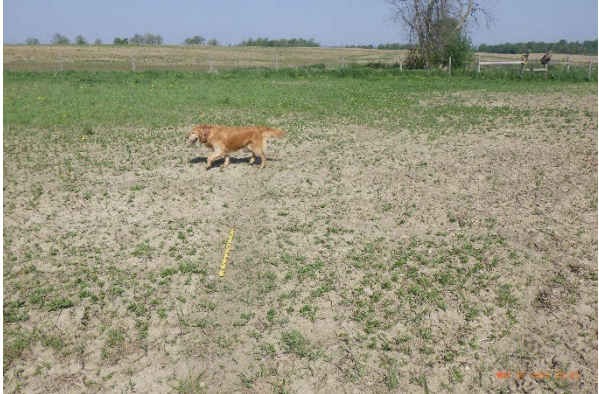
Reach AD4-2

Location: Mayfield Road, Caledon		Watershed: Etobicoke Creek	
Round 1 Hydrology: Flowing water	Round 2 Hydrology: Dry	Round 3 Hydrology: Round 3 site visit will not be completed as the Round 2 site visit was dry.	
Riparian Classification: Through an agricultural field.			
Fish Observed: No	Upstream of HDF: Agricultural field	Downstream of HDF: Alloa Drain	
Notes: Limited feature development and definition with a lack of water in Round 2.			
GEO Morphix Management Recommendation: No Management

Round 1: Photograph facing downstream.		Round 2: Photograph facing downstream.	
Round 3: Round 3 site visit will not be completed as the Round 2 site visit was dry.

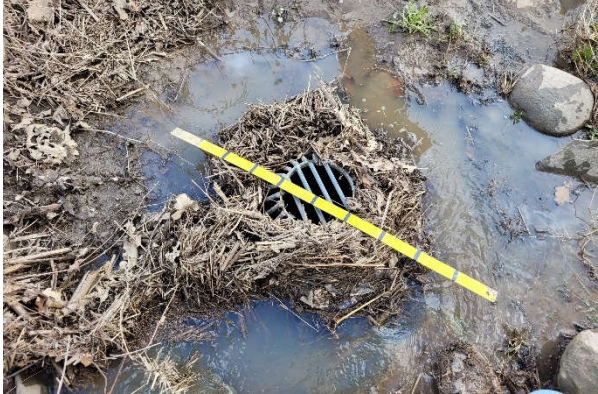
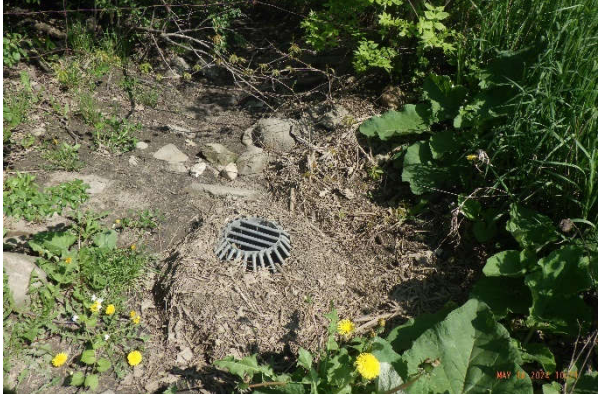
Reach AD4-3

Location: Mayfield Road, Caledon		Watershed: Etobicoke Creek	
Round 1 Hydrology: Flowing water into the drain. Surface flows across 1/3 of the feature.	Round 2 Hydrology: Dry	Round 3 Hydrology: Round 3 site visit will not be completed as the Round 2 site visit was dry.	
Riparian Classification: Through an agricultural field.			
Fish Observed: No	Upstream of HDF: Agricultural field	Downstream of HDF: Alloa Drain	
Notes: Tile drain observed with a defined surface feature and flows. During Round 1 some surface flows were observed across approximately a third of the feature while Round 2 was dry.			
GEO Morphix Management Recommendation: No Management

Round 1: Photograph facing upstream.		Round 2: Photograph facing upstream.	
Round 3: Round 3 site visit will not be completed as the Round 2 site visit was dry.

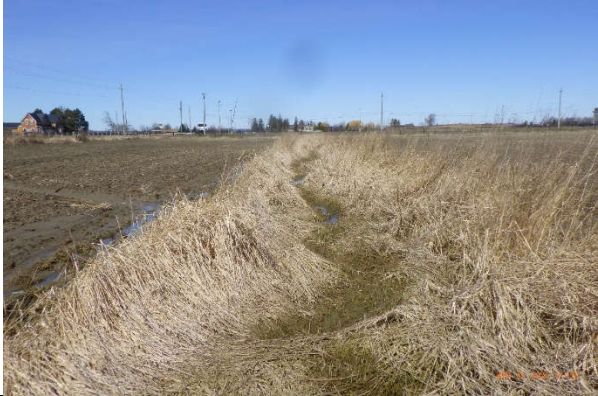
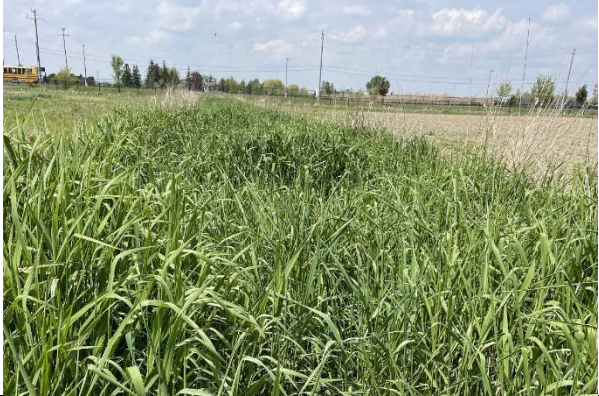
Reach AD5-1

Location: Mayfield Road, Caledon		Watershed: Etobicoke Creek	
Round 1 Hydrology: Minimal flowing water	Round 2 Hydrology: Minimal flowing water	Round 3 Hydrology: To be completed	
Riparian Classification: Immediate riparian vegetation consists of wetland vegetation with agricultural fields further away.			
Fish Observed: No	Upstream of HDF: Agricultural field and school property	Downstream of HDF: Alloa Drain	
Notes: Defined feature with established riparian vegetation and flowing water during Round 1 and 2.			
GEO Morphix Management Recommendation: Conservation <i>*Subject to change following round 3 HDFA*</i>

Round 1: Photograph facing upstream.		Round 2: Photograph facing upstream.	
Round 3: To be completed.

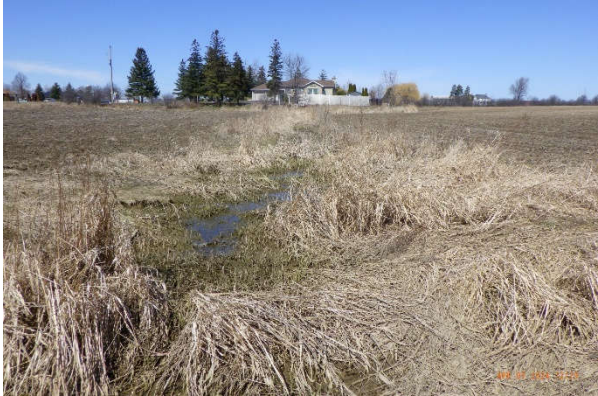
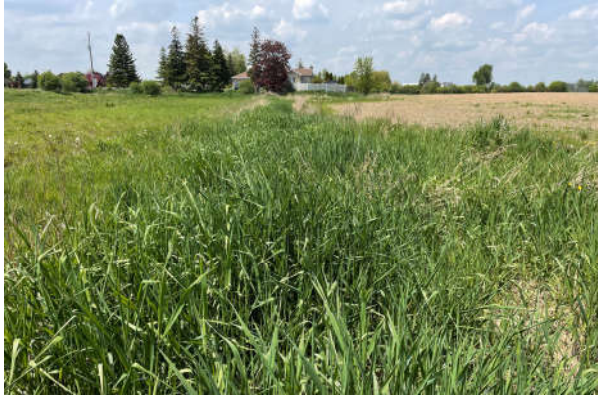
Reach AD5-3

Location: Mayfield Road, Caledon		Watershed: Etobicoke Creek	
Round 1 Hydrology: Flowing water minimally	Round 2 Hydrology: Flowing water minimally	Round 3 Hydrology: To be completed	
Riparian Classification: Immediate riparian vegetation consists of wetland vegetation with agricultural fields further away.			
Fish Observed: No	Upstream of HDF: Agricultural Field	Downstream of HDF: Alloa Drain	
Notes: Defined feature with established riparian vegetation and flowing water during Round 1 and 2.			
GEO Morphix Management Recommendation: Conservation <i>*Subject to change following round 3 HDFA*</i>

Round 1: Photograph facing upstream.		Round 2: Photograph facing upstream.	
Round 3: To be completed.

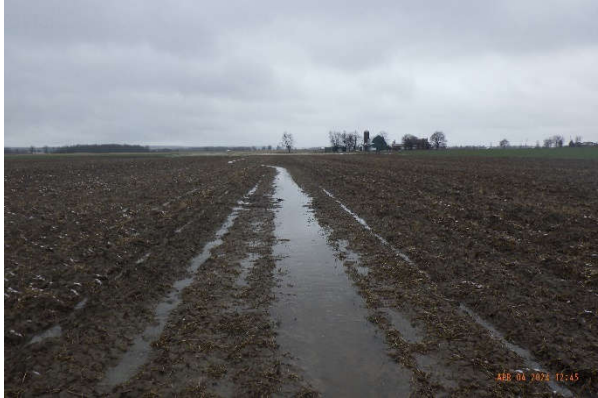
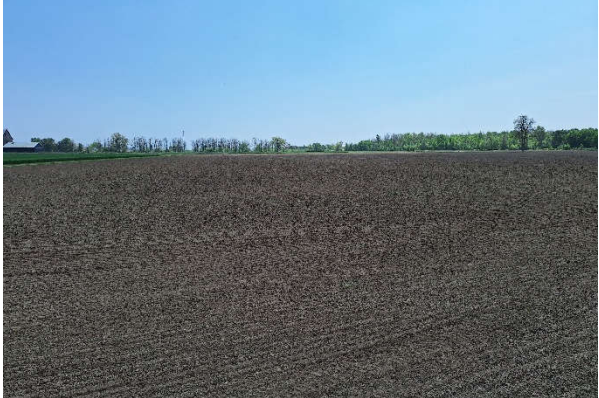
Reach AD6-1

Location: Mayfield Road, Caledon		Watershed: Etobicoke Creek	
Round 1 Hydrology: Flowing water	Round 2 Hydrology: Dry	Round 3 Hydrology: Round 3 site visit will not be completed as the Round 2 site visit was dry.	
Riparian Classification: Feature flowing through agricultural fields.			
Fish Observed: No	Upstream of HDF: Agricultural field	Downstream of HDF: Alloa Drain	
Notes: Limited feature development and a lack of water in Round 2.			
GEO Morphix Management Recommendation: No Management

Round 1: Photograph facing upstream.		Round 2: Photograph facing downstream.	
Round 3: Round 3 site visit will not be completed as the Round 2 site visit was dry.

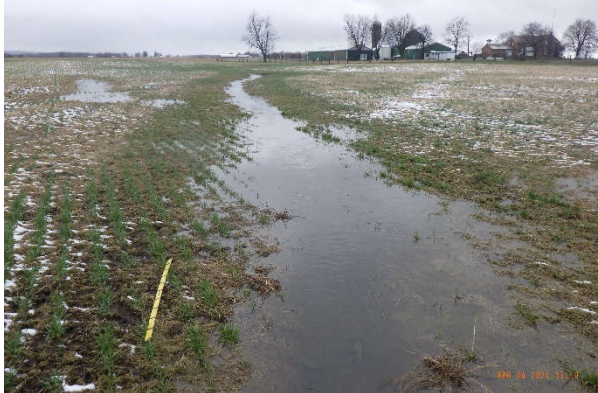
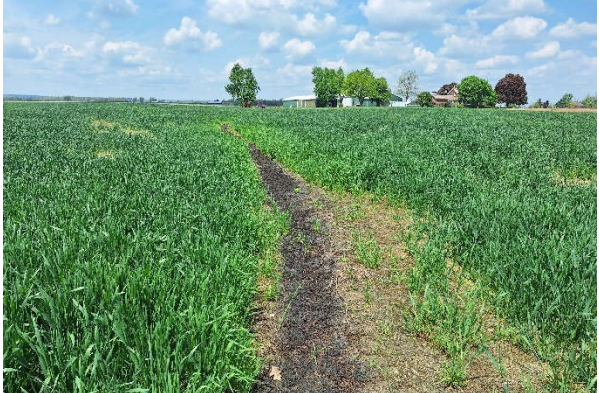
Reach AD6-2

Location: Mayfield Road, Caledon		Watershed: Etobicoke Creek	
Round 1 Hydrology: Flowing water	Round 2 Hydrology: Dry	Round 3 Hydrology: Round 3 site visit will not be completed as the Round 2 site visit was dry.	
Riparian Classification: Feature flowing through agricultural fields.			
Fish Observed: No	Upstream of HDF: Agricultural field	Downstream of HDF: Alloa Drain	
Notes: Limited feature development and a lack of water in Round 2.			
GEO Morphix Management Recommendation: No Management

Round 1: Photograph facing upstream.		Round 2: Photograph facing upstream.	
Round 3: Round 3 site visit will not be completed as the Round 2 site visit was dry.

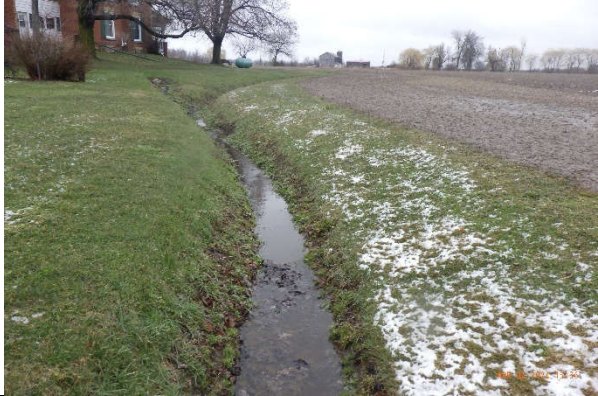
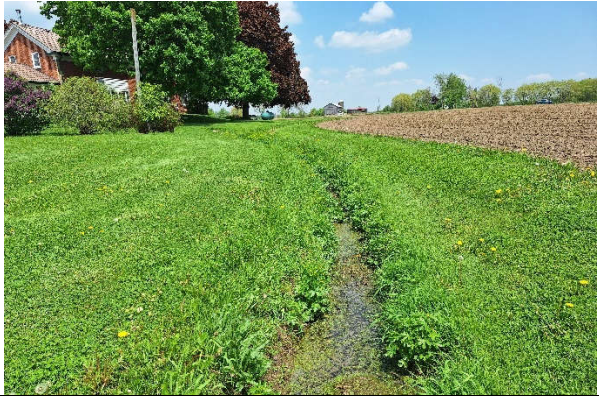
Reach AD6-2A

Location: Mayfield Road, Caledon		Watershed: Etobicoke Creek	
Round 1 Hydrology: Flowing water	Round 2 Hydrology: Dry	Round 3 Hydrology: Round 3 site visit will not be completed as the Round 2 site visit was dry.	
Riparian Classification: Immediate riparian vegetation consisted of lawn with an agricultural field south of the feature.			
Fish Observed: No	Upstream of HDF: Agricultural field	Downstream of HDF: Reach AD6-2 and ultimately Alloa Drain	
Notes: Limited feature development and a lack of water in Round 2.			
GEO Morphix Management Recommendation: No Management

Round 1: Photograph facing upstream.		Round 2: Photograph facing upstream.	
Round 3: Round 3 site visit will not be completed as the Round 2 site visit was dry.

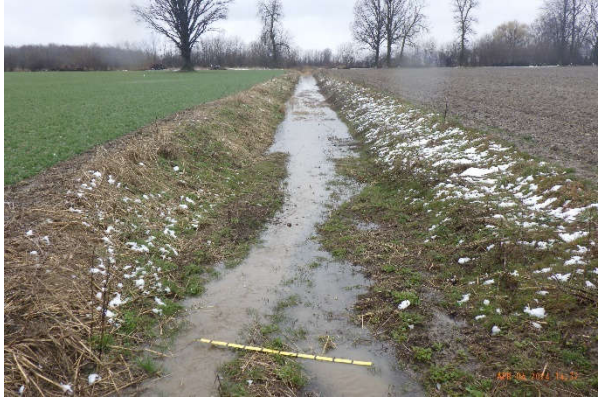
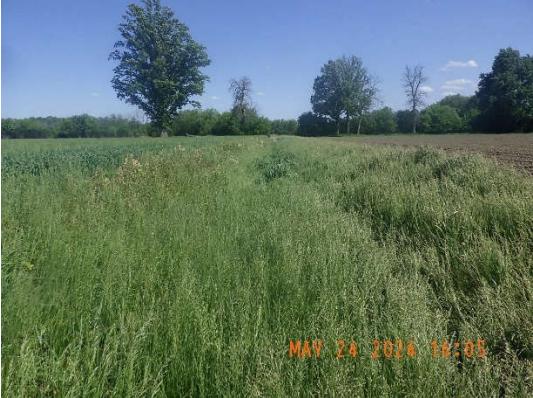
Reach AD8-1

Location: Mayfield Road, Caledon		Watershed: Etobicoke Creek	
Round 1 Hydrology: Standing water	Round 2 Hydrology: Dry	Round 3 Hydrology: Round 3 site visit will not be completed as the Round 2 site visit was dry.	
Riparian Classification: Immediate riparian vegetation consists of meadow vegetation with agricultural fields further away on both sides.			
Fish Observed: No	Upstream of HDF: Agricultural Field	Downstream of HDF: Alloa Drain	
Notes: Defined feature with water in Round 1 but dry in Round 2. Feature may also be impacted by the future Highway 413.			
GEO Morphix Management Recommendation: Mitigation

Round 1: Photograph facing downstream.		Round 2: Photograph facing downstream.	
Round 3: Round 3 site visit will not be completed as the Round 2 site visit was dry.

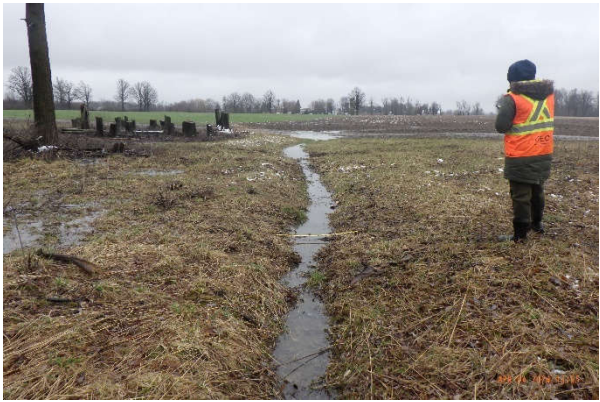
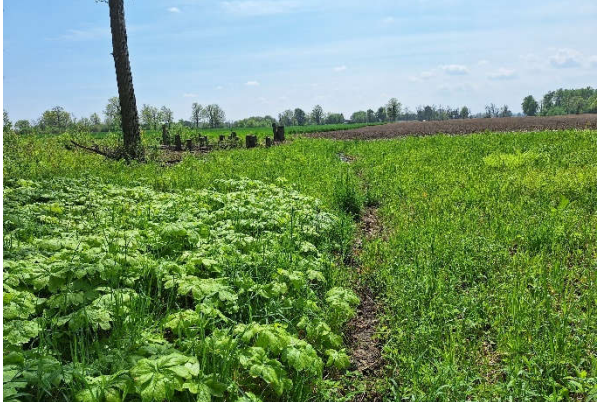
Reach FD1-1

Location: Mayfield Road, Caledon		Watershed: Etobicoke Creek	
Round 1 Hydrology: Flowing water	Round 2 Hydrology: Dry	Round 3 Hydrology: Round 3 site visit will not be completed as the Round 2 site visit was dry.	
Riparian Classification: Feature flowing through meadow vegetation.			
Fish Observed: No	Upstream of HDF: Agricultural field	Downstream of HDF: Fraser Drain	
Notes: Limited feature development with a lack of water in the Round 2 site visit.			
GEO Morphix Management Recommendation: No Management

Round 1: Photograph facing upstream.		Round 2: Photograph facing upstream.	
Round 3: Round 3 site visit will not be completed as the Round 2 site visit was dry.

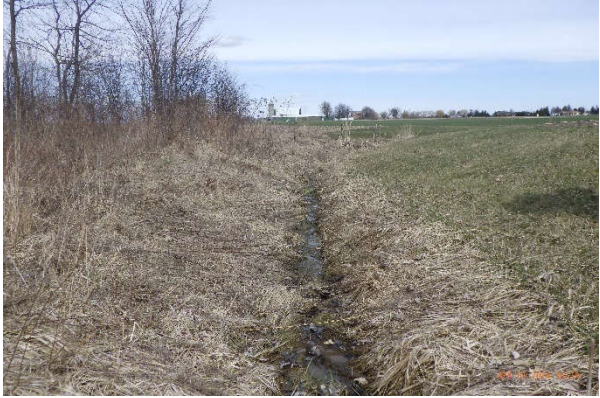
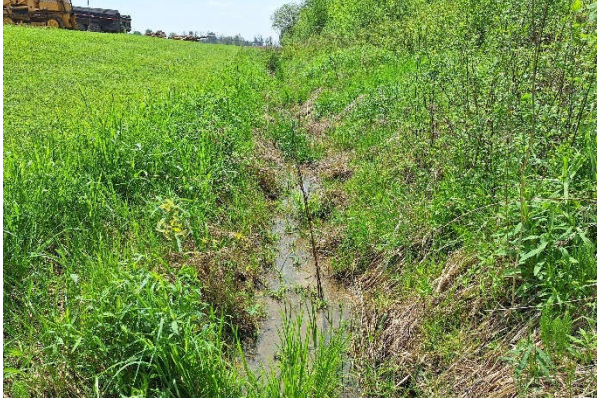
Reach FD2-1

Location: Mayfield Road, Caledon		Watershed: Etobicoke Creek	
Round 1 Hydrology: Flowing water	Round 2 Hydrology: Standing water	Round 3 Hydrology: To be completed	
Riparian Classification: Immediate riparian vegetation consists of meadow with a lawn near the left bank and forest near the right bank.			
Fish Observed: No	Upstream of HDF: Agricultural field	Downstream of HDF: Fraser Drain	
Notes: Defined feature with limited water during the Round 2 site visit. The future Highway 413 may impact the feature as well.			
GEO Morphix Management Recommendation: Mitigation <i>*Subject to change following round 3 HDFA*</i>

Round 1: Photograph facing downstream.		Round 2: Photograph facing upstream.	
Round 3: To be completed

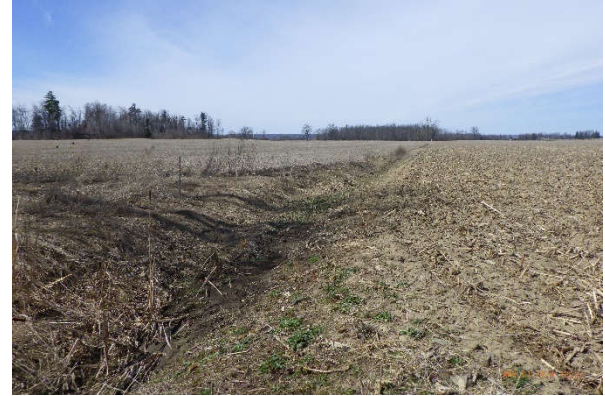
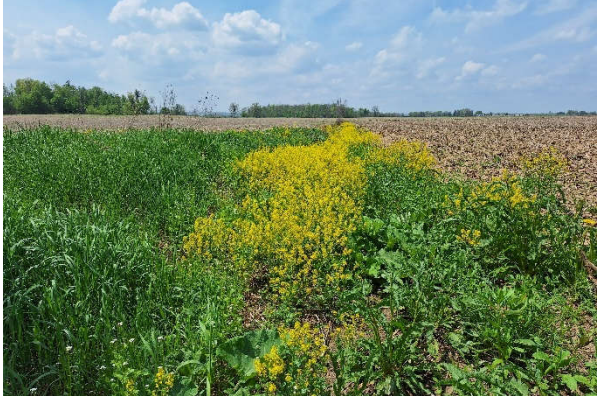
Reach FD3

Location: Mayfield Road, Caledon		Watershed: Etobicoke Creek	
Round 1 Hydrology: Dry on the surface	Round 2 Hydrology: Dry on the surface	Round 3 Hydrology: Round 3 site visit will not be completed as the Round 2 site visit was dry.	
Riparian Classification: Flowing through agricultural fields.			
Fish Observed: No	Upstream of HDF: Agricultural field	Downstream of HDF: Fraser Drain	
Notes: Tile drain with a lack of surface feature present. Flows from the drain are present but dry on the surface. Feature likely to be impacted by the future Highway 413.			
GEO Morphix Management Recommendation: Mitigation <i>*Subject to change following round 3*</i>

Round 1: Photograph facing upstream.		Round 2: Photograph facing upstream.	
Round 3: Round 3 site visit will not be completed as the Round 2 site visit was dry.

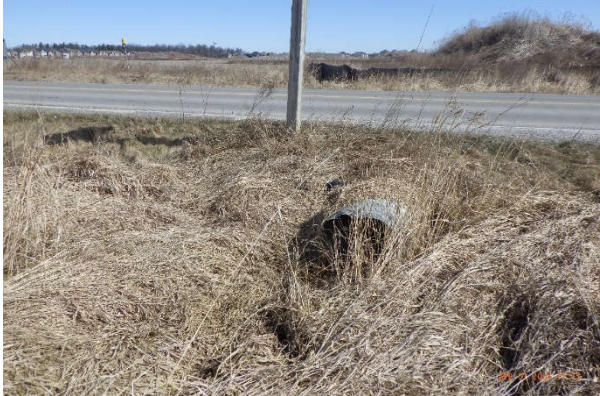
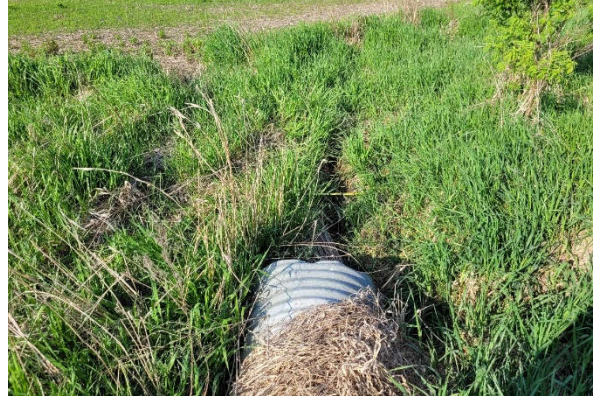
Reach FC-1B

Location: Mayfield Road, Caledon		Watershed: Fletchers Creek	
Round 1 Hydrology: Standing water	Round 2 Hydrology: Standing water	Round 3 Hydrology: To be completed	
Riparian Classification: Flowing through meadow vegetation (grasses).			
Fish Observed: No	Upstream of HDF: Forest	Downstream of HDF: Chinguacousy Road and Residential developments	
Notes: Defined feature with water in both site visits and establish grassy riparian area.			
GEO Morphix Management Recommendation: Conservation The portion of drainage feature east Chinguacousy Road was recently realigned and south of Mayfield Road, this tributary is piped for approximately 600 m. It is recommended that the management of this feature be revised to Mitigation. <i>*Subject to change following round 3 and consultation with the Town of Caledon and CVC*</i>

Round 1: Photograph facing downstream.		Round 2: Photograph facing upstream.

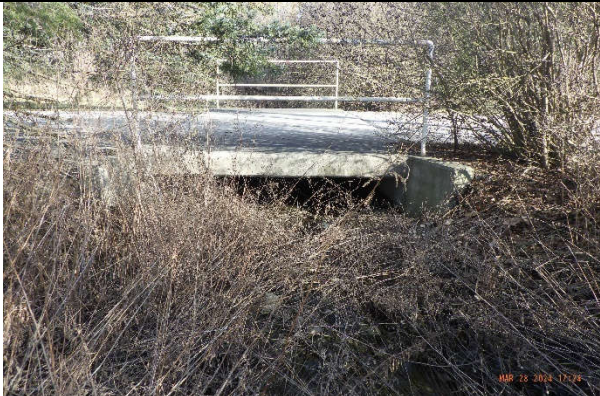
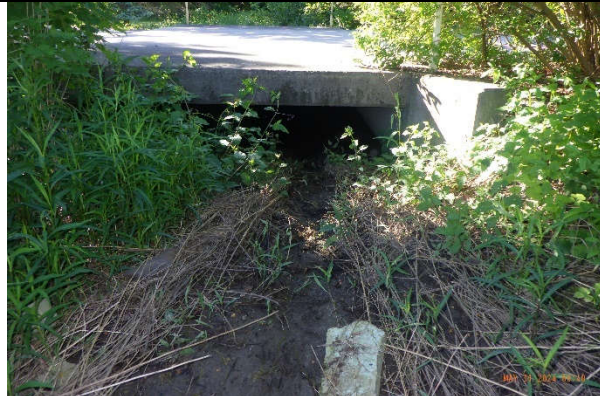
Reach FC-1D

Location: Mayfield Road, Caledon		Watershed: Fletchers Creek	
Round 1 Hydrology: Flowing water minimally	Round 2 Hydrology: Standing water	Round 3 Hydrology: To be completed	
Riparian Classification: Flowing through meadow vegetation with lawn vegetation further from the banks.			
Fish Observed: No	Upstream of HDF: Agricultural field	Downstream of HDF: Forest	
Notes: Defined feature with water in both site visits and a more established riparian area.			
GEO Morphix Management Recommendation: Conservation The portion of drainage feature east Chinguacousy Road was recently realigned and south of Mayfield Road, this tributary is piped for approximately 600 m. It is recommended that the management of this feature be revised to Mitigation. <i>*Subject to change following round 3 and consultation with the Town of Caledon and CVC *</i>

Round 1: Photograph facing downstream.		Round 2: Photograph facing downstream.

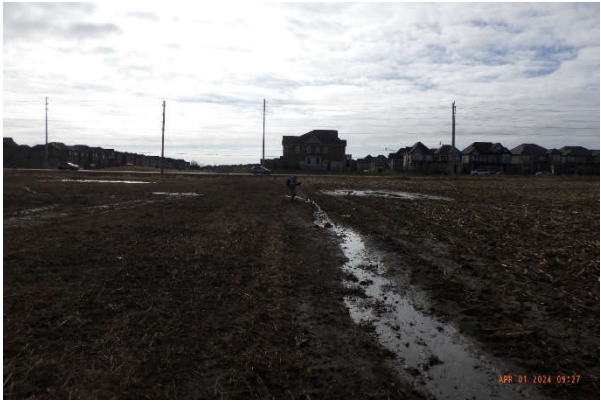
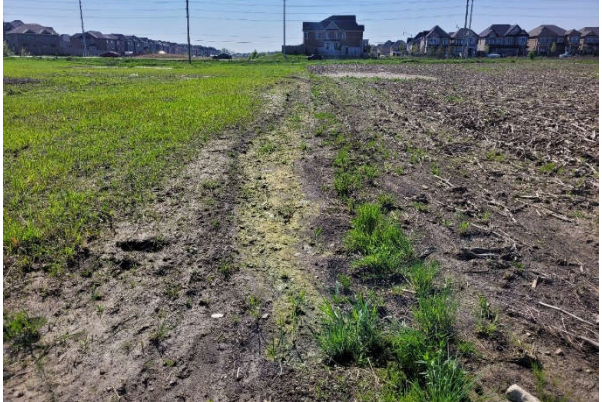
Reach FC-2A

Location: Mayfield Road, Caledon		Watershed: Fletchers Creek	
Round 1 Hydrology: Flowing water	Round 2 Hydrology: Dry	Round 3 Hydrology: To be completed due to fish found upstream.	
Riparian Classification: Feature flowing through agricultural fields.			
Fish Observed: No	Upstream of HDF: Agricultural field	Downstream of HDF: Natural Channel Design	
Notes: The feature was undefined and dry during Round 2. Minimal pooling was observed at the furthest downstream culvert. The feature inputs under the road to a natural channel design and therefore was assigned the Mitigation status.			
GEO Morphix Management Recommendation: Mitigation <i>*Subject to change following round 3 HDFA*</i>

Round 1: Photograph facing downstream.		Round 2: Photograph facing downstream.	
Round 3: To be completed due to fish found upstream.

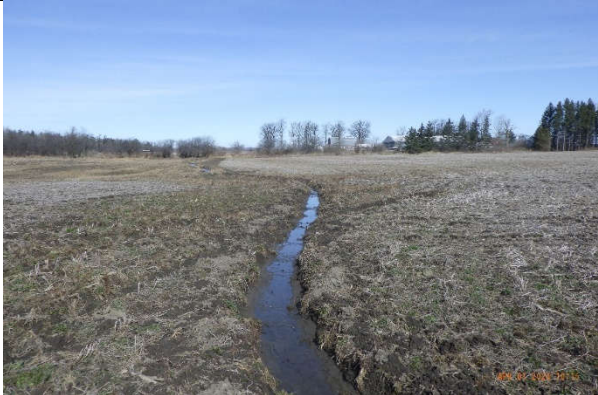
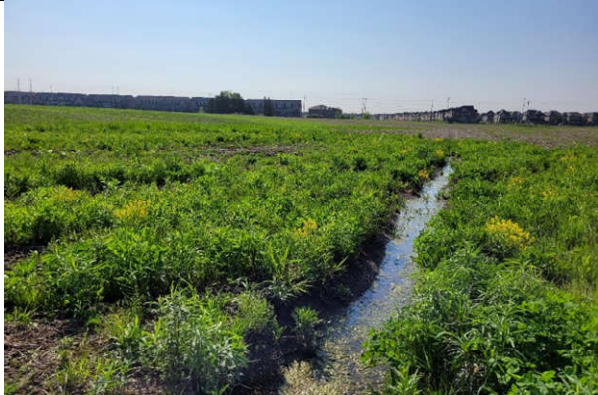
Reach FC-2B

Location: Mayfield Road, Caledon		Watershed: Fletchers Creek	
Round 1 Hydrology: Flowing water	Round 2 Hydrology: Standing water	Round 3 Hydrology: To be completed due to the presence of fish in Round 2.	
Riparian Classification: Feature flowing through agricultural fields.			
Fish Observed: Yes (Round 2)	Upstream of HDF: Agricultural field	Downstream of HDF: Natural Channel Design south of Mayfield Road	
Notes: Limited channel definition with small, intermittent pools of standing water observed through an active agricultural field in Round 2. Minnows were observed in one isolated pool which is expected to dry up and be influenced by agricultural practices. The feature inputs under the road into a Natural Channel Design and as such, was assigned the Mitigation status.			
GEO Morphix Management Recommendation: Mitigation <i>*Subject to change following round 3 HDFA*</i>

Round 1: Photograph facing upstream.		Round 2: Photograph facing downstream.

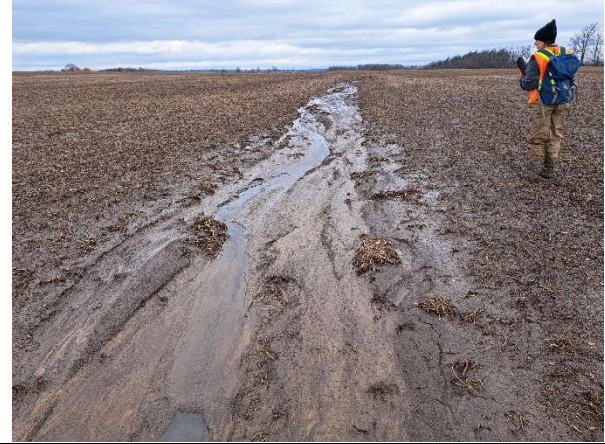
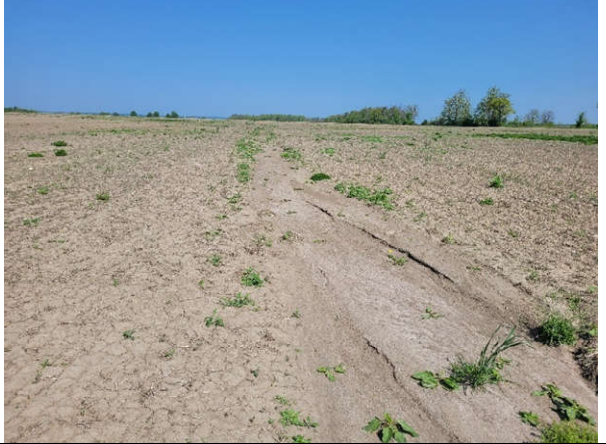
Reach FC-2C

Location: Mayfield Road, Caledon		Watershed: Fletchers Creek	
Round 1 Hydrology: Flowing water	Round 2 Hydrology: Dry	Round 3 Hydrology: Round 3 site visit will not be completed as the Round 2 site visit was dry.	
Riparian Classification: Feature flowing through agricultural fields.			
Fish Observed: No	Upstream of HDF: Agricultural field	Downstream of HDF: Mayfield Road and residential developments	
Notes: Limited feature development with a lack of water in the Round 2 site visit.			
GEO Morphix Management Recommendation: No Management

Round 1: Photograph facing upstream.		Round 2: Photograph facing upstream.	
Round 3: Round 3 site visit will not be completed as the Round 2 site visit was dry.

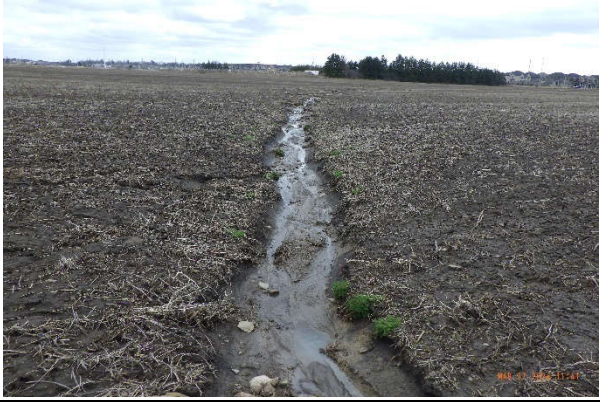
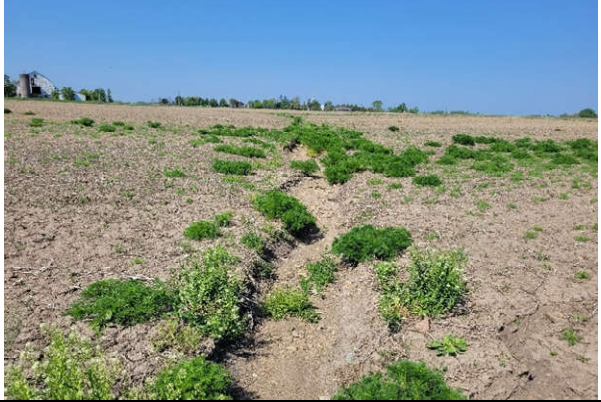
Reach FC-2C-1

Location: Mayfield Road, Caledon		Watershed: Fletchers Creek	
Round 1 Hydrology: Flowing water	Round 2 Hydrology: Dry	Round 3 Hydrology: Round 3 site visit will not be completed as the Round 2 site visit was dry.	
Riparian Classification: Feature flowing through agricultural fields.			
Fish Observed: No	Upstream of HDF: Agricultural field	Downstream of HDF: Mayfield Road and residential developments	
Notes: Limited feature development with a lack of water in the Round 2 site visit.			
GEO Morphix Management Recommendation: No Management

Round 1: Photograph facing downstream.		Round 2: Photograph facing upstream.	
Round 3: Round 3 site visit will not be completed as the Round 2 site visit was dry.

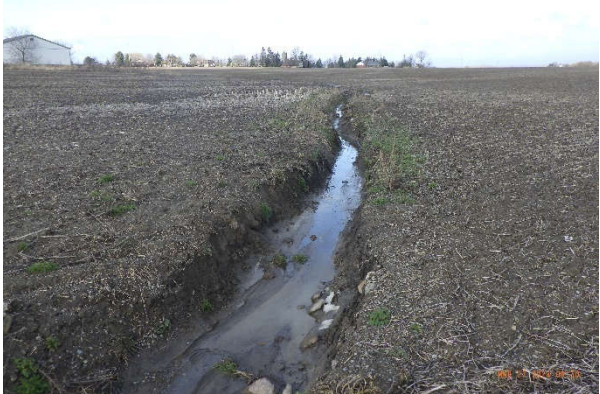
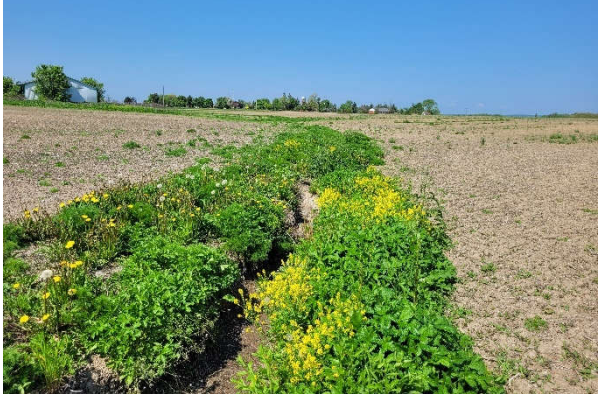
Reach FC-3A

Location: Mayfield Road, Caledon		Watershed: Fletchers Creek	
Round 1 Hydrology: Flowing water	Round 2 Hydrology: Dry	Round 3 Hydrology: Round 3 site visit will not be completed as the Round 2 site visit was dry.	
Riparian Classification: Feature flowing through agricultural fields.			
Fish Observed: No	Upstream of HDF: Agricultural field	Downstream of HDF: Mayfield Road and residential developments	
Notes: Limited feature development with a lack of water in the Round 2 site visit.			
GEO Morphix Management Recommendation: No Management

Round 1: Photograph facing upstream.		Round 2: Photograph facing upstream.	
Round 3: Round 3 site visit will not be completed as the Round 2 site visit was dry.

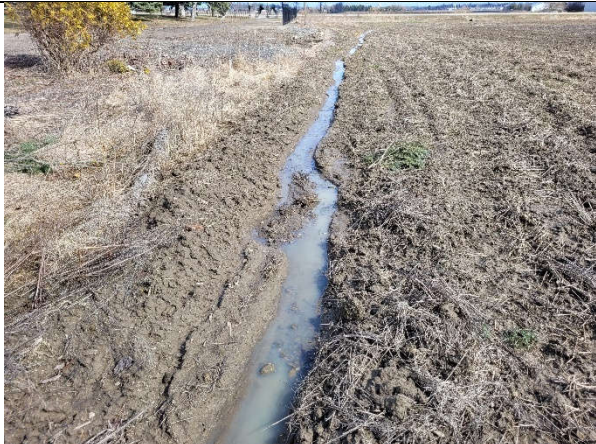
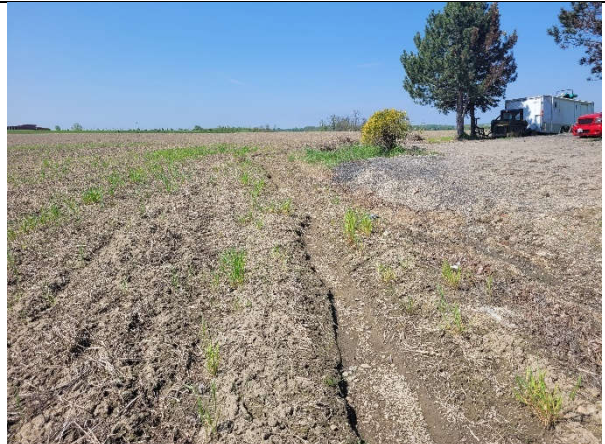
Reach FC-3B

Location: Mayfield Road, Caledon		Watershed: Fletchers Creek	
Round 1 Hydrology: Flowing water	Round 2 Hydrology: Dry	Round 3 Hydrology: Round 3 site visit will not be completed as the Round 2 site visit was dry.	
Riparian Classification: Feature flowing through agricultural fields.			
Fish Observed: No	Upstream of HDF: Agricultural field	Downstream of HDF: Mayfield Road and residential developments	
Notes: Limited feature development with a lack of water in the Round 2 site visit.			
GEO Morphix Management Recommendation: No Management

Round 1: Photograph facing downstream.		Round 2: Photograph facing upstream.	
Round 3: Round 3 site visit will not be completed as the Round 2 site visit was dry.

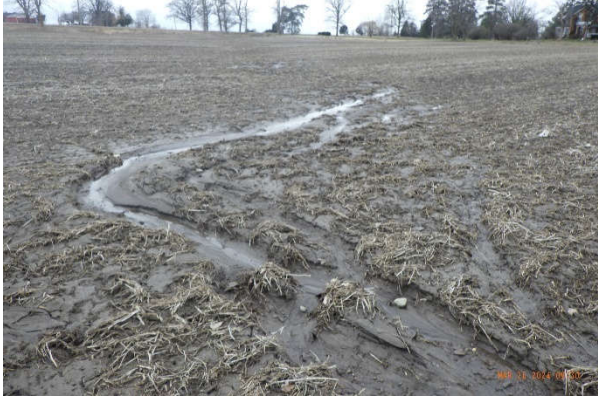
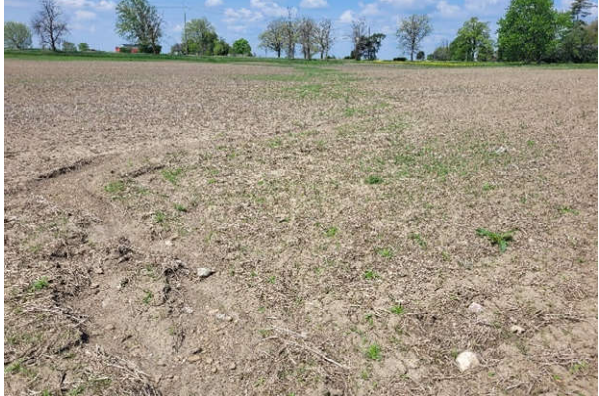
Reach FC-3C

Location: Mayfield Road, Caledon		Watershed: Fletchers Creek	
Round 1 Hydrology: Flowing water	Round 2 Hydrology: Dry	Round 3 Hydrology: Round 3 site visit will not be completed as the Round 2 site visit was dry.	
Riparian Classification: Feature flowing through agricultural fields.			
Fish Observed: No	Upstream of HDF: Agricultural field	Downstream of HDF: Mayfield Road and residential developments	
Notes: Limited feature development with a lack of water in the Round 2 site visit.			
GEO Morphix Management Recommendation: No Management

Round 1: Photograph facing upstream.		Round 2: Photograph facing upstream.	
Round 3: Round 3 site visit will not be completed as the Round 2 site visit was dry.

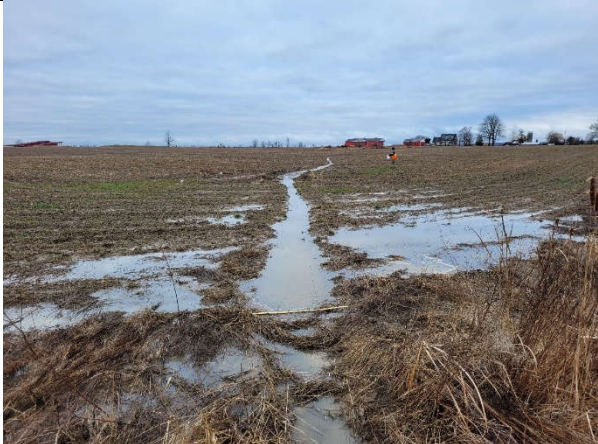
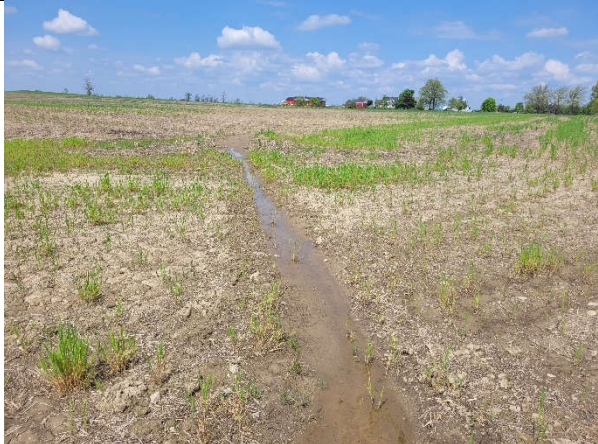
Reach FC-4A

Location: Mayfield Road, Caledon		Watershed: Fletchers Creek	
Round 1 Hydrology: Flowing water	Round 2 Hydrology: Dry	Round 3 Hydrology: Round 3 site visit will not be completed as the Round 2 site visit was dry.	
Riparian Classification: Feature flowing through agricultural fields.			
Fish Observed: No	Upstream of HDF: Agricultural field	Downstream of HDF: Mayfield Road and residential developments	
Notes: Limited feature development with a lack of water in the Round 2 site visit.			
GEO Morphix Management Recommendation: No Management

Round 1: Photograph facing upstream.		Round 2: Photograph facing upstream.	
Round 3: Round 3 site visit will not be completed as the Round 2 site visit was dry.

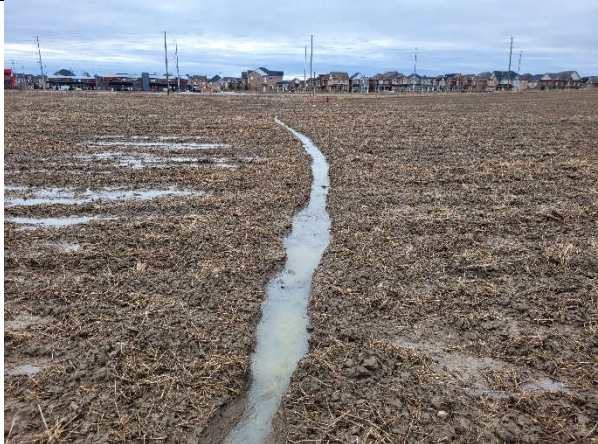
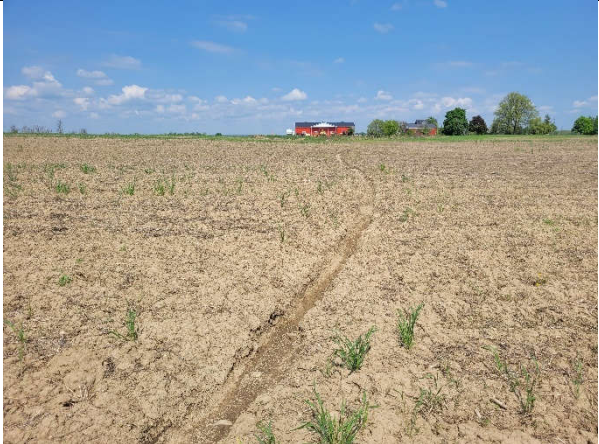
Reach FC-4B

Location: Mayfield Road, Caledon		Watershed: Fletchers Creek	
Round 1 Hydrology: Flowing water	Round 2 Hydrology: Dry	Round 3 Hydrology: Round 3 site visit will not be completed as the Round 2 site visit was dry.	
Riparian Classification: Feature flowing through agricultural fields.			
Fish Observed: No	Upstream of HDF: Agricultural field	Downstream of HDF: Mayfield Road and residential developments	
Notes: Limited feature development with a lack of water in the Round 2 site visit.			
GEO Morphix Management Recommendation: No Management

Round 1: Photograph facing upstream.		Round 2: Photograph facing upstream.	
Round 3: Round 3 site visit will not be completed as the Round 2 site visit was dry.

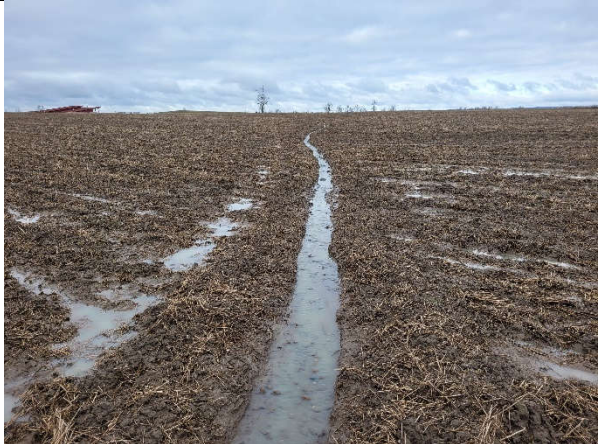
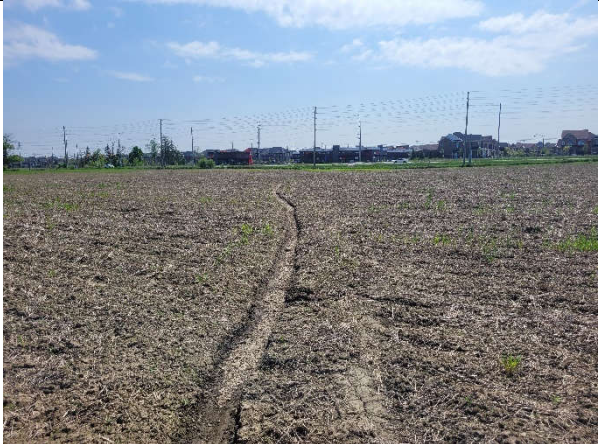
Reach FC-4C

Location: Mayfield Road, Caledon		Watershed: Fletchers Creek	
Round 1 Hydrology: Flowing water	Round 2 Hydrology: Dry	Round 3 Hydrology: Round 3 site visit will not be completed as the Round 2 site visit was dry.	
Riparian Classification: Feature flowing through agricultural fields.			
Fish Observed: No	Upstream of HDF: Agricultural field	Downstream of HDF: Mayfield Road and residential developments	
Notes: Limited feature development with a lack of water in the Round 2 site visit.			
GEO Morphix Management Recommendation: No Management

Round 1: Photograph facing upstream.		Round 2: Photograph facing upstream.	
Round 3: Round 3 site visit will not be completed as the Round 2 site visit was dry.
