**Summary Action Report**  
**Structure B20092243 (MTO Site No. )**  
**Old School Road, 0.45 km West of Torbram Road**

Inspection Date 06/10/2021 mm/dd/yyyy

# Municipal Structure Inspection Form

**B20092243**

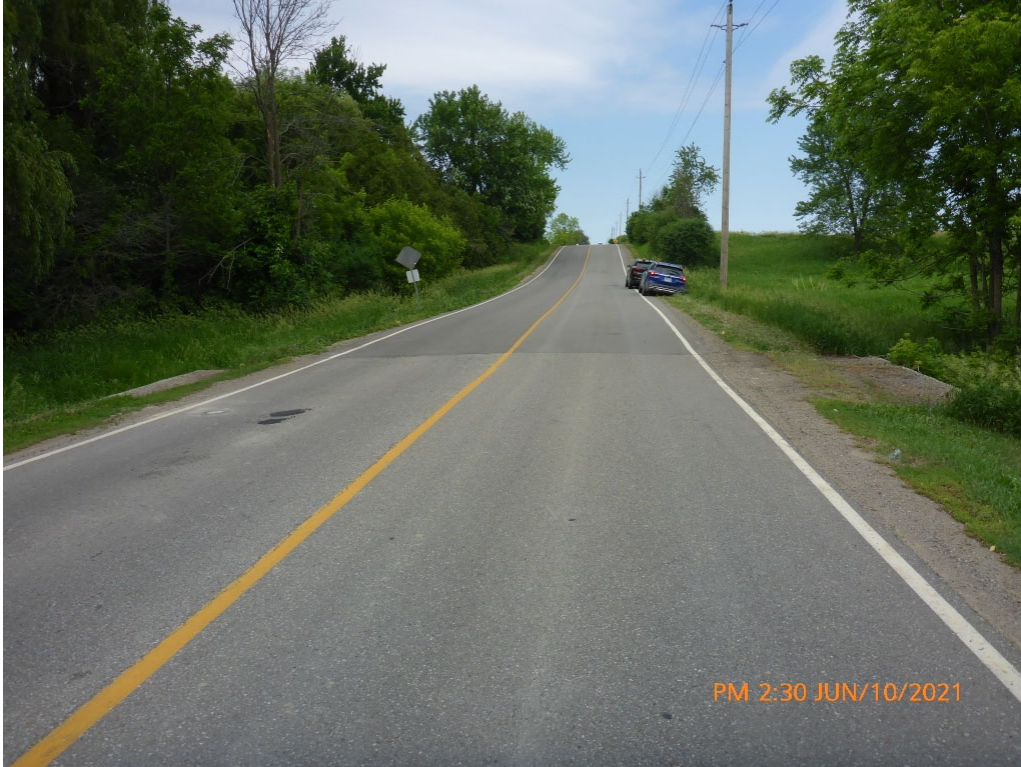
**Looking East at Bridge - Photo 1**

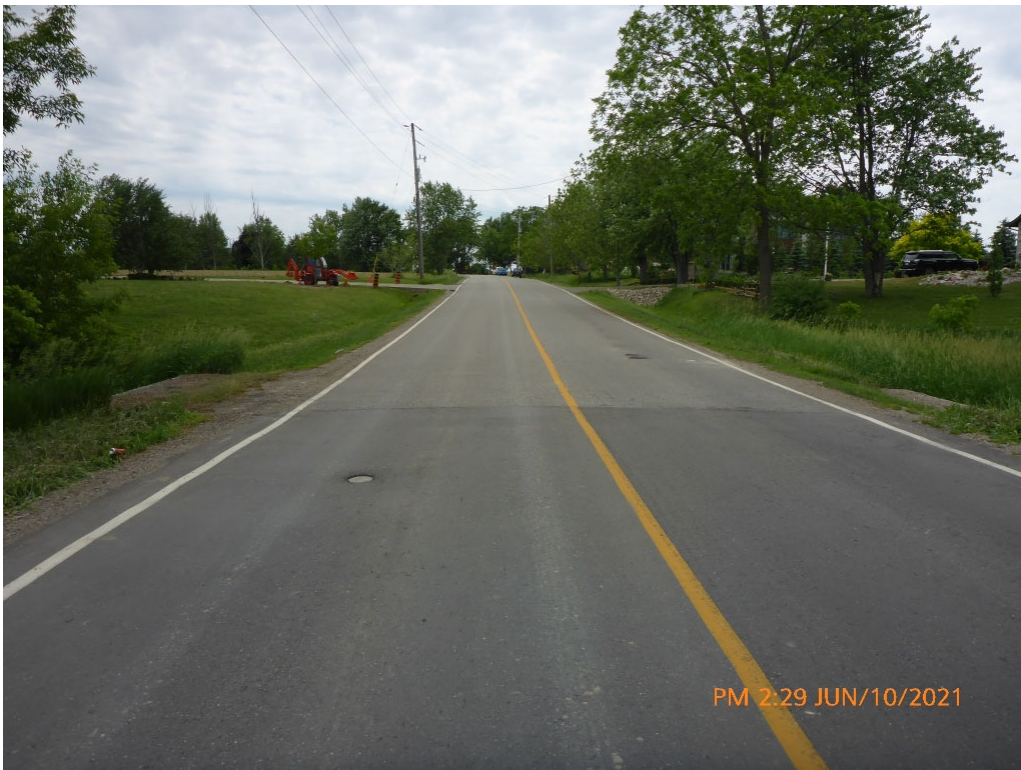
**Looking West at Bridge - Photo 2**

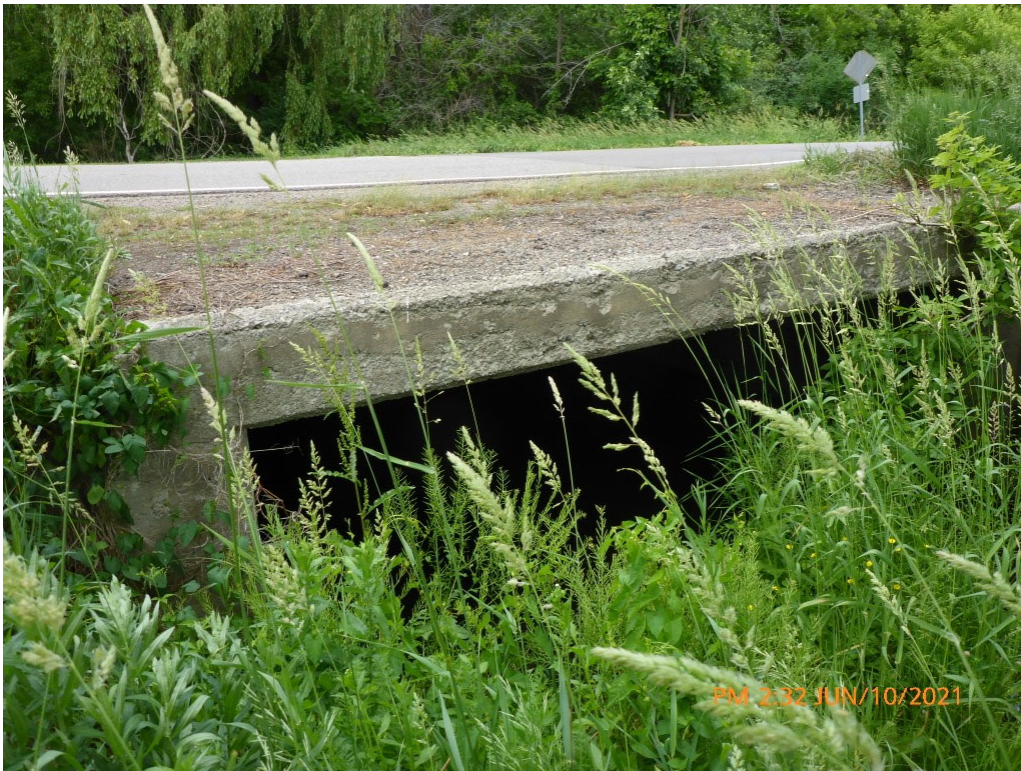
**South Elevation - Photo 4**

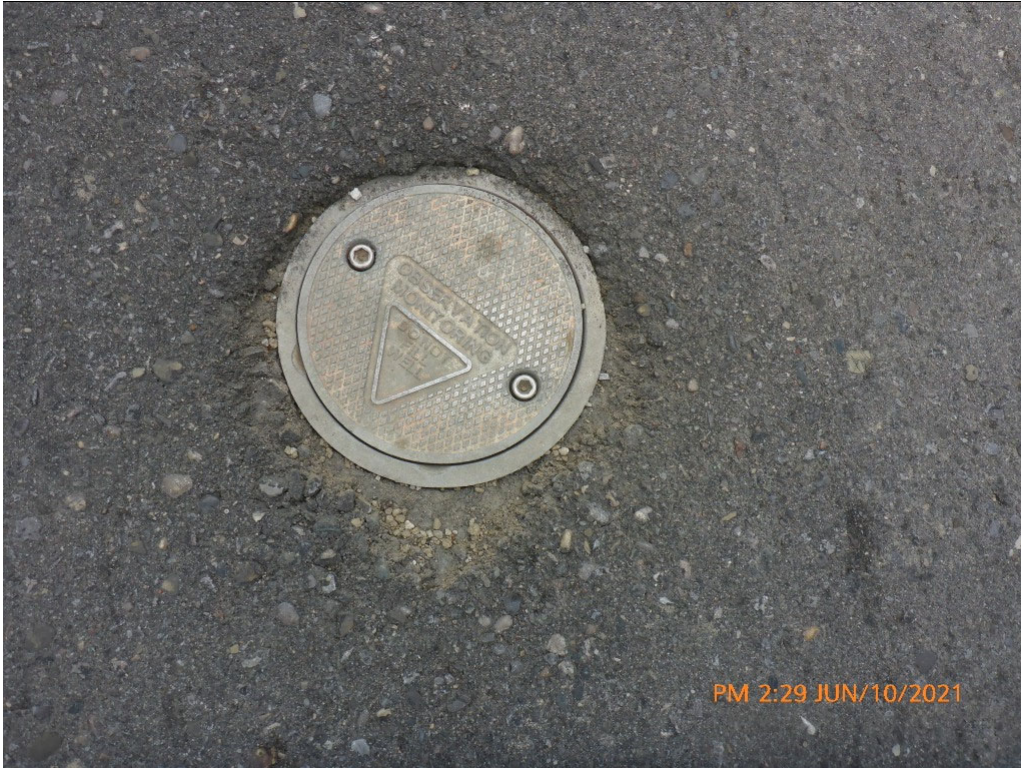
**Comments**  
 Light cracks, asphalt patches, monitoring wells at West and East approaches, East approach resurfaced in 2018.

**Approaches - Wearing Surface - Monitoring Well - East Approach - Photo 5**

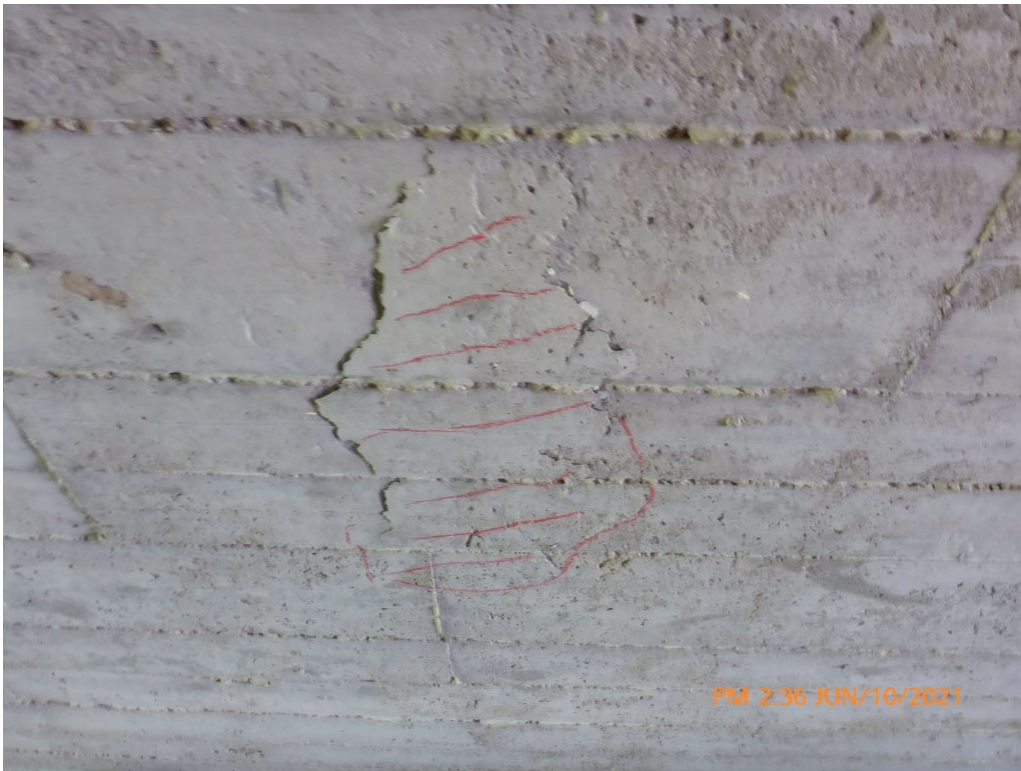
**Decks - Soffit - Thick Slab - Interior - Medium Delamination - Photo 14**

Element Group	Element	Repair/Rehabilitation			Priority	Cost
Decks	Soffit - Thick Slab	Interior	Rehab	Patch soffit	1-5 yrs	\$20,000
Decks	Soffit - Thick Slab	Exterior	Rehab	Patch repair soffit	1-5 yrs	\$15,000
Abutments	Abutment Walls		Rehab	Patch repair	1-5 yrs	\$5,000
<b>Total Repair/Rehabilitation Cost</b>						<b>\$40,000</b>

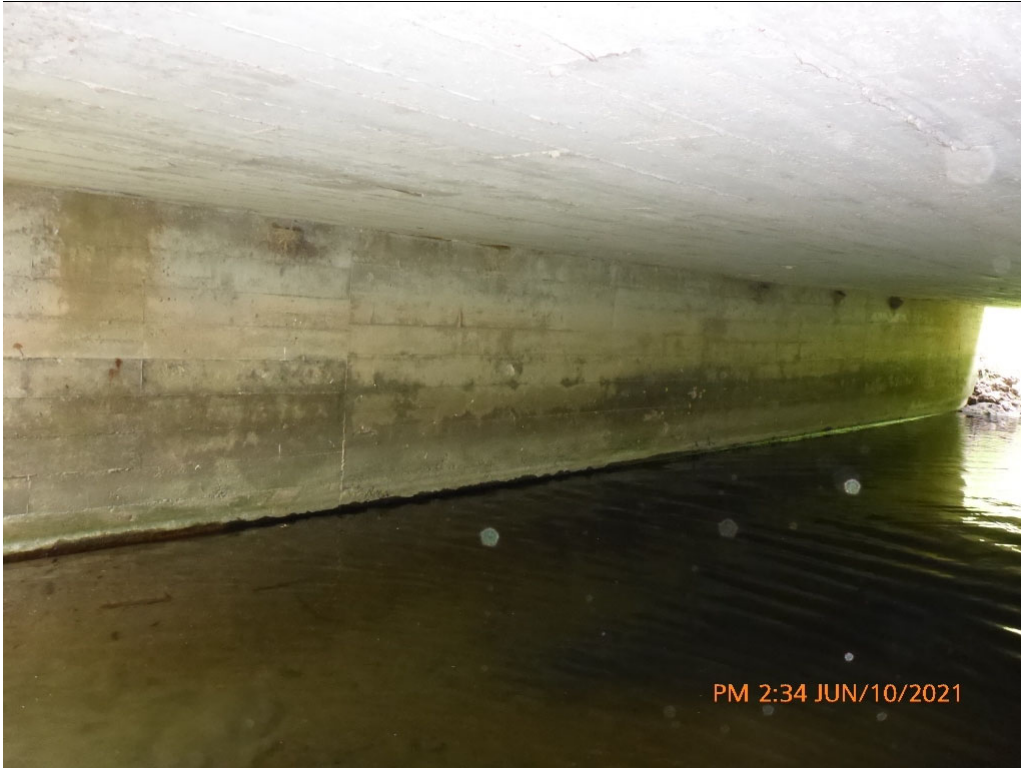
**Abutments - Abutment Walls - Typical - West - Photo 19**

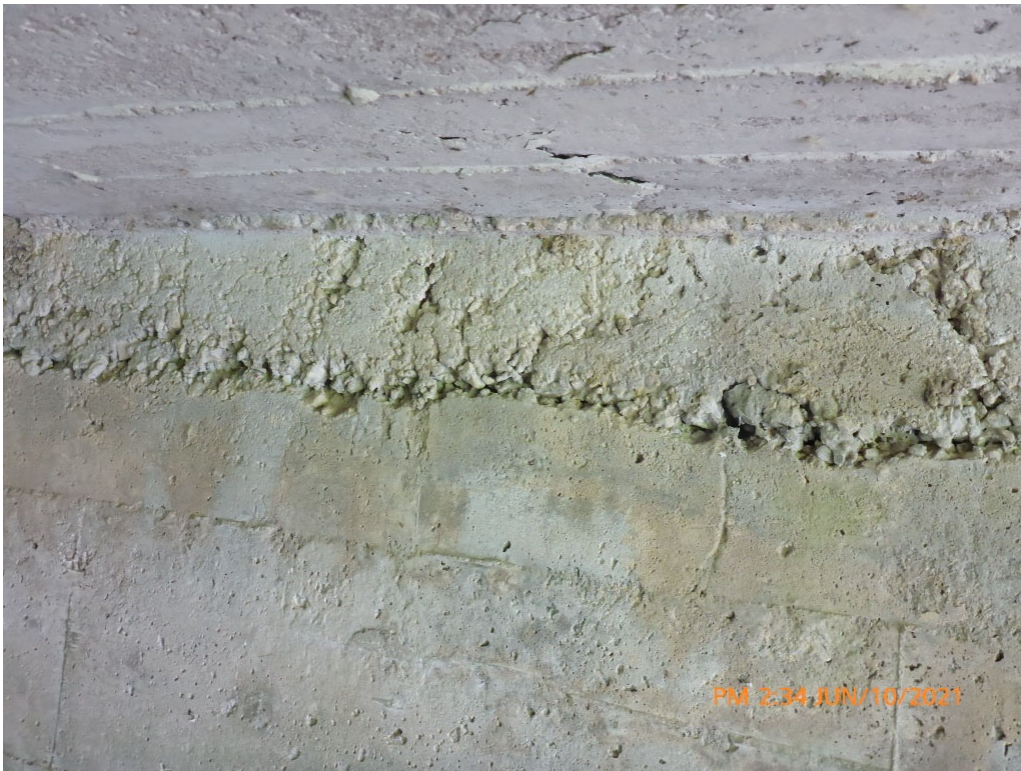
**Abutments - Abutment Walls - Light to Severe Honeycombing - Photo 20**

Patch soffit and abutments.

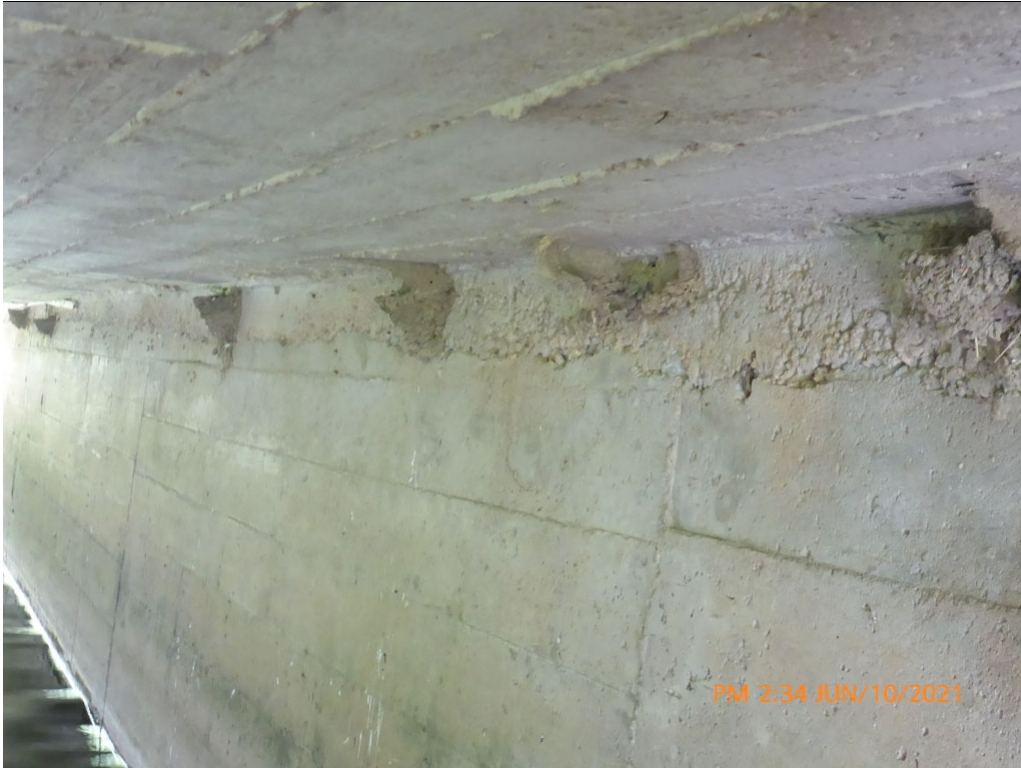
**Abutments - Abutment Walls - Birds Nests - Photo 21**

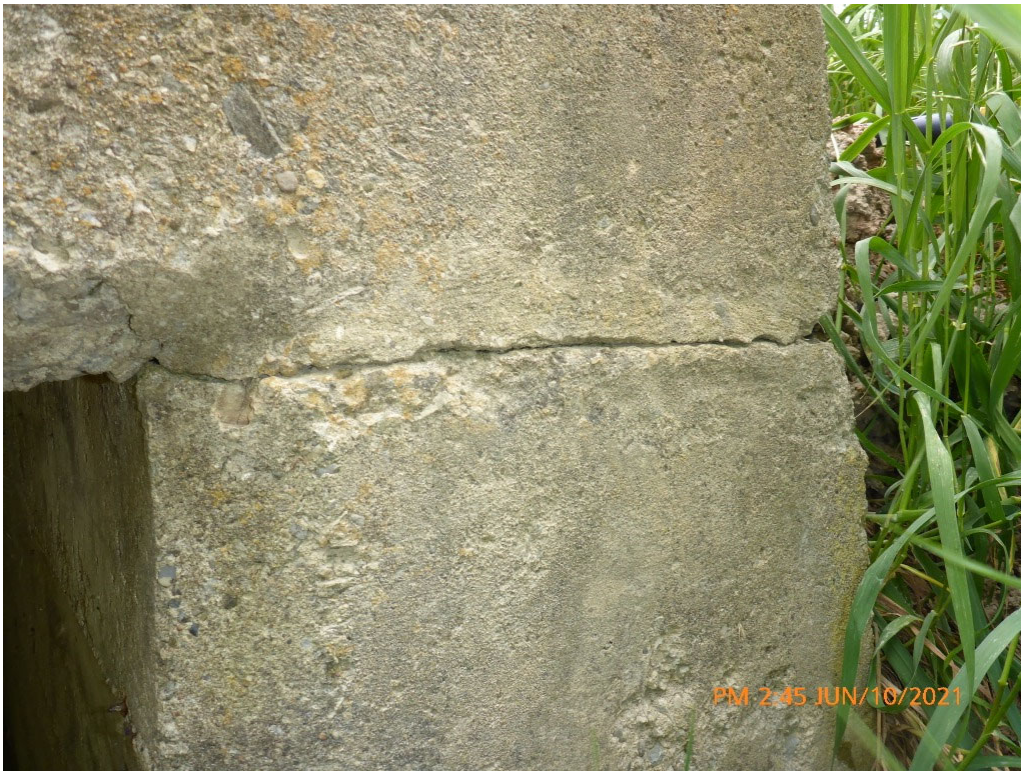
**Abutments - Abutment Walls - Wide Gap at Cold Joint - Northwest - Photo 22**

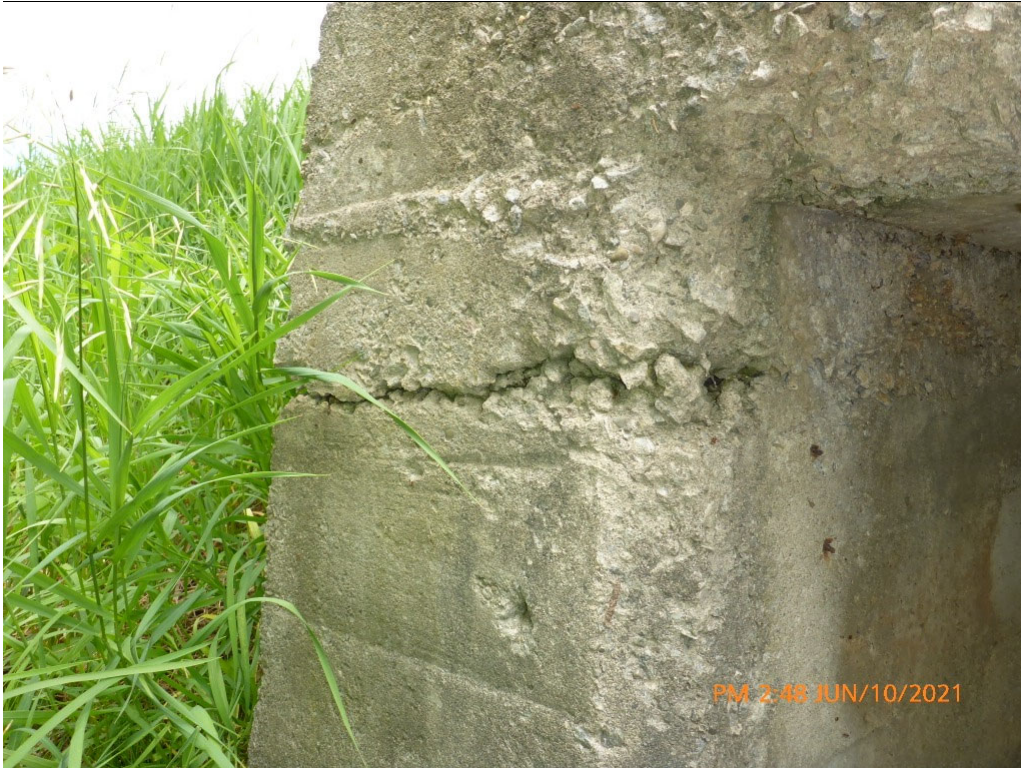
**Abutments - Abutment Walls - Wide Gap at Cold Joint - Northeast - Photo 23**

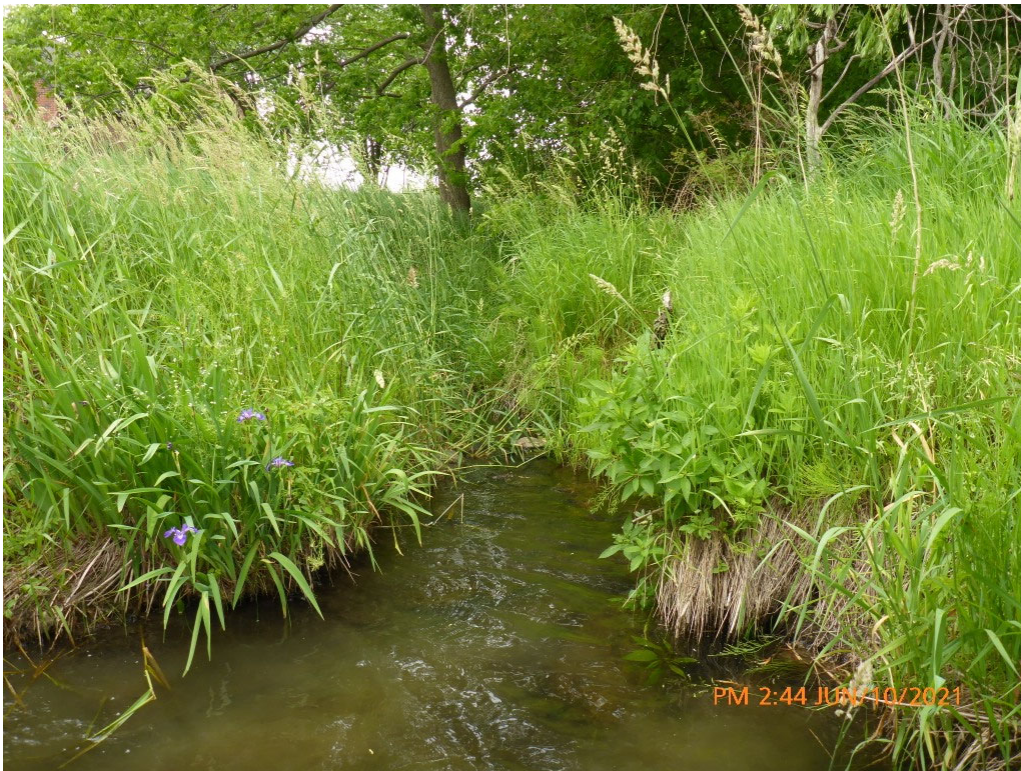
**Looking North Upstream - Photo 24**

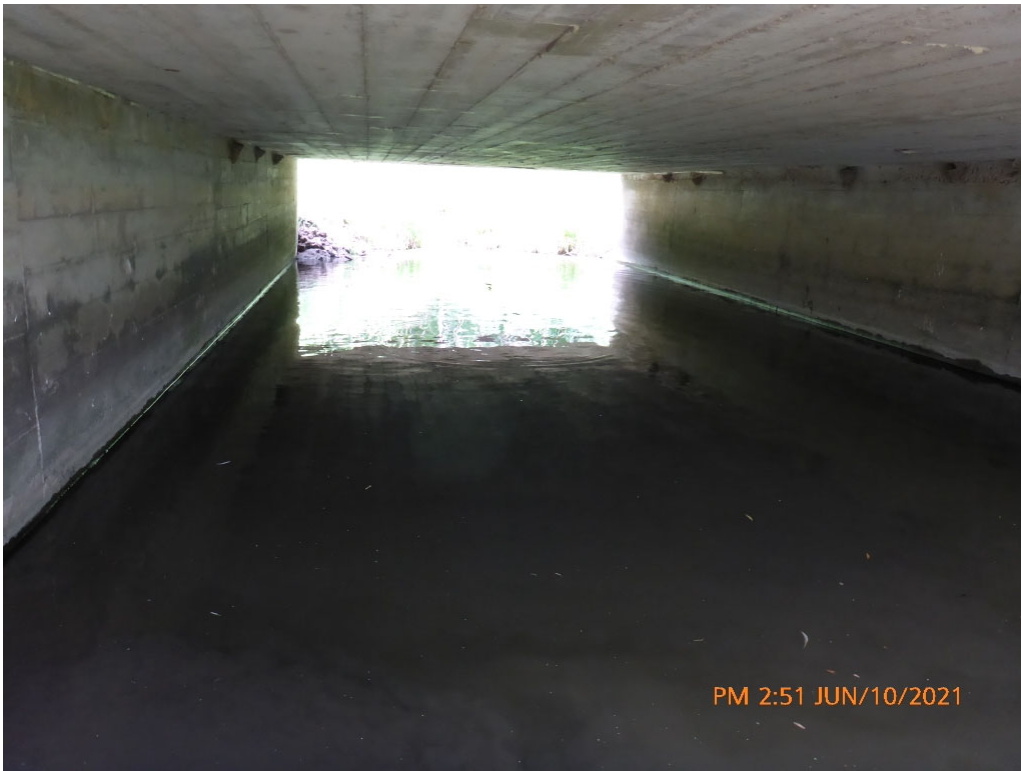
**Embankments and Streams - Streams\_Waterways - Watercourse Below Bridge - Photo 26**

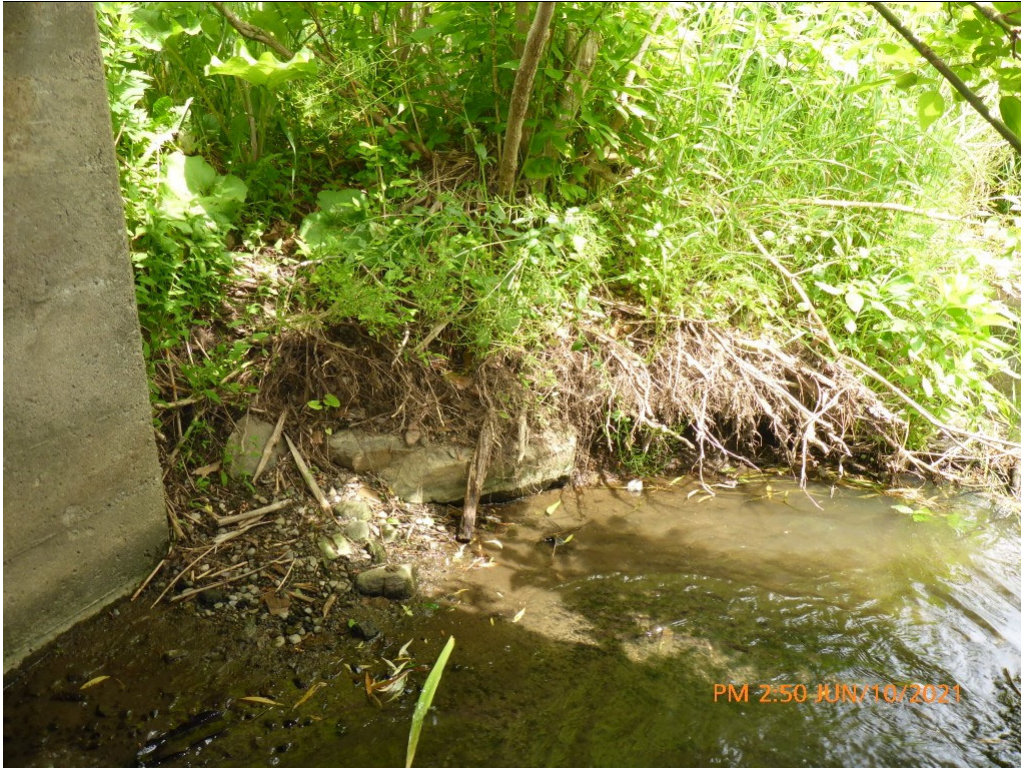
**Embankments and Streams - Streams\_Waterways - Light Scour - Southeast - Photo 27**

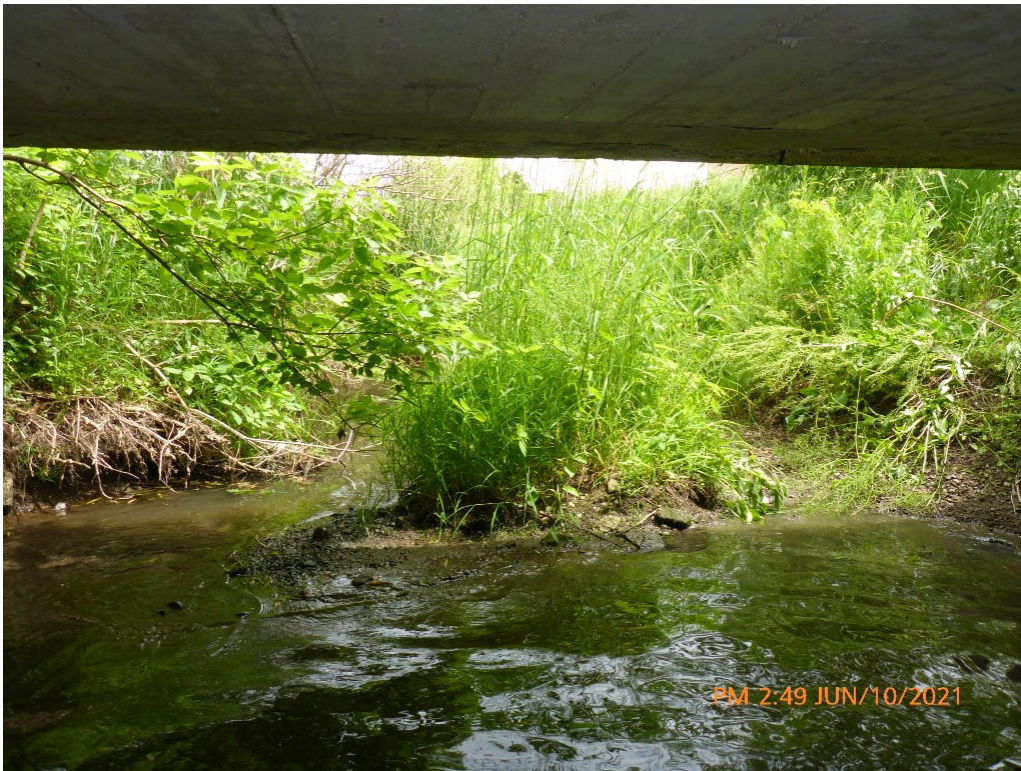
**Embankments and Streams - Streams\_Waterways - Aggradation of Watercourse - South - Photo 28**

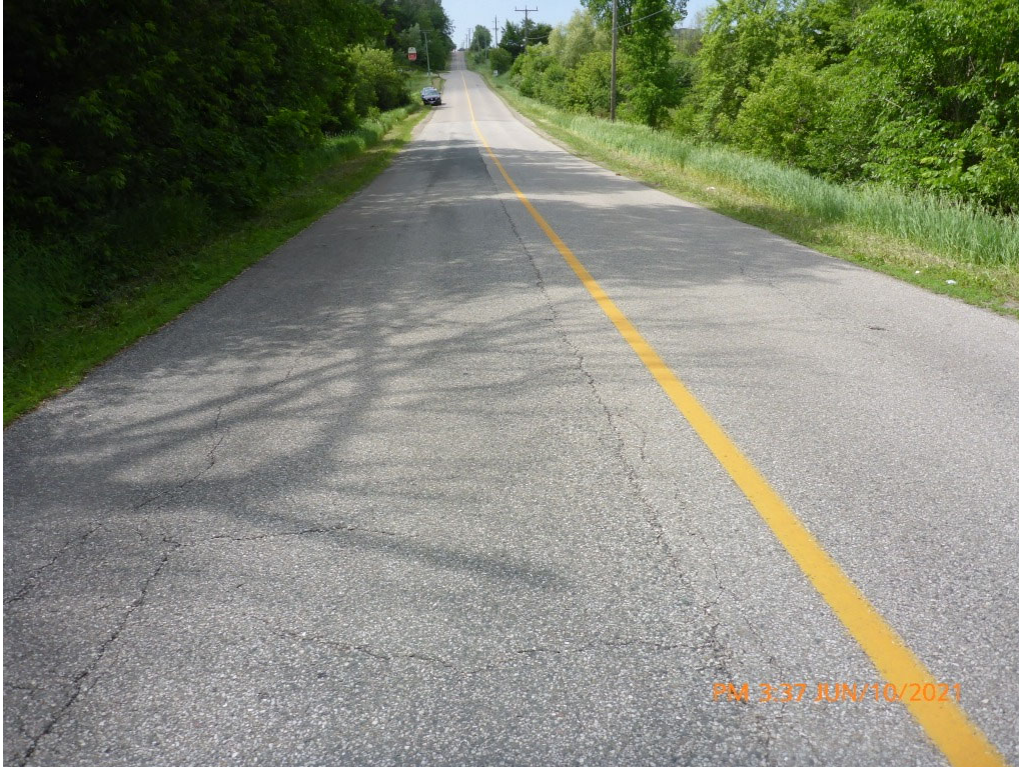
**Looking North at Roadway over Culvert - Photo 1**

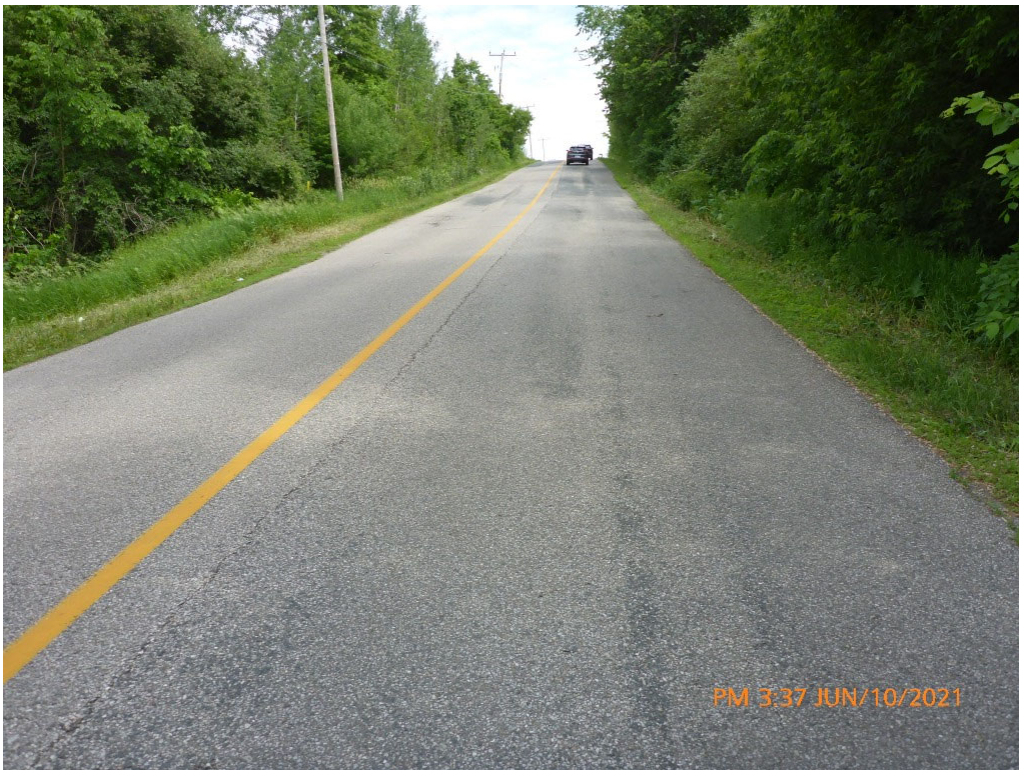
**Looking South at Roadway over Culvert - Photo 2**

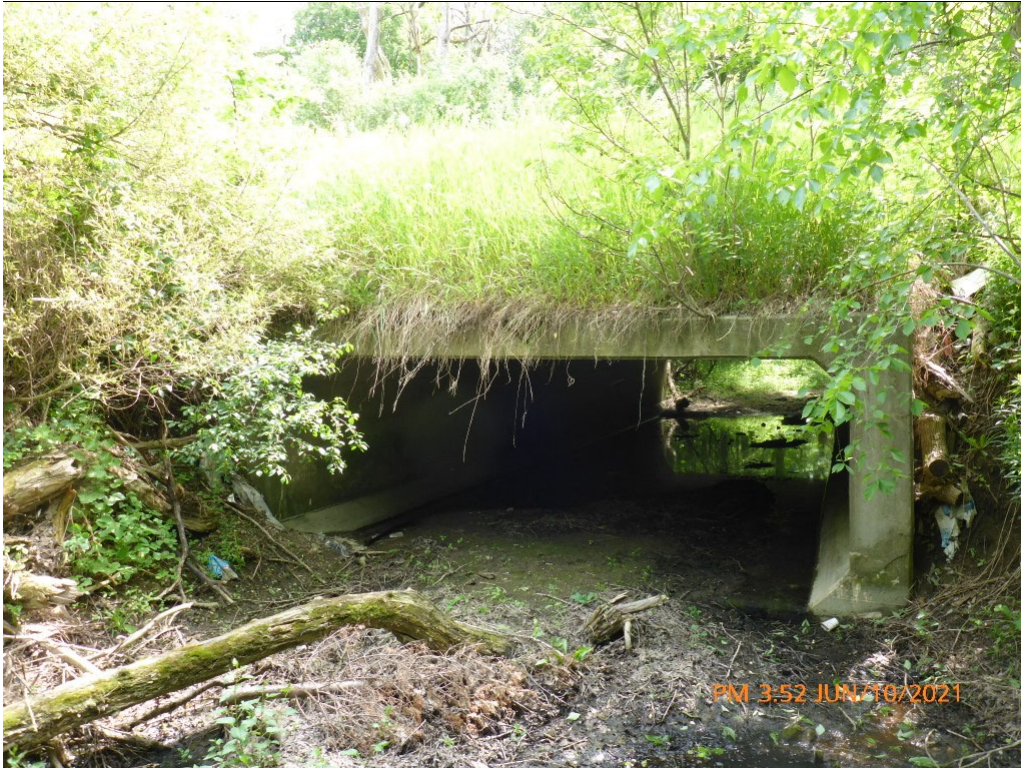
**East Elevation - Photo 3**

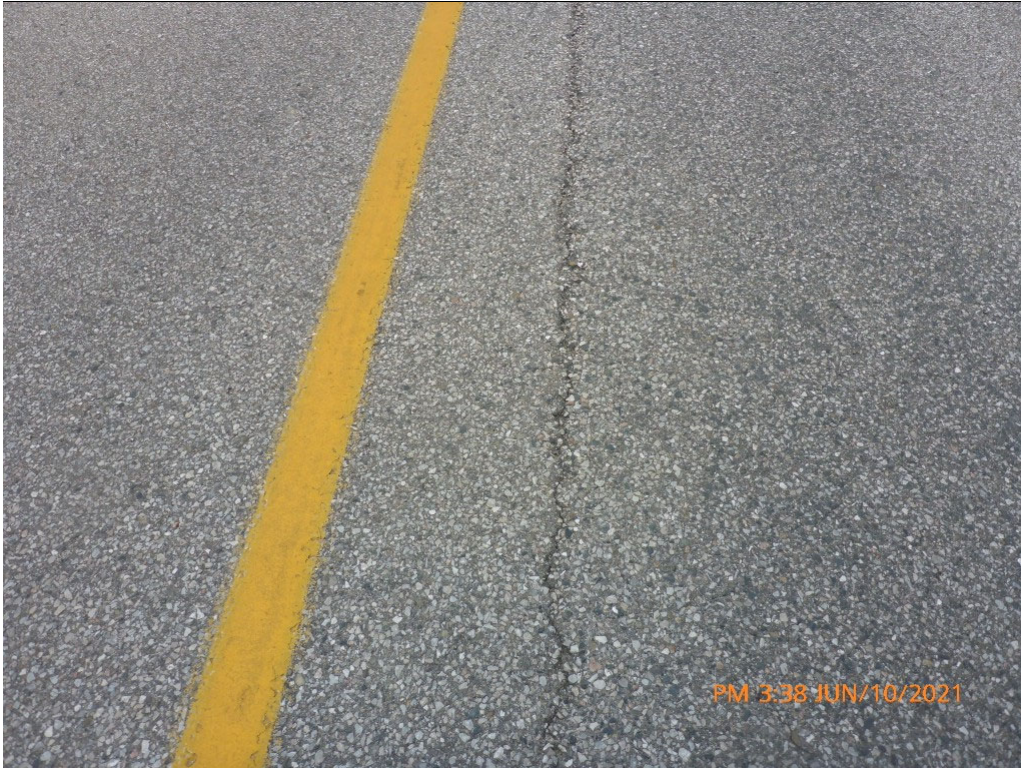
**Approaches - Wearing Surface - Light Crack - Photo 5**

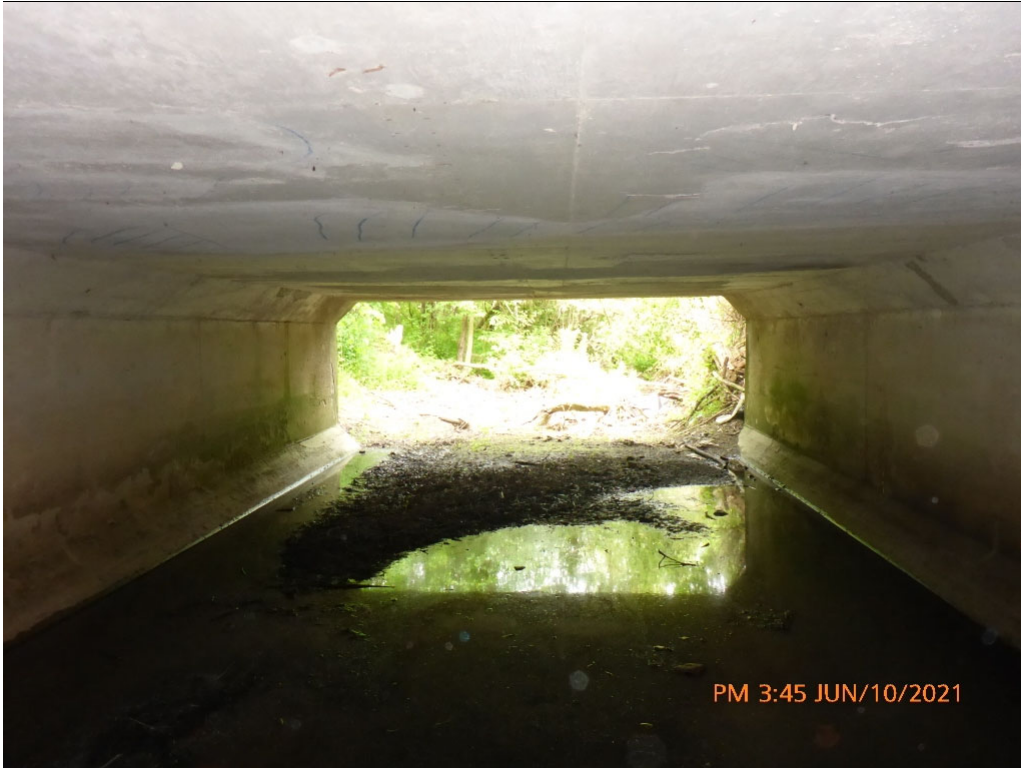
**Looking East through Barrel at Midspan - Photo 7**

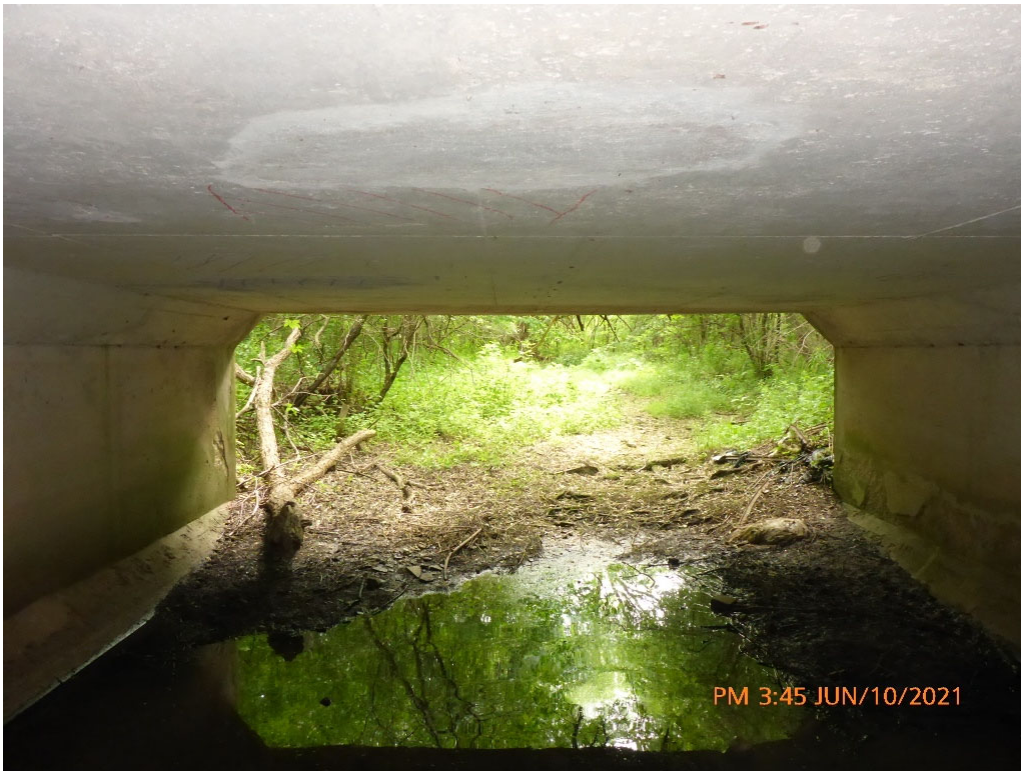
**Looking West through Barrel at Midspan - Photo 8**

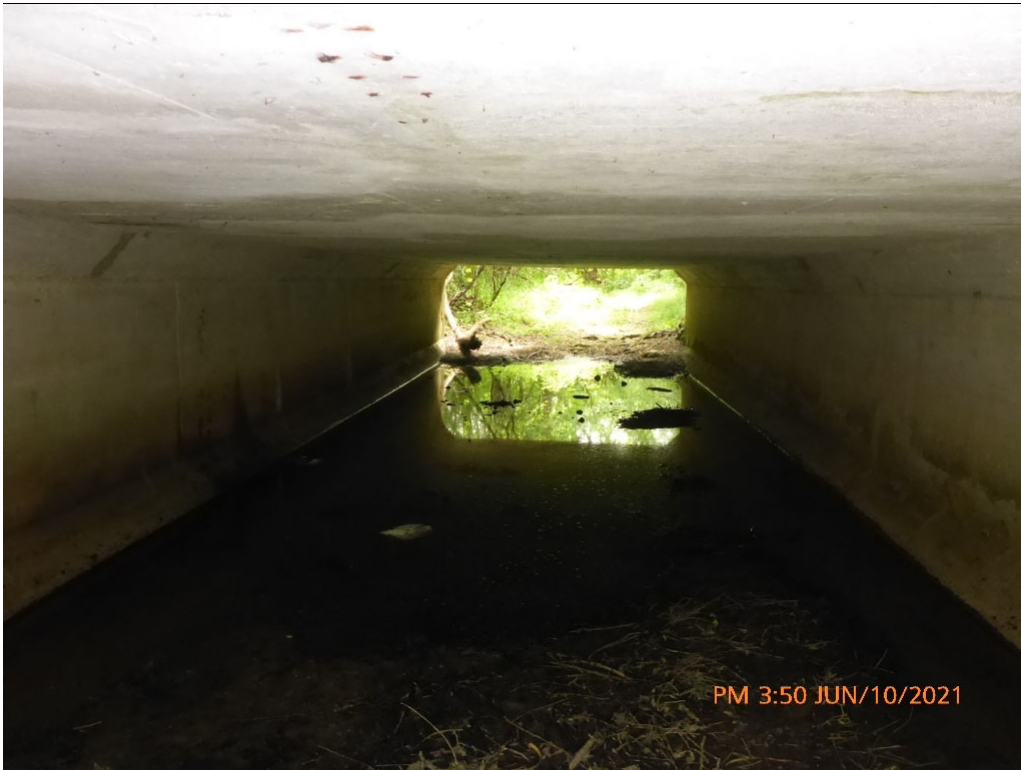
**Looking West through Barrel from End - Photo 9**

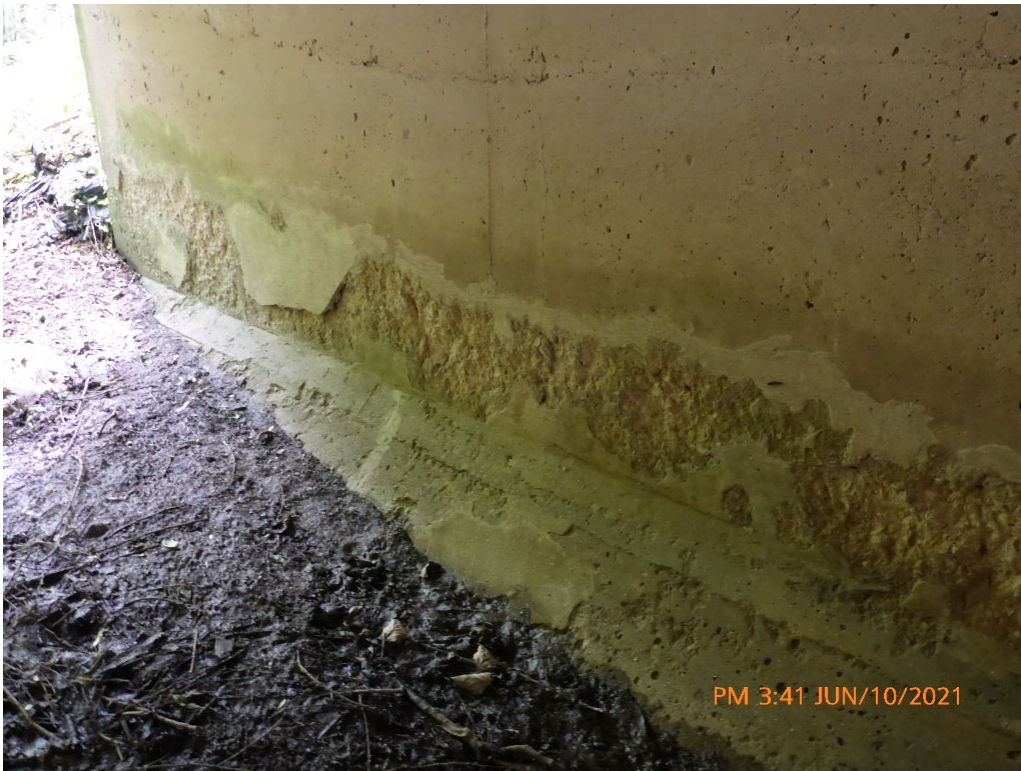
**Culverts - Barrels - Severe Erosion on Wall - North Wall - Photo 10**

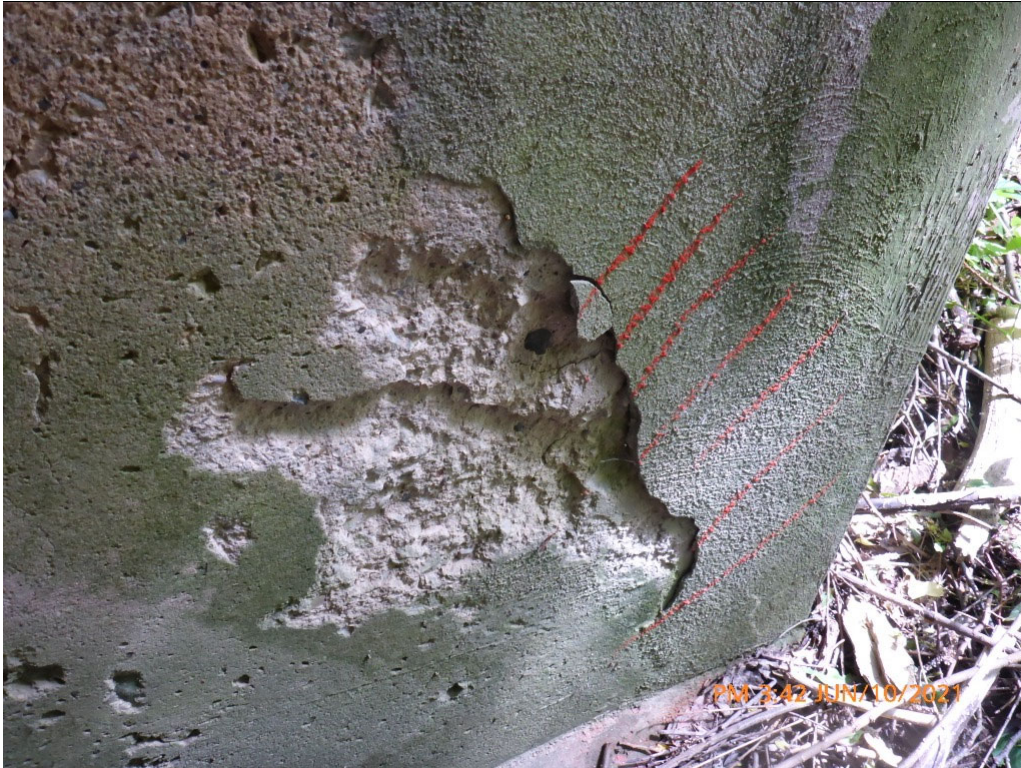
**Culverts - Barrels - Debonded Concrete Patch - South Wall - Photo 11**

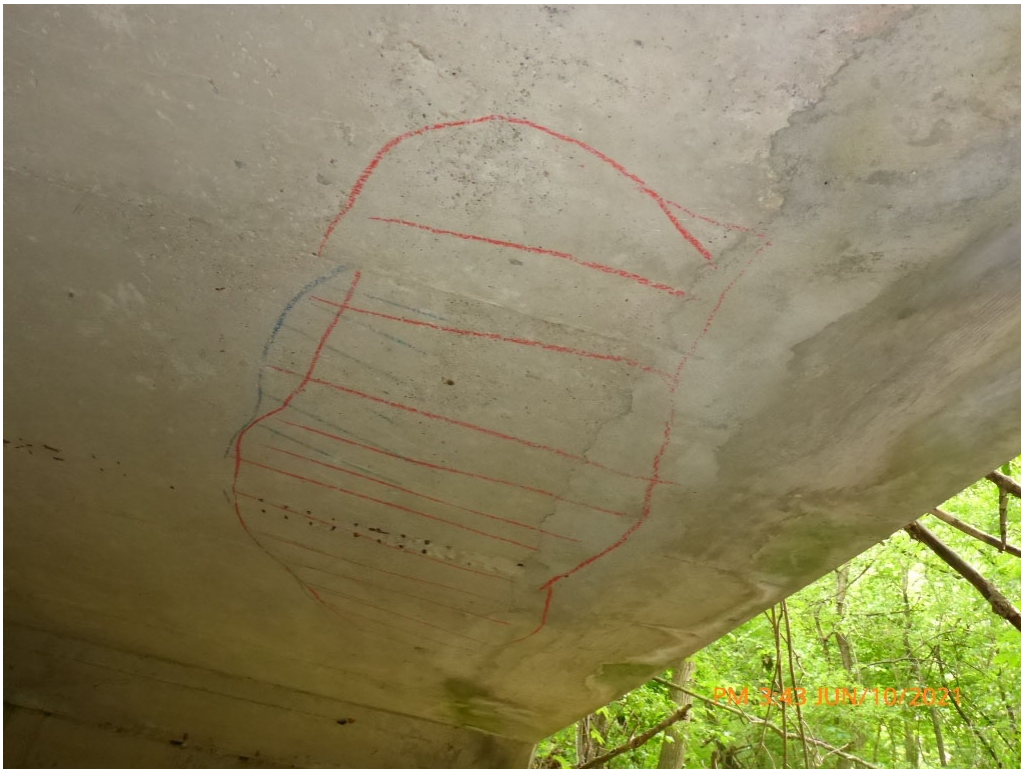
**Culverts - Barrels - Severe Delamination on Soffit - Photo 12**

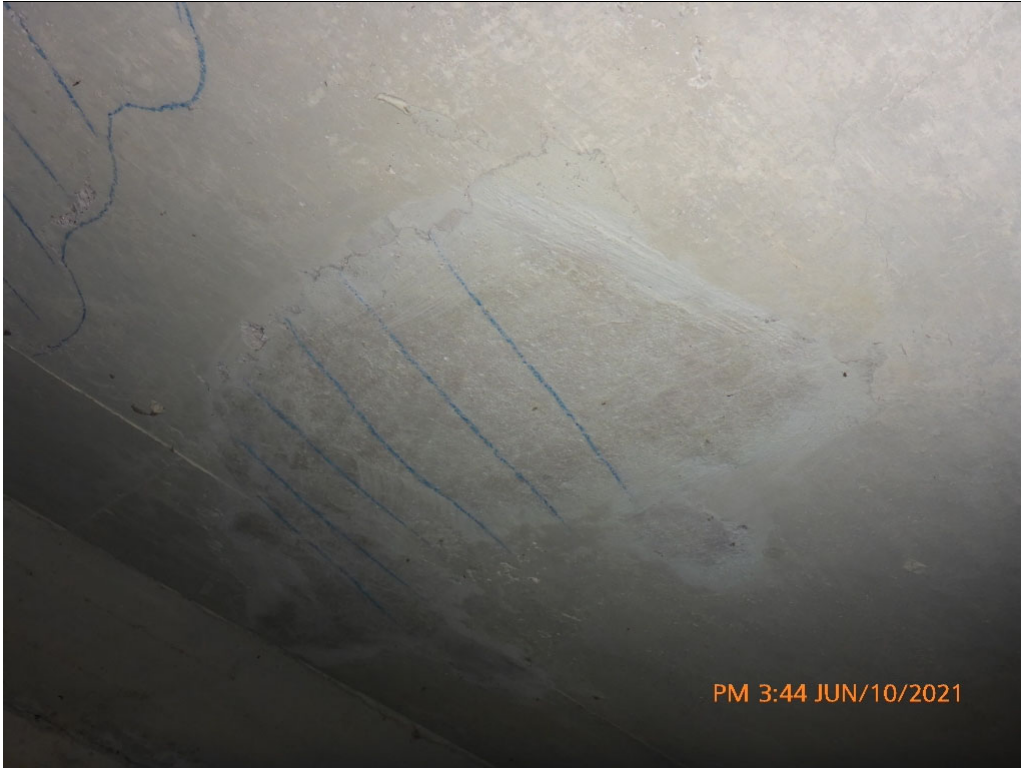
**Culverts - Barrels - Debonded Concrete Patch on Soffit - Photo 13**

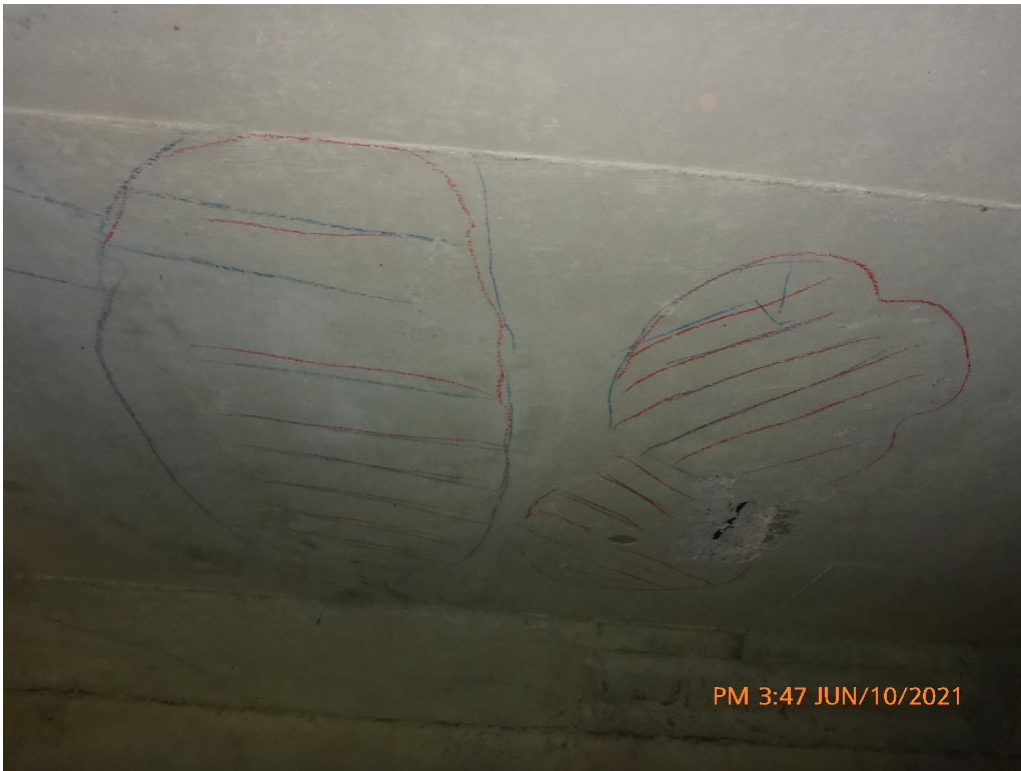
**Culverts - Barrels - Severe Delaminations on Soffit - Photo 14**

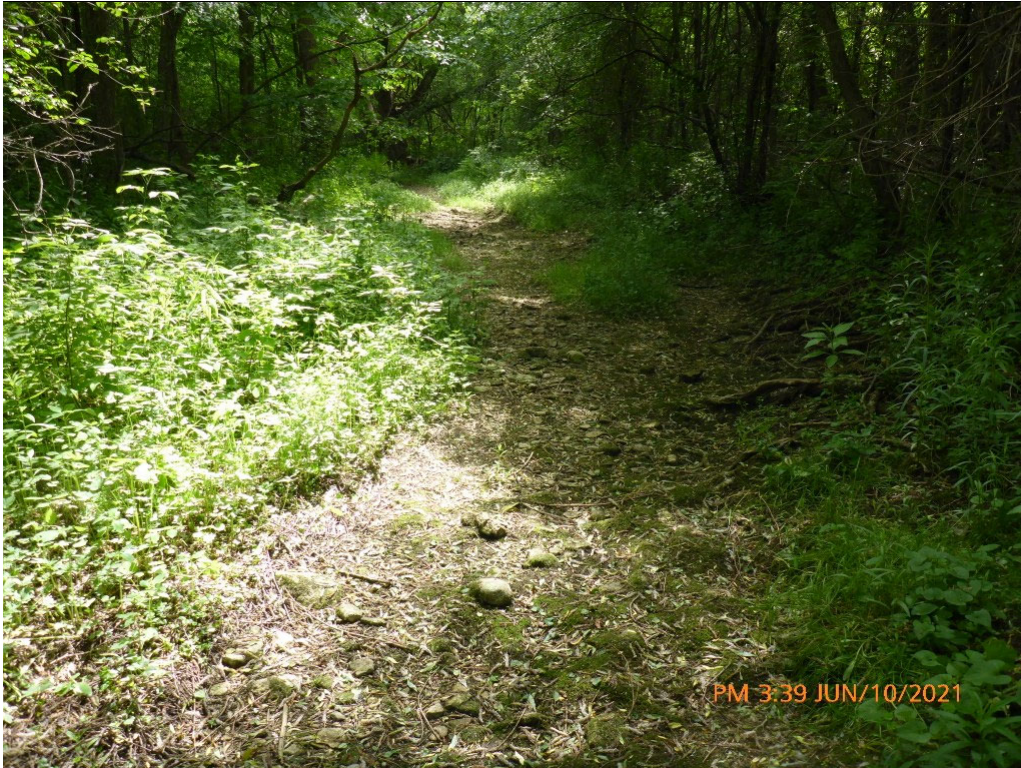
**Looking West Downstream - Photo 17**

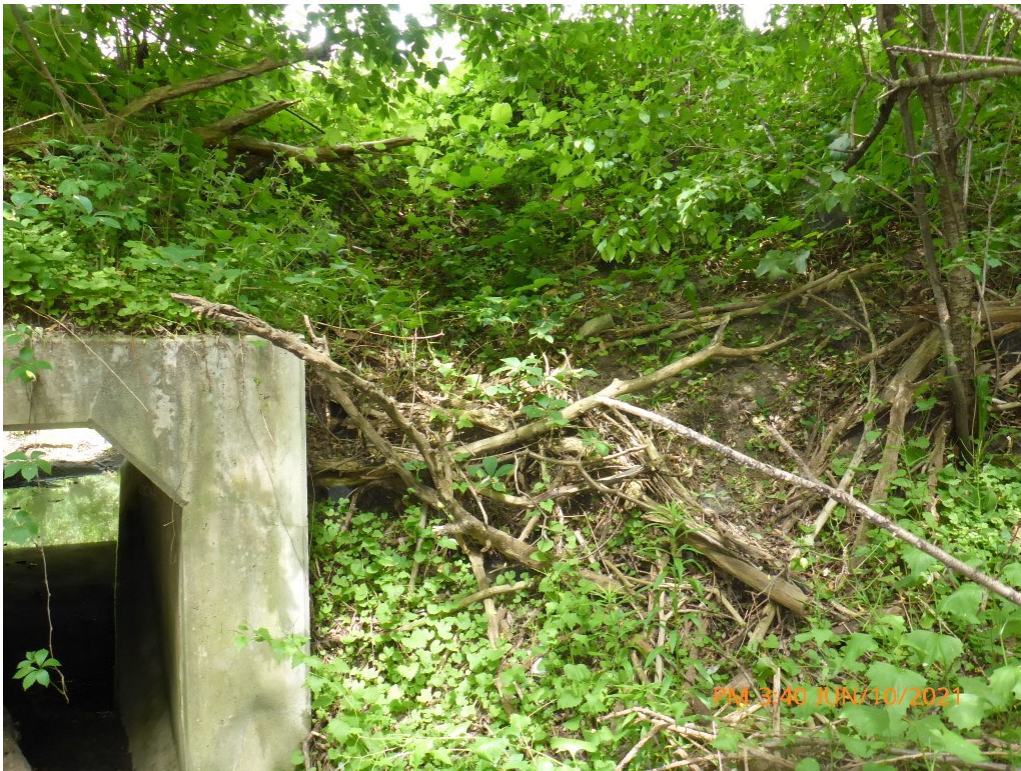
**Embankments and Streams - Embankments - Medium Erosion - SW - Photo 18**
