**Summary Action Report**  
**Structure B20092243 (MTO Site No. )**  
**Old School Road, 0.45 km West of Torbram Road**

Inspection Date 06/10/2021 mm/dd/yyyy

# Municipal Structure Inspection Form

**B20092243**

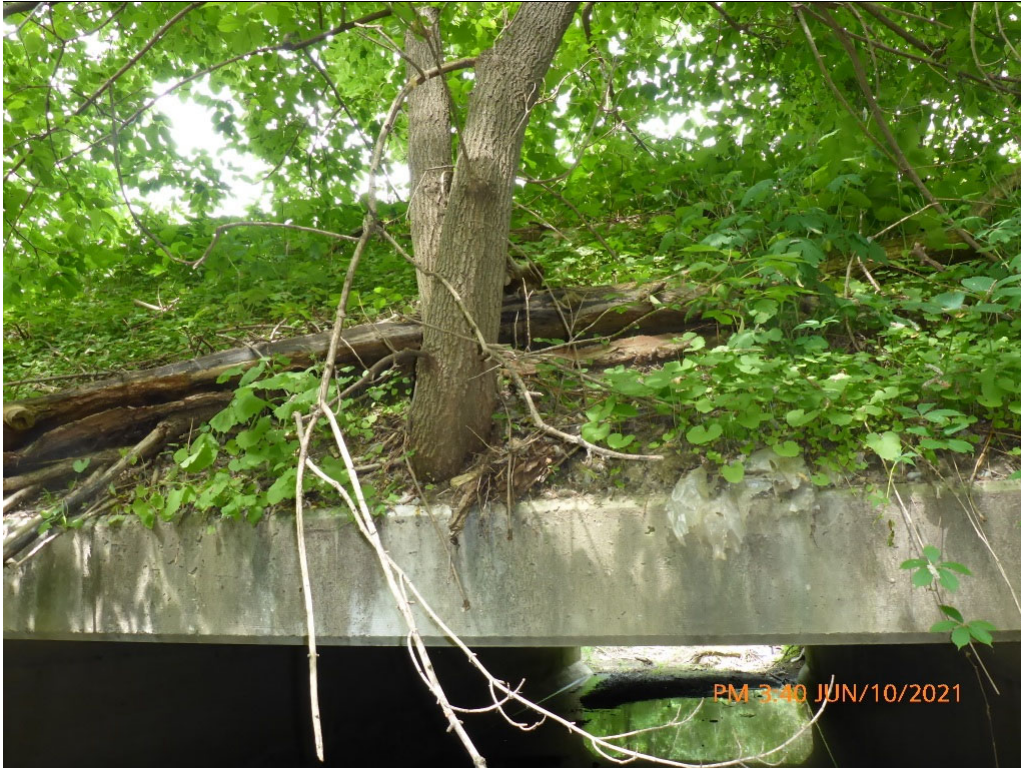
**Embankments and Streams - Embankments - Tree Growing over Barrel - West - Photo 19**

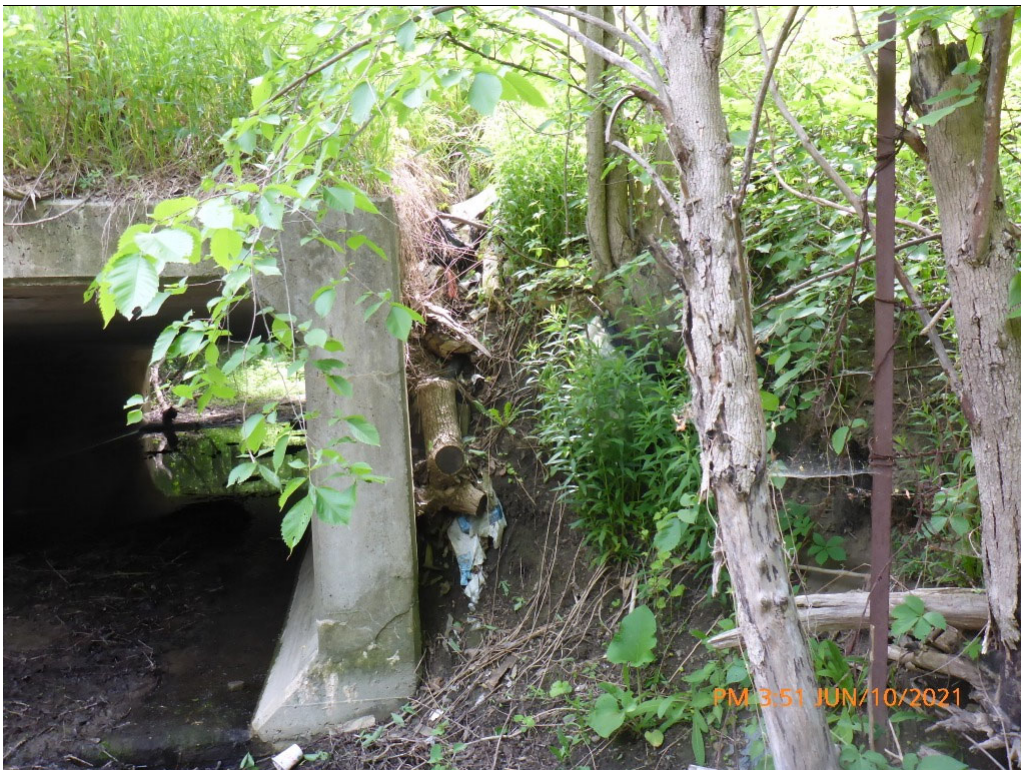
**Embankments and Streams - Embankments - Severe Erosion - Northwest - Photo 20**

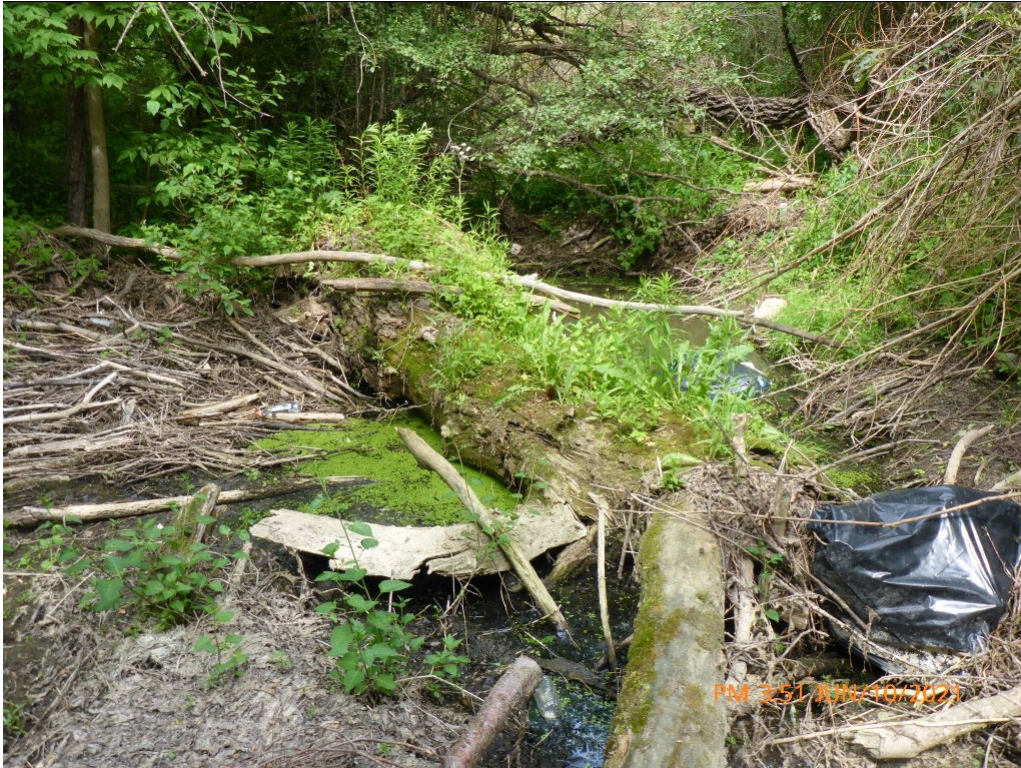
**Embankments and Streams - Streams\_Waterways - Trees in Watercourse - East - Photo 21**

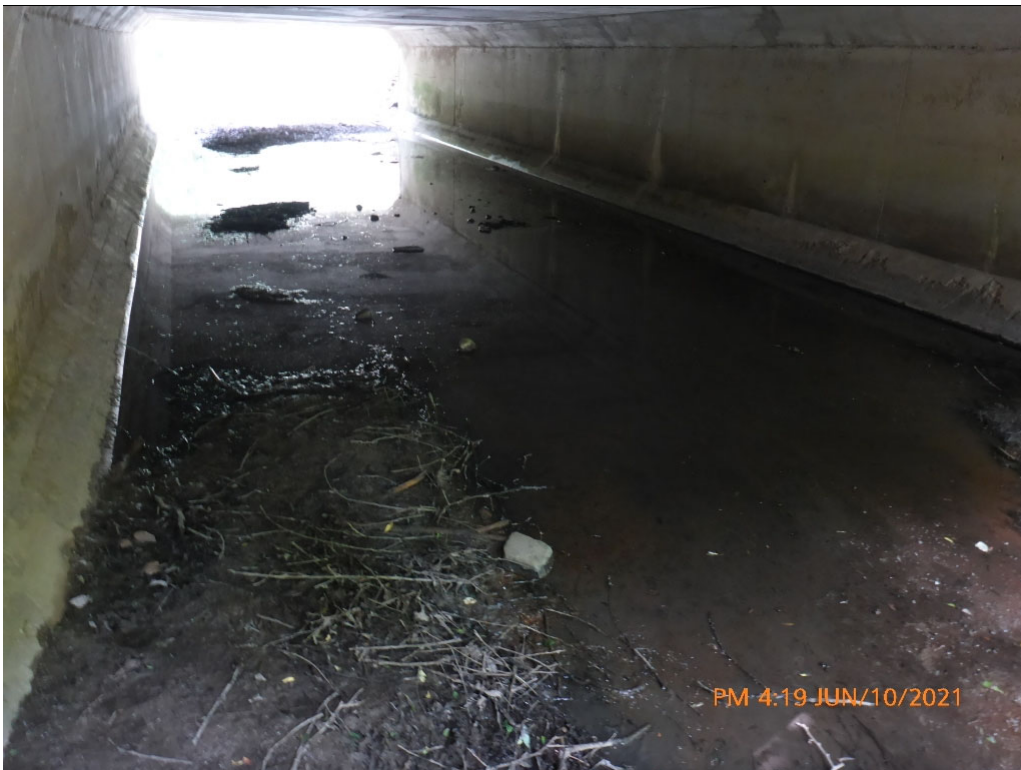
**Embankments and Streams - Streams\_Waterways - Watercourse through Structure - Photo 22**

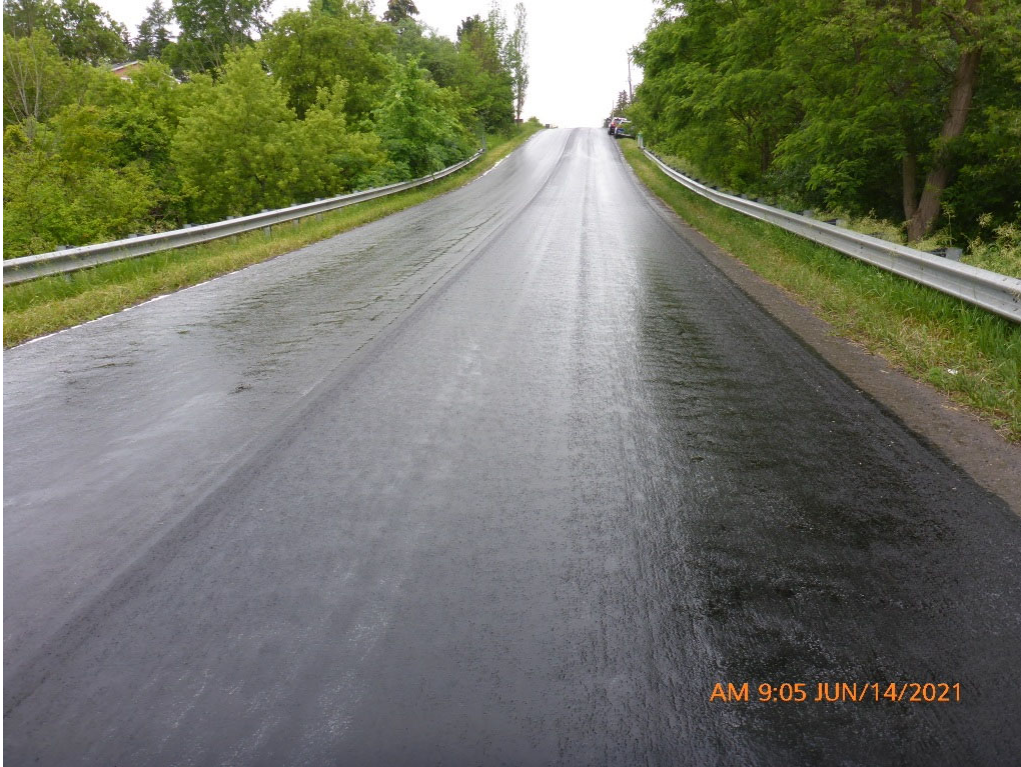
**Looking North at Roadway over Culvert - Photo 1**

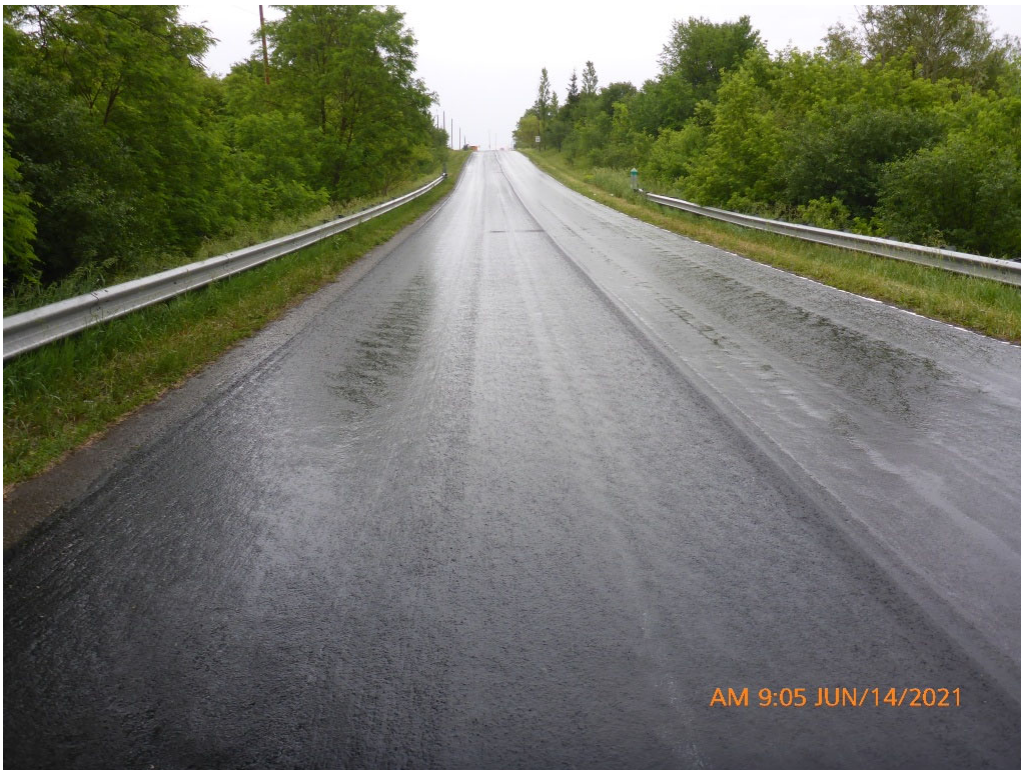
**Looking South at Roadway over Culvert - Photo 2**

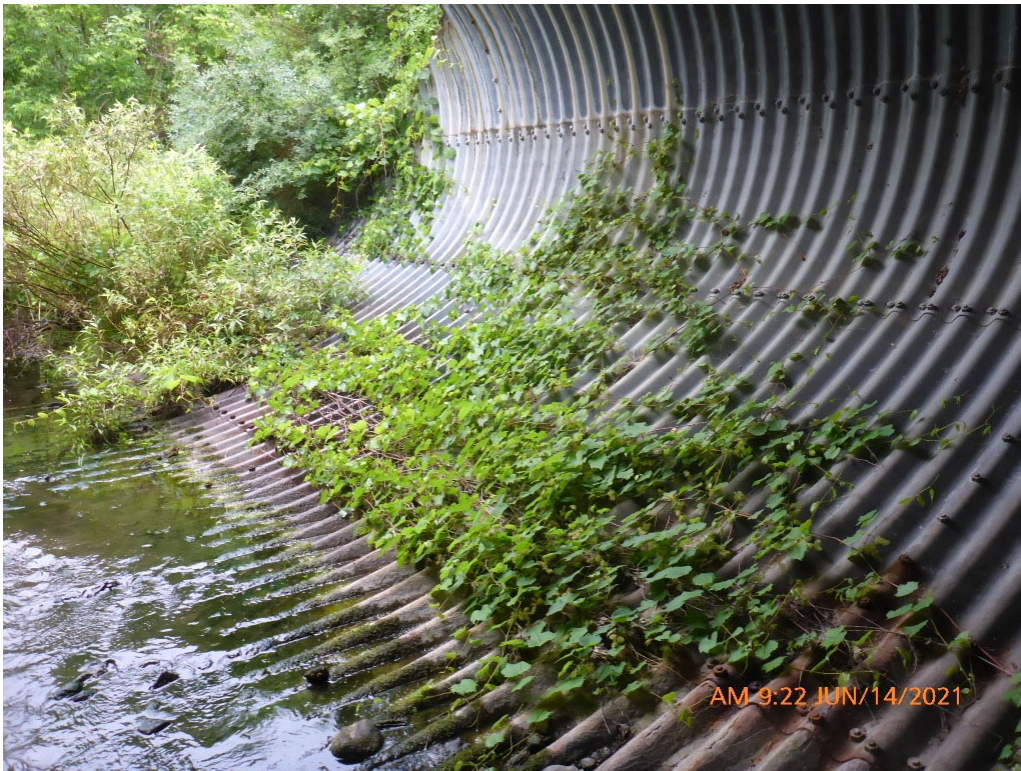
**Culverts - Barrels - Stalactites on Wall - Photo 17**

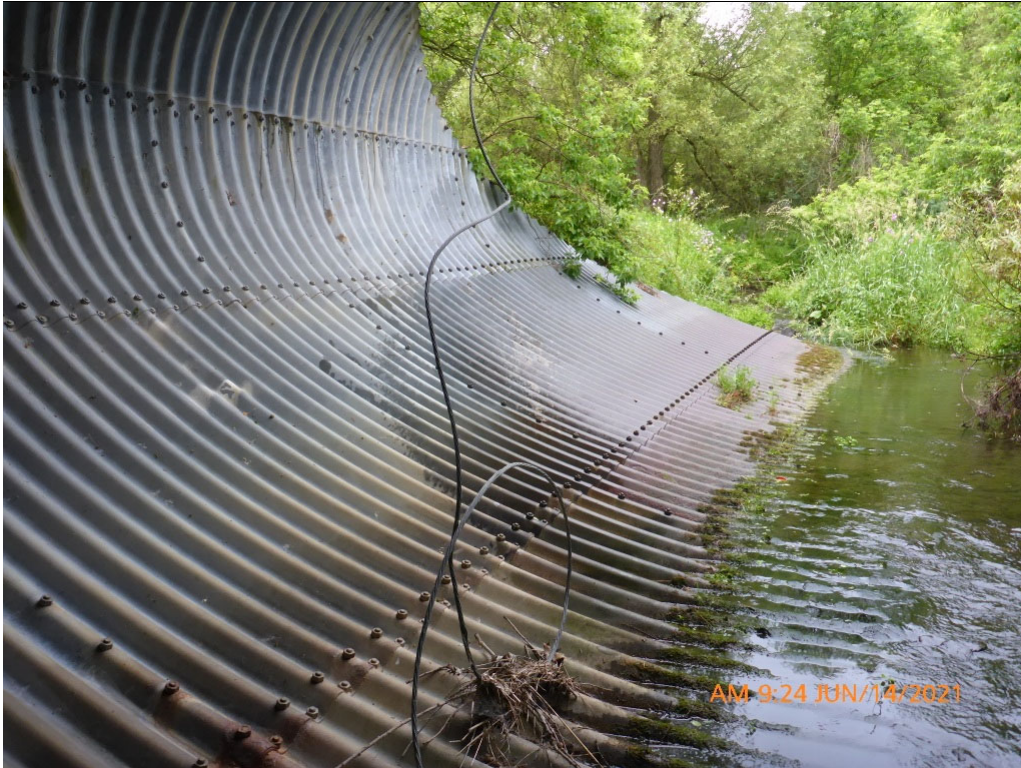
**Culverts - Barrels - Vegetation Growing in Barrel - Photo 18**

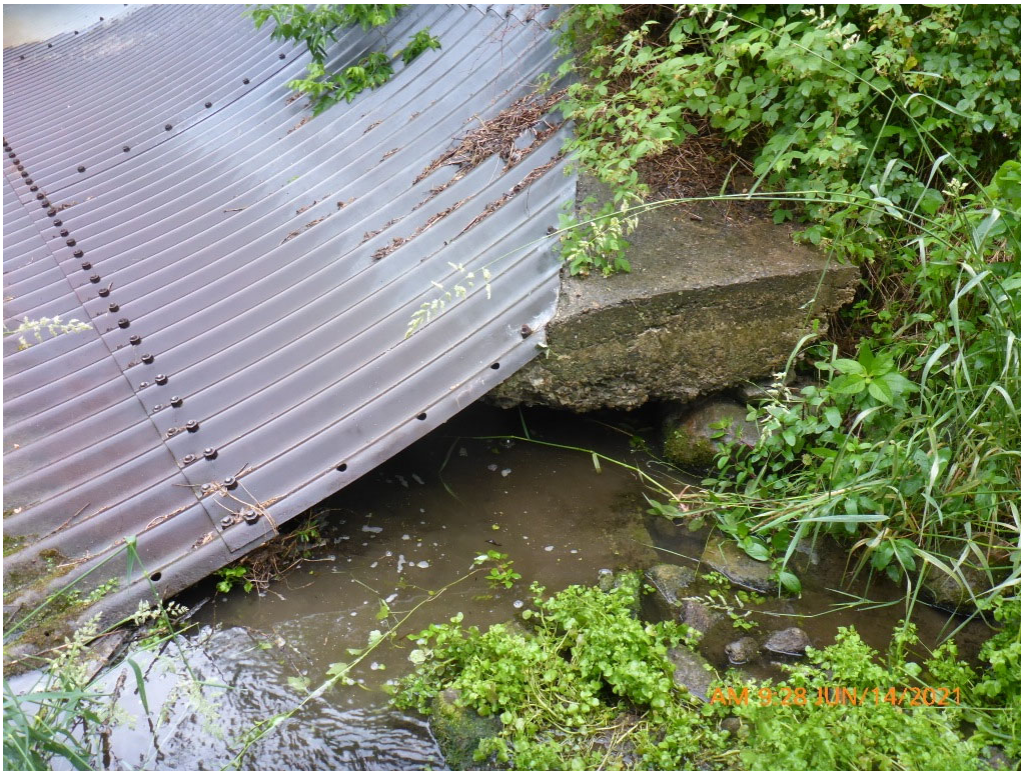
**Coatings - Structural Steel - Light to Severe Breakdown of Coating - Photo 21**

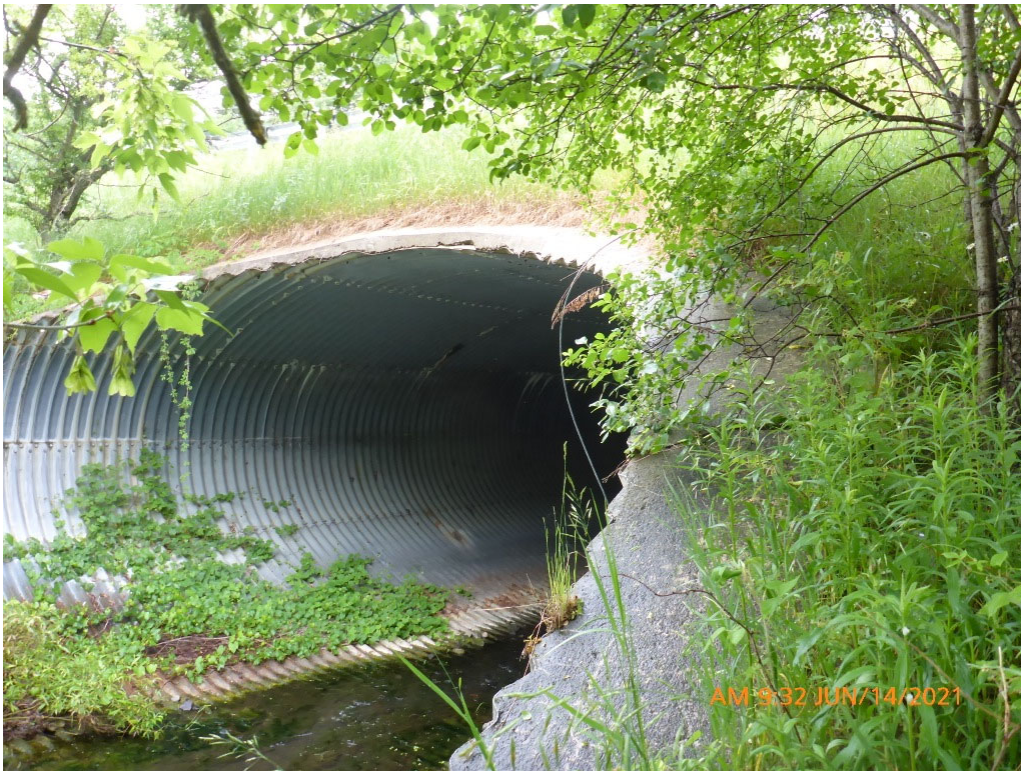
**Culverts - Inlet Components - Severe Honeycombing on Cut-off Wall - SW - Photo 23**

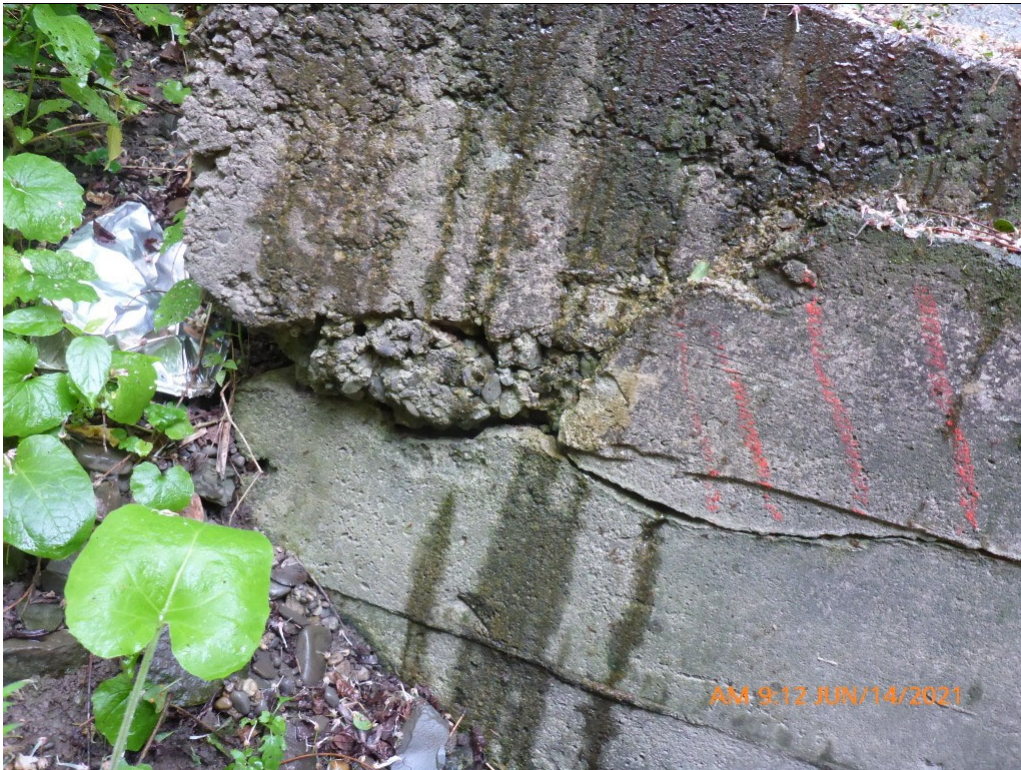
**Culverts - Outlet Components - Light Delamination - SE Cut-off Wall - Photo 28**
