12197 Hurontario Street, Brampton, Ontario

Geotechnical Investigation

Proposed Residential Development (Summer Valley)

BRM-00257876-D0

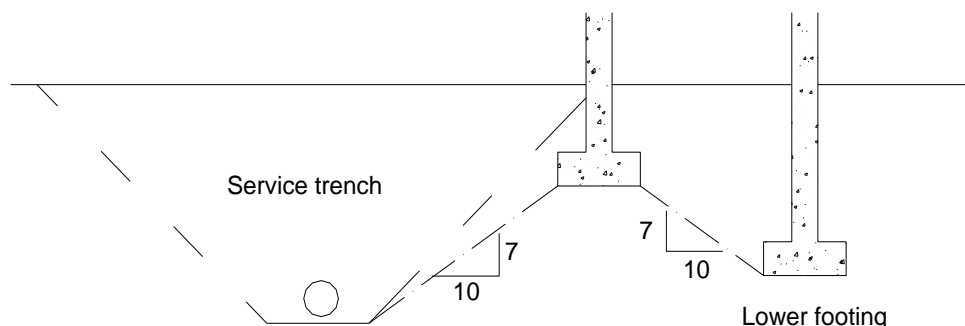
FOOTINGS NEAR SERVICE TRENCHES OR AT DIFFERENT ELEVATIONS

Footings which are to be placed at different elevations should be located such that the higher footings are set below a line drawn up at 10 horizontal to 7 vertical from the near edge of the lower footing. This concept should also be applied to excavations for new foundations in relation to existing footings or underground services. This concept is illustrated in the following sketch:

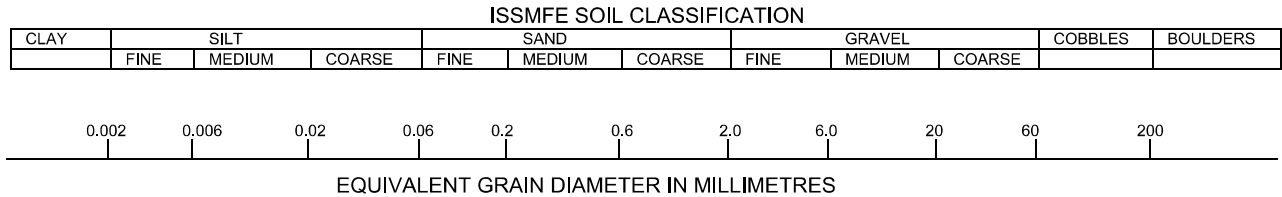
# Drawing 1A

1. All sample descriptions included in this report follow the Canadian Foundations Engineering Manual soil classification system. This system follows the standard proposed by the International Society for Soil Mechanics and Foundation Engineering. Laboratory grain size analyses provided by exp Services Inc. also follow the same system. Different classification systems may be used by others; one such system is the Unified Soil Classification. Please note that, with the exception of those samples where a grain size analysis has been made, all samples are classified visually. Visual classification is not sufficiently accurate to provide exact grain sizing or precise differentiation between size classification systems.

CLAY (PLASTIC) TO SILT (NONPLASTIC)	FINE	MEDIUM	CRS.	FINE	COARSE
	SAND			GRAVEL

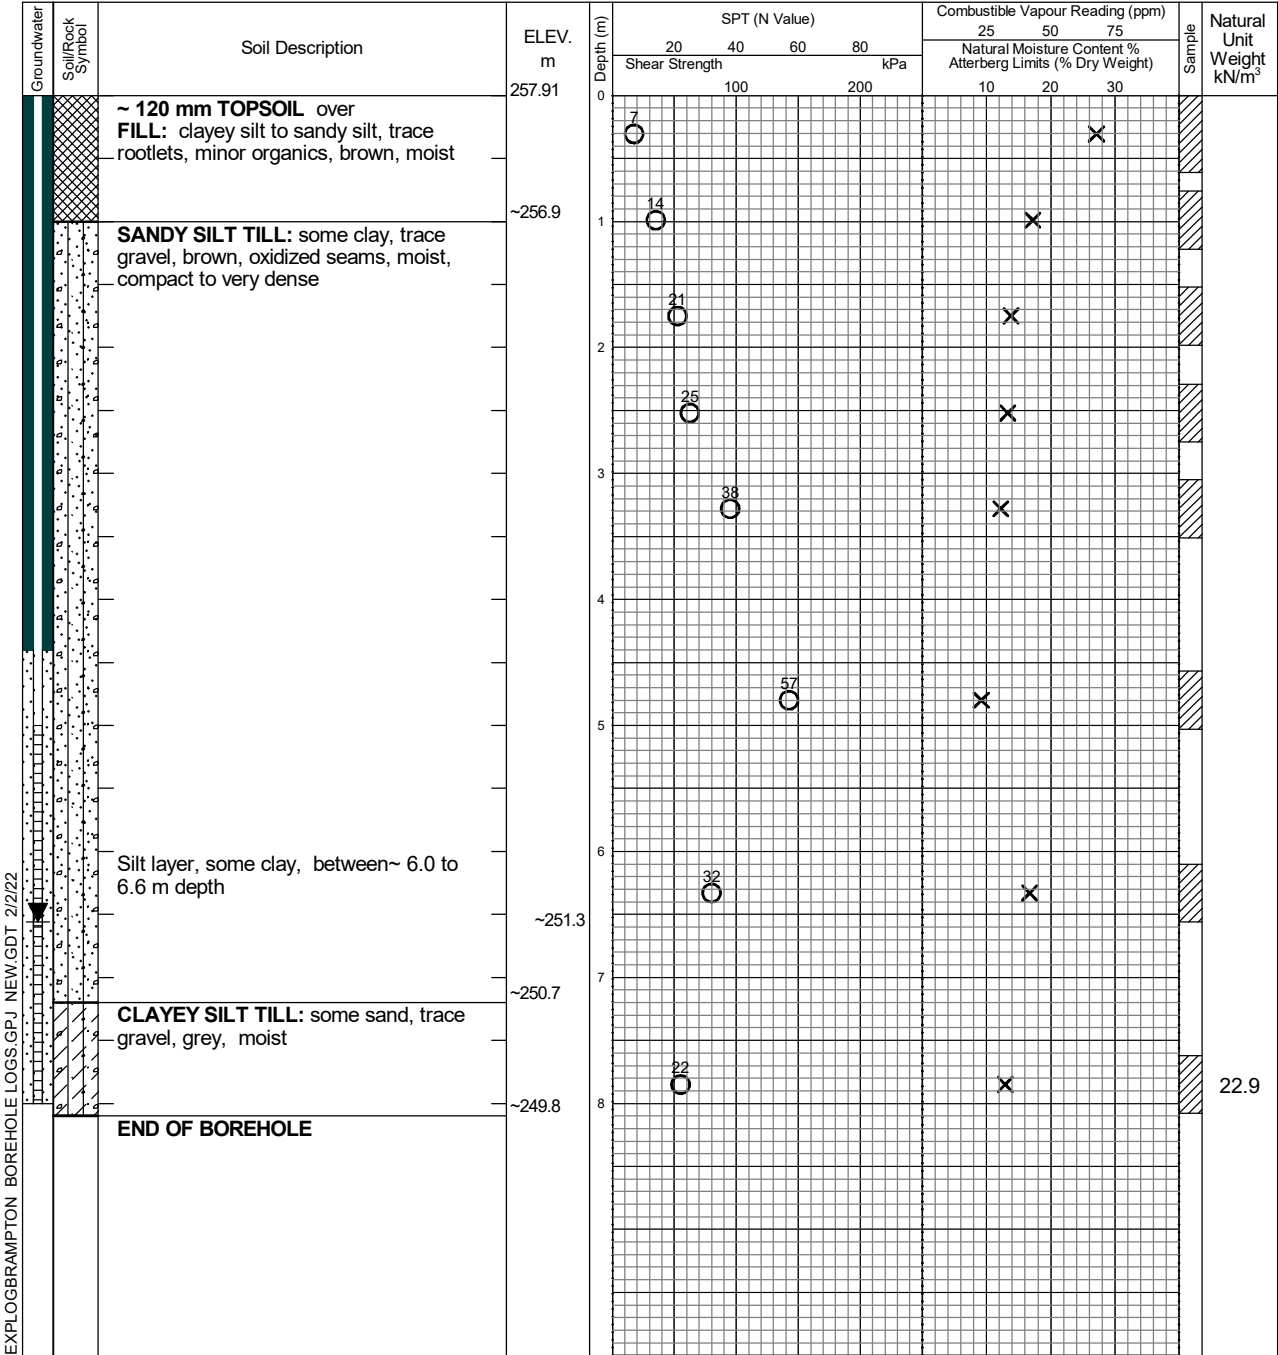
Date	Water Level (m)	Hole Open to (m)
On completion	Dry	
January 5, 2022	6.59	
January 12, 2022	6.49

The detailed soil profiles encountered in each borehole and the results of geotechnical laboratory testing are indicated on the attached borehole logs (Drawing Nos. 2 through 7) and figures in Appendix A. It should be noted that the soil boundaries indicated on the borehole logs are inferred from non-continuous sampling and observations during drilling. These boundaries are intended to reflect approximate transition zones for the purpose of geotechnical design and should not be interpreted as exact planes of geological change.

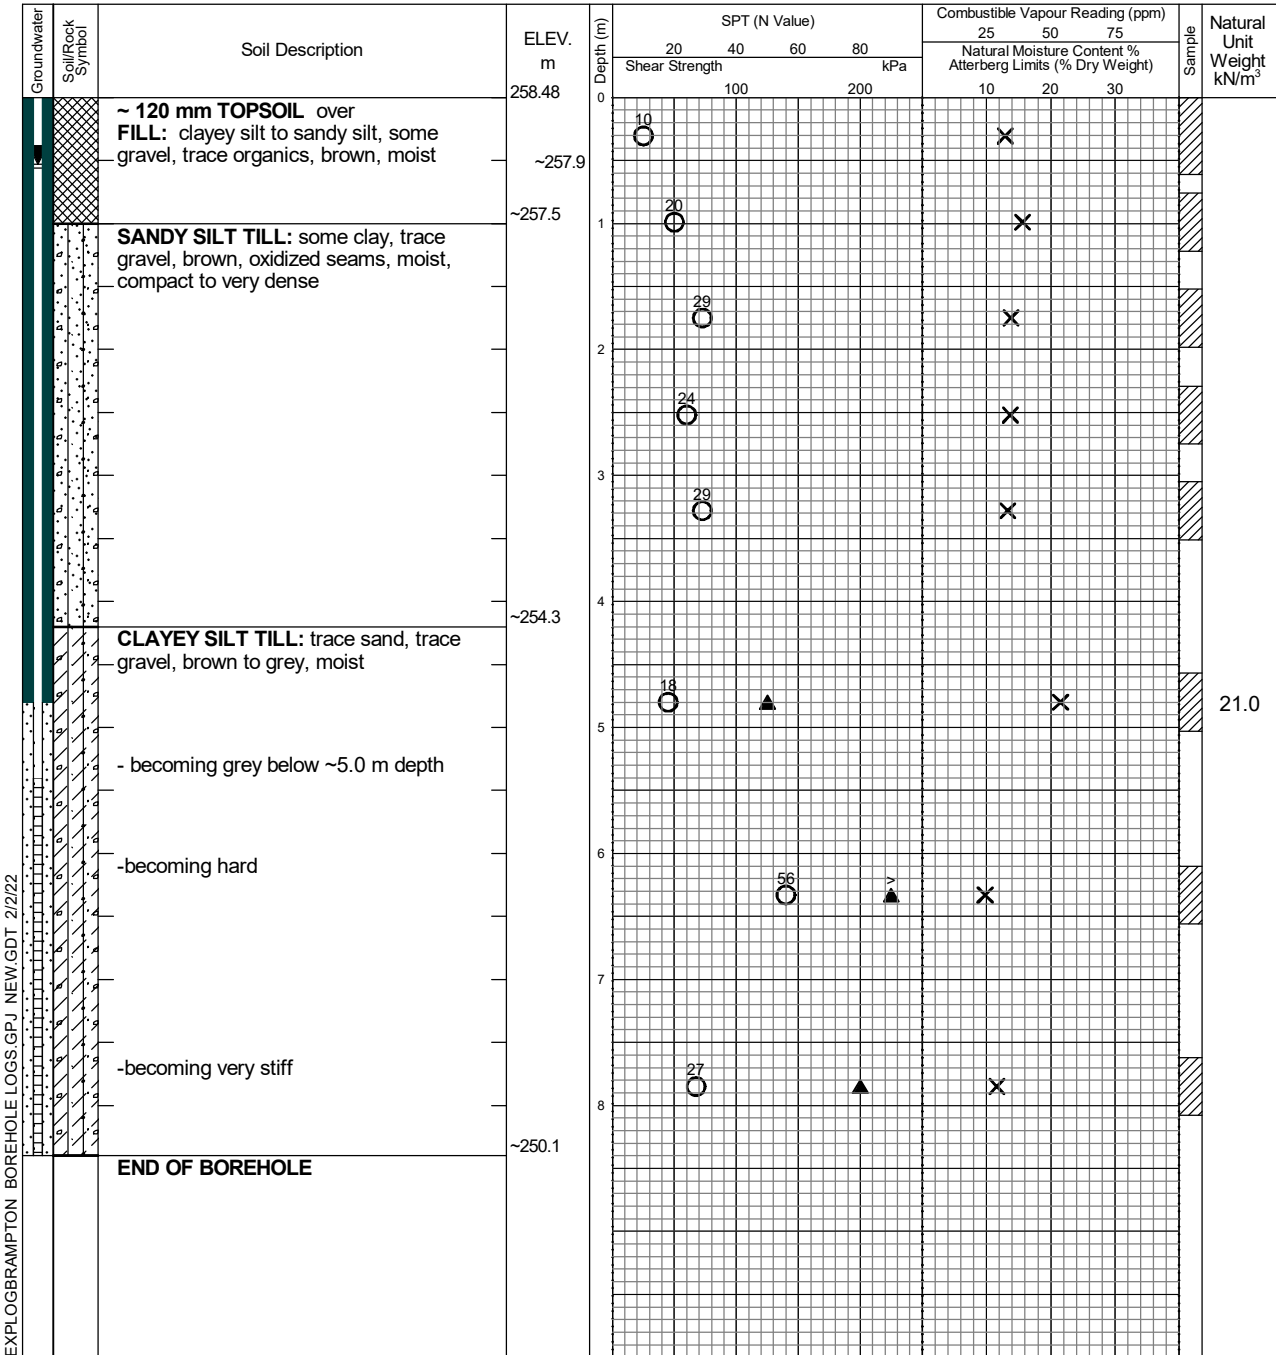
Date	Water Level (m)	Hole Open to (m)
On completion	8.0	
January 5, 2022	0.56	
January 12, 2022	1.72

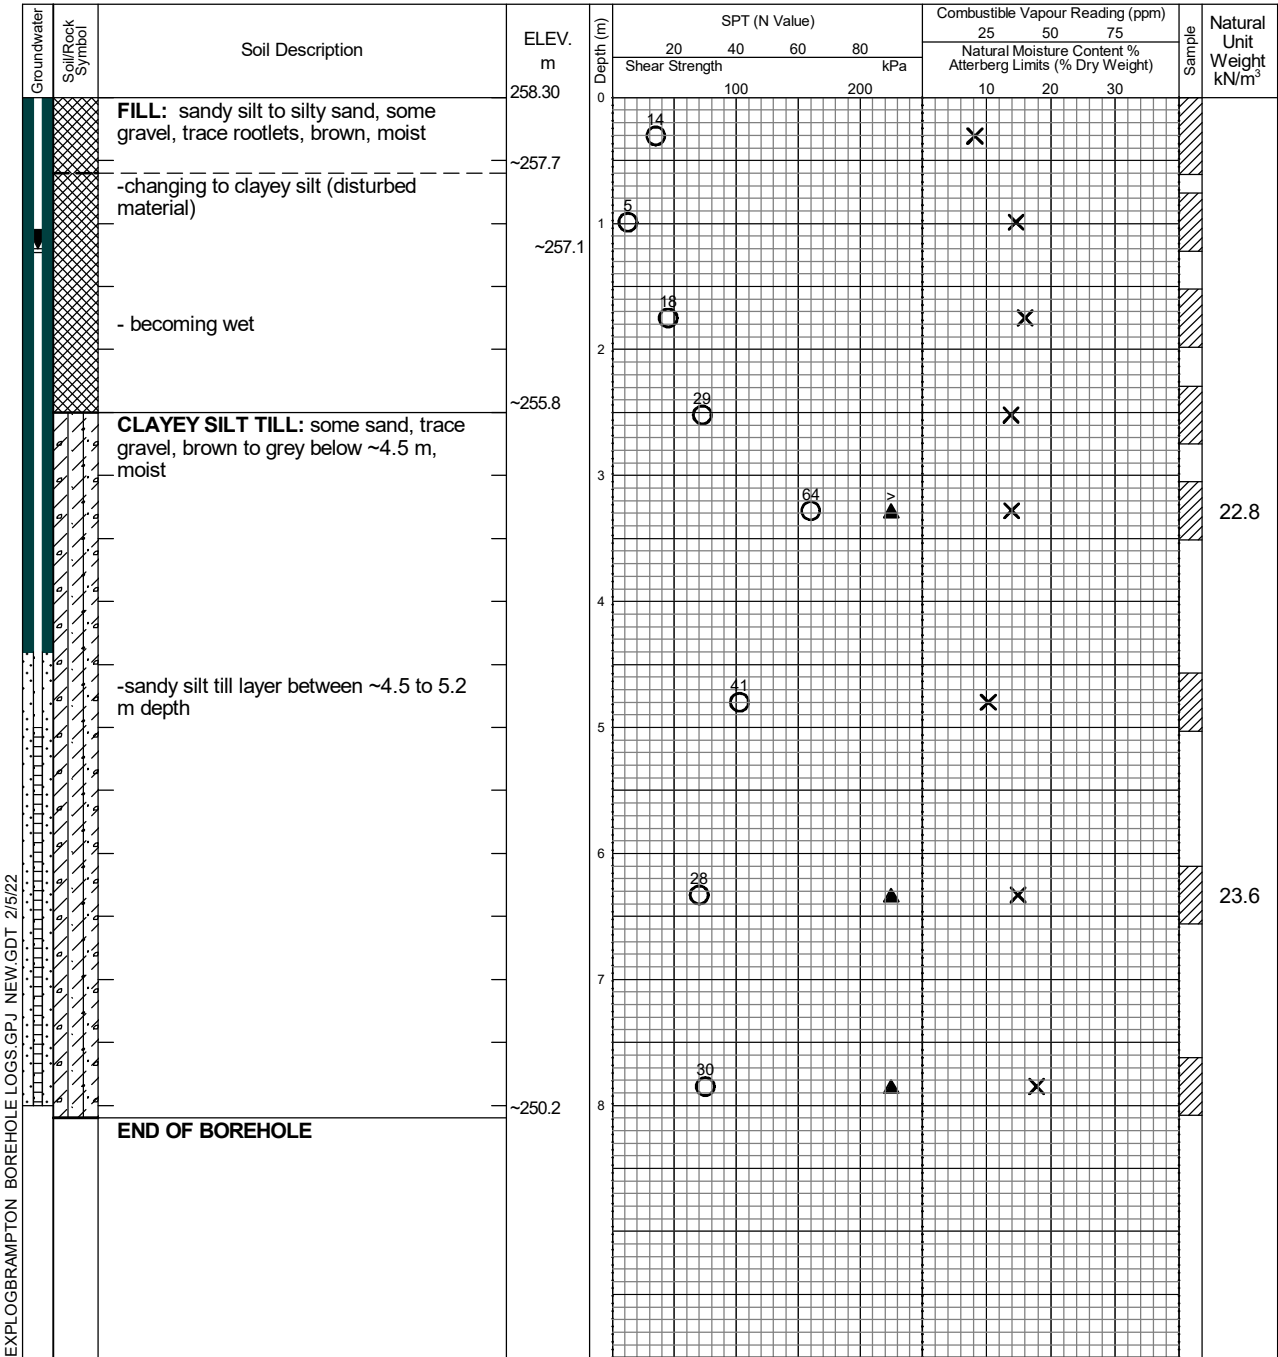
Date	Water Level (m)	Hole Open to (m)
On completion	7.9	
January 5, 2022	1.23	
January 12, 2022	1.55

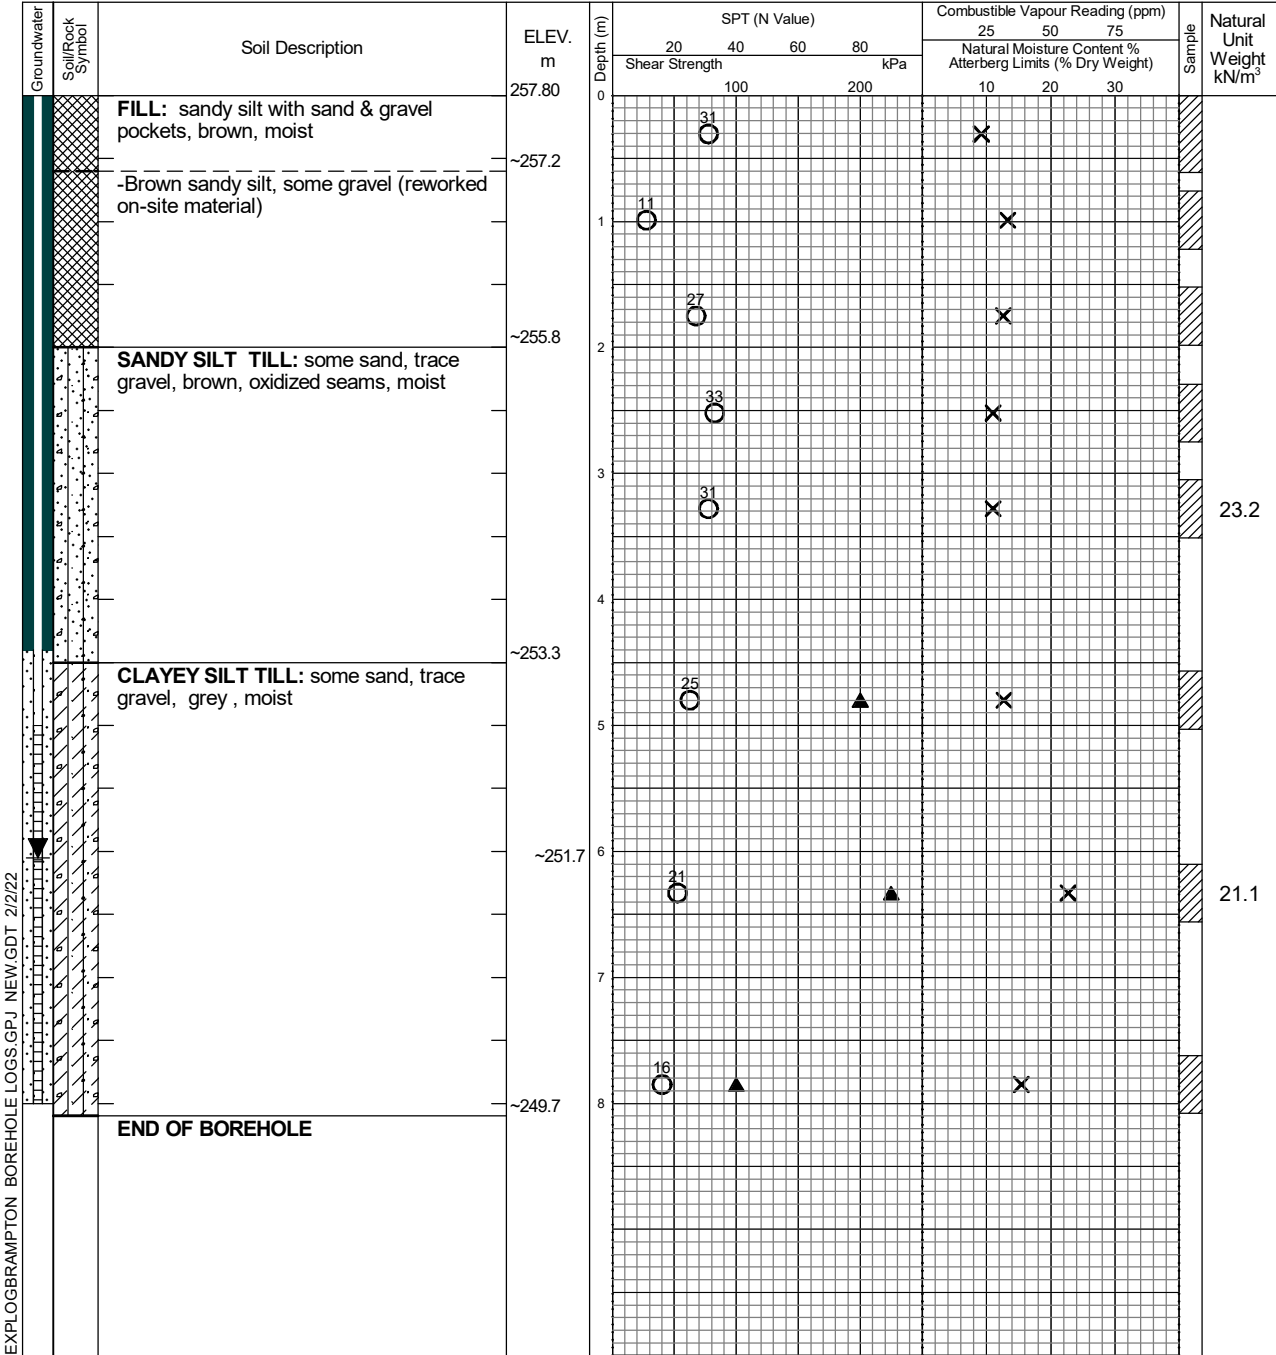
Date	Water Level (m)	Hole Open to (m)
On completion	8.0	
January 5, 2022	6.08	
January 12, 2022	6.20

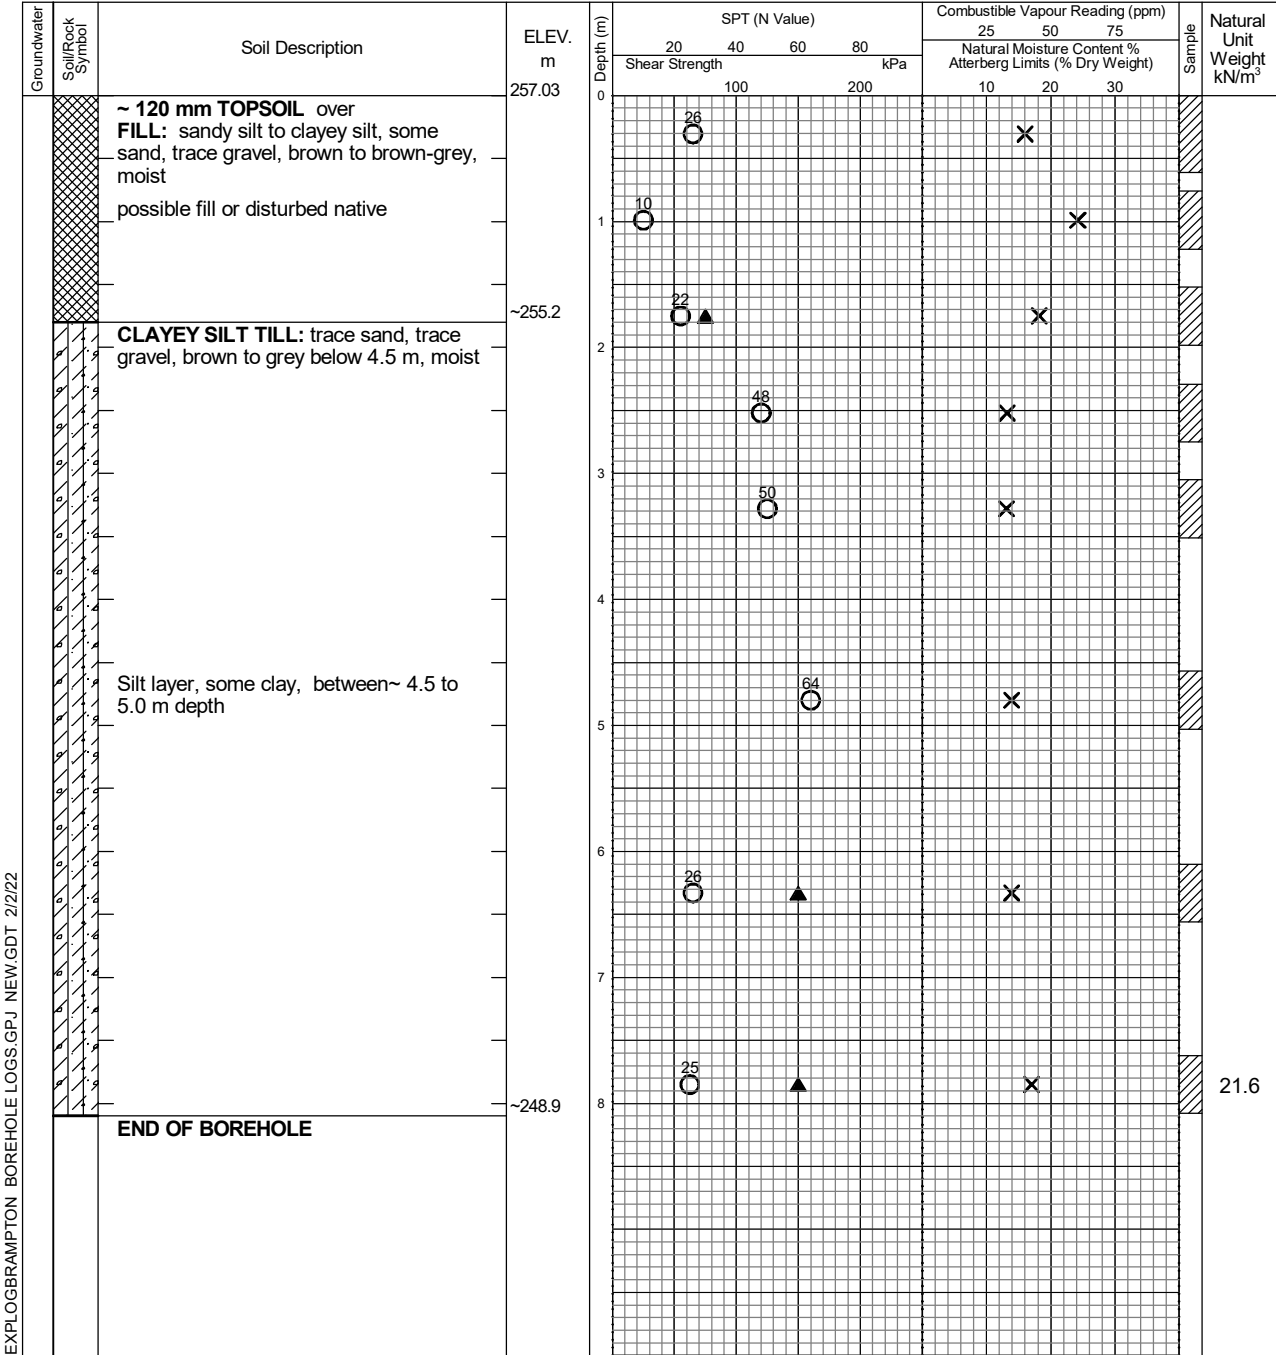
Date	Water Level (m)	Hole Open to (m)
On completion	8.0

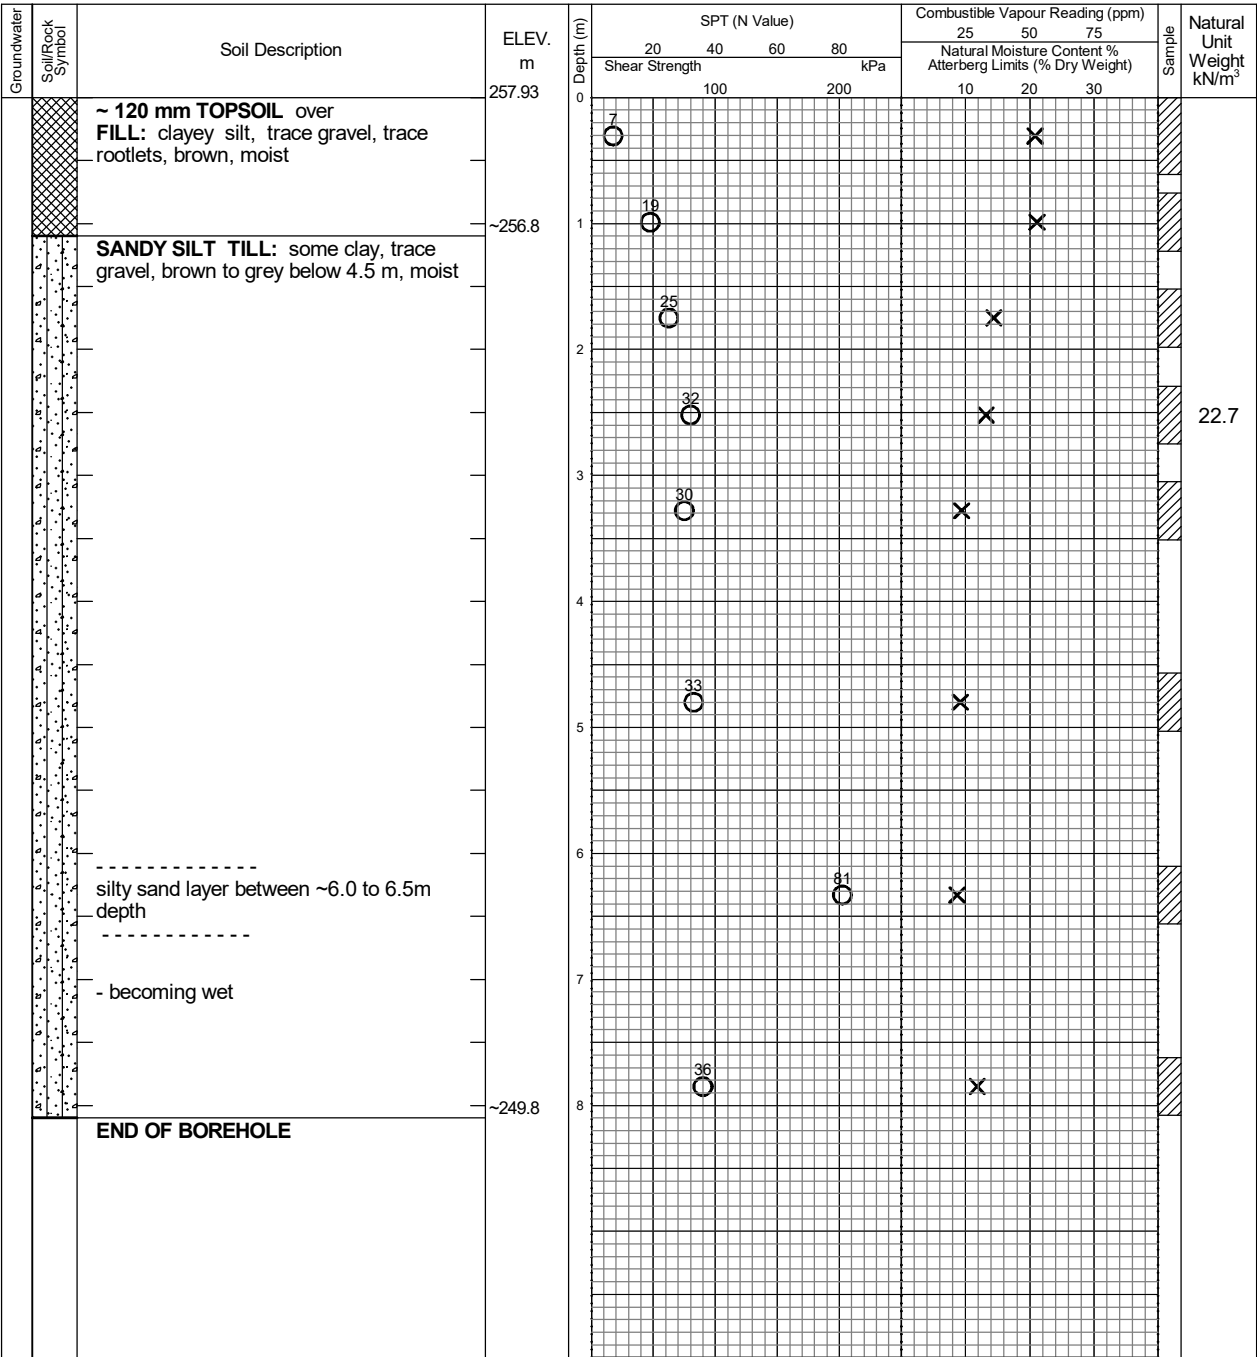
Date	Water Level (m)	Hole Open to (m)
On completion	7.0

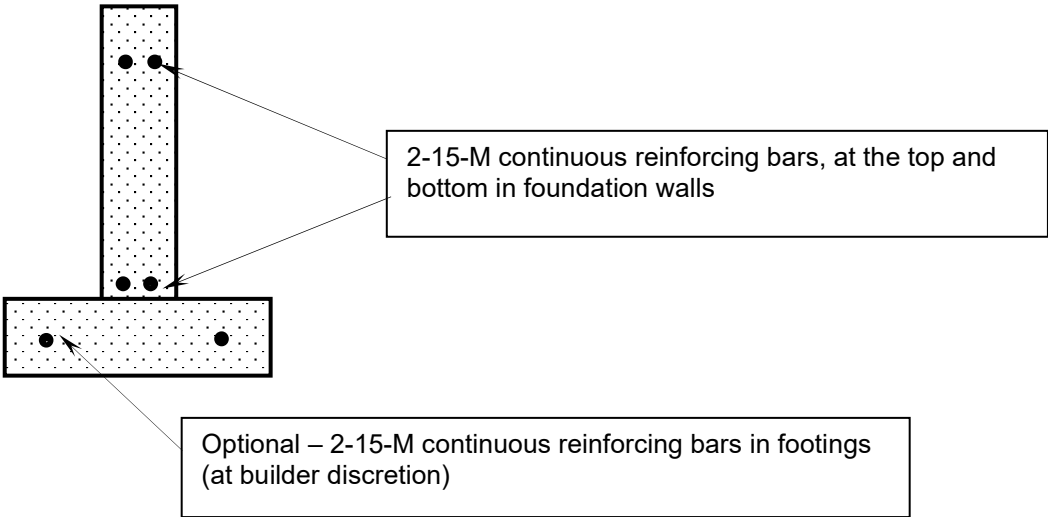
**Steel Reinforcement for Footings and Foundation Walls on Engineered Fill**

The sketch below outlines the reinforcement required for footings founded on engineered fill.

**Note: At windows, reinforcing bars should be placed both above and below the windows.**

It is recommended that nominal reinforcing steel be installed in the footings and foundation walls of structures supported on engineered fill to minimize cracking from differential settlement. The basement walls should be reinforced continuously with 2-15M bars above the footings and below the windowsill. If the basement walls are made from concrete blocks, equivalent top and bottom reinforcing should be provided as designed by a structural engineer.

If the dwellings are founded on engineered fill, reinforcement should be provided in the foundation wall as shown in Drawing 8.

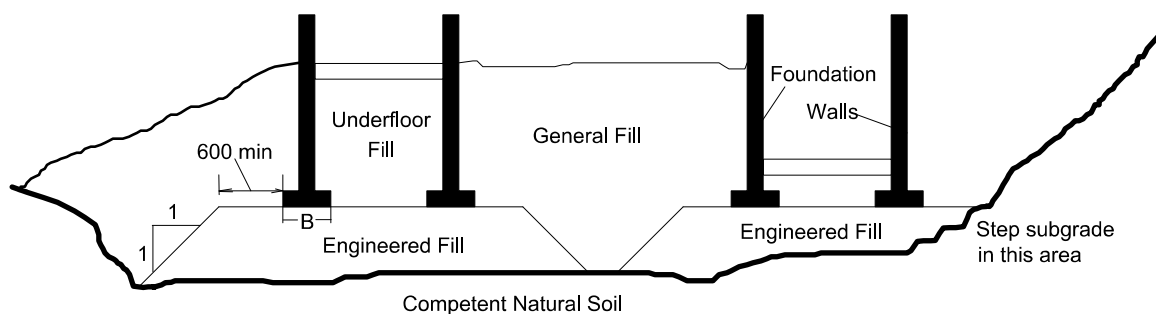
Foundations on Engineered Fill (schematic)

- The area must be stripped of all topsoil, existing fill material or other deleterious material and proof-rolled. Soft spots must be dug out. The stripped native subgrade must be examined and approved by a geotechnical engineer prior to placement of fill.
- The approved engineered fill must be placed in loose lifts not exceeding 200 mm and compacted to 100% Standard Proctor dry density throughout. Granular fill is preferred.
- Full time geotechnical inspection during placement of engineered fill is required.
- The fill must be placed such that the specified geometry is achieved as follows:.

- A minimum footing width of 500 mm (20 inches) is suggested. It is recommended that poured concrete basement walls should be reinforced with 2 – 15M rebars above the footings and below the window sill.
- All excavations must be done in accordance with the Occupational Health and Safety Regulations of Ontario.

Foundations placed on engineered fill comprising native soil from the site - or imported materials - may be designed for an SLS geotechnical reaction of 150 kPa (ULS factored geotechnical resistance of 225 kPa).

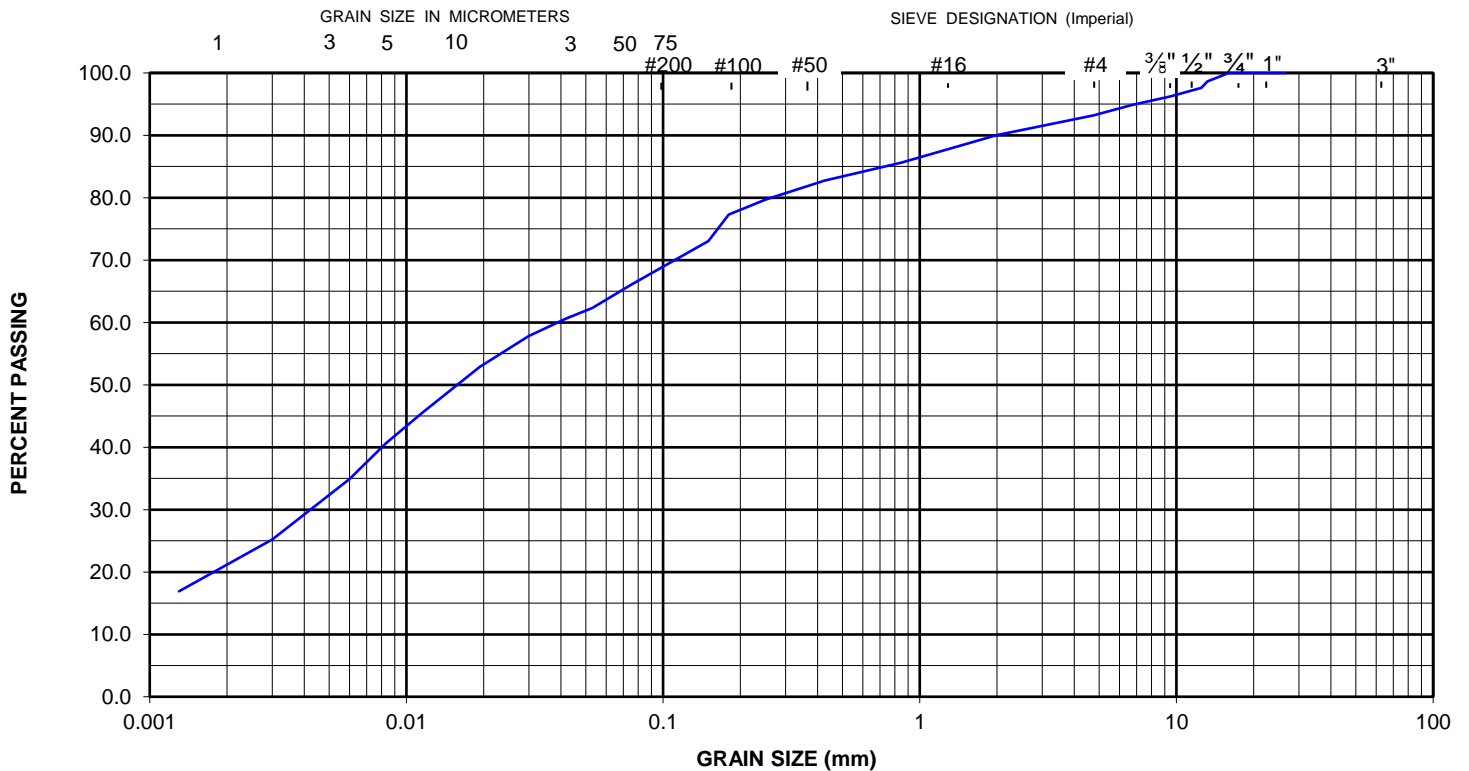
UNIFIED SOIL CLASSIFICATION SYSTEM

CLAY AND SILT	SAND			GRAVEL	
	Fine	Medium	Coarse	Fine	Coarse

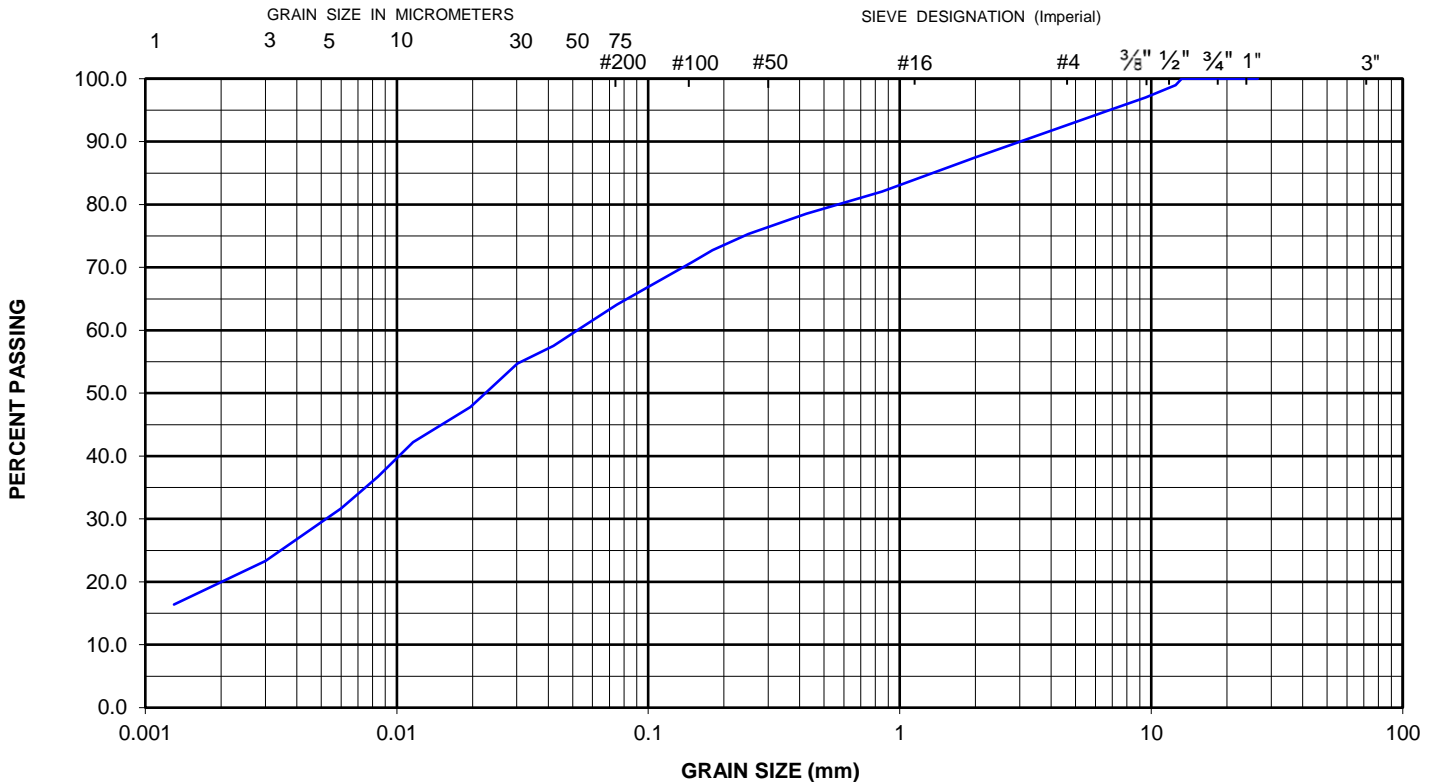
UNIFIED SOIL CLASSIFICATION SYSTEM

CLAY AND SILT	SAND			GRAVEL	
	Fine	Medium	Coarse	Fine	Coarse

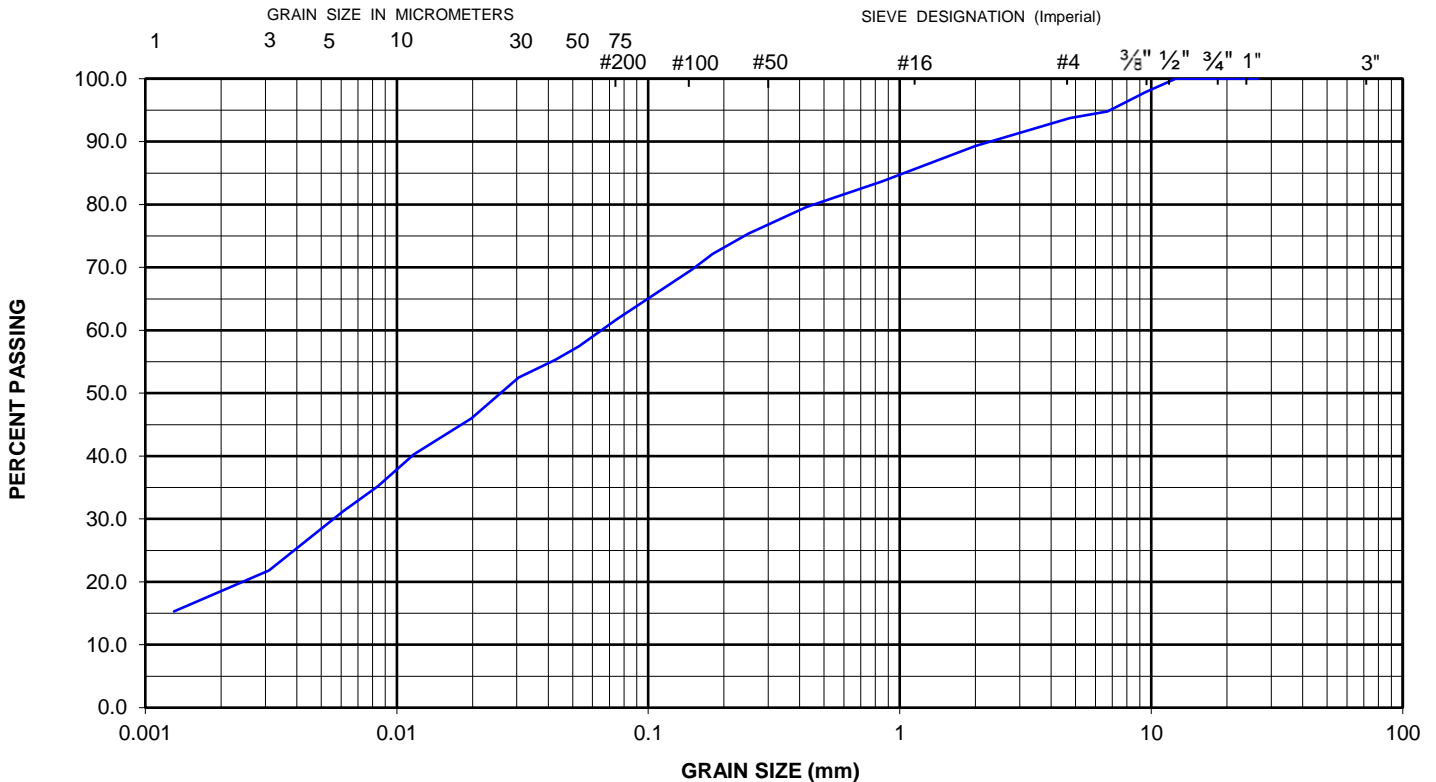
UNIFIED SOIL CLASSIFICATION SYSTEM

CLAY AND SILT	SAND			GRAVEL	
	Fine	Medium	Coarse	Fine	Coarse

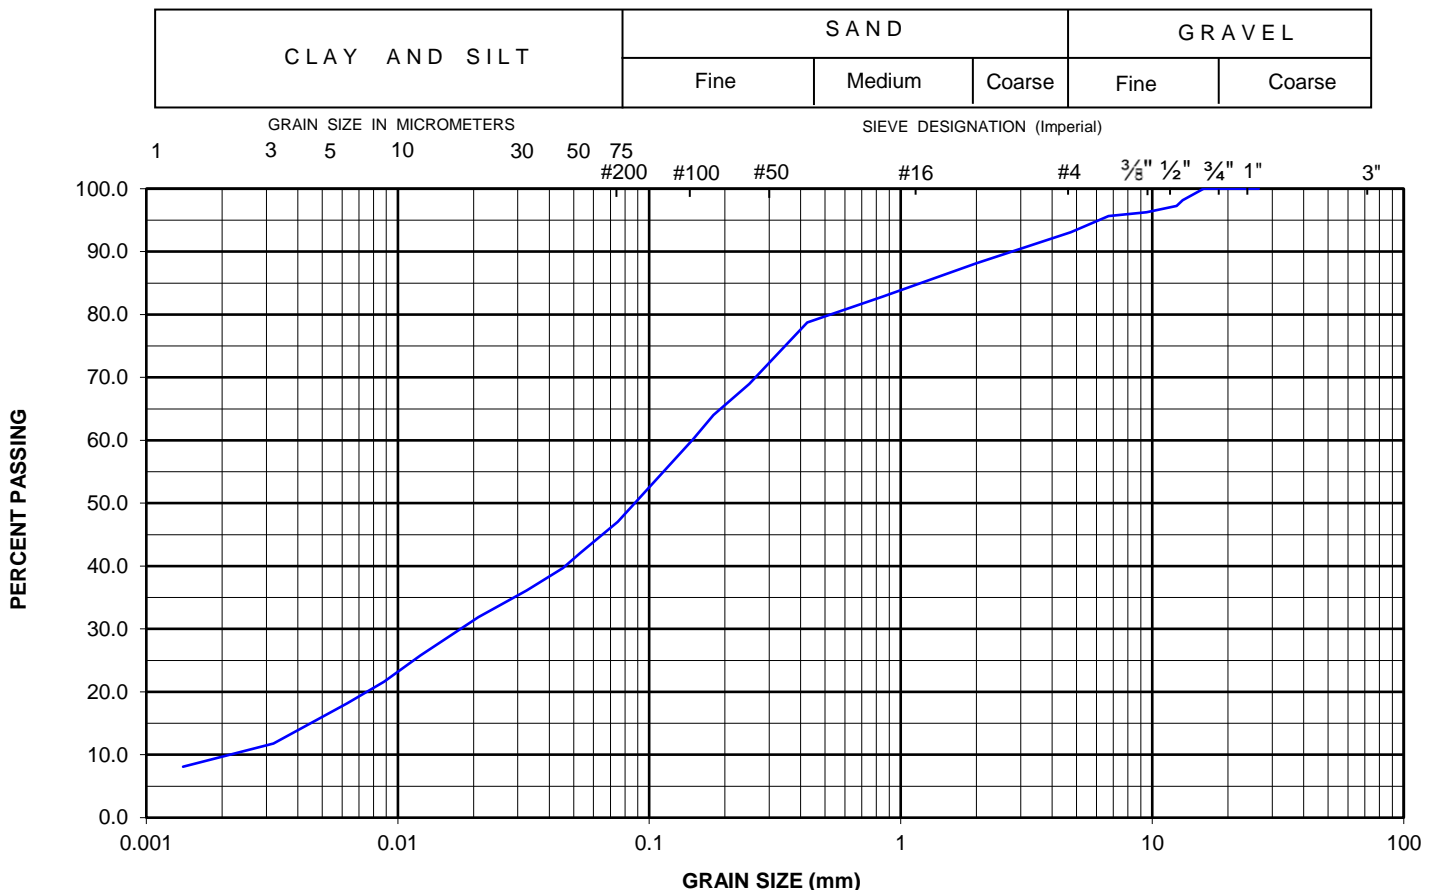
Grain Size (mm)	% Passing	Grain Size (mm)	% Passing
26.5	100.0	0.0454	39.7
22.4	100.0	0.0325	36.1
19	100.0	0.0209	31.9
16	100.0	0.0123	25.8
13.2	98.2	0.0088	21.6
12.5	97.3	0.0063	18.2
9.5	96.2	0.0032	11.8
6.7	95.7	0.0014	8.1
4.75	93.1		
2	88.1		
0.85	82.8		
0.425	78.7		
0.25	69.0		
0.18	64.0		
0.15	60.2		
0.075	47.0		
0.053	42.1

UNIFIED SOIL CLASSIFICATION SYSTEM
