**Summary Action Report**  
**Structure B20092243 (MTO Site No. )**  
**Old School Road, 0.45 km West of Torbram Road**

Inspection Date 06/10/2021 mm/dd/yyyy

# Municipal Structure Inspection Form

**B20092243**

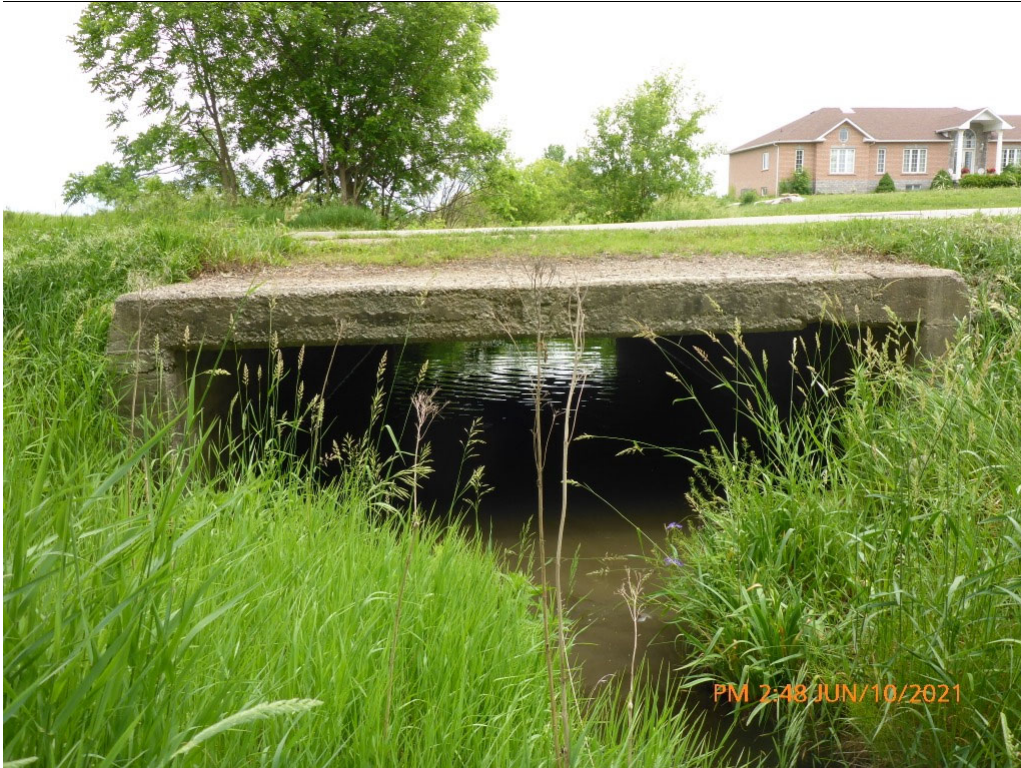
**North Elevation - Photo 3**

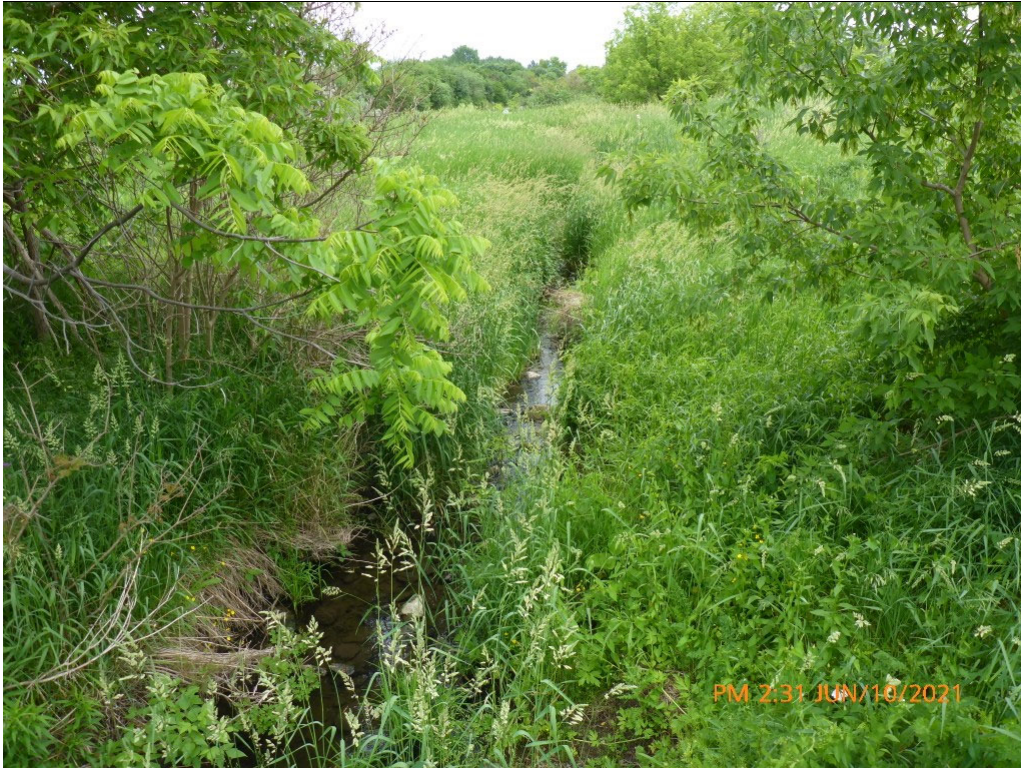
**Looking South Downstream - Photo 25**

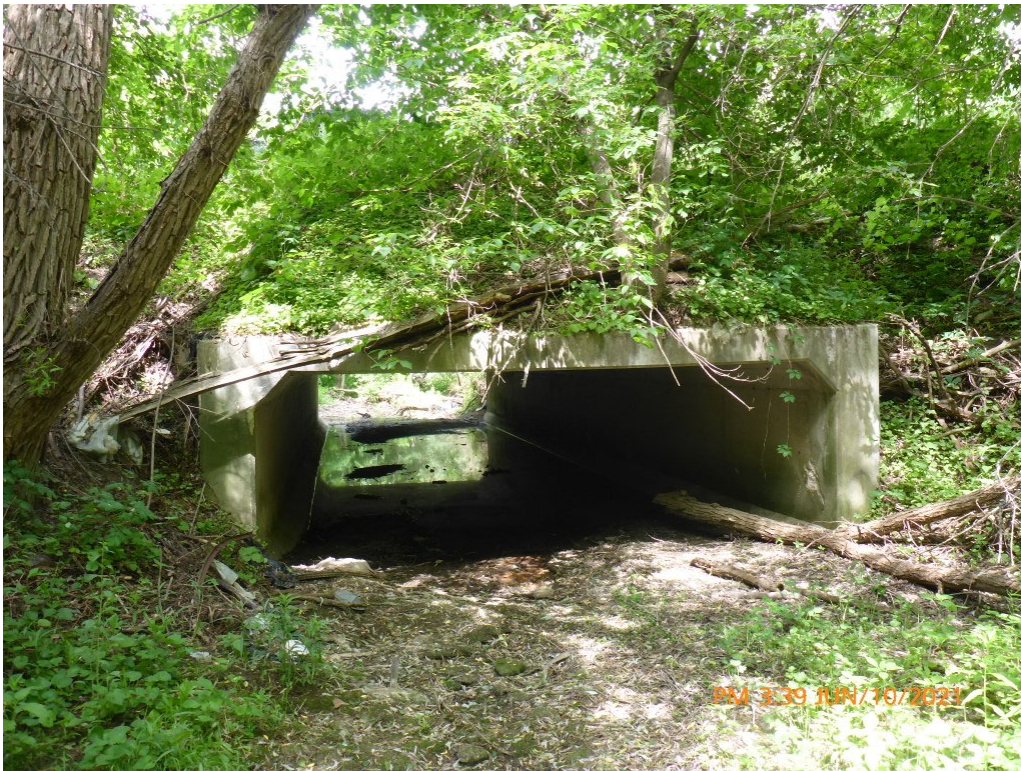
**West Elevation - Photo 4**

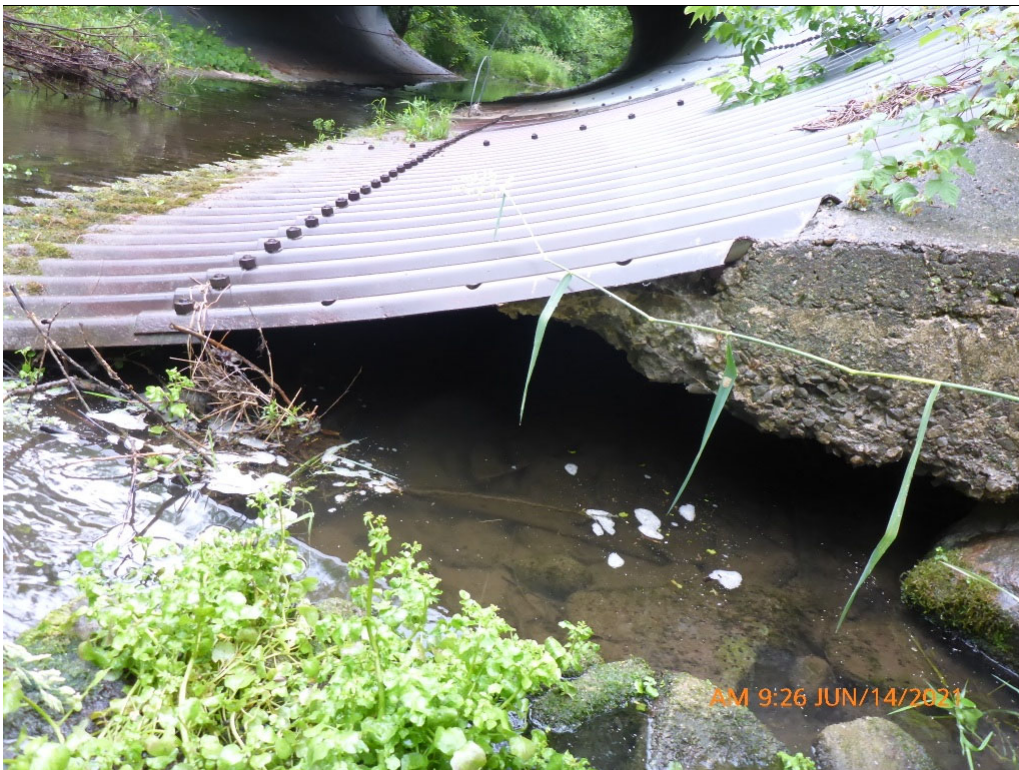
**Embankments and Streams - Embankments - Vegetation Overgrowing Culvert at West - Photo 37**

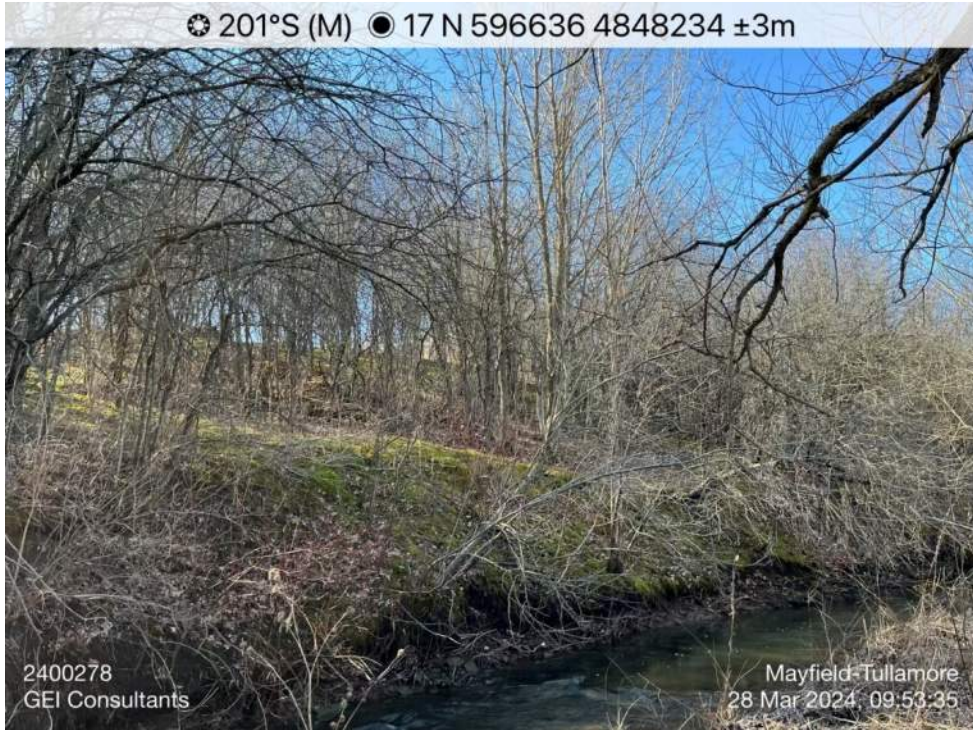
<p>2400278 GEI Consultants</p> <p>Mayfield-Tullamore 28 Mar 2024 09:53:35</p>	<p><b><u>PHOTOGRAPH 21</u></b></p> <p><b>Description:</b> Water feature and base of slope at Broccolini Slope 02. Evidence of scour at bank of water feature.</p> <p>(GEI 2024)</p>
<p>☼ 213°SW (M) ● 17 N 596730 4848303 ±4m</p>

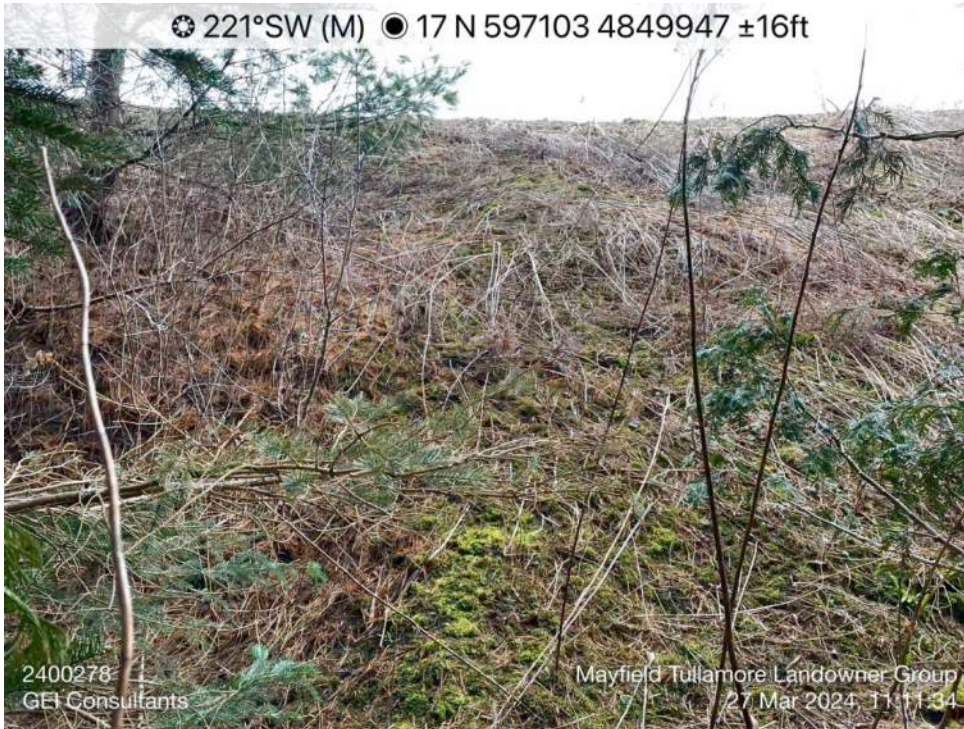
**PHOTOGRAPH 44**

**Description:**  
Face of slope from  
bottom of slope at  
DG2 Slope 01.

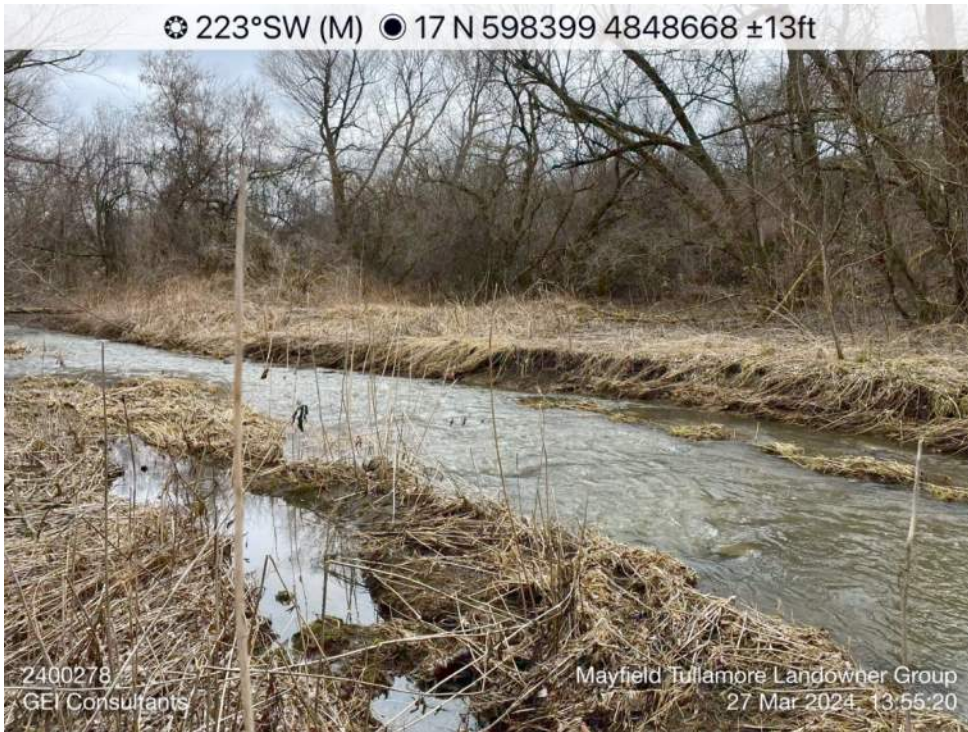
**PHOTOGRAPH 47**

**Description:**  
Water feature at DG3  
Slope 01. Scour  
along water edge.

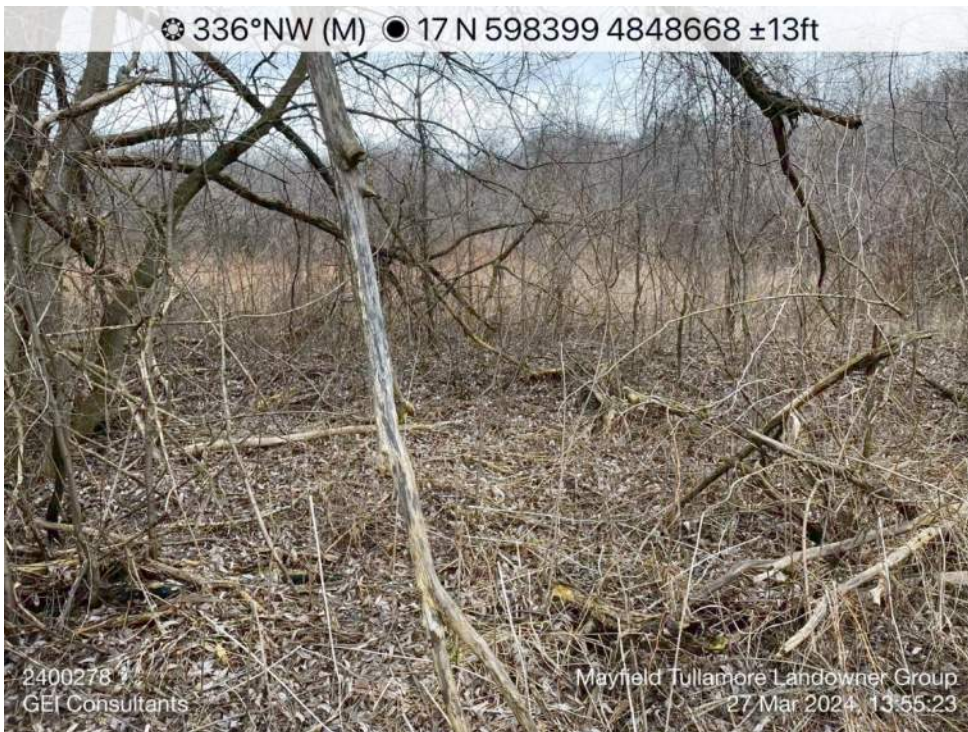
**PHOTOGRAPH 48**

**Description:**  
Floodplain at DG3  
Slope 01.

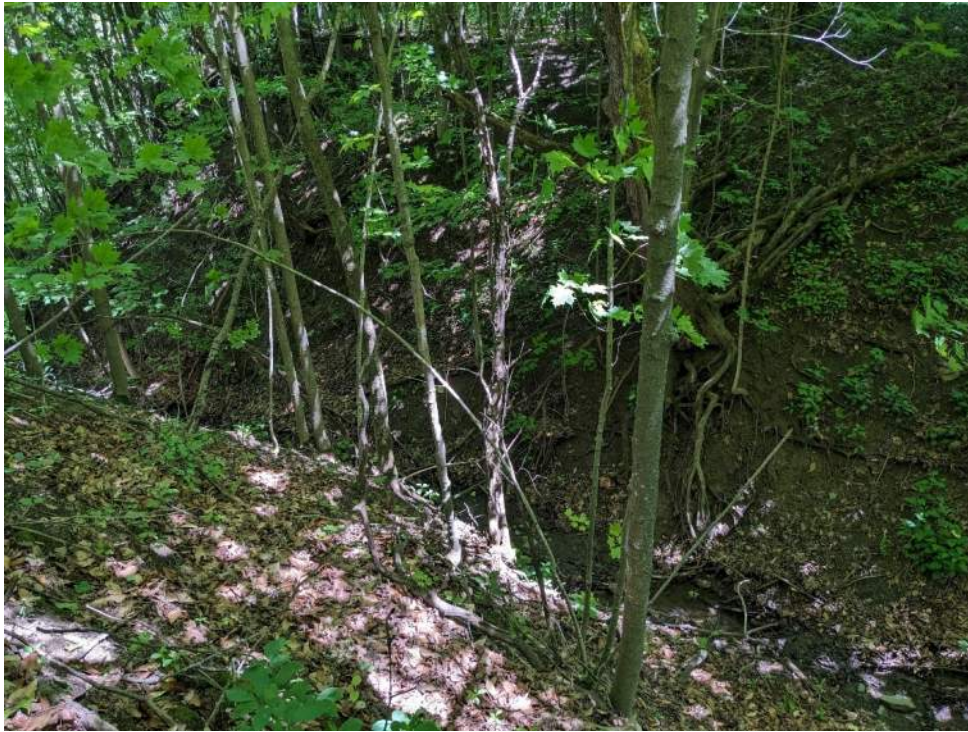
**PHOTOGRAPH 51**

Two distinct erosion gullies were observed on site, extending from the tableland to the bottom of the slope. The gullies appear to originate from tile drains actively discharging water. Both gullies extend back into the tableland and have over-steepened sidewalls with exposed roots and active erosion.

Large erosion gully cutting into the slope at DG4 slope. Flowing water within the gully observed from an outletting tile drain.

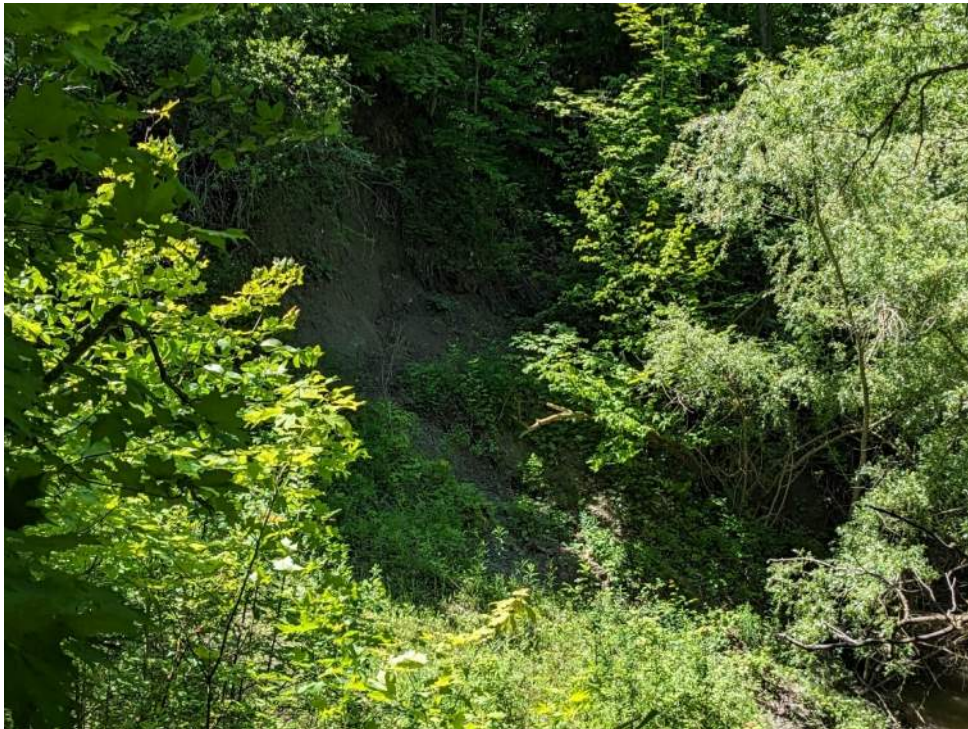
**PHOTOGRAPH 52**

A large rotational, bowl-shaped slope failure was observed extending from the top to bottom of the slope, expected to be the result of toe erosion and downcutting undermining the slope. The scarp was near-vertical. Fallen / tilting trees in the failure area.

Large rotational slope failure at DG4 slope. Likely caused by active toe erosion from the river.

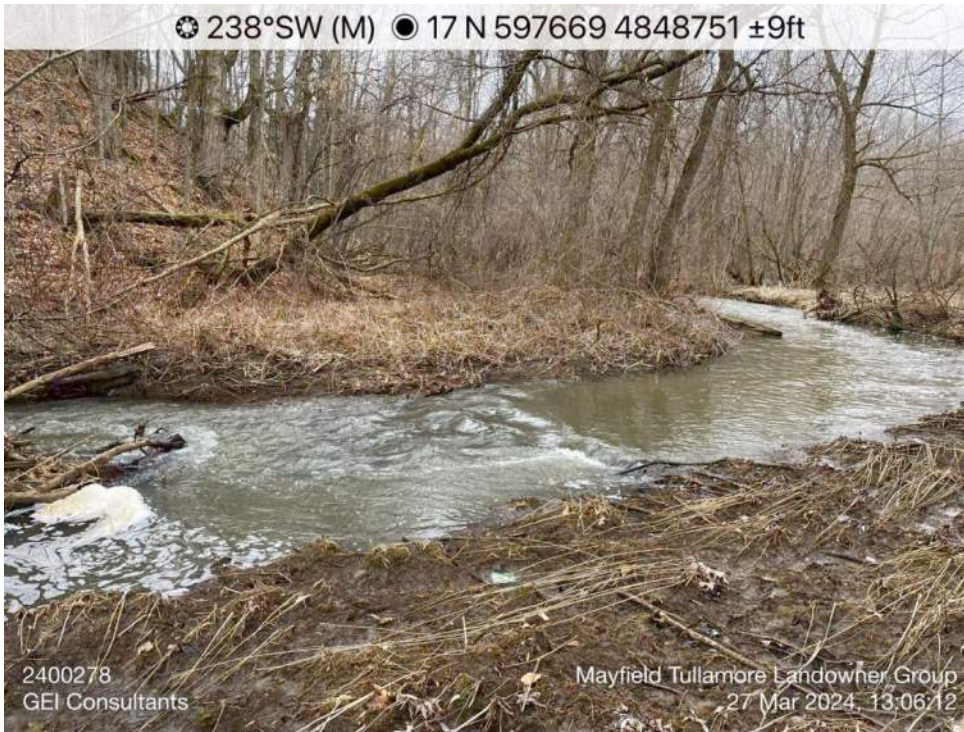
**PHOTOGRAPH 53**

**Description:**  
West Humber River  
tributary near the  
DG4 slope.

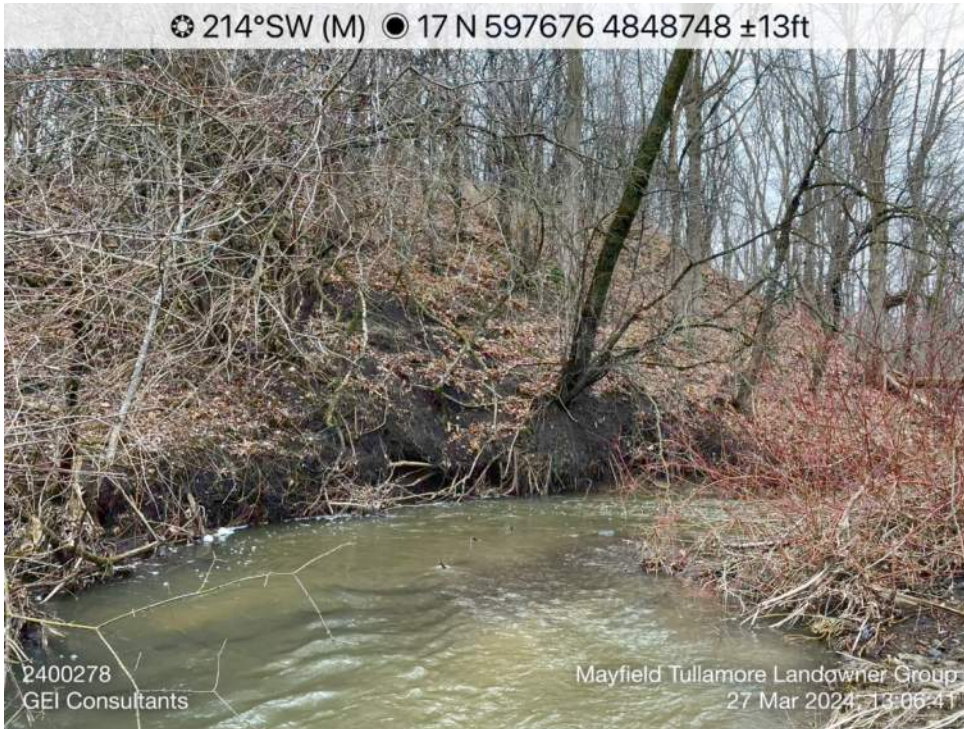
**PHOTOGRAPH 54**

**Description:**  
West Humber River  
tributary near the  
DG4 slope. Active  
erosion at water edge  
/ slope toe observed.
